# National Transportation Safety Board

WPR22FA255

## **AIRFRAME AND ENGINE EXAMINATION**

Location: Lake McMurray, Washington  
Date: 07/16/2022  
Time: 0730 PDT  
1430 UTC  
Airplane: N2588C, Aeronca 7BCM

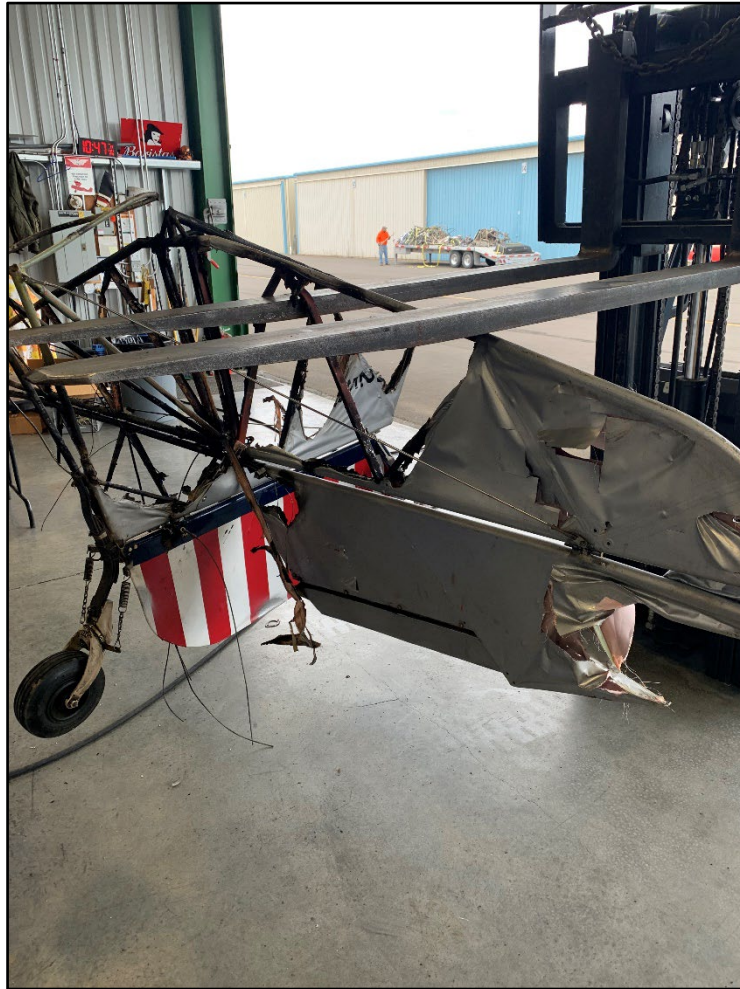
The airframe sustained impact damage and significant thermal damage to the fuselage and wings. The empennage was relatively intact. The vertical stabilizer was attached and sustained impact and thermal damage. The rudder was attached and sustained impact damage. The left horizontal stabilizer and elevator were attached and relatively intact and the right horizontal stabilizer and elevator were attached and sustained thermal damage.

**Figure 1: The airplane's empennage as viewed from the right side.**

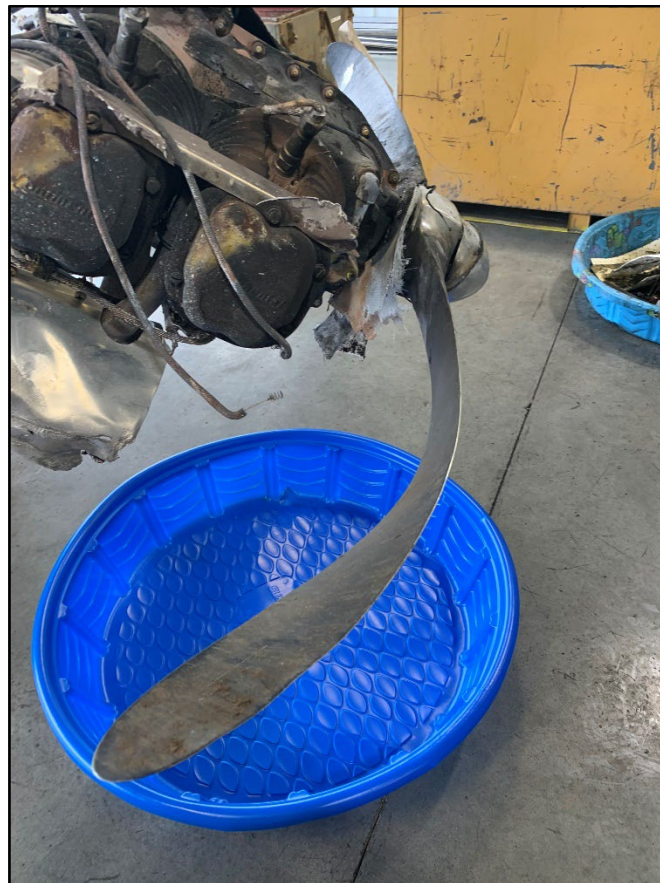
The engine was separated from the fuselage for the recovery and sustained impact and significant thermal damage. The top engine mounts were intact and the bottom engine mounts sustained impact damage. No catastrophic damage was noted. The rocker covers were removed and there was evidence of heat distress from thermal damage on the left-side cylinders, and on the right- side cylinders, the valves were appropriately lubricated. Rotational continuity was unable to be established due to extensive thermal damage. The top spark plugs were removed, and the electrodes were undamaged and exhibited coloration consistent with normal wear in accordance with Champion AV-Chart.

**Figure 2: The engine as viewed from the right side.**
