# National Transportation Safety Board

WPR22FA255

## **ACCIDENT SITE SUMMARY**

Location: Lake McMurray, WA  
Date: July 16, 2022  
Time: 0730 PDT  
1430 UTC  
Airplane: N2588C, Aeronca 7BCM

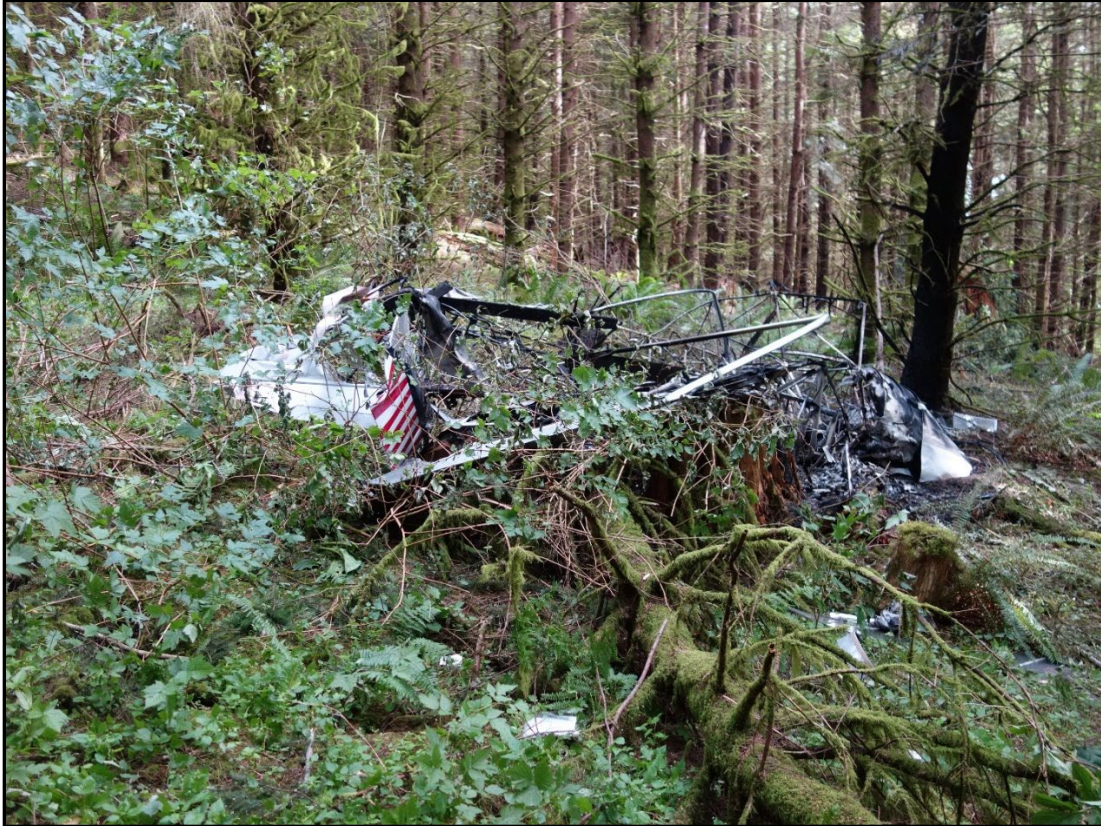
Most of the wreckage debris, consisted of small fragments of the fuselage and windshield and of the landing gear that had sheared off. Flight control continuity was unable to be established on site due to the extensive impact and thermal damage sustained by the airplane.

**Figure 1: Airplane wreckage at accident site as viewed from the right side.**

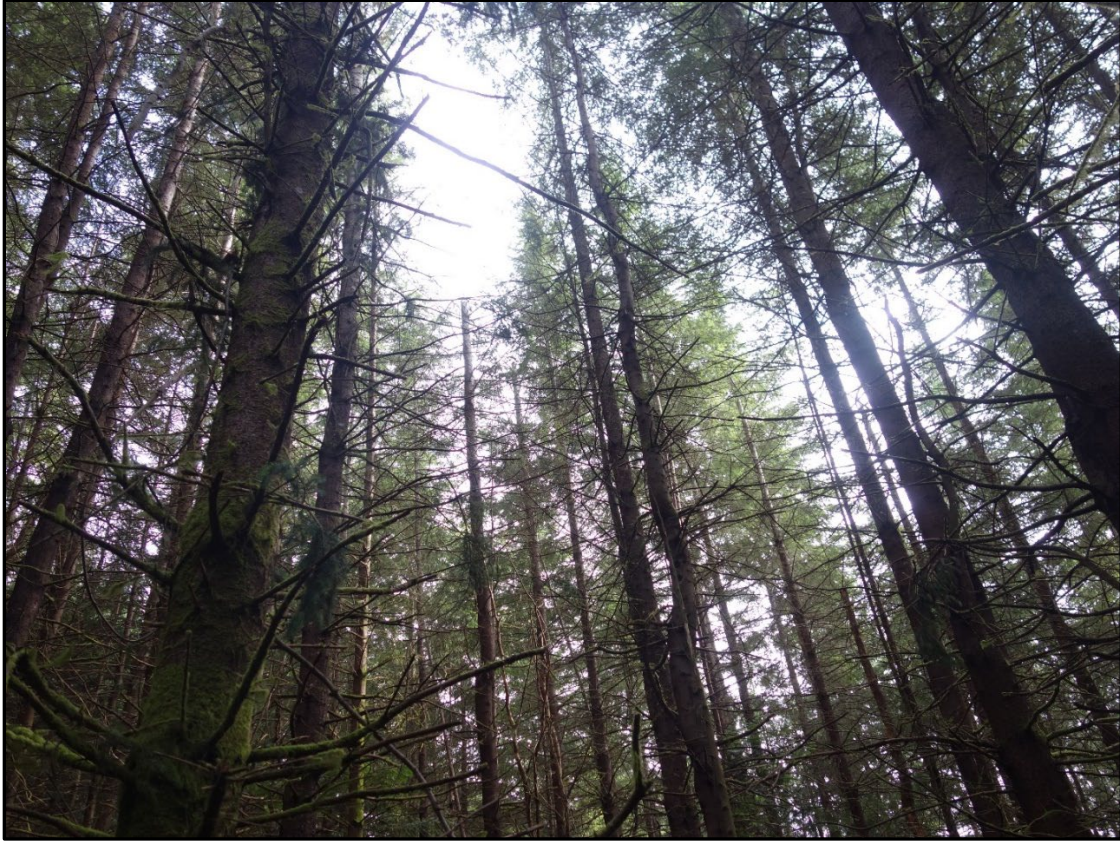
The terrain consisted of tall trees over about 120 ft in height on a hill slope of about 15°. The terrain was noted to be lower in elevation to the south. On the trees with separated tops, small fragments of aircraft debris were intertwined in the broken off branches that were scattered near the base of the trees. Fragments of the airplane were scattered about 120 ft from the main wreckage.

**Figure 2: Trees near accident site; some with damage to the top.**
