# National Transportation Safety Board

WPR22FA256

## **ACCIDENT SITE, AIRFRAME, AND ENGINES EXAMINATION**

Location: Gold Hill, Colorado  
Date: July 17, 2022  
Time: 0938 mountain daylight time  
Airplane: N337KN, Cessna P337G

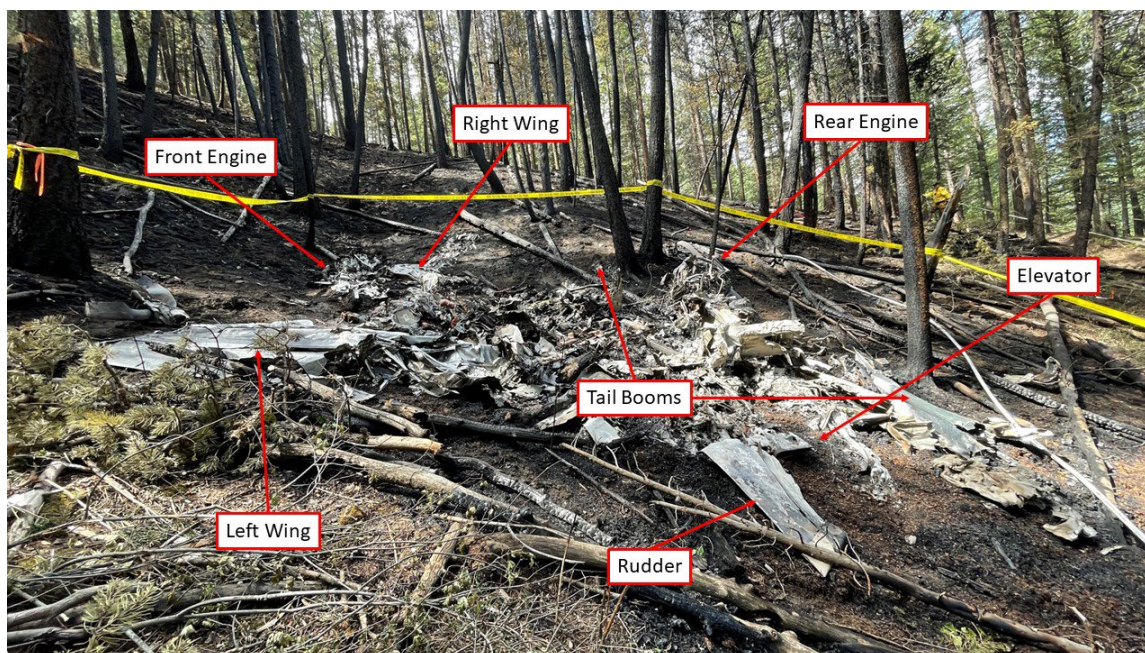
**Figure 1: Accident Site Diagram**

Examination of the accident site revealed that the airplane impacted mountainous terrain on a heading of about 283° magnetic. The first identified point of contact was a cluster of 3 trees, that were severed/broken about 17 to 20 ft above the ground. The trees were grouped within an area of trees that were about 75 to 100 ft in height.

The airplane came to rest mostly upright on a heading of about 091° magnetic. All major structural components of the airplane were located within about a 30 ft by 40 ft area. The area surrounding the wreckage was fire damaged.

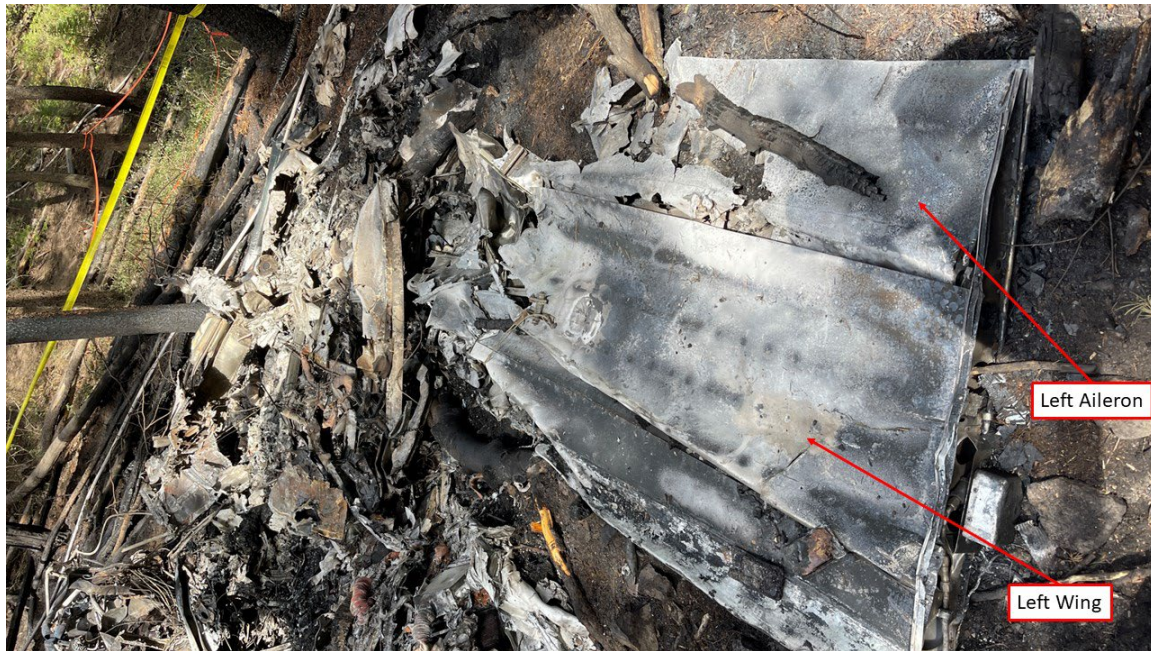
**Figure 2: Left wing**

The left wing was located adjacent to the fuselage, however, was displaced and found in an orientation that paralleled the fuselage. The inboard portion of the wing structure was mostly consumed by fire. The outboard portion of the wing was observed, and the outboard portion of the aileron remained attached to its mount. The unconsumed portion of the leading edge of the wing was slightly crushed throughout.

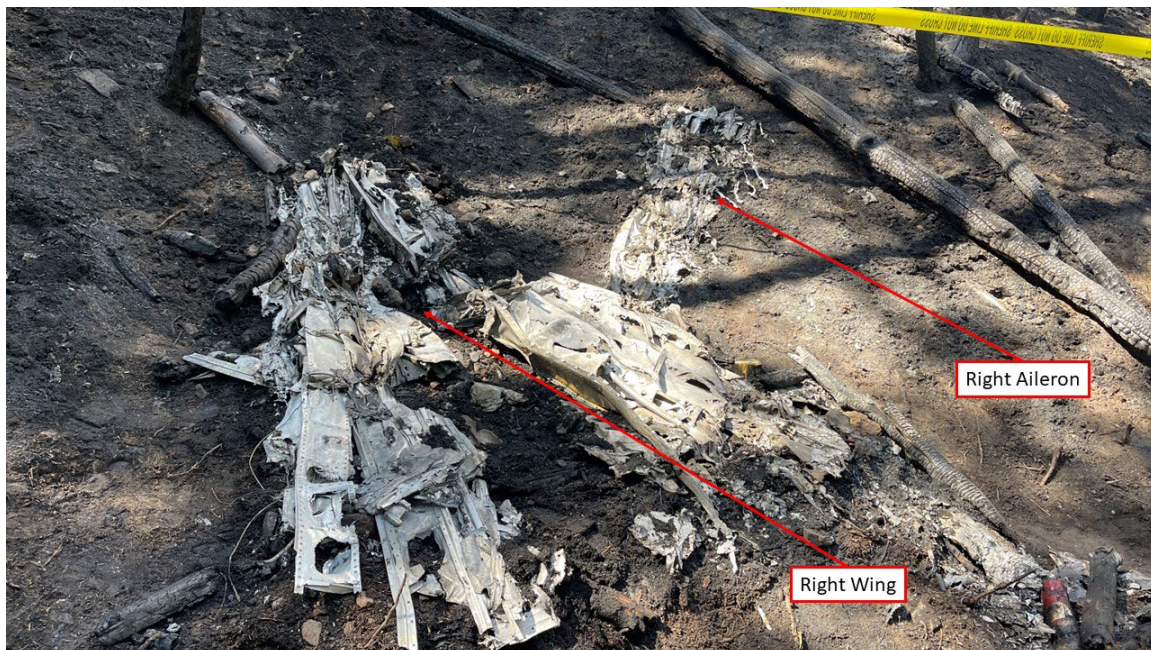
**Figure 3: Right Wing**

The right wing was located adjacent to the fuselage and was damaged by fire. The leading edge of the wing was crushed aft throughout its span to the main spar. The aileron remained partially attached (inboard mount) and was slightly displaced aft about 45°.

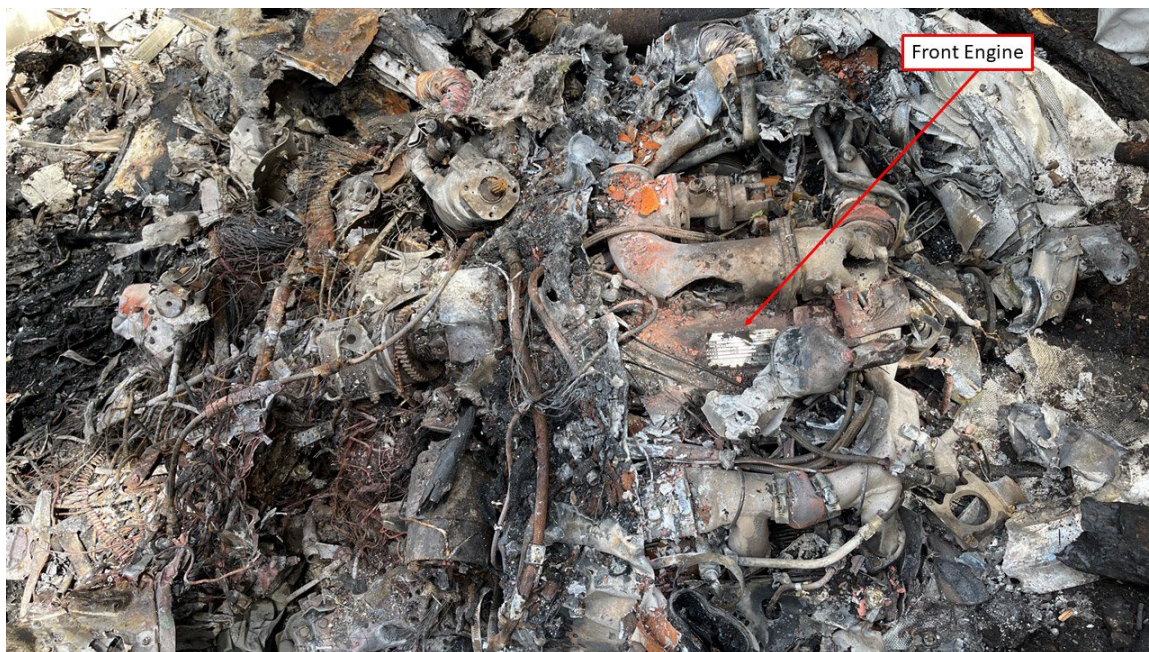
**Figure 4: Front engine**

The front engine appeared to have remained attached to the airframe and exhibited varying degrees of thermal damage. The induction system was impact damaged. The throttle cable remained attached to the throttle body. The propeller was separated from the crankshaft. Both propeller blades exhibited varying degrees of "S" bending, along with leading edge nicks and polishing. One propeller blade appeared in the feathered position, and the opposing blade appeared to be in a non-feathered position.

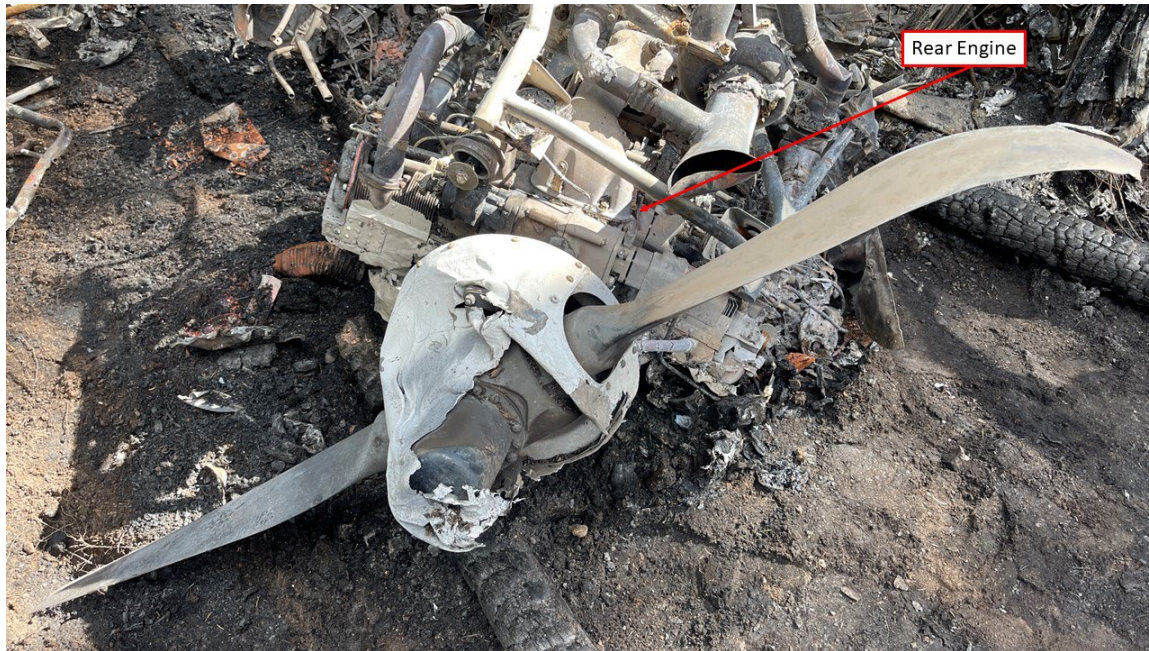
**Figure 6: Rear engine and propeller**

The rear engine remained attached to the engine mount structure and was found in an inverted position. The engine sustained significant thermal and impact damage. The oil sump was partially burned away, exposing the internal components of the engine. The 1/3/5 side of the engine exhibited significant impact damage to the cylinder heads. The turbo charger was impact damaged. The propeller remained attached to the engine, and both propeller blades appeared to be in a feathered position. One propeller blade exhibited a slight bend toward the non-cambered side of the blade just outboard of mid span. The opposing propeller blade appeared undamaged.

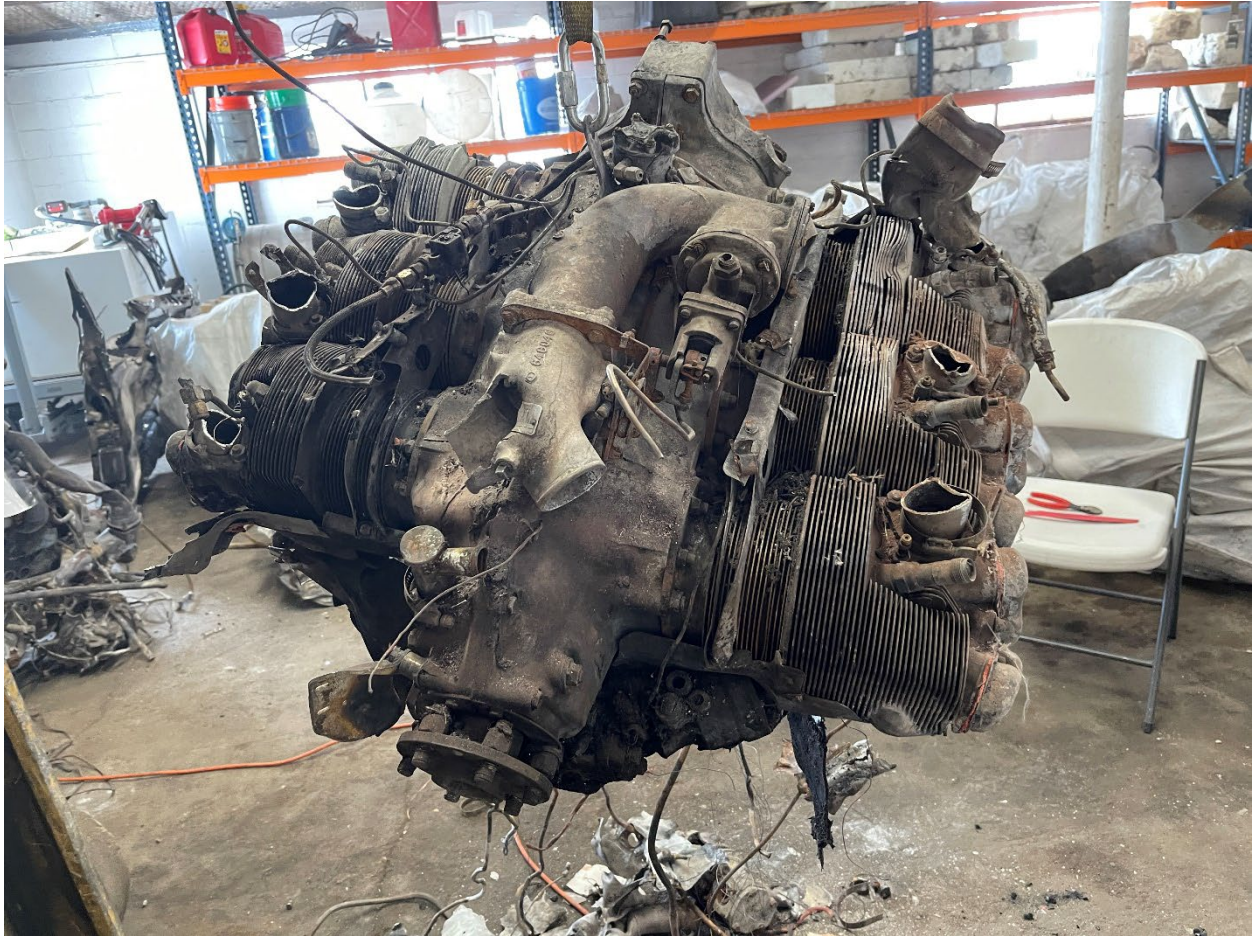
**Figure 7: View of the front engine**

The front engine was separated from its mounts. The engine exhibited extensive thermal and impact damage throughout. A large crack extending from the no. 6 cylinder across the upper portion of the crankcase, and downward in front of cylinder no. 5, to an area near the fuel pump mount was observed. The accessory housing was impact and thermally damaged, exposing the camshaft gears, crankshaft gears, and idler gears. The fuel pump was separated from its mounts. The starter adapter was impact and thermally damaged and separated from the engine. Visual mechanical continuity was established throughout the engine (crankshaft, camshaft, connecting rods). The cylinder no. 3 intake and exhaust rocker arms, and cylinder no. 5 exhaust rocker arm were intact. The throttle interconnect was intact and fire damaged and the throttle plate appeared to be in the full open position.

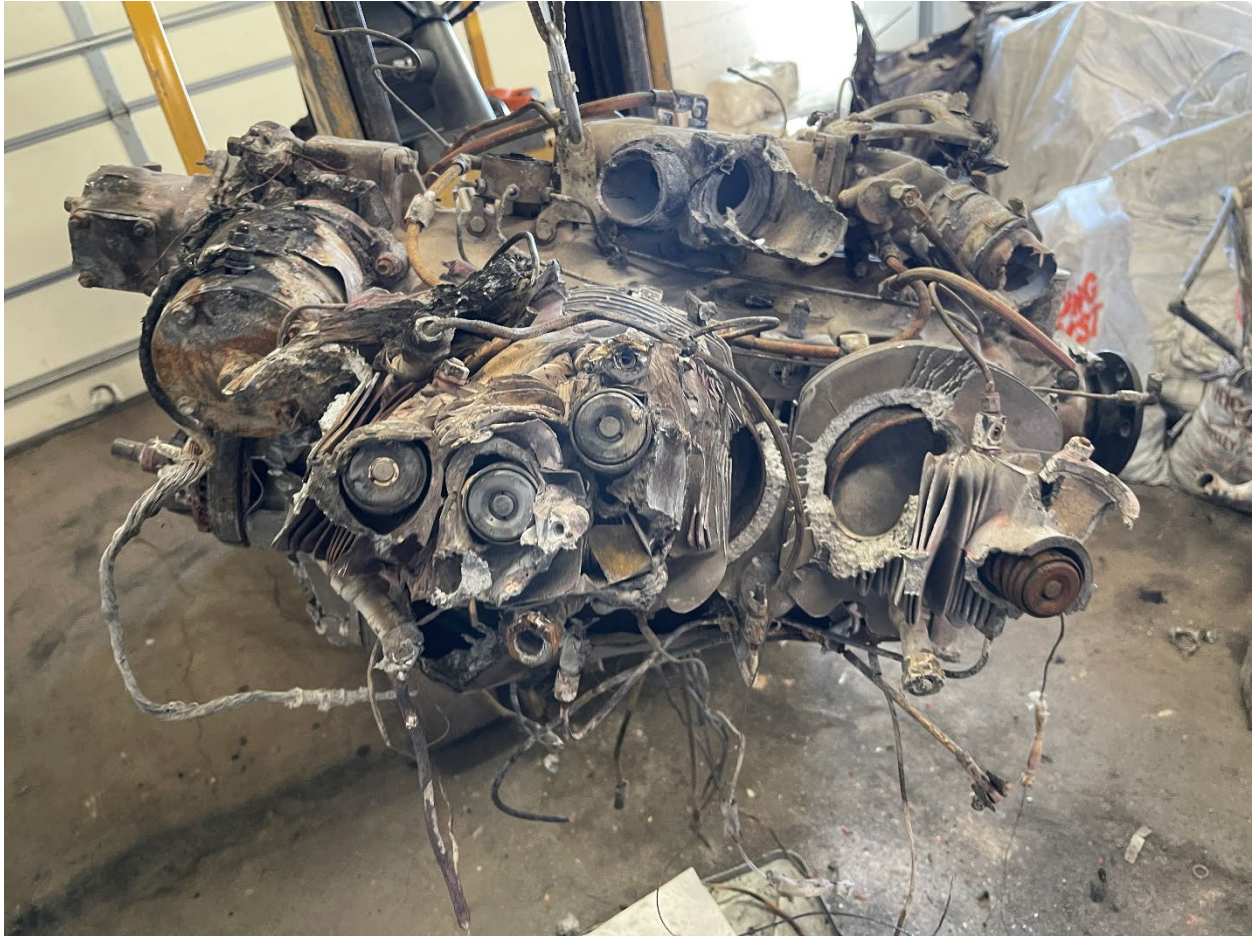
**Figure 8: Cylinder 1, 3, and 5 side of the engine**

Visual mechanical continuity was established throughout the crankshaft, camshaft, and connecting rods when looking through the burned away portion of the oil sump. The rocker box covers for cylinders 2, 4, and 6 were removed. Cylinder no. 4, 6, intake and exhaust rocker arms, and cylinder no. 2 exhaust were oil coated. The intake rocker arm on cylinder no. 2 was thermally damaged. Cylinders no. 2, 4, and 6 examined internally using a borescope, and were unremarkable with the exception of corrosion throughout the cylinders.

Cylinders 1, 3, and 5 exhibited extensive impact and thermal damage. The pistons of cylinder no. 1, 3, and 5 were exposed and exhibited varying degrees of corrosion.
