## Air Safety Investigations Aircraft Incident/Accident Technical Report

| Aircraft Incident/<br>Accident Information | Year: 1973 | Make: Cessna | Model: P337G |
| | Serial number: P337-0016 | | Registration: 337KN |
| Senior Air Safety Investigator: Ernest C. Hall | | Report #: ASI-22-BP-T | Report date: 02-08-23 |

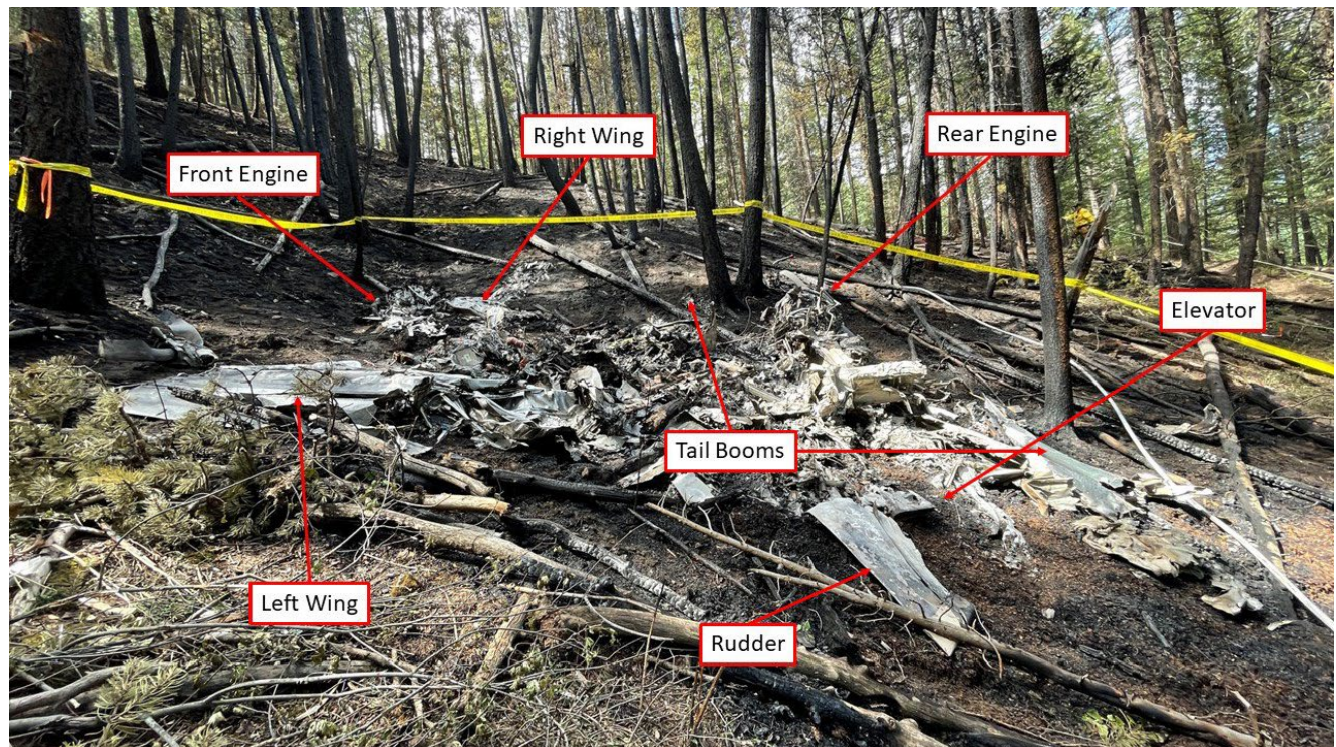
NTSB – Accident Site Diagram

The aircraft impacted the mountainous terrain on approximate magnetic heading of 283° in a nose down attitude. The first identified point of contact was a cluster of three trees that were severed/broken approximately 17' to 20' above the ground. The trees were grouped within an area of trees that were approximately 75' to 100' in height.

The aircraft came to rest mostly upright on a magnetic heading of approximately 019°. The rear engine and the tail booms came to rest inverted. The wreckage was contained within an area of approximately 30' x 40'. The area around the wreckage was fire damaged.

All four corners of the aircraft were accounted for at the accident site. Majority of the aircraft was thermally damaged.

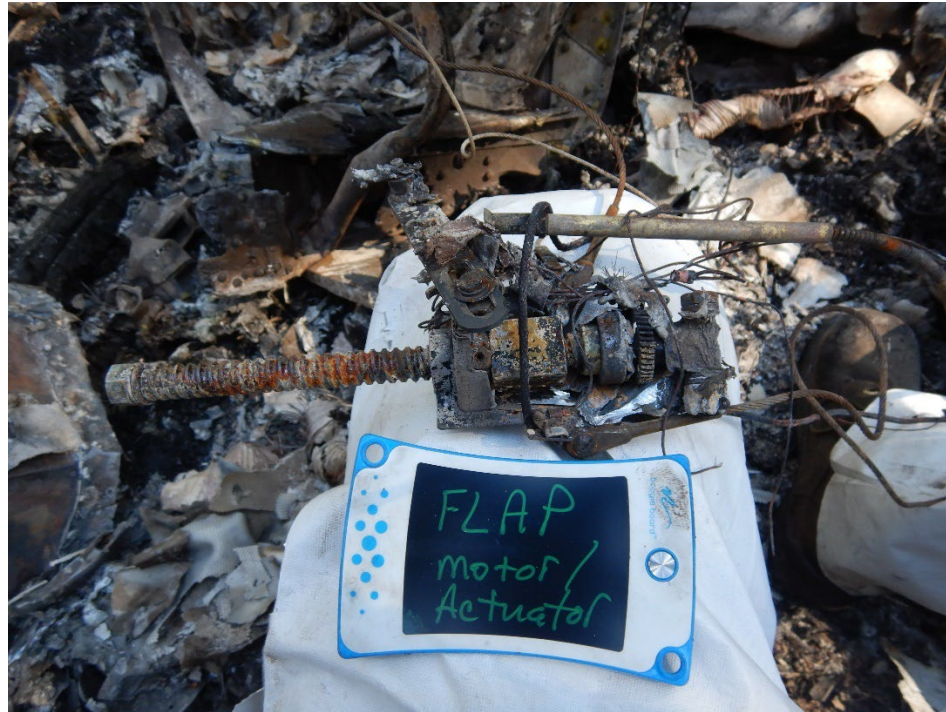
ASI-22-BP-061 – Flap Motor/Actuator

The flap actuator/motor exhibited thermal damage and the steel component remained. The flap motor/actuator was found in the UP position.

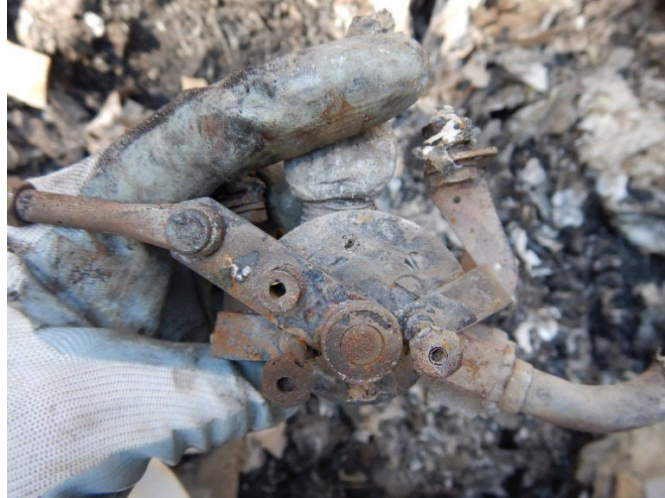
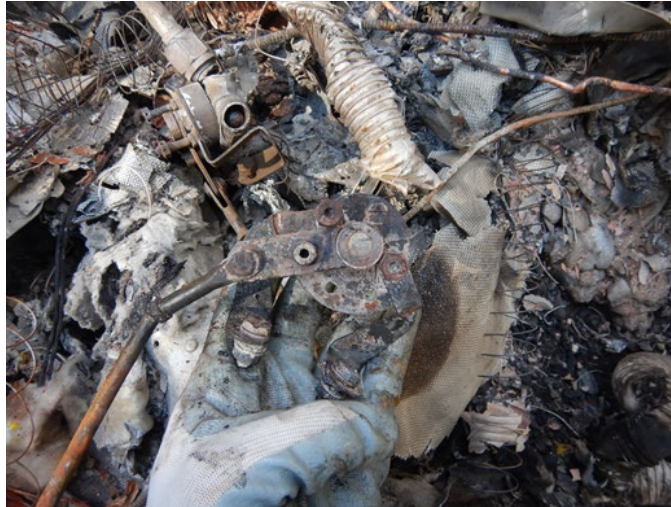
Both fuel selector handles were thermally damaged. Due to the thermal damage of the aircraft, the two fuel selector valves could not be determined which wing the fuel selector valve was installed. Both valves were found in ON (LH or RH Tank) position.

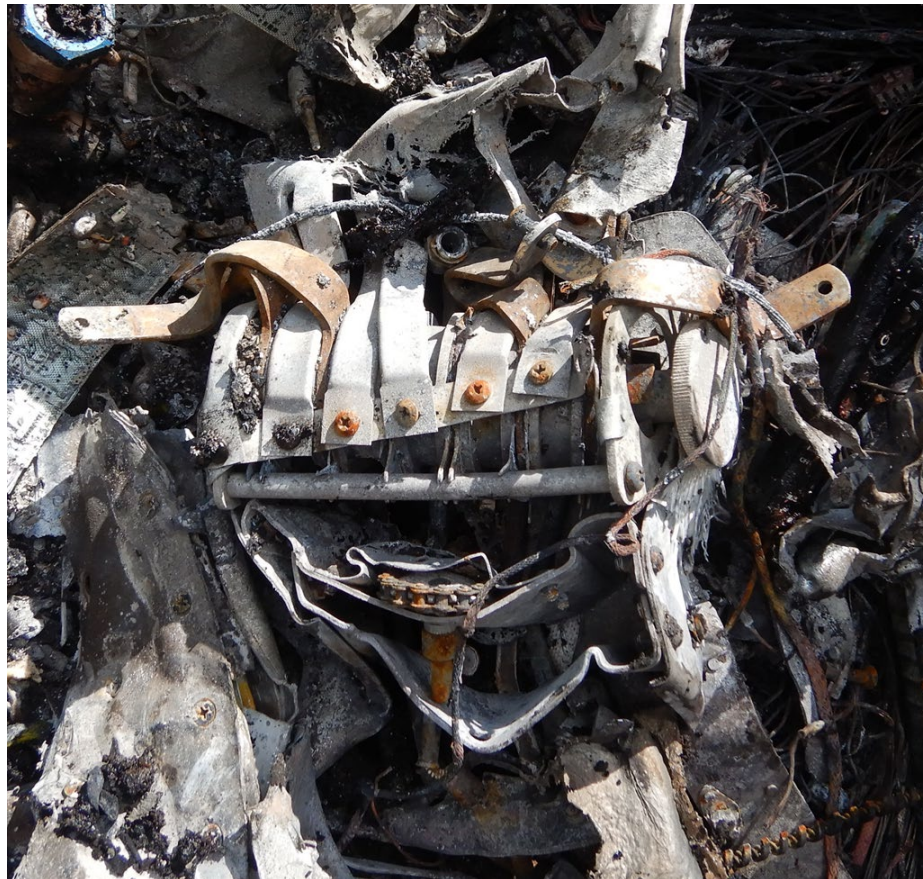
Cropped – ASI-22-BP-108 – Throttle Quadrant

The throttle quadrant exhibited impact and thermal damage.

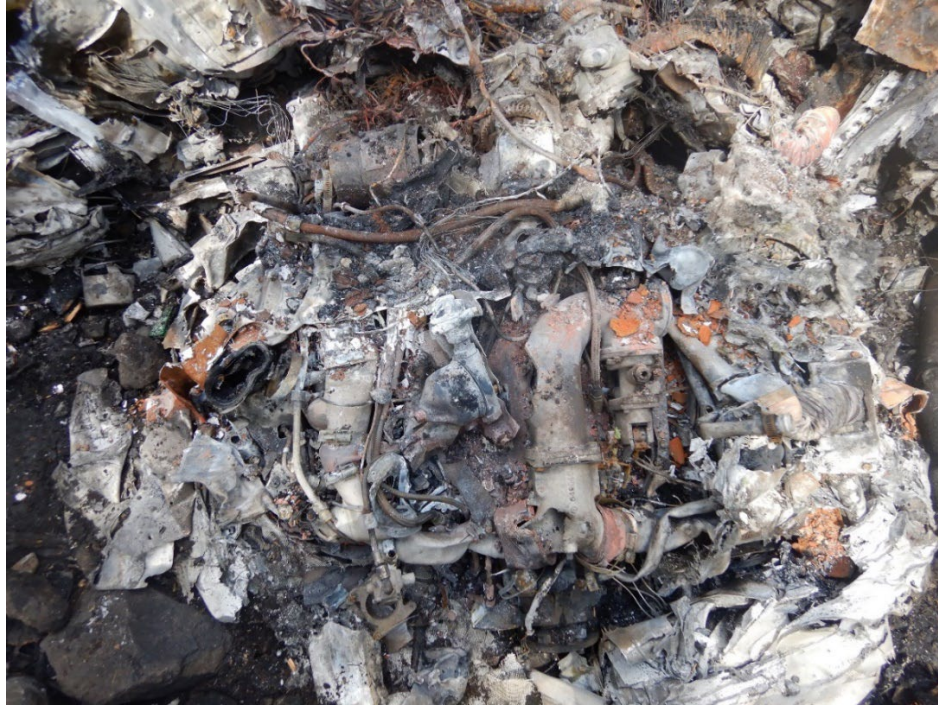
ASI-22-BP-128 – Front Engine

The front engine exhibited impact and thermal damage and was found upright. The induction system exhibited post-impact damage. The throttle cable remained attached to the throttle body.

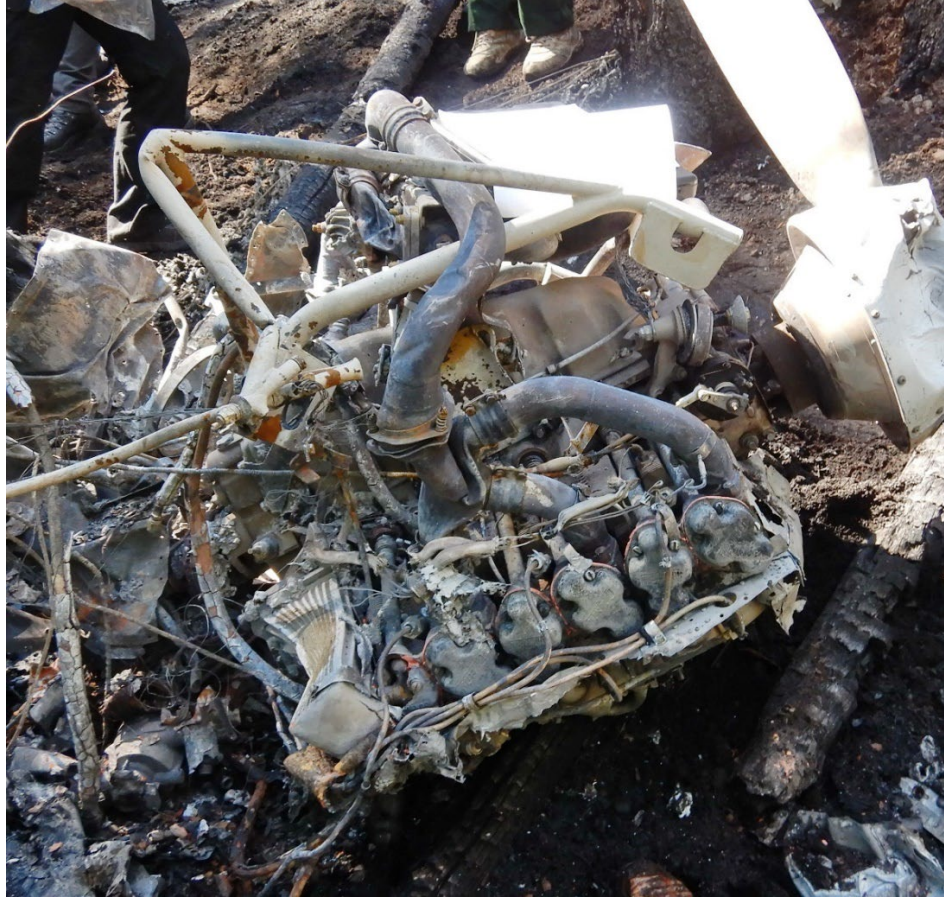
Cropped and Lighten - ASI-22-BP-075 – Rear Engine

The rear engine exhibited heat, thermal, and post-impact damage and was found inverted. The oil sump was partially burned away exposing the internal components of the engine. The #1-, #3-, and #5-cylinder heads exhibit post-impact damage. The turbo charger exhibited post-impact and thermal damage.

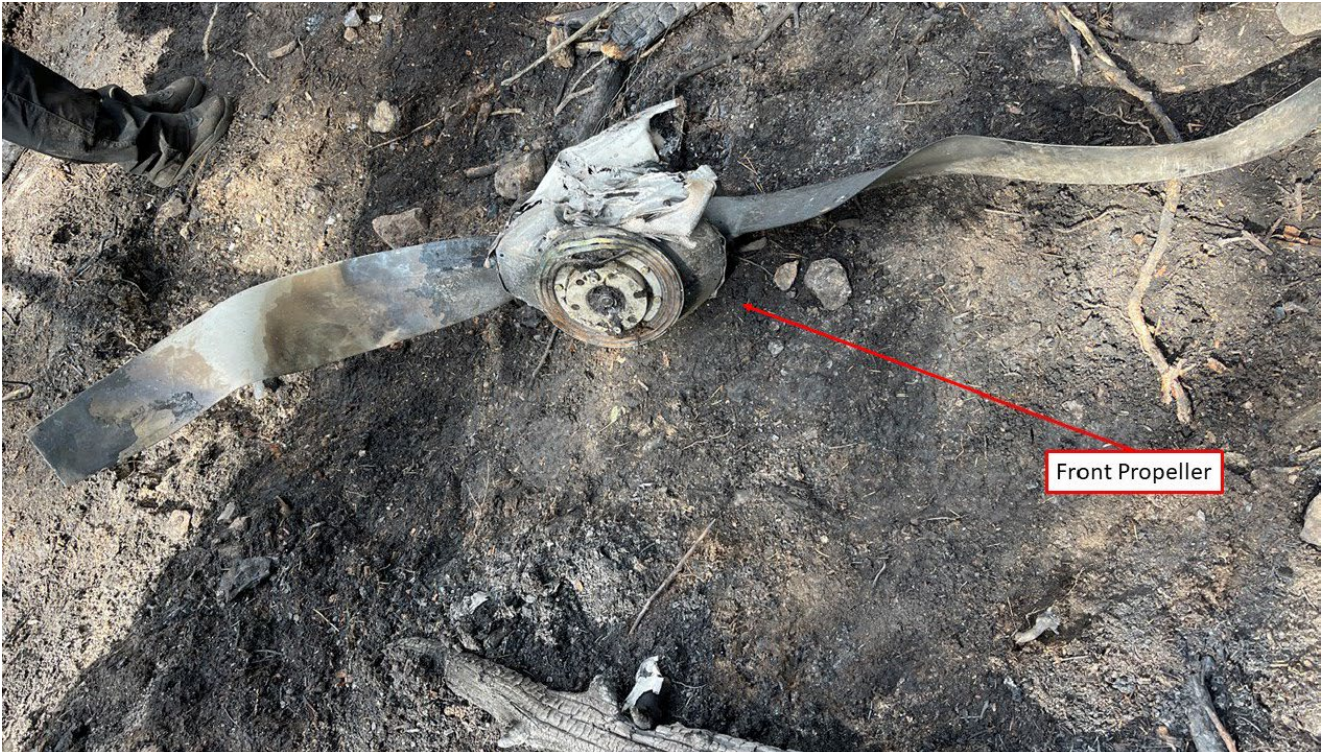
NTSB – Front Propeller

Both propeller assemblies exhibited impact and thermal/heat damage. The front 2-bladed propeller separated from the engine crankshaft flange. Both propeller blades exhibited varying degrees of “S” bending, leading edge nicks, and polishing. The rear 2-bladed propeller remained attached to the engine crankshaft flange. Both propeller blades appeared to be in the feathered position. One blade, approximately mid-section outboard, exhibited a slight bend to the non-camber side. The other was unremarkable. Both propeller assemblies are targeted to be examined at McCauley. At the writing of this report, a date and time has not been set.
