## **NATIONAL TRANSPORTATION SAFETY BOARD**

# **ACCIDENT SITE AND WRECKAGE EXAMINATION SUMMARY**

**WPR22FA264**

| Aircraft: | N8542W; PA-28-235 |

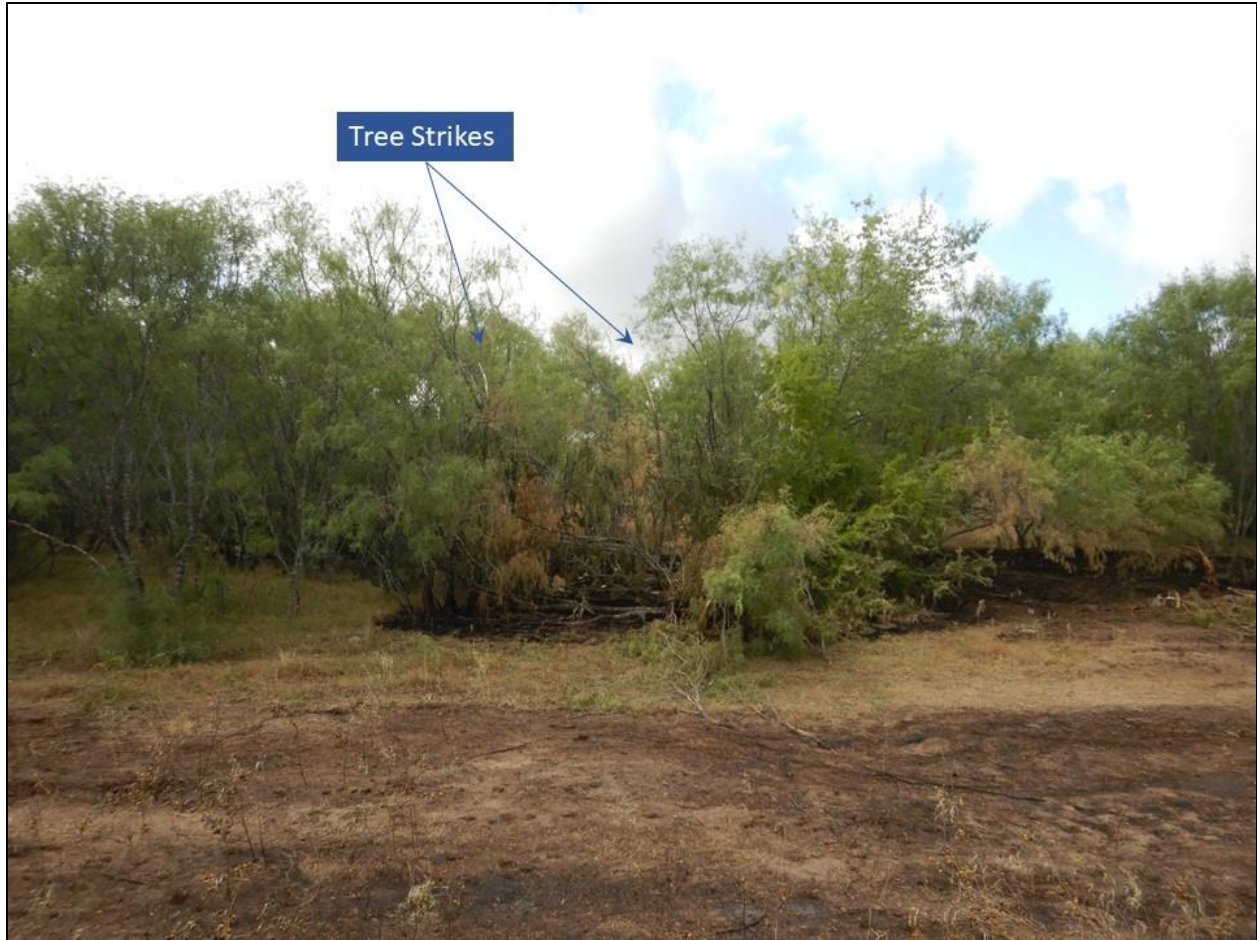
The accident site was about 1/4 mile from 0TX6 and located on sparsely wooded terrain. An area of burned grass and trees surrounded the debris field and extended about 500 ft to the North of the main wreckage.

Figure 1-Accident site, initial tree strikes.

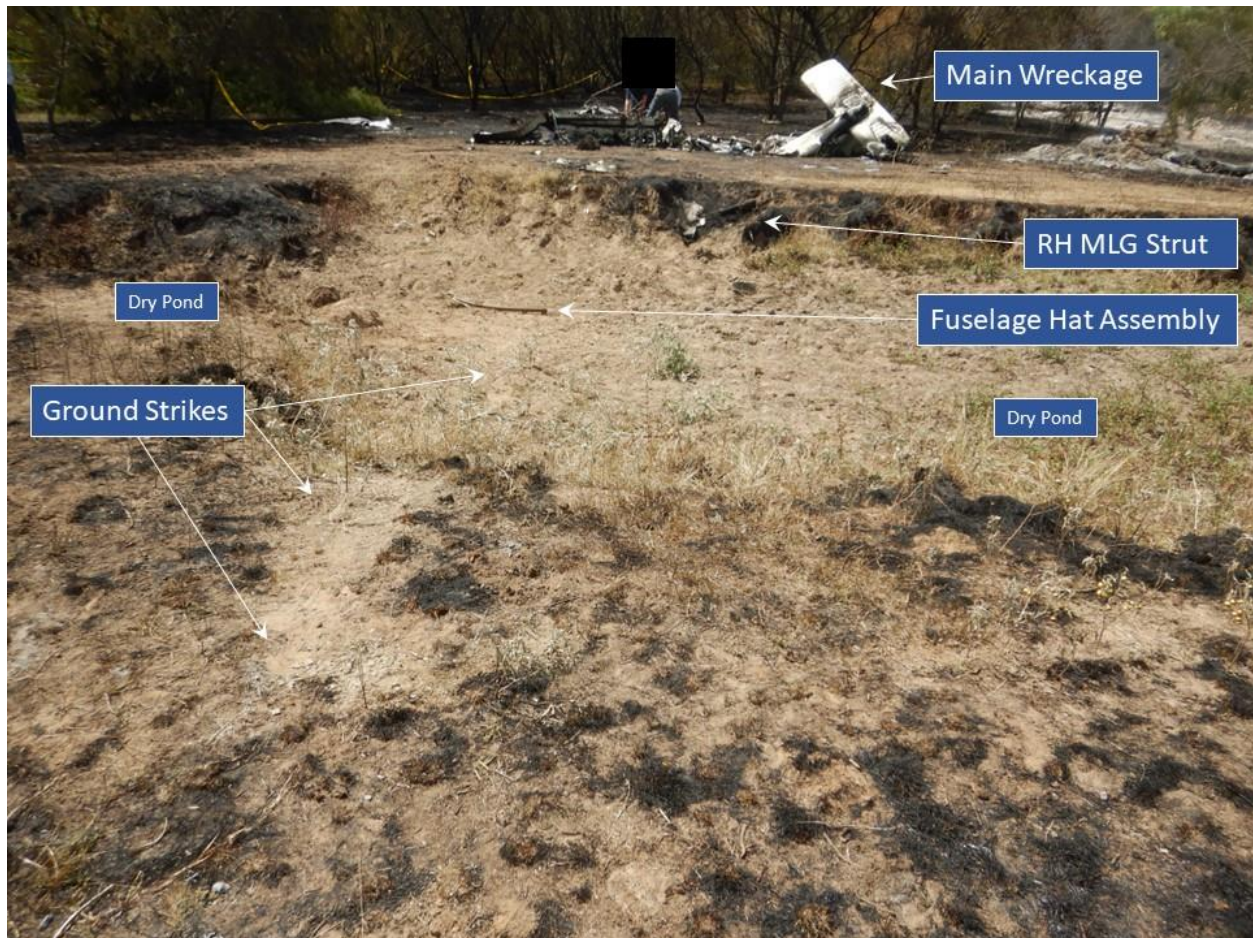
The debris field was about 181 ft long and on a directional heading of 332 degrees magnetic from the initial impact with trees to the engine cowling located furthest in the debris field. A 3 ft deep 30 ft wide dry pond was located within the debris field between the initial tree strikes and the main wreckage. A 5 ft long ground strike was identified near the edge of the pond and disturbed ground extended through the pond to the right main landing gear strut that separated from the main wreckage and was located on the other side of the pond. A 'longeron stringer' and portions of fiberglass were located in the dry pond. The main wreckage was found further in the debris field about 20 feet from the dry pond. The fuselage and engine were inverted and the wings separated and remained upright. The fuselage was positioned at a directional heading of about 250 degrees. The wreckage was mostly consumed by postimpact fire.

Figure 2-Ground scars and main wreckage.

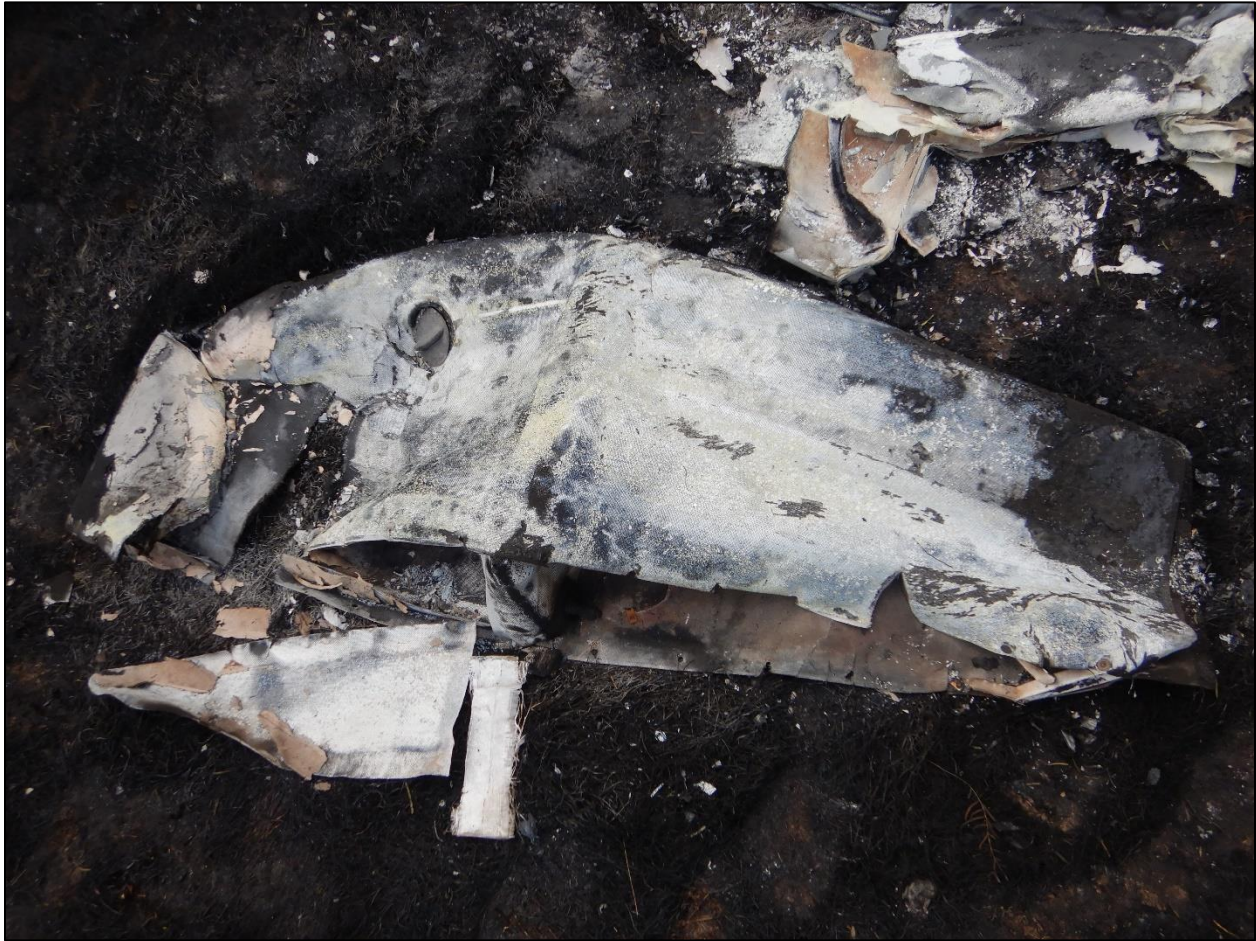
Both wing tip tanks separated from the main wreckage and were found further in the debris field. The tip tanks had thermal damage and were mostly destroyed by postimpact fire.

Figure 3-Right wing tip tank.

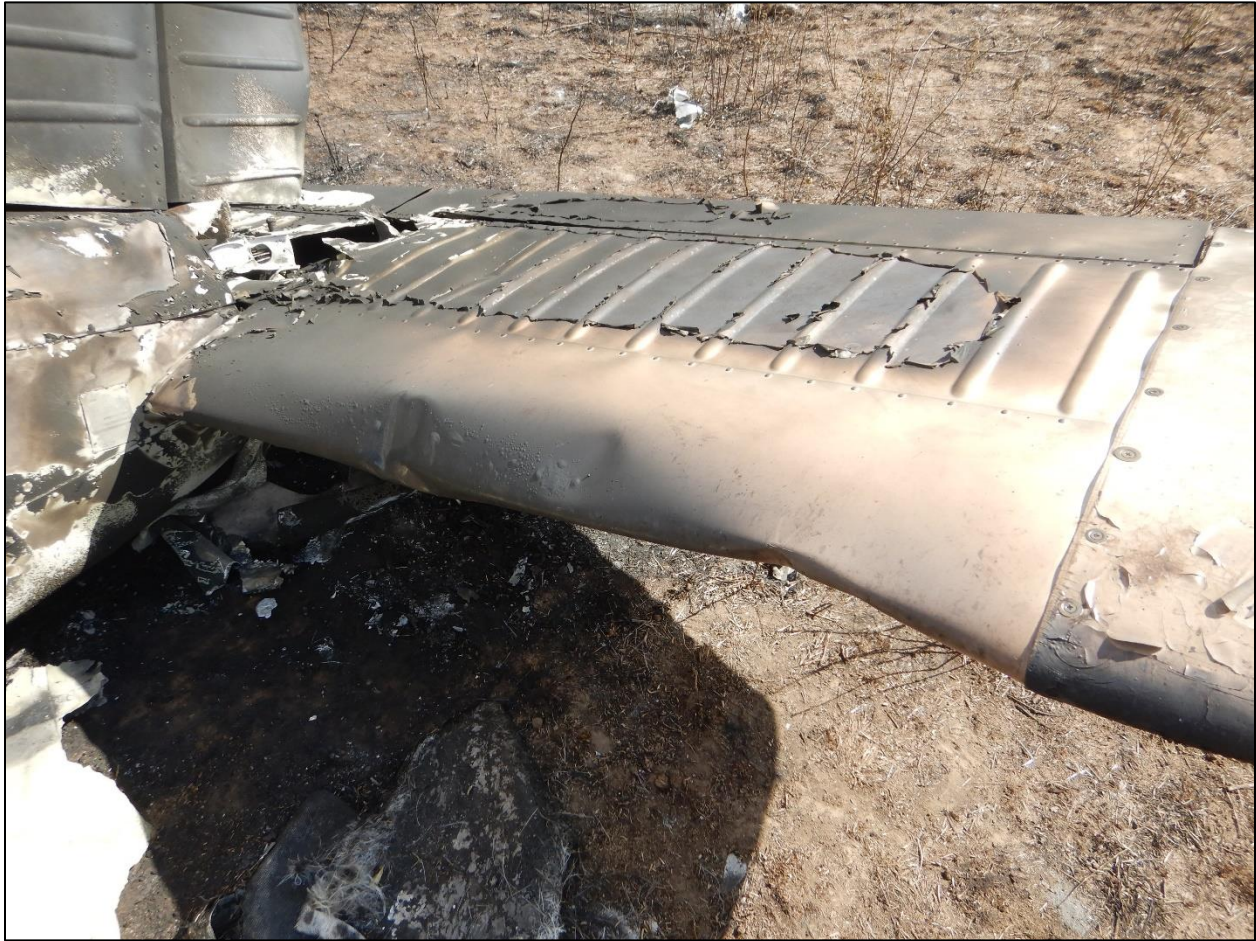
The left horizontal stabilizer leading edge had impact signatures consistent with impacting small trees.

Figure 4-View of the left horizontal stabilizer.

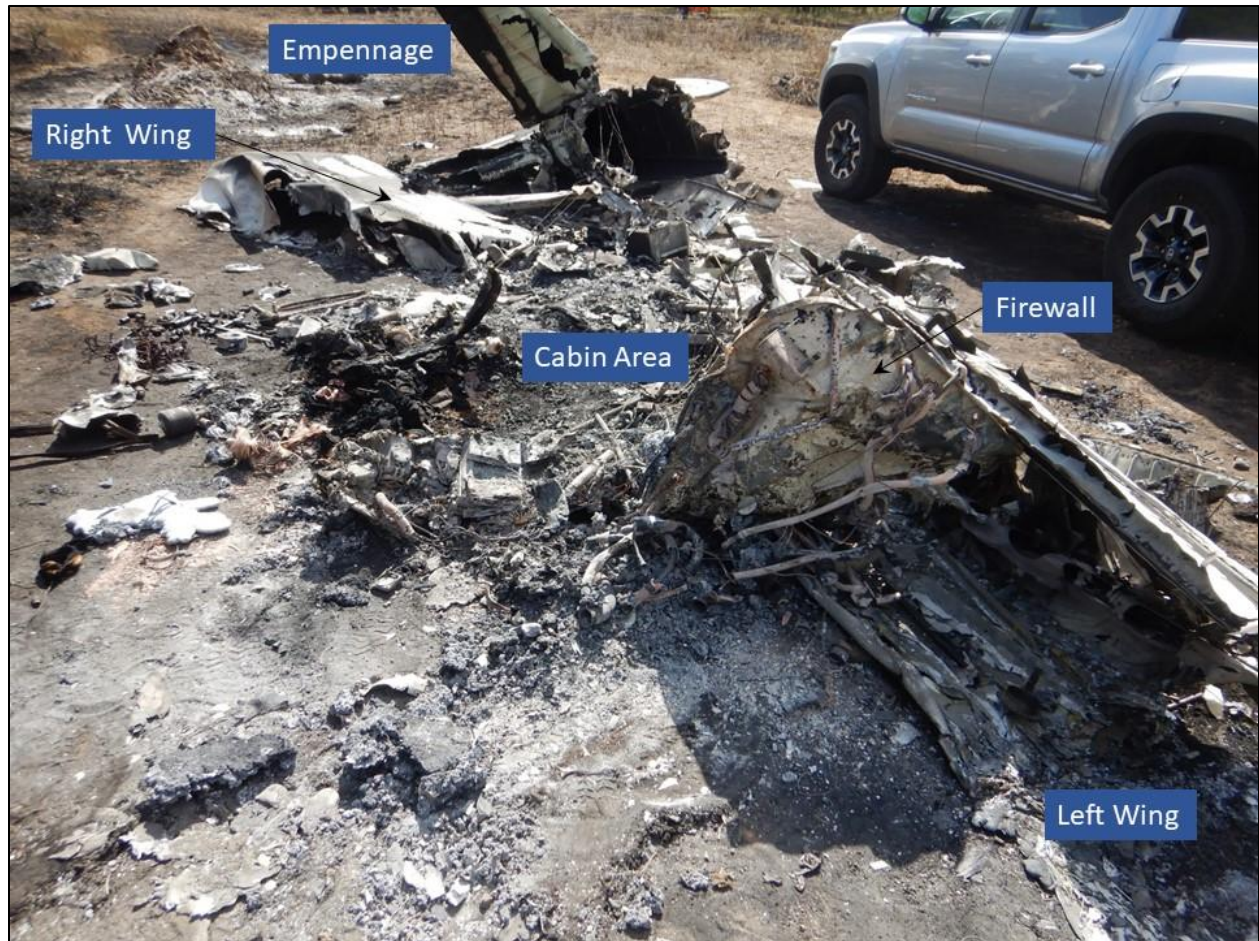
Flight control cable continuity was established to the central cabin area and associated bellcranks and attachments. The cabin area had excessive thermal damage and most had been consumed by postimpact fire. The instrument panel had excessive thermal damage and no switches or instruments offered any data or positions.

Figure 5-Main wreckage, cabin and wings.

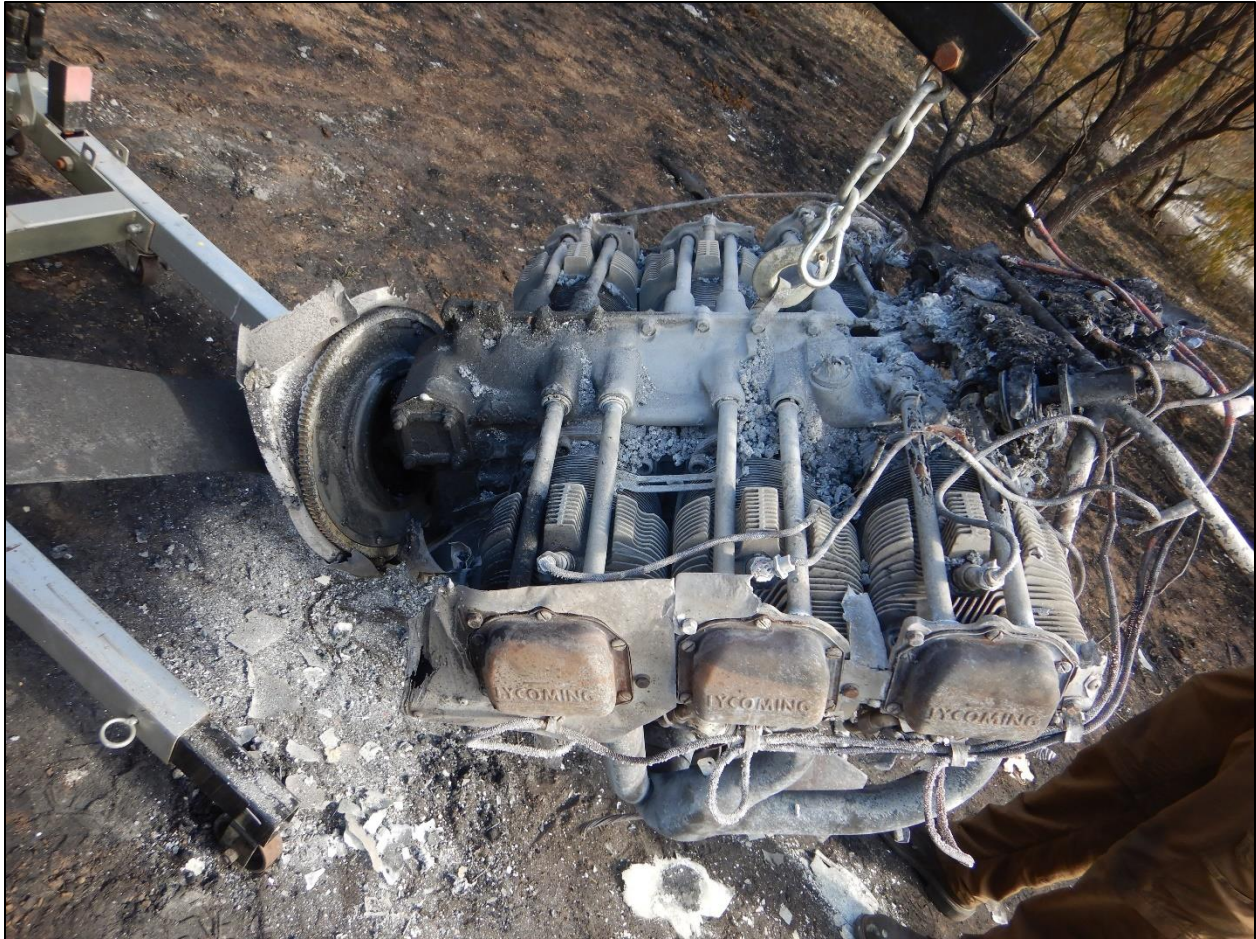
The engine remained partially attached to the engine mounting assembly. The engine mounts were cut and the engine was examined hanging from a hoist. Most of the engine accessories had been consumed by postimpact fire. Internal engine component surfaces were visible through melted crankcase areas and no preimpact mechanical damage was noted.

Figure 6-Propeller and engine assemblies.

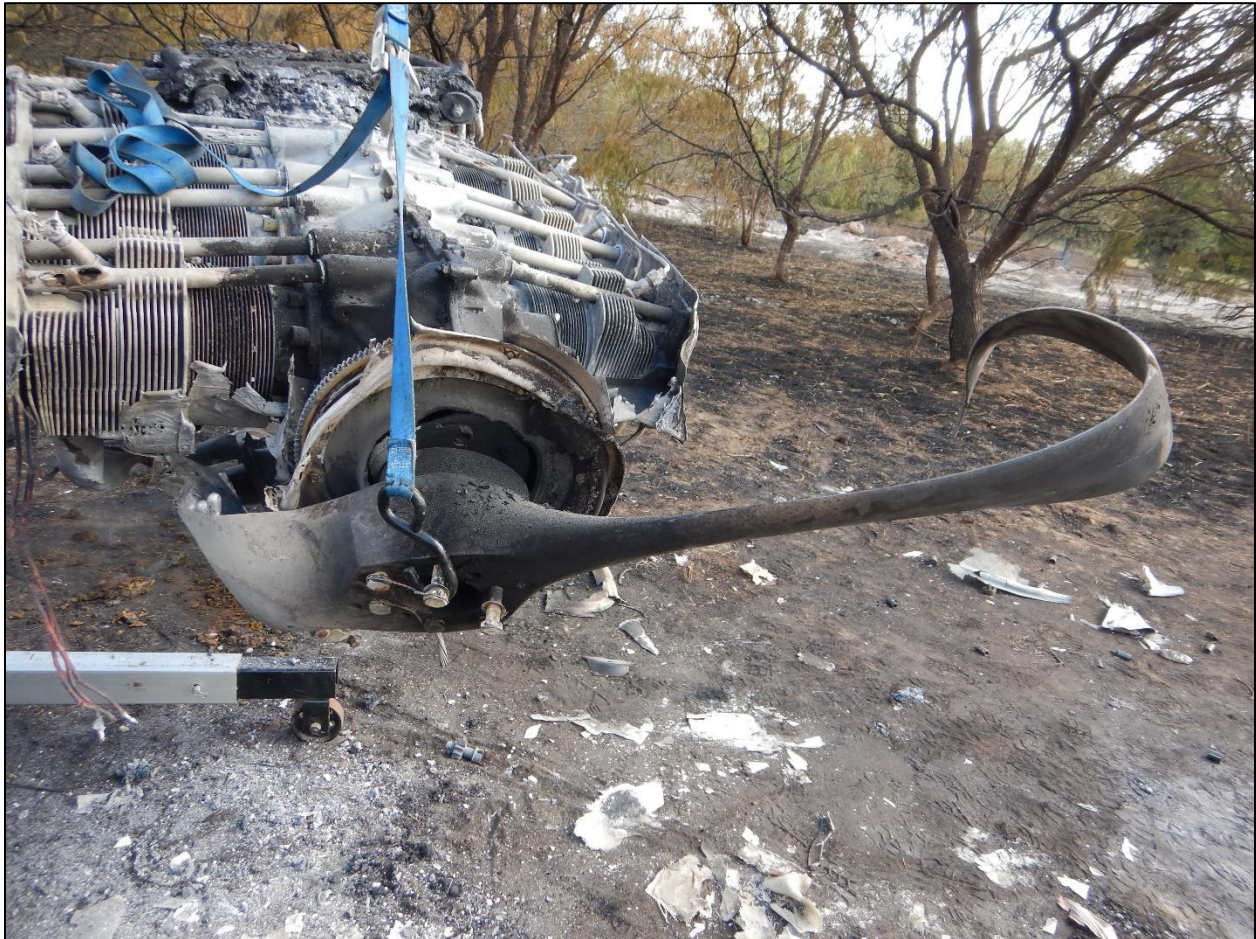
The propeller assembly remained attached to the engine and one blade was mostly consumed by postimpact fire. The other blade was intact and was bent in multiple areas consistent with an undetermined amount of power at the time of impact with the ground.

Figure 7-Propeller assembly and engine.

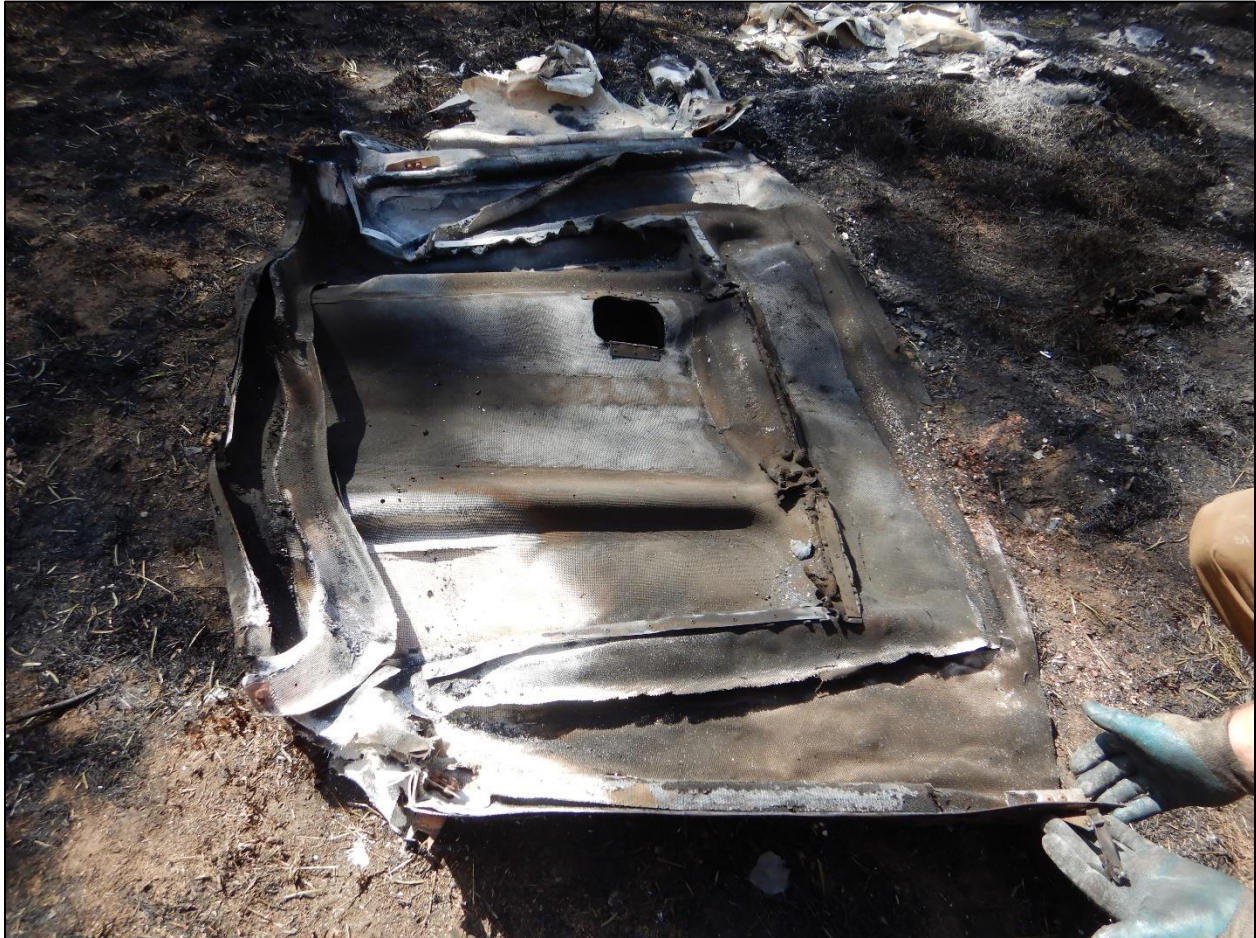
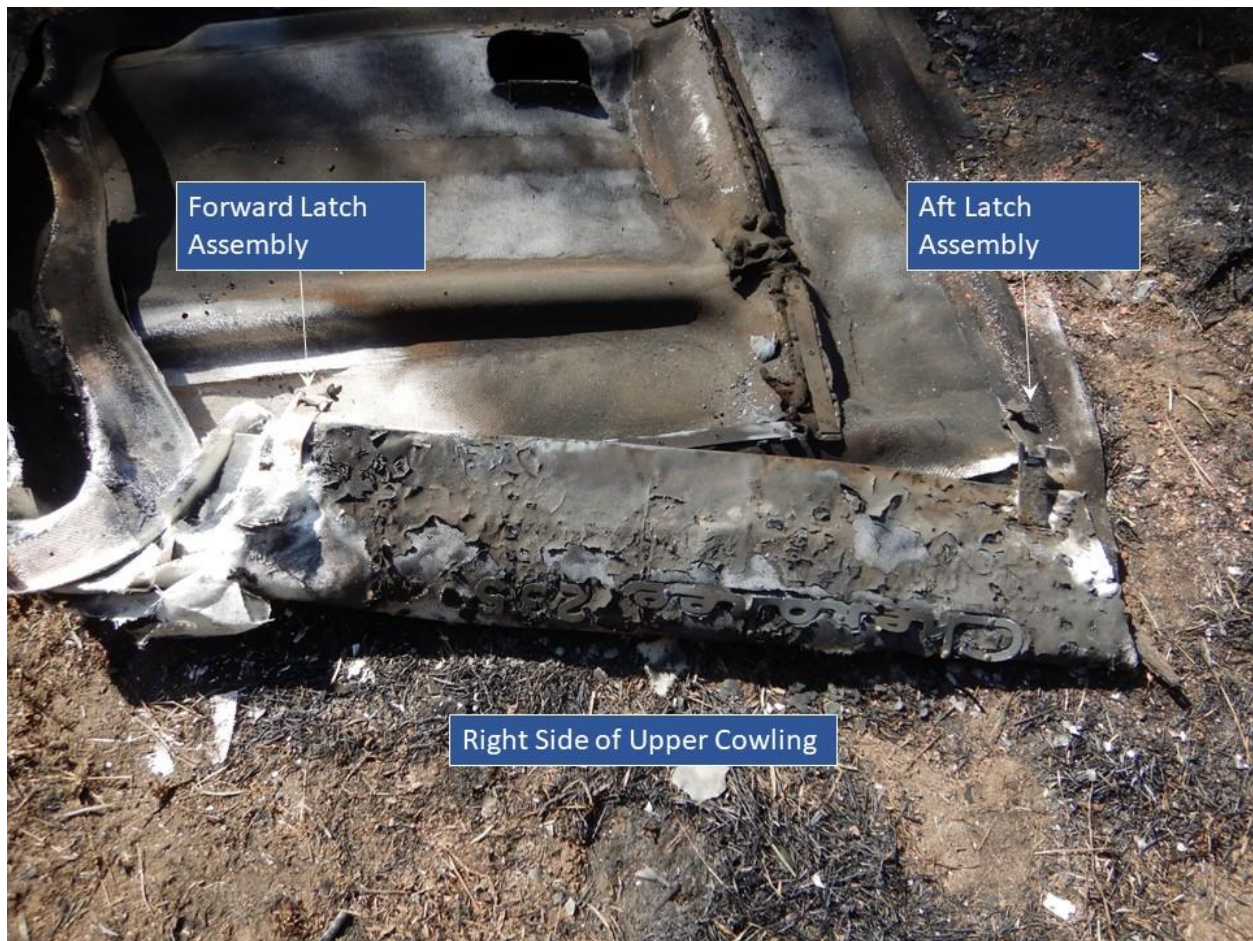
The engine cowling was found furthest in the debris field. The cowling was found right side up and had thermal damage throughout. The four cowling latches and fasteners remained attached to the upper cowling. The left side cowling latch and fasteners remained attached to the receiver ends of the thermally damaged sections of the lower cowling. The right side cowling latch and fasteners were intact and the aft latch assembly was bent. The lower cowling right side fastener receivers were not found during the examination.

Figure 8-Upper engine cowling.

Figure 9-Upper engine cowling.
