## RECORD OF CONVERSATION

**Date: July 23, 2022**  
**Where: Elm Creek Airpark (0TX6), Seguin, Texas**  
**Person Contacted: Jerry Angler**  
**NTSB Accident Number: WPR22FA264**

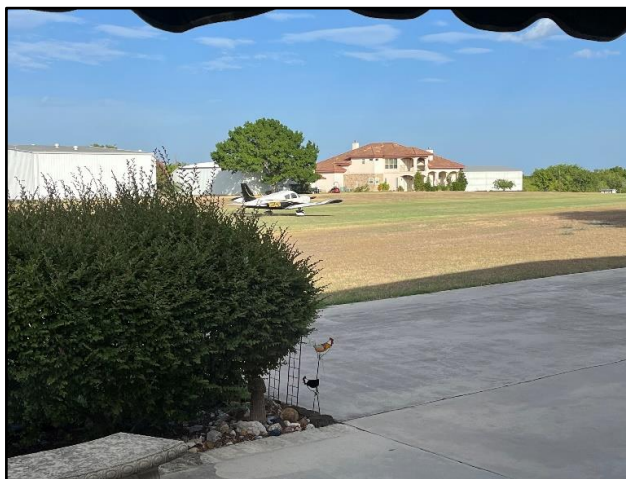
*Figure 1-Accident airplane on departure roll. (Photo Courtesy of Mr. Angler)*

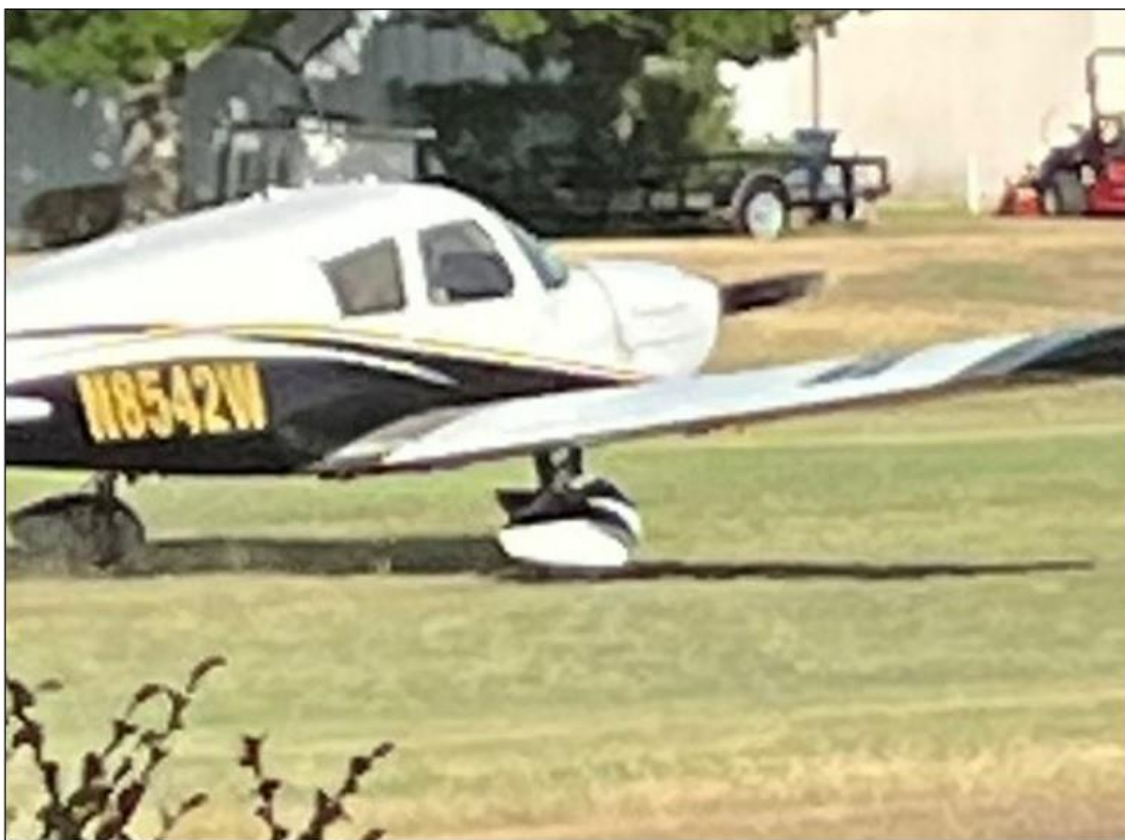
I met with Mr. Angler at his residence located at 0TX6 near the approach end of runway 14. His residence is about 300 ft from the accident pilot's home and hangar. He said it was common that the pilot would taxi the airplane from his house to the runway "like a Harley Davidson motorcycle," by revving the engine to a high RPM momentarily, then back to idle. On the day of the accident, just prior to the departure of the accident airplane, Mr. Angler captured a photo of the airplane as it crossed in front of his hangar, during the departure roll on runway 14. On multiple occasions he would watch as the accident airplane would depart but said this time someone had arrived at his residence and prevented him from doing so. On normal departures of the accident airplane, the pilot would use the complete runway before lifting off and turning left. He further stated that almost every landing that he had witnessed from the accident pilot at 0TX6, was a "hard landing." The photo shows a right rear side view of the accident airplane on the grass strip. The right side of the upper cowling appears not flush with the adjacent fuselage or lower cowling.

*Figure 2-Accident airplane photo zoomed in. (Photo Courtesy of Mr. Angler)*
