# National Transportation Safety Board

WPR22FA298

## **METEOROLOGY**

Specialist's Factual Report

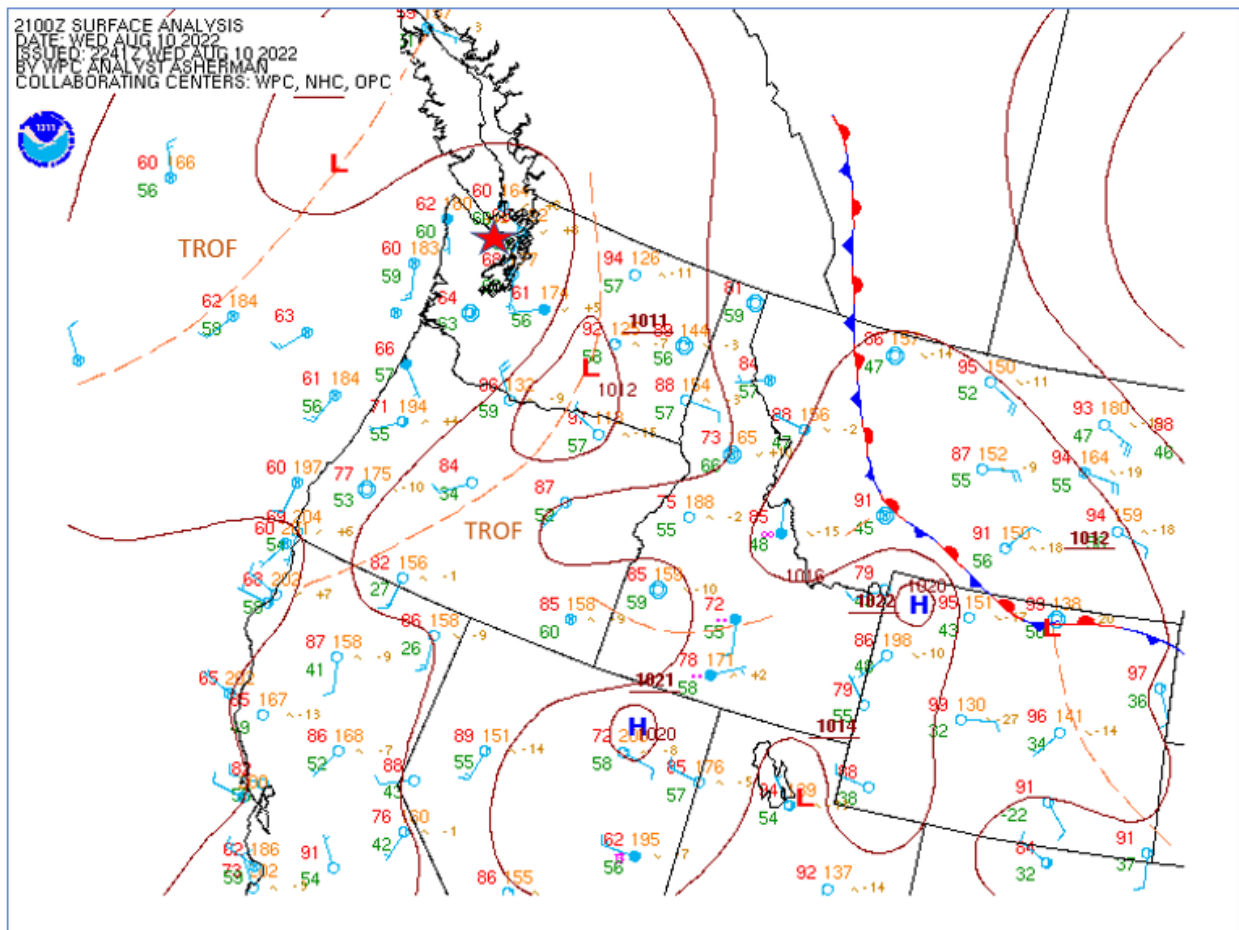
The NWS northwest section of the Surface Analysis Chart for 1400 PDT is included as figure 1 with the approximate accident site marked by the red star. The chart depicted a low-pressure system at 1011-hectopascals (hPa) over eastern Washington with a trough of low pressure extending north and south of the low. Another low-pressure system was located off the Washington Pacific coast with similar troughs extending north and south from the low. A mesoscale ridge of high pressure extended over western Washington between the two lows and over the area of the accident site.

**Figure 1 - NWS Surface Analysis Chart for 1400 PDT with the approximate accident site marked by the red star.**

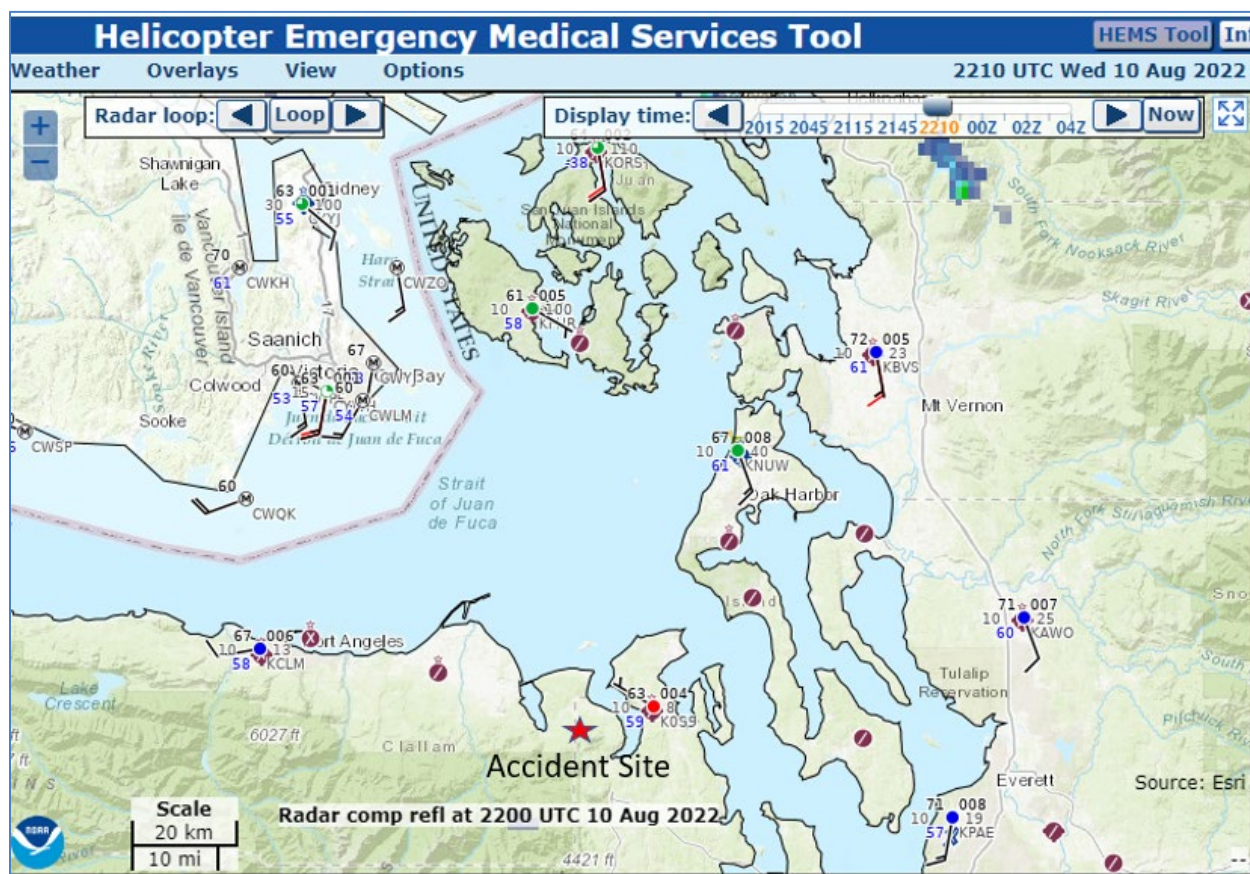
**Figure 2 - NWS Aviation Weather Center's METAR display at 1510 PDT with weather radar overlaid and approximate accident site.**

The display showed general VFR to MVFR conditions over the area with an area of IFR conditions in the vicinity of the accident site. The station models showed a generally diffluent wind pattern over the area with winds from the northwest in the vicinity of the accident site and from the southeast over the departure airport.

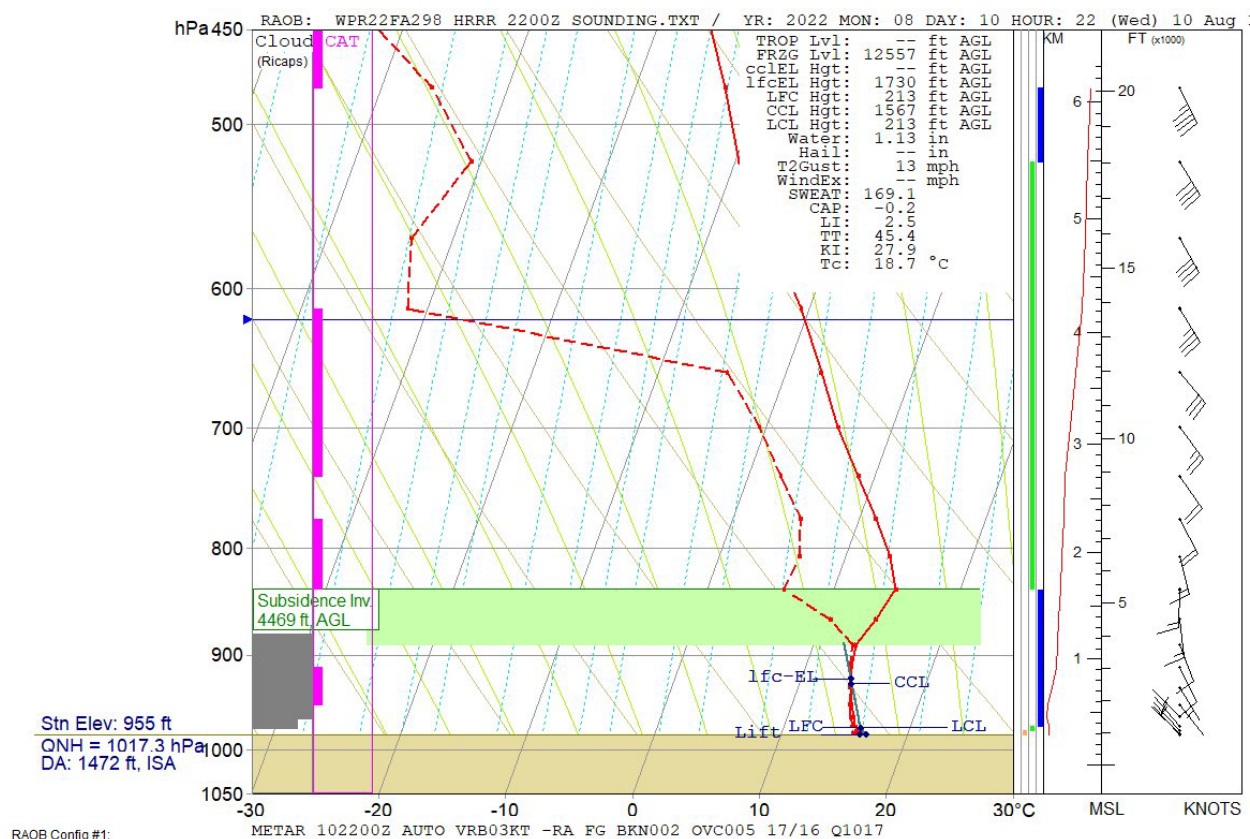
**Figure 3 - HRRR numerical sounding for 1500 PDT over the approximate accident site.**

The HRRR sounding indicated an elevation of 955 ft over the grid point with a near surface temperature of 16.7° C (62° F), a dew point temperature of 16.2° C (61° F), a relative humidity of 97%, with an approximate density altitude of 1,472 ft. The lifted condensation level (LCL) and level of free convection (LFC) were identified at 213 ft agl and represented the estimated cloud bases. The convective condensation level (CCL) was at 1,567 ft agl, and the precipitable water content was 1.13 inches. A temperature inversion was noted between 3,500 and 5,500 ft, where temperature increased with altitude with drier air above. The freezing level was identified at about 13,500 ft, well above the accident airplane's altitude. The RAOB Analysis program depicted broken to overcast layer of stratiform clouds from the LCL or from 200 ft agl through 4,000 ft (gray bar on left axis), with the relative humidity of 99% in that layer.

The HRRR wind profile indicated a surface wind from 320° at 3 knots and abruptly sheared to the south-southeast and increased in speed immediately above the inversion. The mean 0 to 6 km (or 18,000 ft) wind was from 150° at 27 knots.

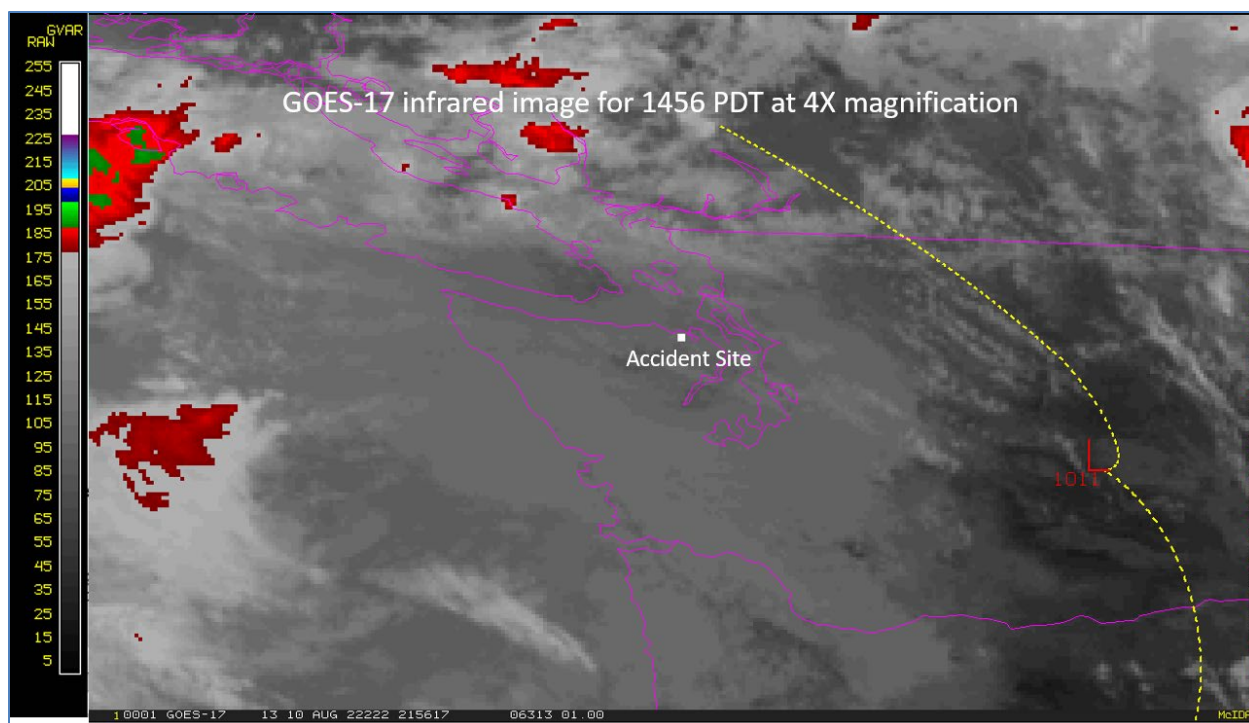
The GOES-17 infrared and visibility images for 1456 PDT are included as figures 3 and 4, respectively. The images depicted clouds over the route and over the accident site with radiative cloud temperatures of 280 kelvin or 6.8° C, which corresponded to cloud tops near 9,000 ft based on the HRRR sounding.

**Figure 4 - GOES-17 infrared image for 1456 PDT at 4X magnification with a standard MB temperature enhancement curve applied with the accident site marked by white square.**

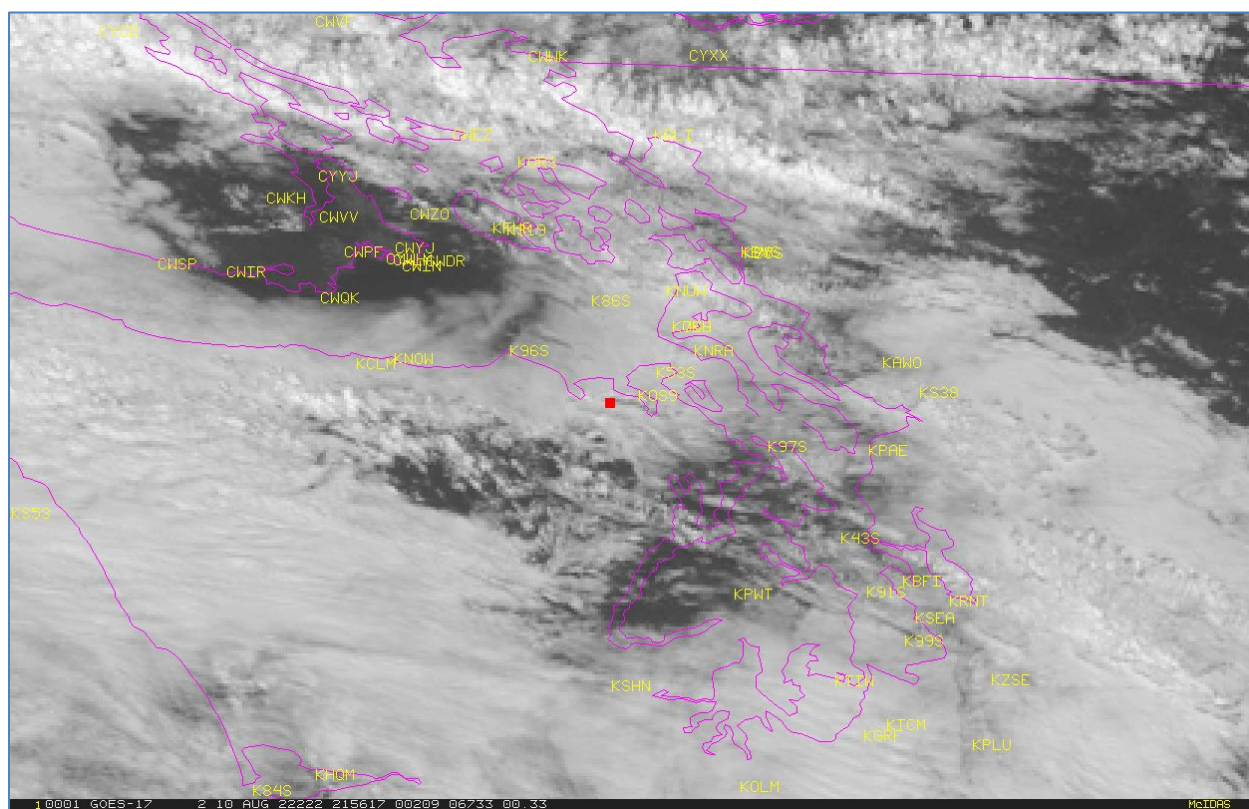
**Figure 5 - GOES-17 visible image for 1456 PDT at 3X magnification with accident site marked by red square.**

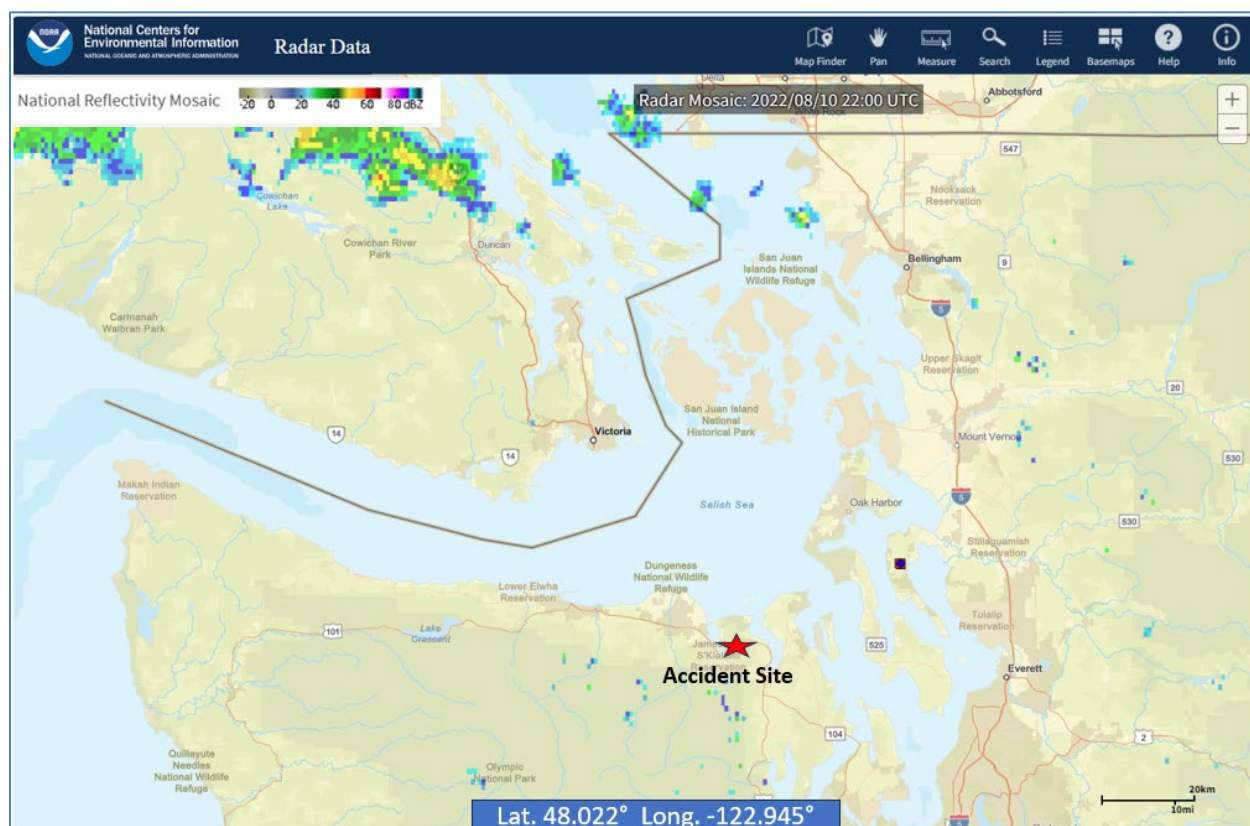
The NWS NCEI National Composite Radar Mosaic for 1500 PDT was reviewed and the regional display over the accident documented in figure 6. The radar image depicted an area of echoes near 45 dBZ over Vancouver Island to the northwest of the accident site, with no significant weather echoes noted in the vicinity of the accident site.

**Figure 6 - NWS Regional Composite Radar Mosaic for 1500 PDT with the approximate accident site marked by the red star.**

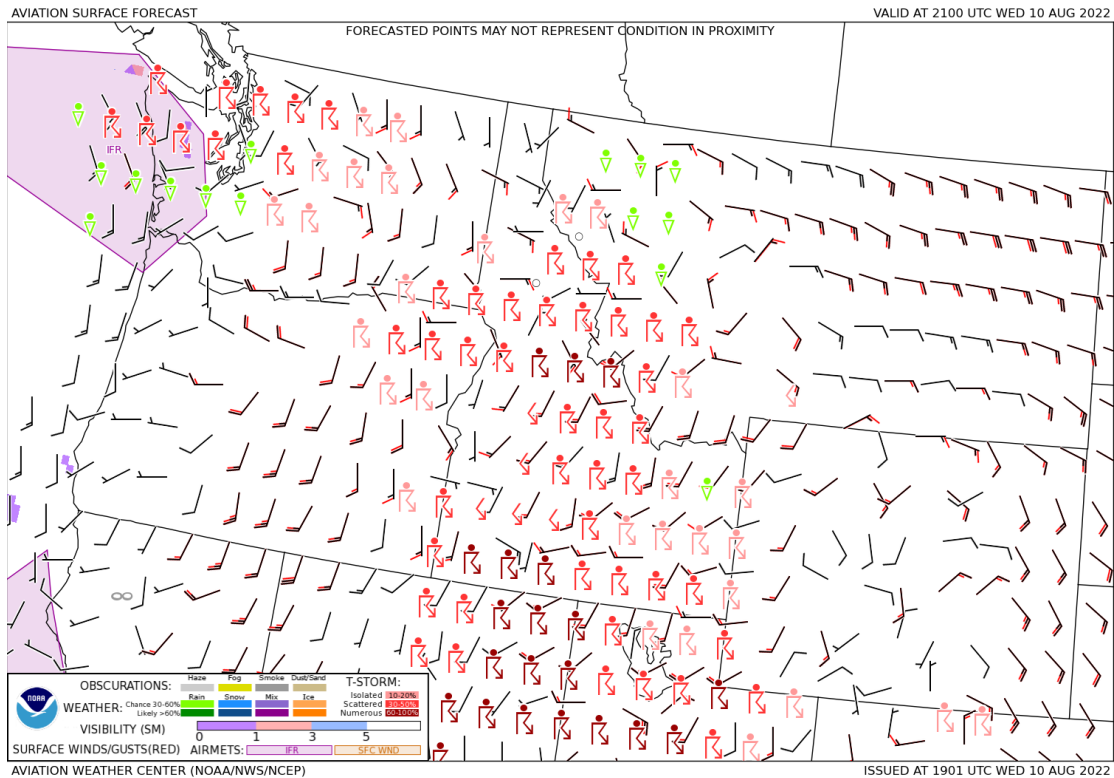
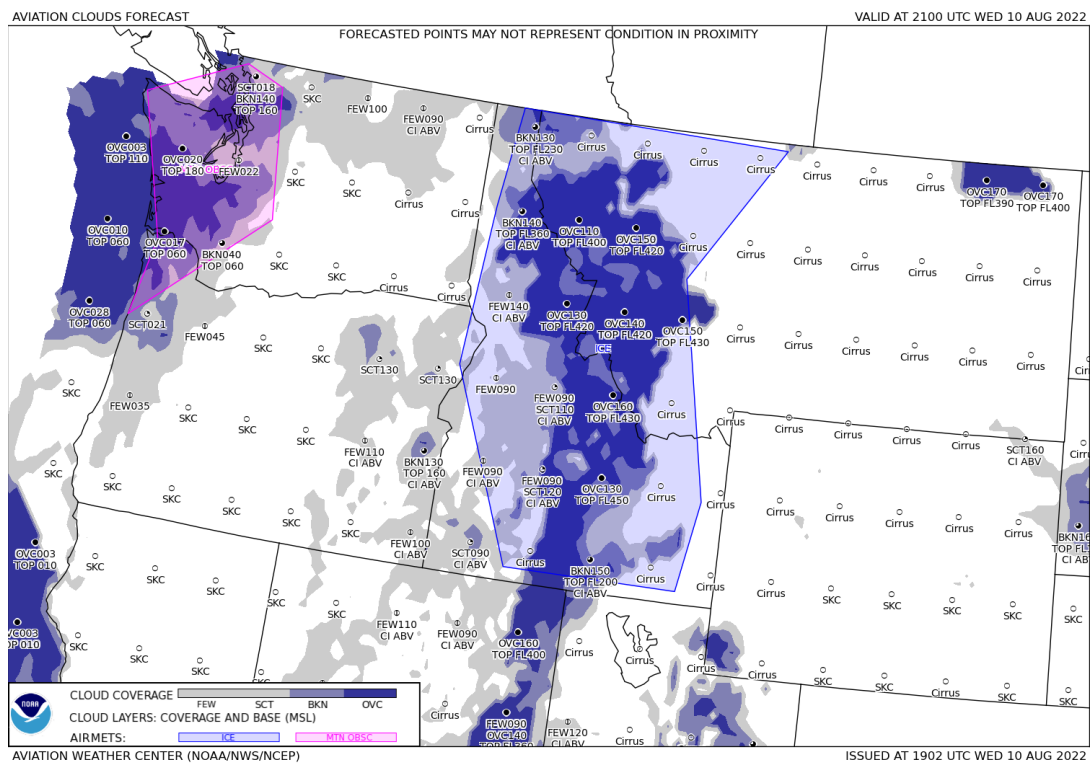
**Figure 7 - NWS 3-hour Graphic Forecast for Aviation (GFA) Surface Forecast valid for 1400 PDT.**

**Figure 8 - NWS 3-hour Graphic Forecast for Aviation Cloud Forecast valid for 1400 PDT.**

A review of the 3-hour GFA forecasts indicated generally light surface winds of 10 knots or less over the area with a chance of scattered thunderstorms (30% to 60% probability) and rain showers over the region. A G-AIRMET for IFR conditions was depicted over the Washington Pacific coast west of the accident site. The 3-hour GFA cloud forecast indicated a broken to overcast layer of clouds with bases near 2,000 ft msl and tops to 18,000 ft. The chart also depicted a G-AIRMET for mountain obscuration conditions over the area of the accident site.

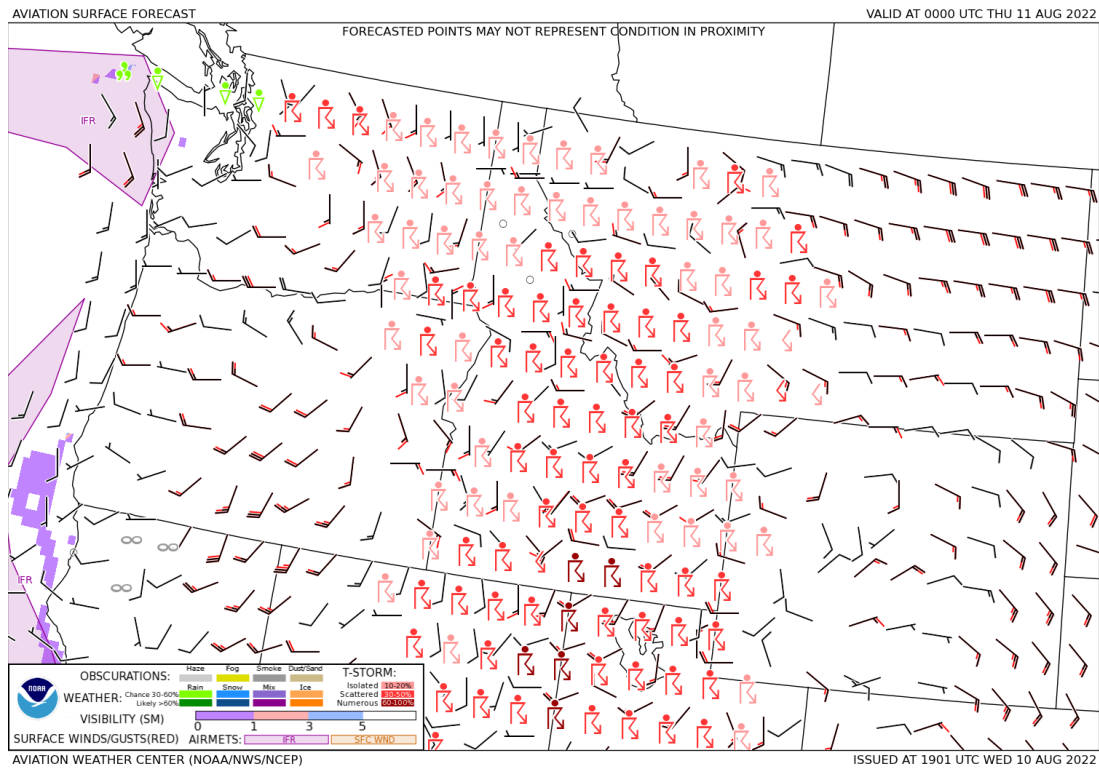
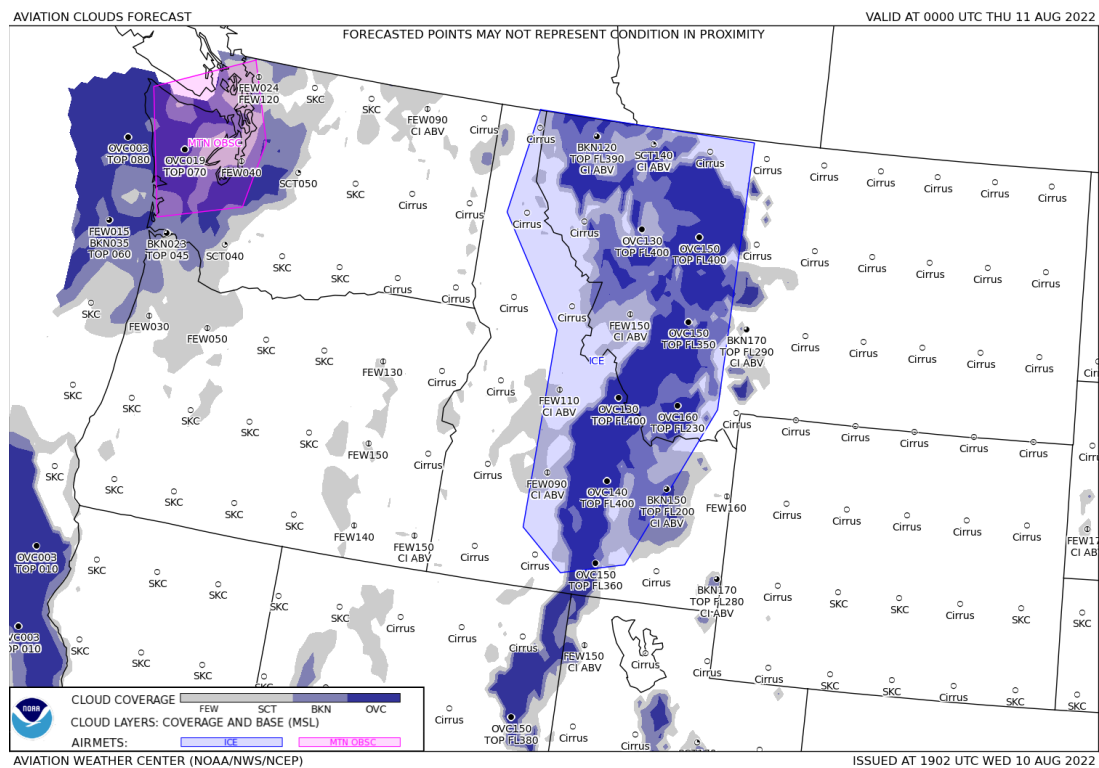
**Figure 9 - NWS 6-hour Graphic Forecast for Aviation (GFA) Surface Forecast valid for 1700 PDT.**

**Figure 10 - NWS 6-hour Graphic Forecast for Aviation Cloud Forecast valid for 1700 PDT.**

The 6-hour GFA forecasts showed the precipitation diminishing over the area with light winds. The G-AIRMET for IFR conditions also diminished in size but remained along the Washington Pacific coast to the west of the accident site. The 6-hour GFA cloud forecast showed the area of broken to overcast clouds shrinking over the area with the G-AIRMET for mountain obscuration conditions continuing over the area.

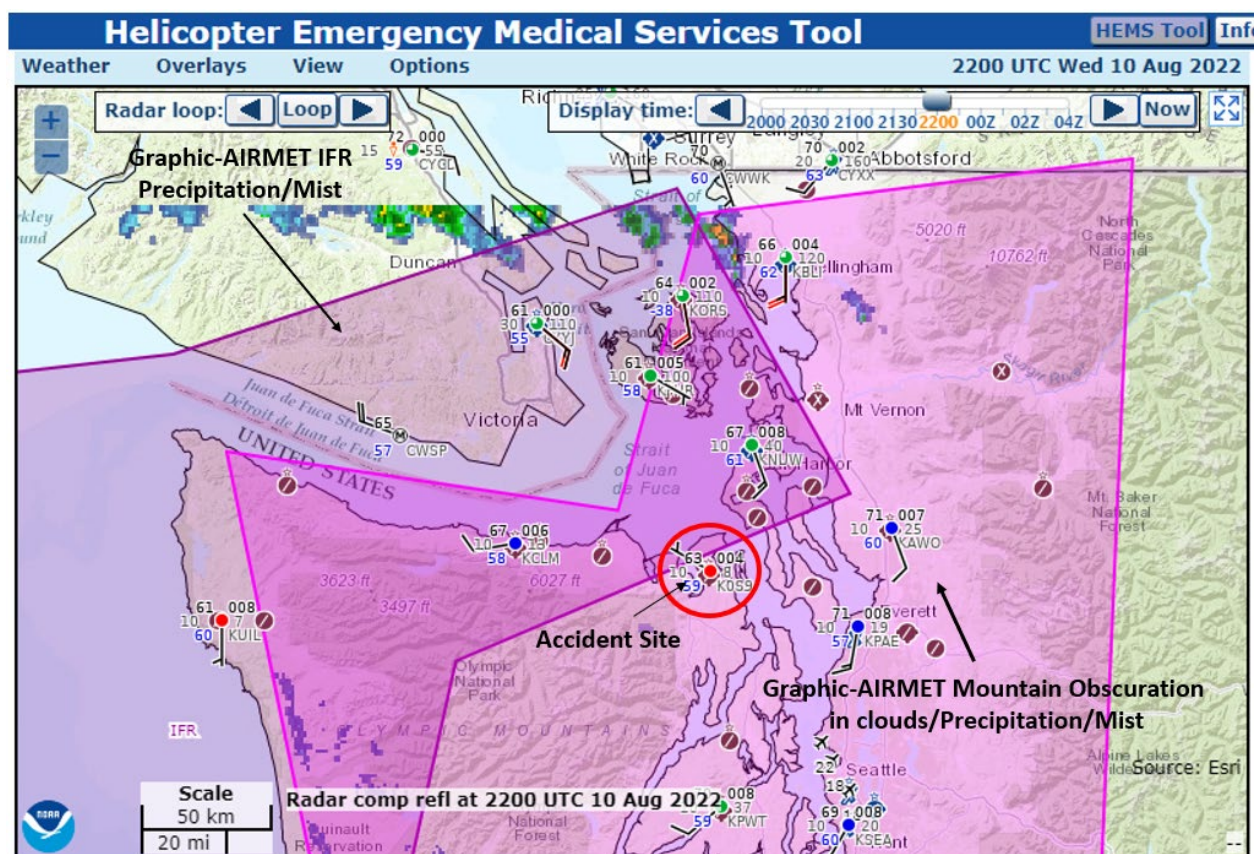
During the period surrounding the accident the NWS AWC and CWSU did not have any SIGMETs, Convective SIGMETs, or CWAs current. The NWS did have Graphic-AIRMETs current for IFR and mountain obscuration conditions, which extended over or bordered the accident site and are included in Figure 11.

Figure 11 - NWS AWC METAR display with Graphic-AIRMETs current at 1500 PDT.
