# National Transportation Safety Board

WPR22FA304

## **AIRFRAME AND ENGINE EXAMINATION**

Location: Yellow Pine, Idaho  
Date: August 15, 2022  
Airplane: Aviat, A-1A, N26HV

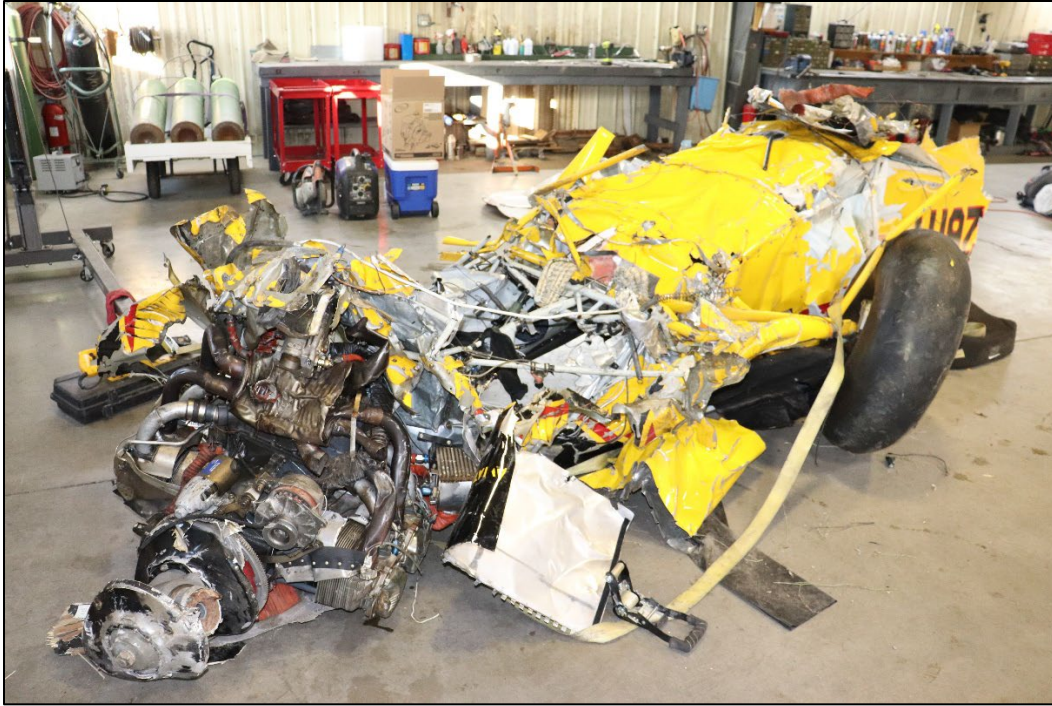
Examination of the recovered airframe revealed that the recovery company had removed both wings and empennage for transport. The forward section of the cockpit was impact damaged and crushed aft. The instrument panel was impact damaged with multiple instruments displaced. Crushing and bending was observed throughout the fuselage.

**Figure 1: View of airplane during examination**

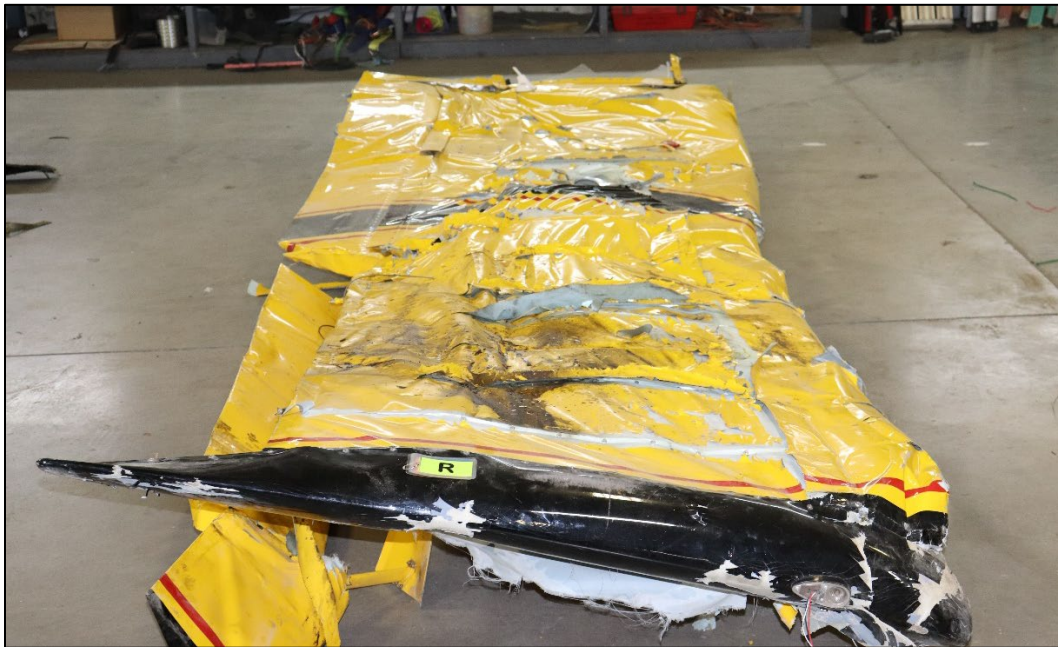
The right wing separated from the fuselage at the wing root; the aileron separated from the wing, but remained tethered to the wing via the flight control cables, and the flap remained attached to the wing via its mounts. The wing and aileron exhibited bending and crush damage. A turnbuckle barrel from the flight control stick to the right aileron was separated about mid span. Visual inspection of the right fuel cap revealed that the rubber seal appeared normal and unremarkable. The fuel filler port was also normal and unremarkable. A breach in the right wing fuel tank, consistent with impact damage was observed near the top, aft tank. The right landing gear remained attached to the fuselage and was bent aft.

**Figure 2: View of right-wing during examination**

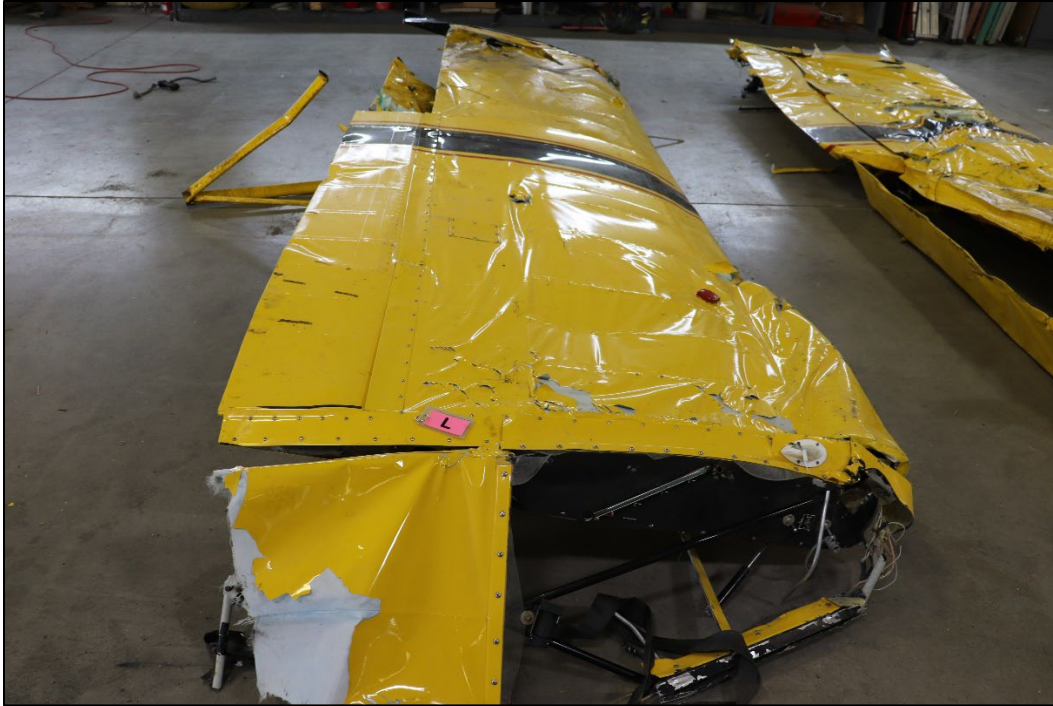
The left wing separated from the fuselage at the wing root; the aileron separated from the wing, but remained tethered to the wing via the flight control cables, and the flap remained attached to the wing via its mounts. The wing and aileron exhibited bending and crush damage. Visual inspection of the left fuel cap revealed that the rubber seal appeared normal and unremarkable. The fuel filler port was also normal and unremarkable. The left landing gear separated from the fuselage and was impact damaged.

**Figure 3: View of left-wing during examination**

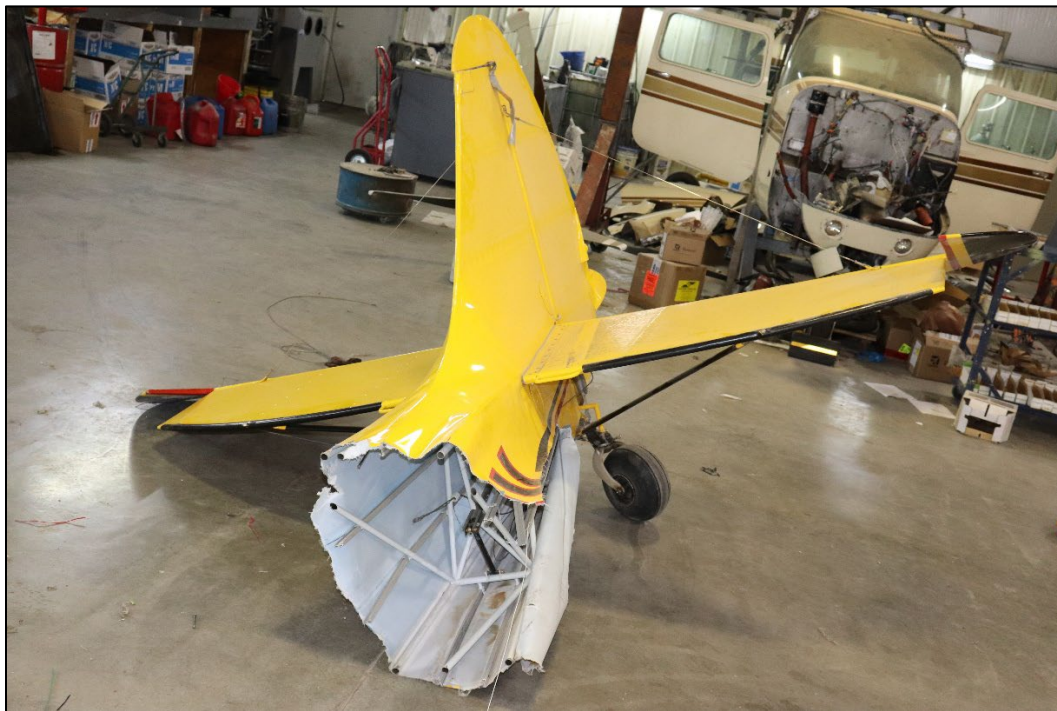
The empennage structure aft of the cabin area was removed from the fuselage by recovery personnel. The vertical stabilizer, rudder, horizontal stabilizers, elevator, and elevator trim tabs remained attached and secure to their respective mounts.

**Figure 4: View of empennage during examination**

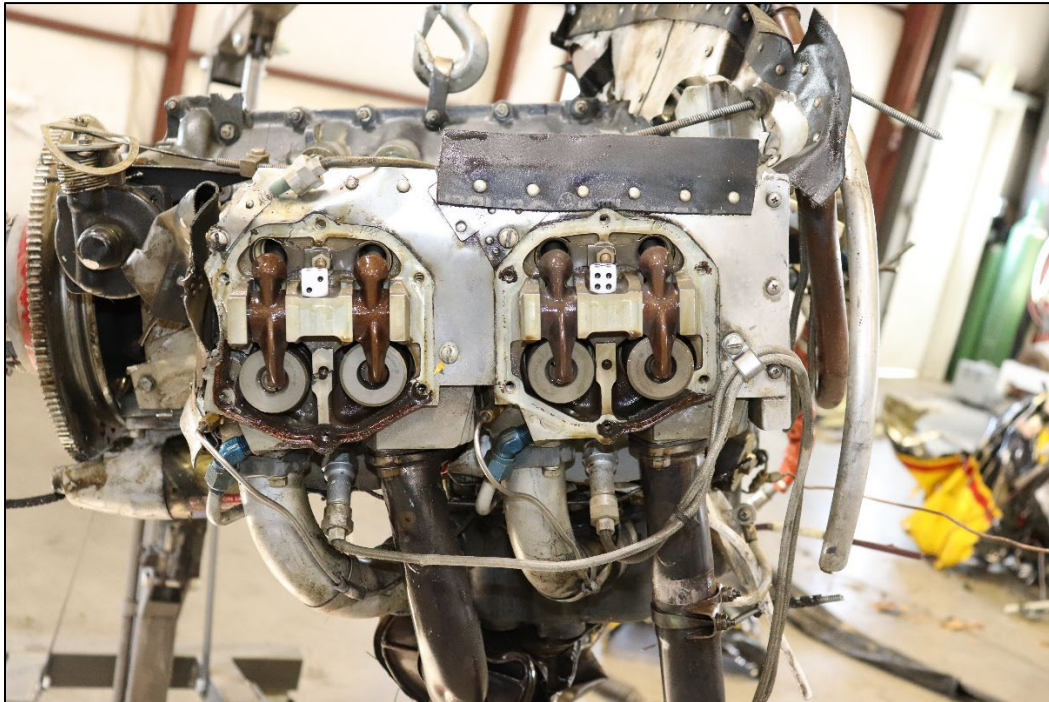
Examination of the recovered engine revealed that engine remained attached to the engine mount. All four cylinders remained attached. All fuel and oil lines that were removed were tight. The forward left/right side of the engine at the number 1 and 2 cylinders exhibited impact damage. The rocker box covers were removed. The intake and exhaust rocker arms were intact, and oil coated on all cylinders. All intake and exhaust valve springs were in place, the number 1 cylinder exhaust valve assembly exhibited impact damage, the remaining intake and exhaust valve springs appeared to be undamaged. The upper spark plugs were removed, and all four cylinders were examined internally using a lighted borescope. A normal amount of combustion deposits was observed within the combustion dome of each cylinder and piston face. The crankshaft was rotated by hand using the propeller hub. Rotational continuity was established throughout the engine and valve train. Thumb compression was not obtained at the number 1 cylinder due to damage of the exhaust valve assembly.

**Figure 5: View of left side of the engine**

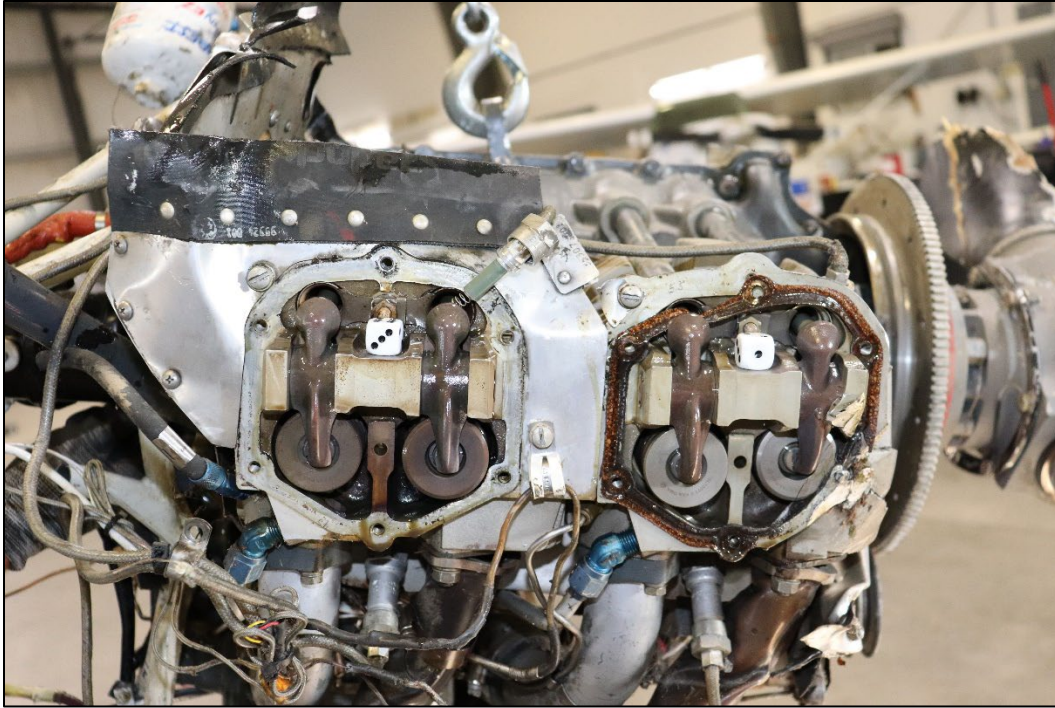
**Figure 6: View of right side of the engine**

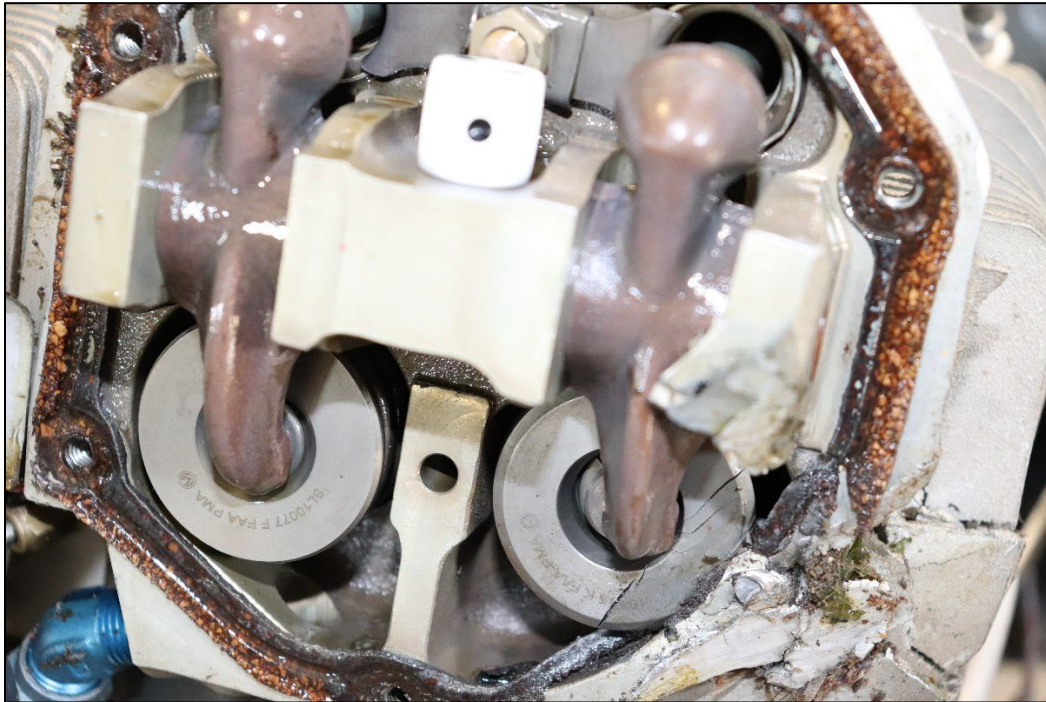
**Figure 7: View of damage to the number 1 cylinder exhaust valve assembly**

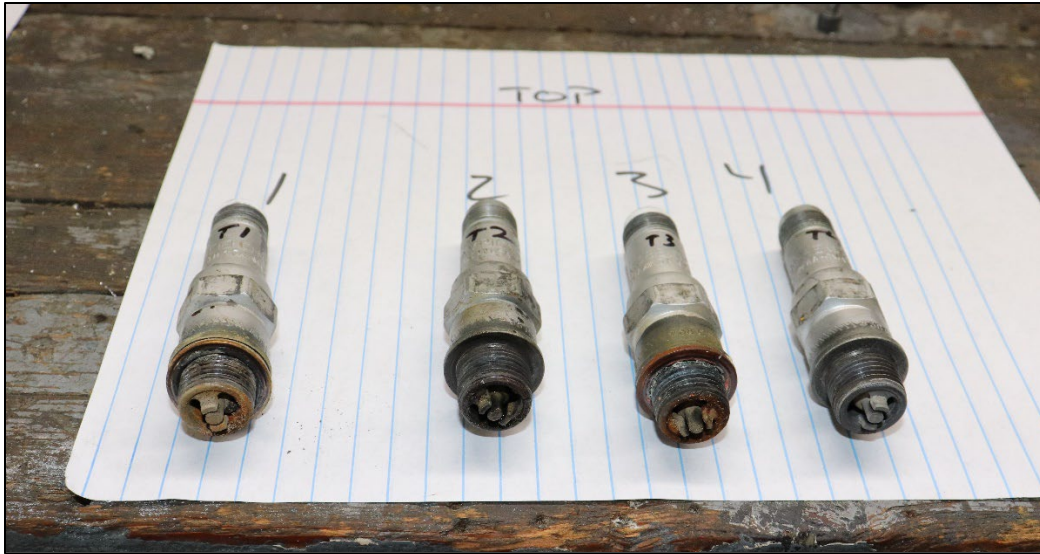
The spark plugs were removed from the engine, and they were the massive electrode type. All sparkplugs exhibited rust signatures within the electrode area or were oil soaked.

**Figure 8: View of spark plugs**

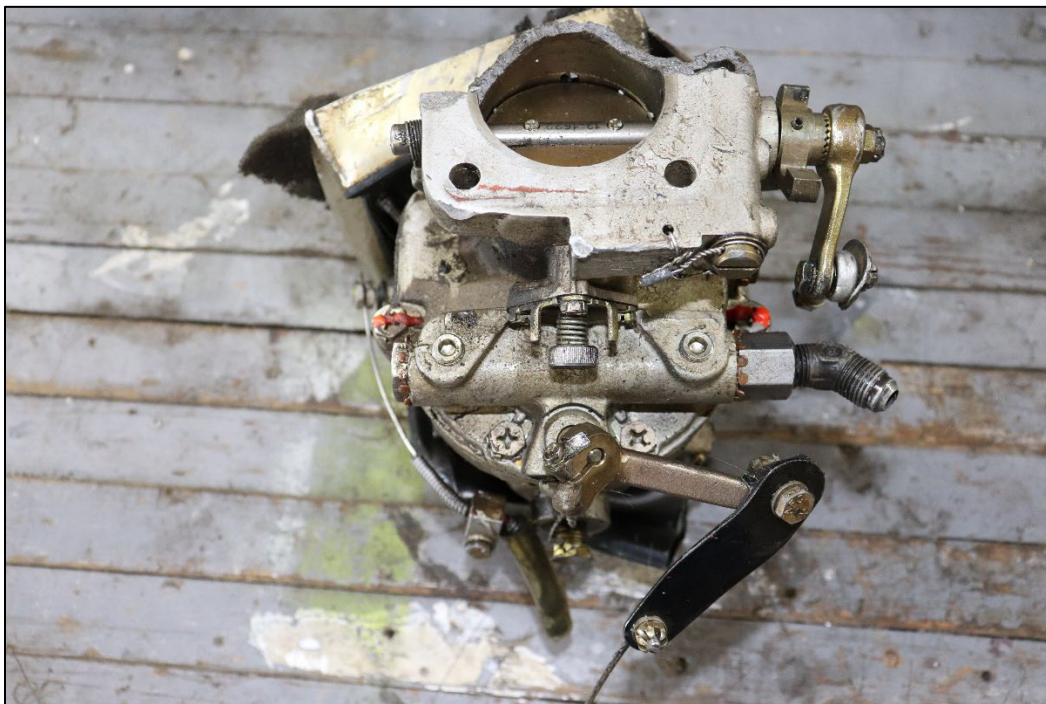
The carburetor separated from the engine, but remained tethered via the fuel line, throttle cable and fuel mixture cable. The throttle control lever was intact and moved freely from stop to stop. The mixture control cable remained attached to the carburetor, but the connecting linkage to the mixture cable was impact damaged. The mixture control lever arm moved the available length. The carburetor inlet fuel screen was removed and was free of debris.

**Figure 9: View of carburetor**

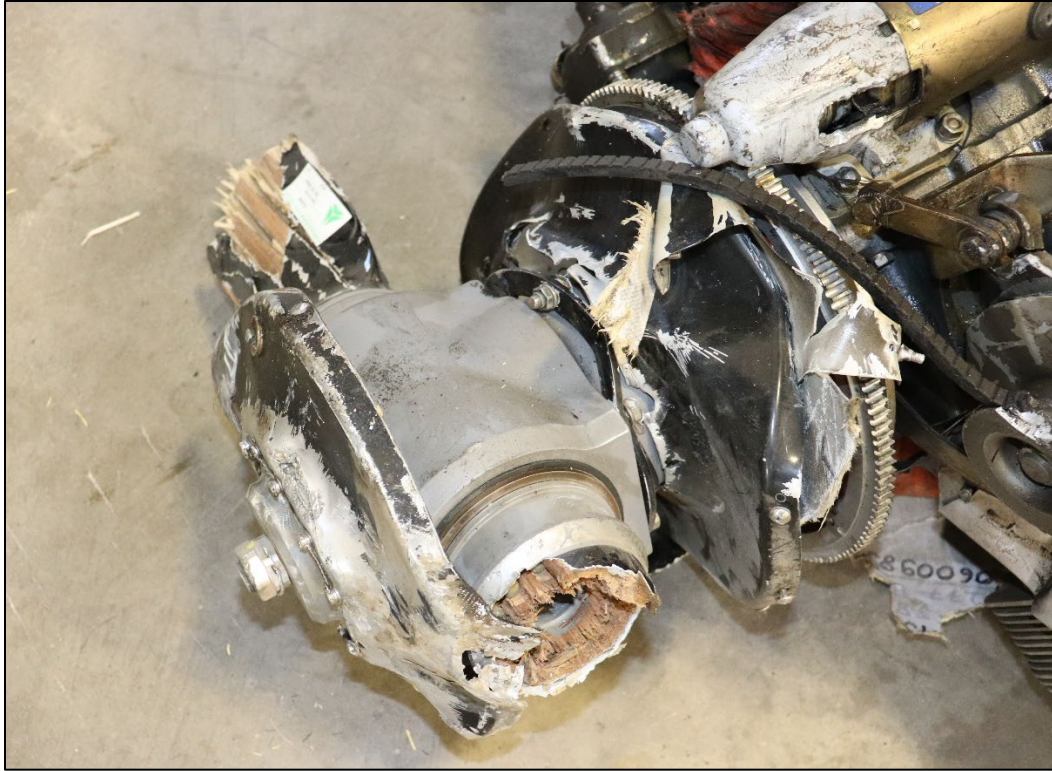
The airplane was equipped with a two blade, constant speed, MT propeller. The propeller hub remained attached to the engine. Propeller blade A splintered and separated near the propeller hub. Propeller blade B splintered and separated mostly flush near the propeller hub. Sections of the propeller blade root remained attached to the propeller hub, via lag bolts.

**Figure 10: View of propeller hub during exam**

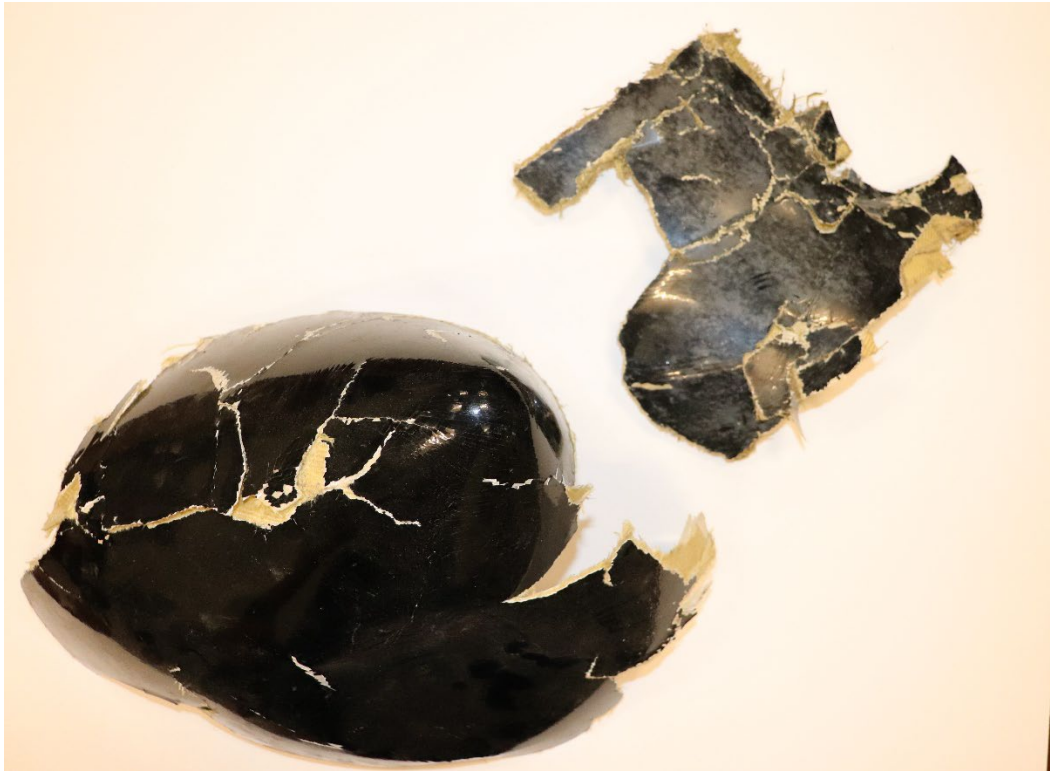
The propeller spinner separated with crush damage consistent with impact damage.

**Figure 11: View of propeller spinner**

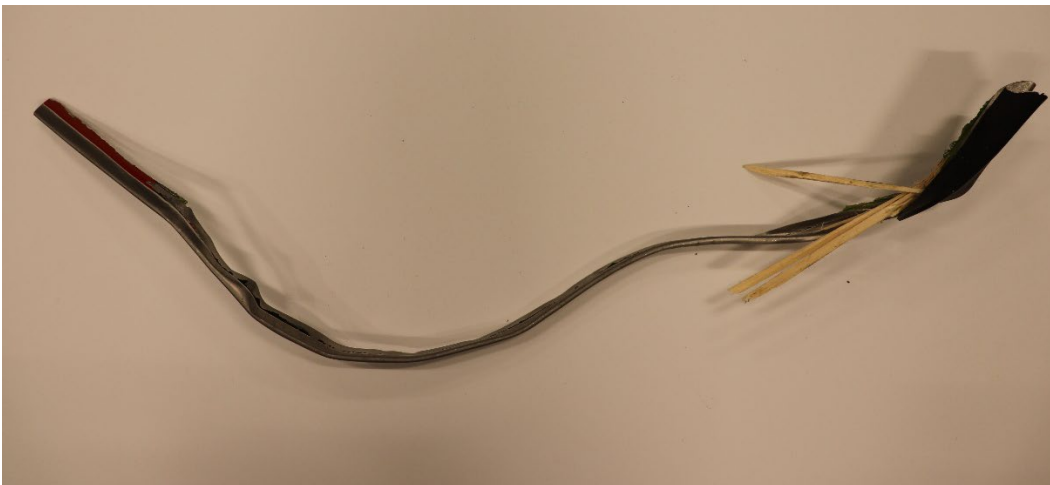
A propeller blade leading edge separated. Crushing and bending consistent with impact damage was observed throughout.

**Figure 12: View of propeller blade leading edge**

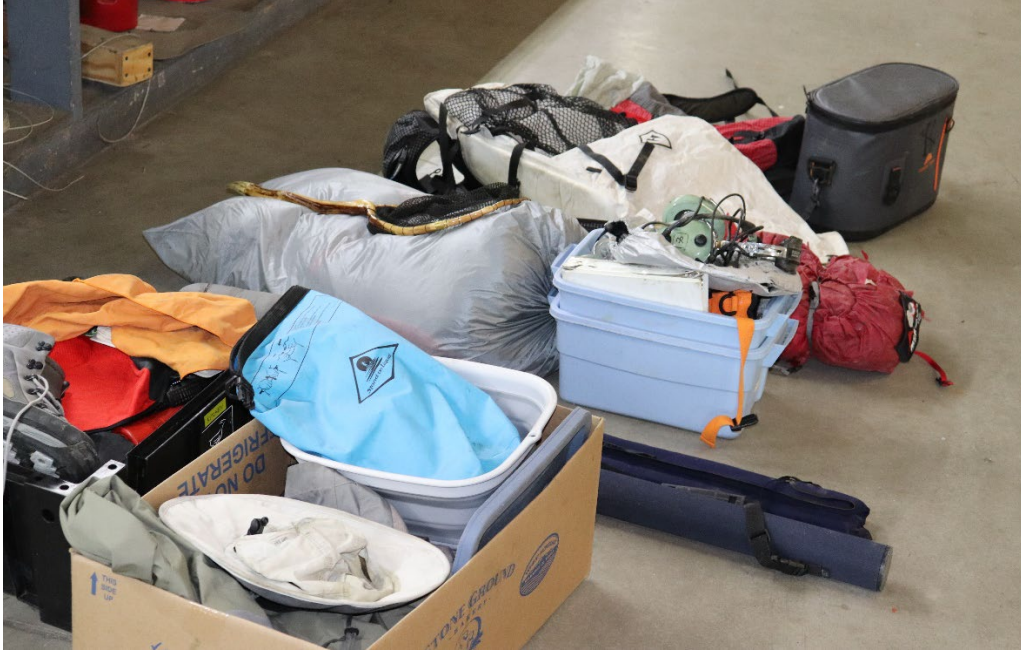
The total weight of the recovered personal effects was 66 lbs, however; the location of the personal effects could not be determined.

**Figure 13: View of recovered personal effects**

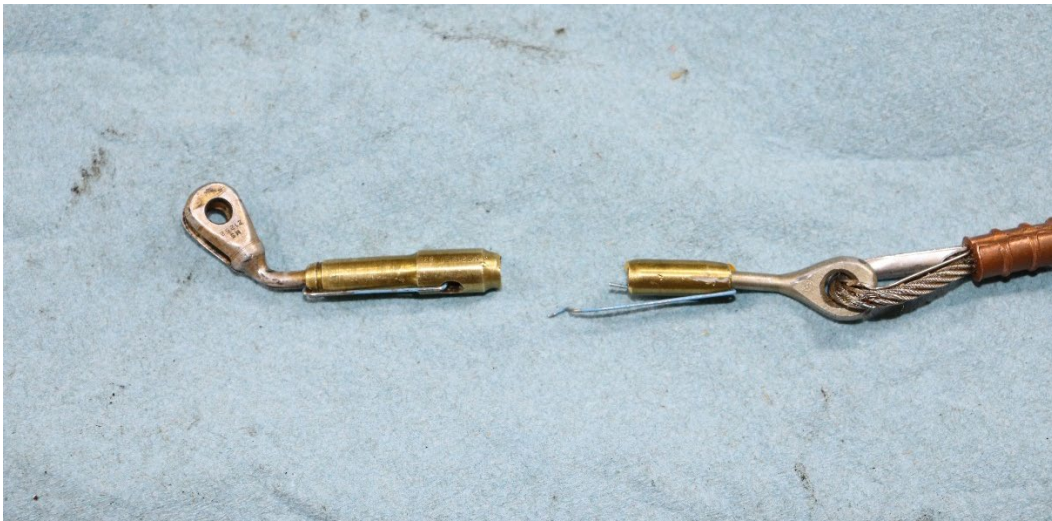
A turnbuckle barrel from the flight control stick to the right aileron was retained for further examination.

**Figure 14: View of damaged turnbuckle barrel**
