# National Transportation Safety Board

WPR22FA304

## **MATERIALS LABORATORY**

Factual Report 22-103

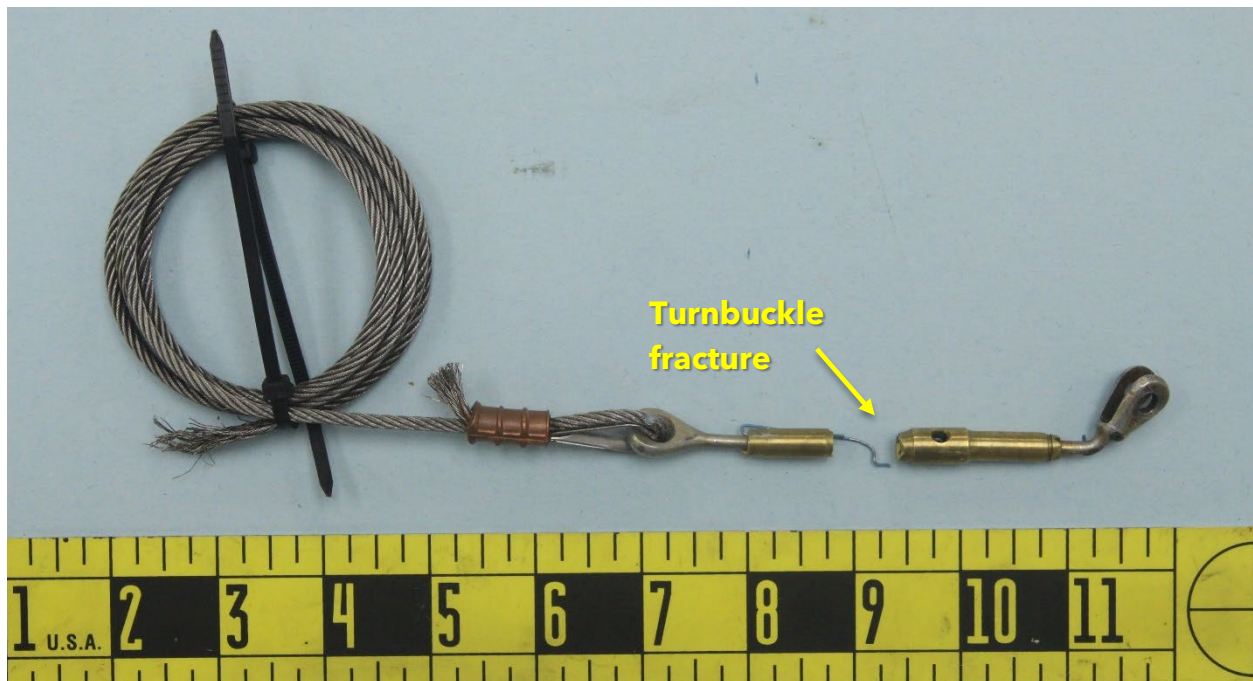
Figure 1 shows the cable assembly as received. This remnant included a fractured turnbuckle subcomponent, shown on the right in the figure. The turnbuckle was removed from the rest of the cable and cleaned in an ultrasonic bath of acetone. The fracture was located between 0.077 and 0.79 inches from the tapered (shorter) end and 1.49 to 1.50 inches from the face of the longer end. Other measurements are annotated in Figure 3. The markings on the body of the turnbuckle stated, "P2005 MS21251 B35".

**Figure 1.** View cable assembly with the fractured turnbuckle, as received.

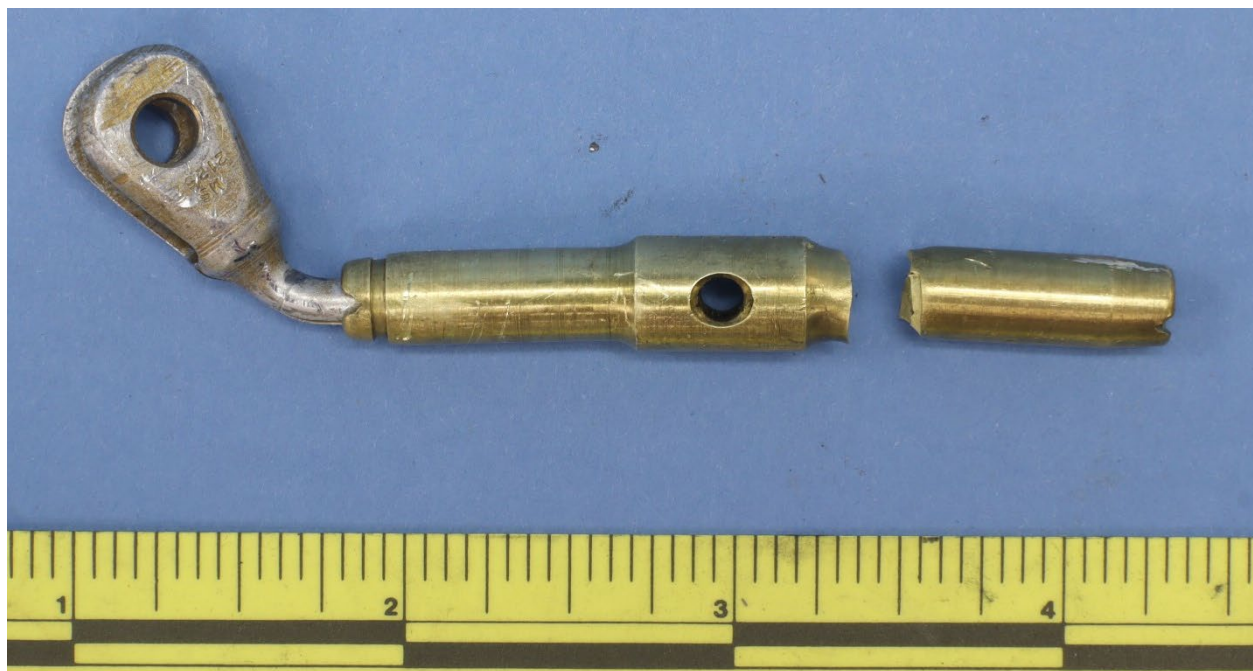
Figures 2 and 3 show the fracture turnbuckle remnants, with the mating fracture surfaces positioned to face each other. While the nominal outer diameter of much of the turnbuckle was 0.280 inches, near the fracture surface, the diameter varied between 0.264 and 0.289 inches. Likewise, the inner diameter varied between 0.155

and 0.205 inches. These measurement variabilities were consistent with localized deformation near the fracture surface.

Figure 2 shows some downward deformation from the left or larger remnant. The fracture surfaces exhibited a general cup and cone shape, exemplified in Figures 3 and 4. The fracture surfaces were angled at a 45° inward towards the bore.

**Figure 2.** View of the fractured pieces of the turnbuckle, after removal from the cable and cleaning.

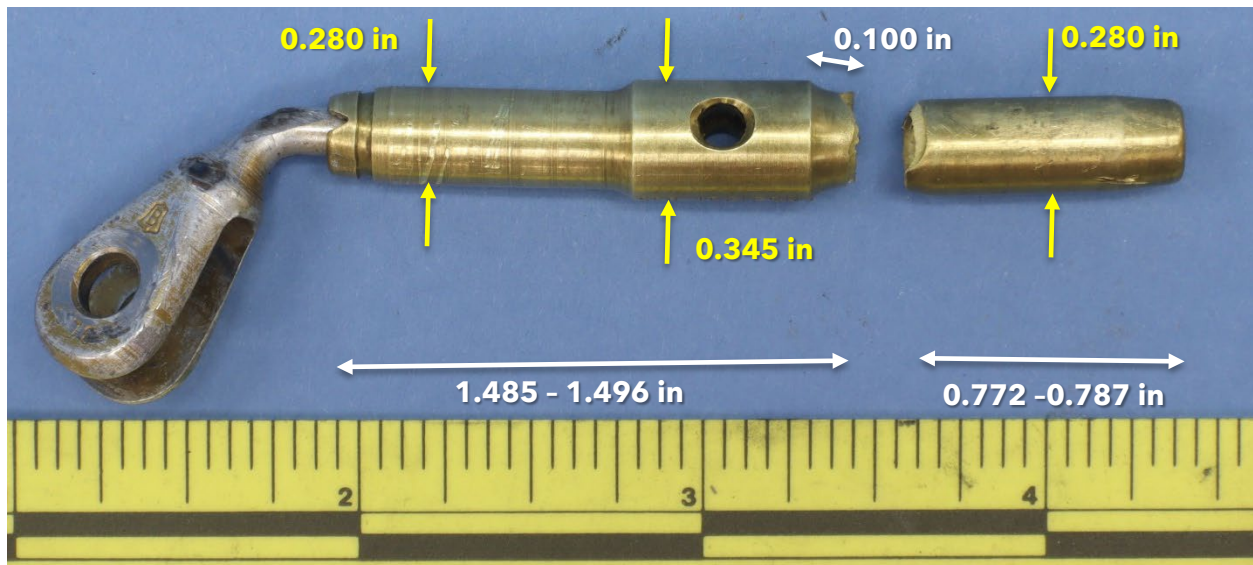
**Figure 3.** View of the turnbuckle, 180° from the side view in **Figure 2**.

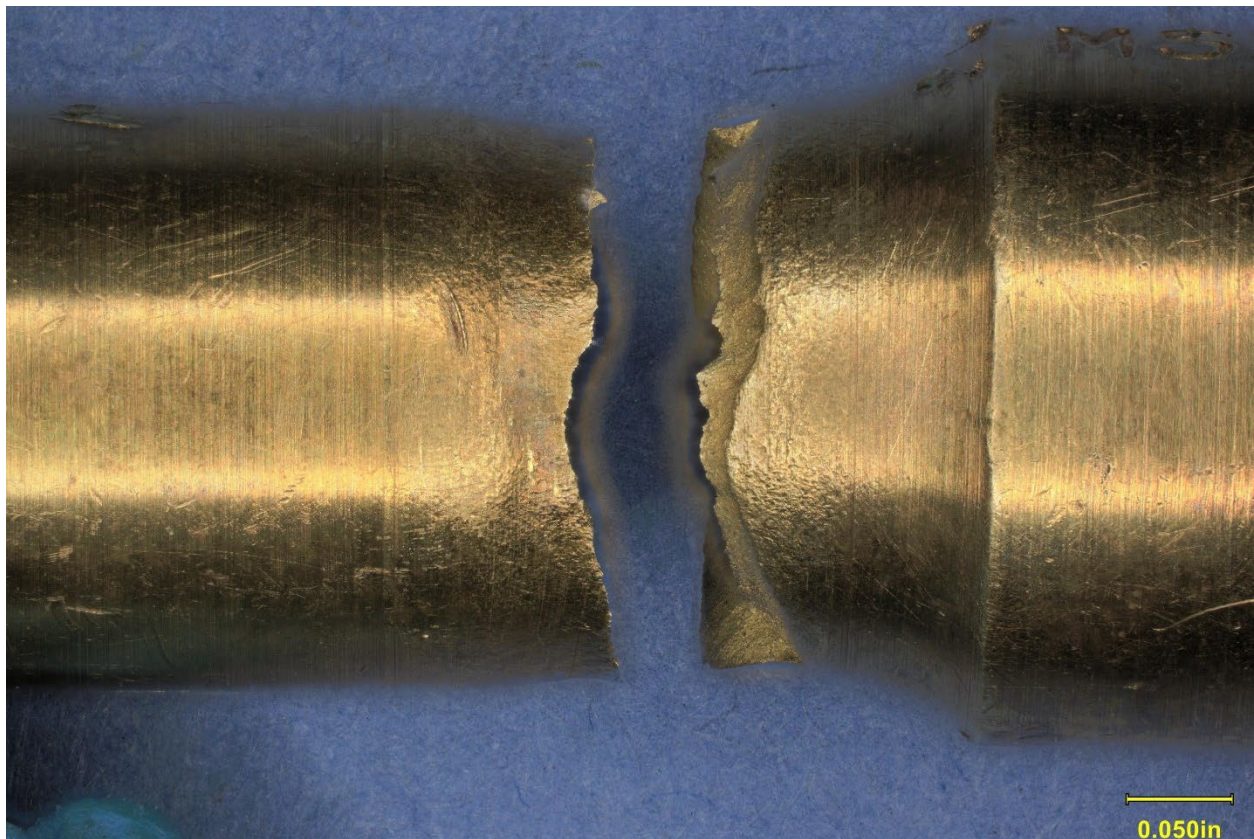
**Figure 4.** Closer view of the mating fracture surfaces of the turnbuckle remnants.

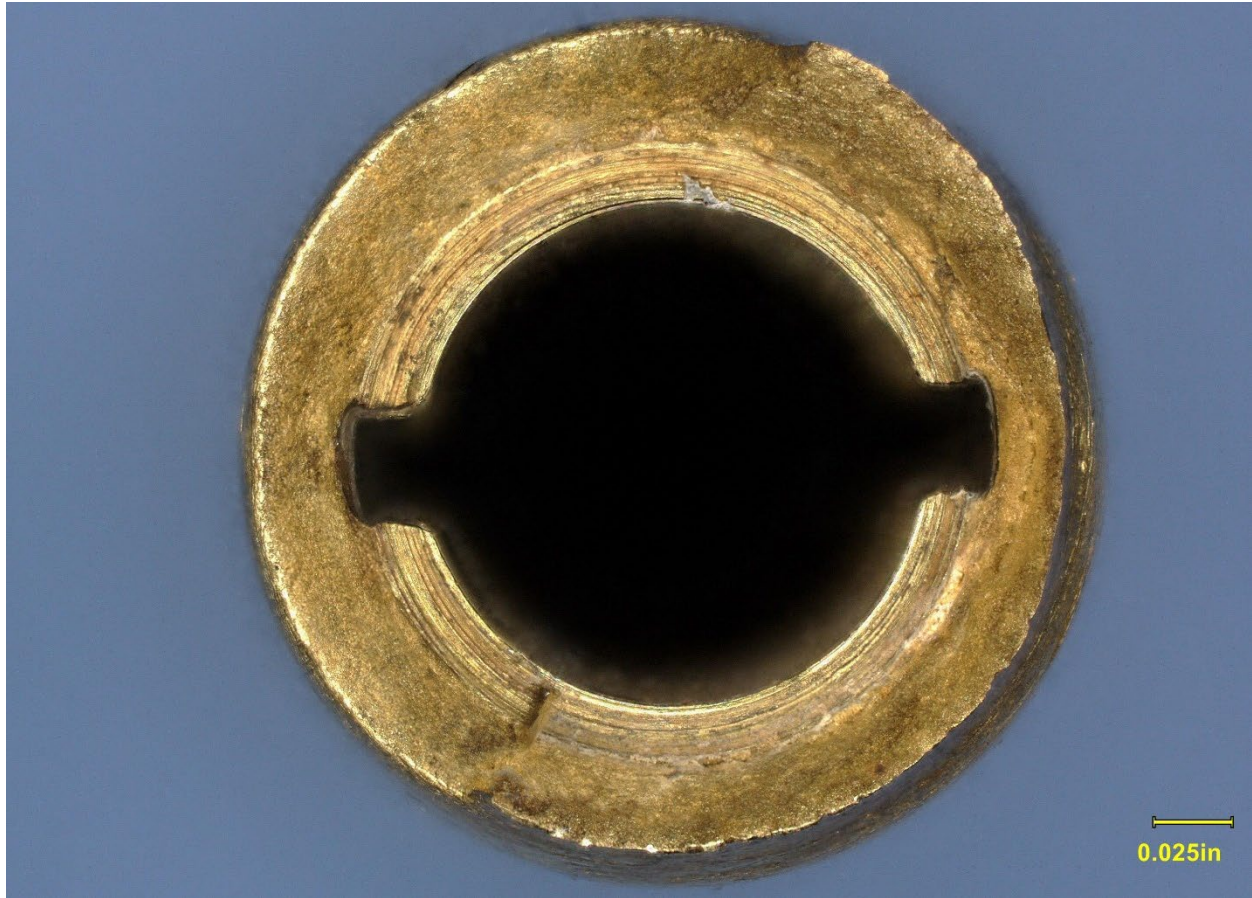
Figure 5 shows the fracture surface of the smaller remnant (on the right in Figures 2 through 4). This surface exhibited a rough texture and a general dull luster. The inward orientation of the fracture is illustrated in Figure 6. There was a small ridge in the upper portion of the fracture surface, illustrated in Figure 7.

**Figure 5.** View of the fracture surface of the smaller turnbuckle remnant on the right in **Figure 4**.

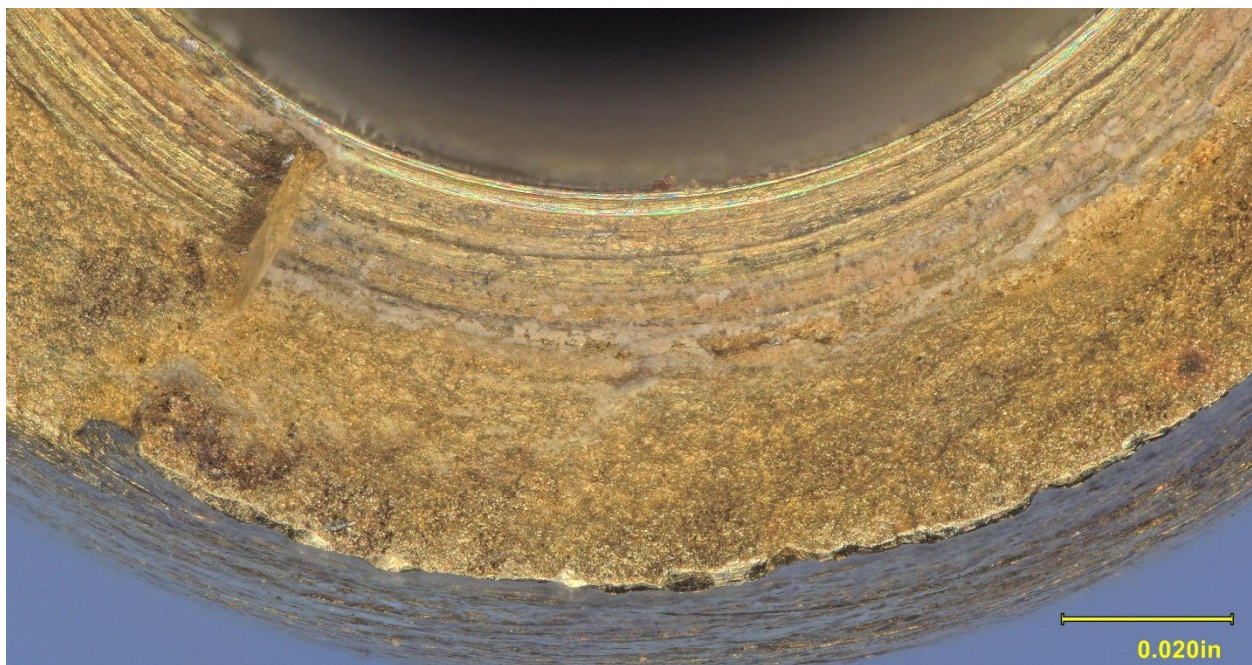
**Figure 6.** Closer view of the angled fracture surface portion from **Figure 5**.

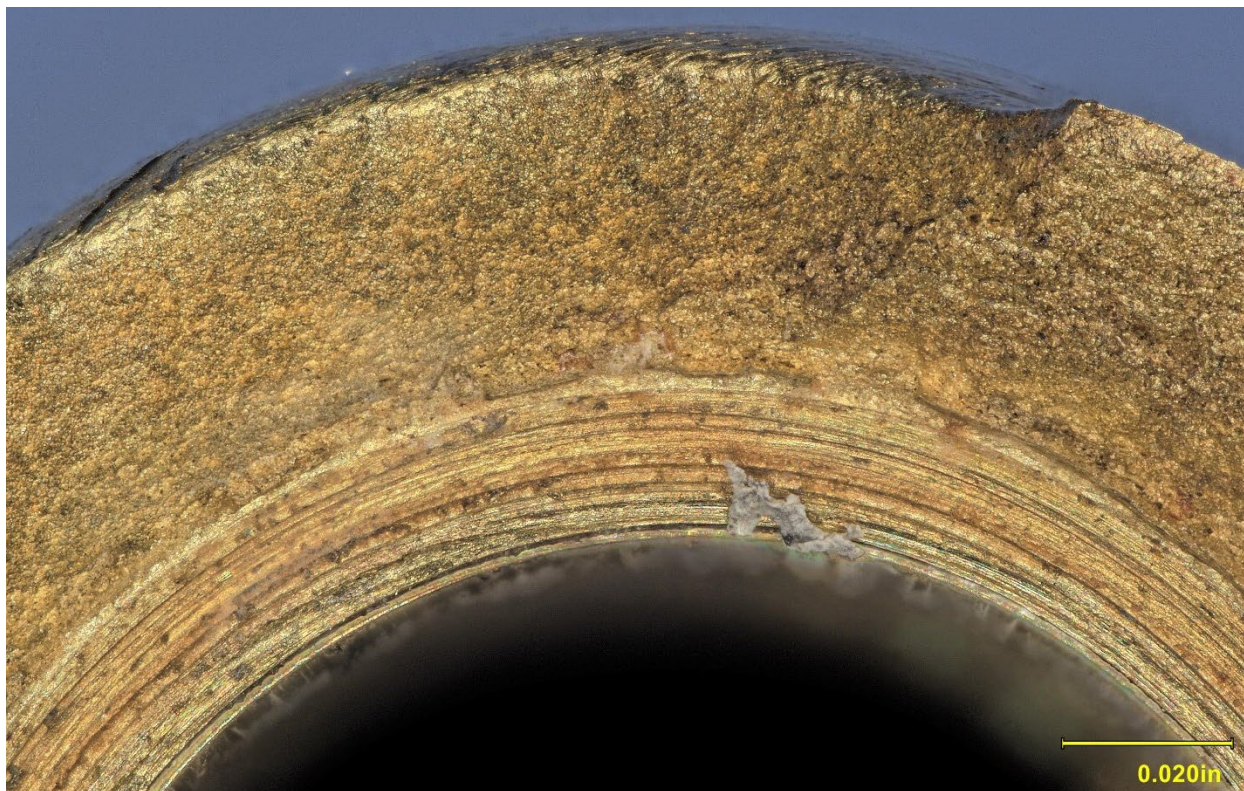
**Figure 7.** View of the ridge from the upper portion of the fracture surface in Figure 5.

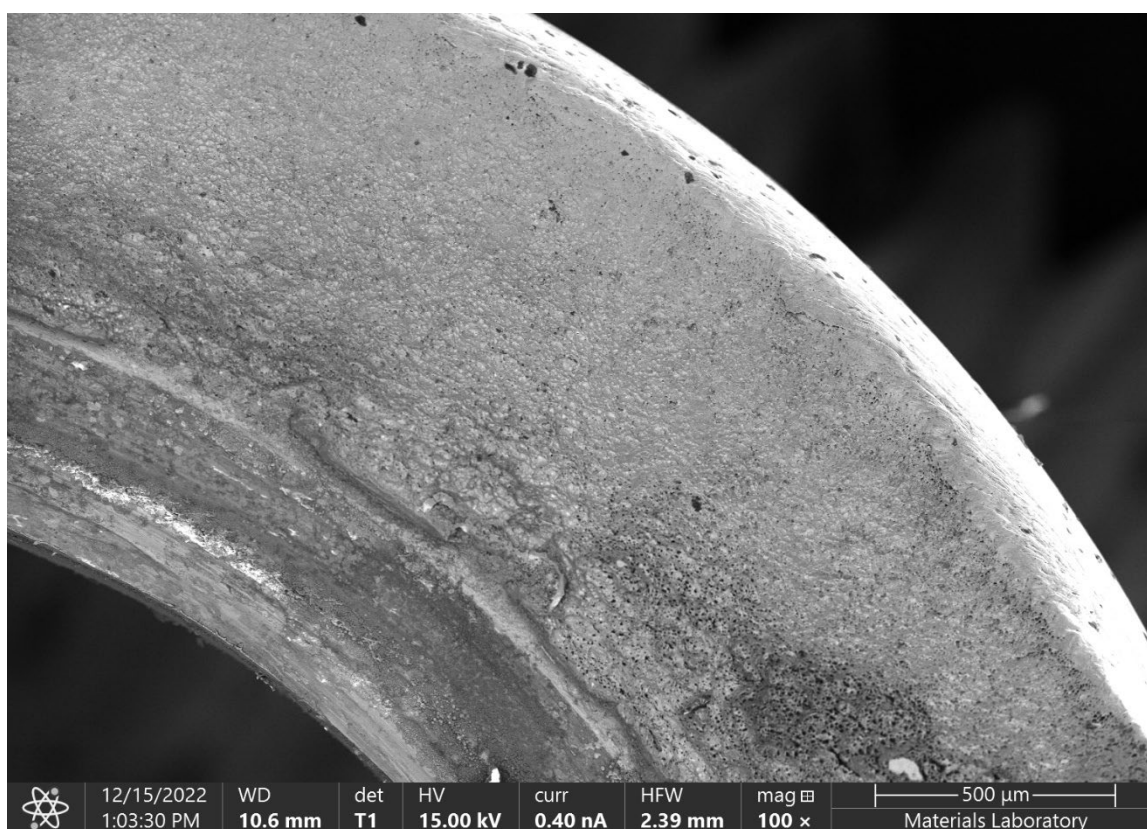
The turnbuckle fracture surface was examined using a field emission scanning electron microscope (SEM). Figures 8 and 9 show an overall view of the fracture surface with the ridge. This fracture exhibited V-shaped chevron marks, annotated in Figure 9. A closer examination of the fracture surface revealed dimpled rupture features, as exemplified in Figure 10. These features were consistent with overstress fracture. The fracture morphology was indicative of overstress fracture of thin-walled structures in tension, torsion, and bending.

**Figure 8.** Backscattered electron (BE) micrograph of the fracture surface in Figure 7.

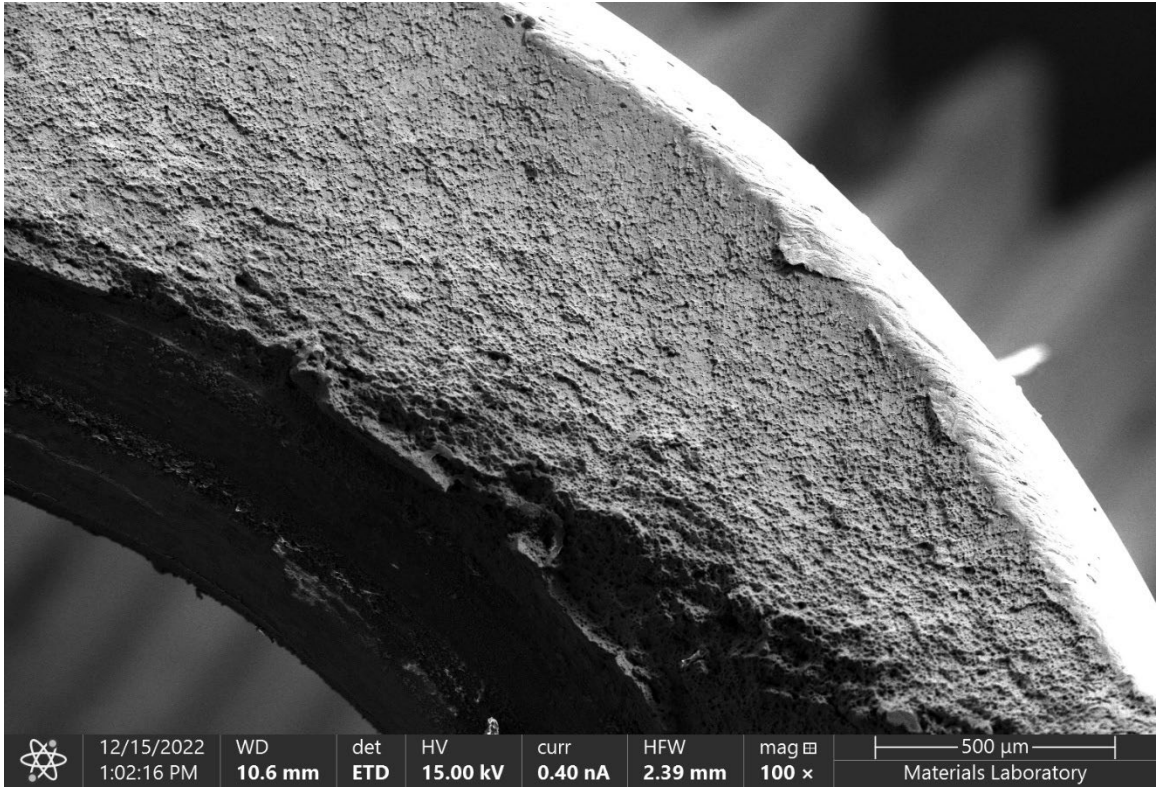
**Figure 9.** Secondary electron (SE) micrograph of the fracture surface in Figure 8, with the chevron marks annotated.

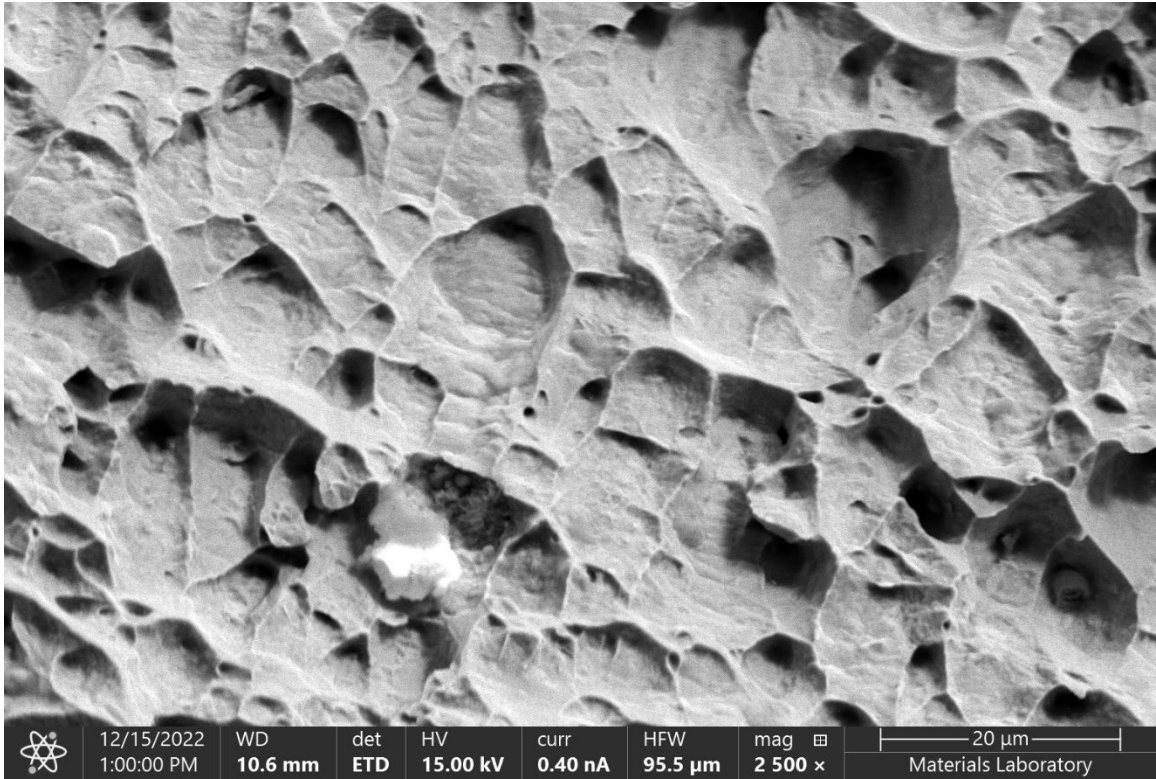
**Figure 10.** SE micrograph of a typical area of the fracture surface, showing dimpled rupture.
