# National Transportation Safety Board

WPR22FA304

## **ACCIDENT SITE EXAMINATION**

Location: Yellow Pine, Idaho  
Date: August 15, 2022  
Airplane: Aviat, A-1A, N26HV

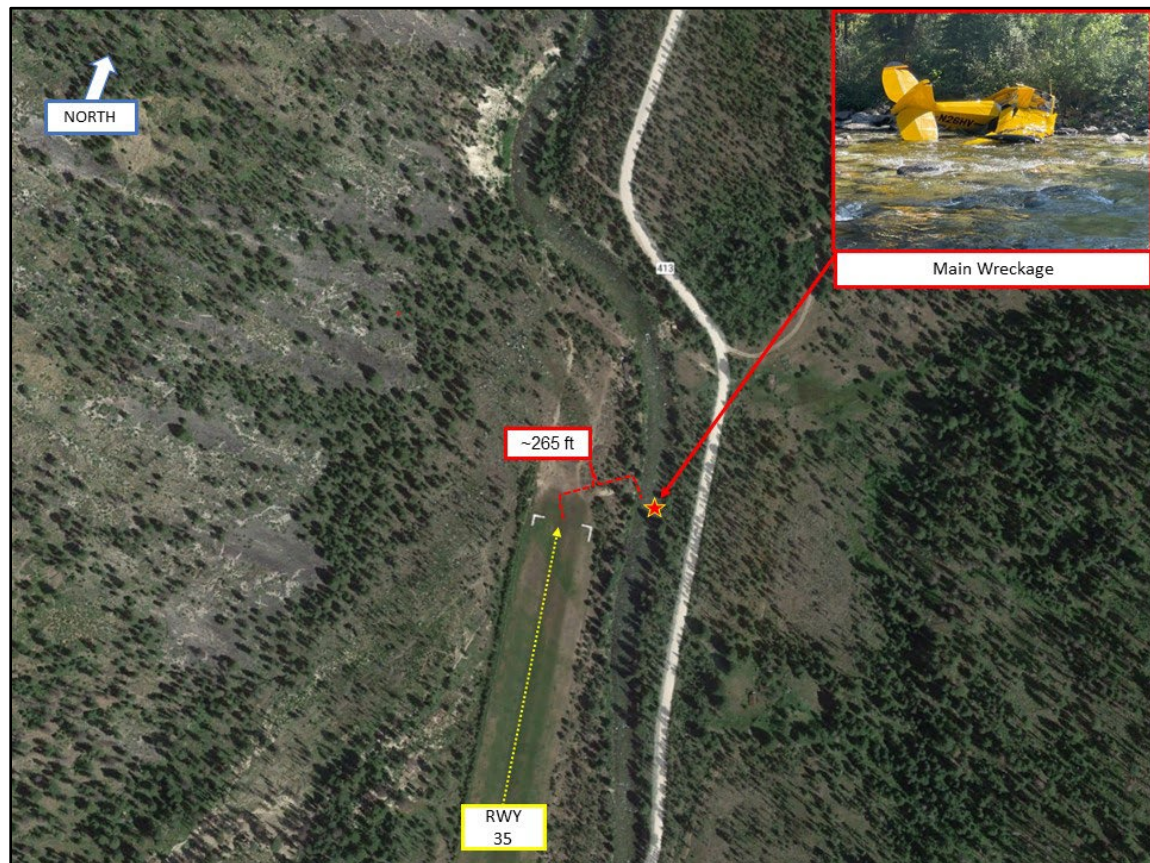
**Figure 1: View of accident site diagram**

Examination of the accident site revealed that the airplane impacted heavy brush near a creek bed, about 265 ft northeast of the departure end of runway 35. The airplane came to rest upright in the Johnson Creek, on a heading of about 116° magnetic, at an altitude of 4,892 ft mean sea level. No visible ground scars were observed in the area near the wreckage. All major structural components of the airplane were located at the accident location.

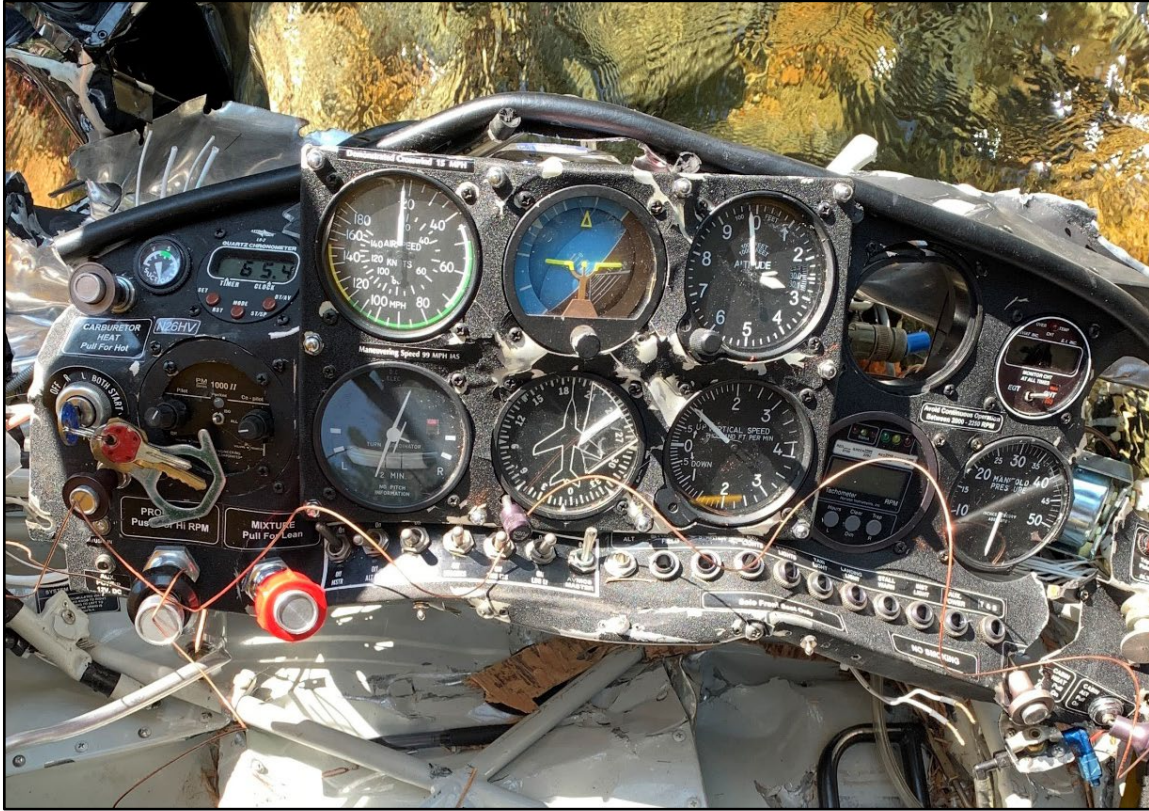
**Figure 2: View of airplane instrument panel**

The forward section of the fuselage sustained extensive impact damage. The engine, engine mount, firewall and instrument panel were partially separated. The instrument panel remained attached to the firewall with various instruments separated. The aft section of the fuselage exhibited buckling, compression and crushing throughout.

Attitude: pitch was about 15° up and about a 50° bank to the right

Turn Coordinator: Bank to the right, ball was to the right

Heading indicator: 190°

VSI: 1000 up

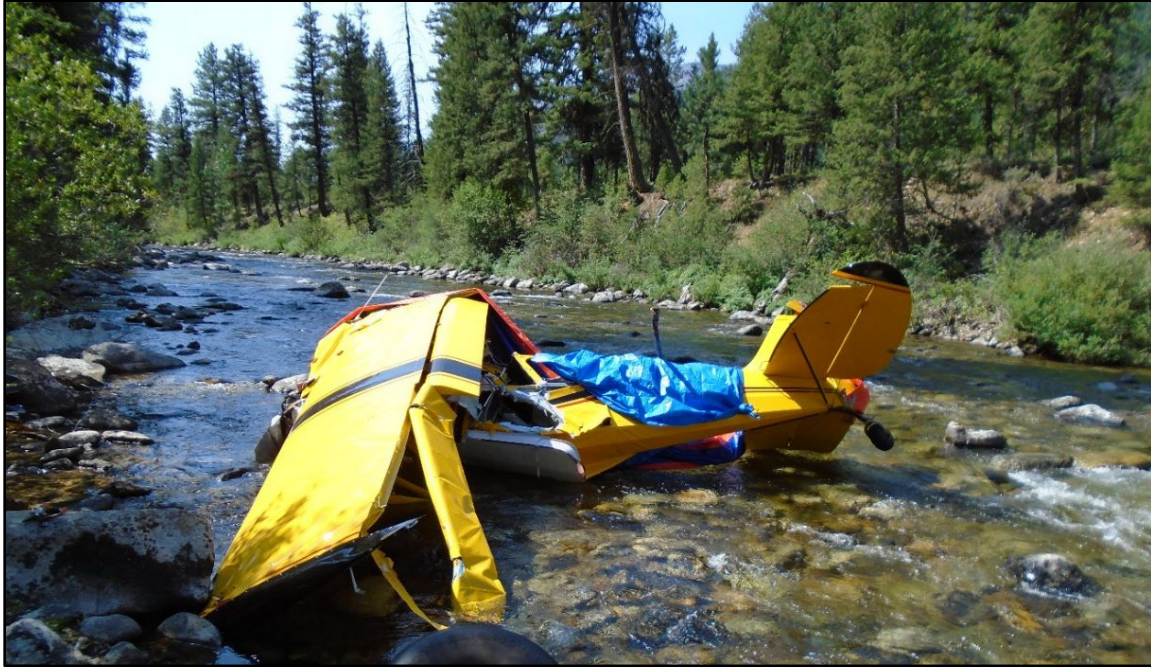
**Figure 3: View of airplane left wing**

The left wing remained attached to the fuselage. Crushing and bending was observed throughout the wing. The left flap remained attached via its mounts. The left aileron remained attached via its inboard attachment mount and separated at the outboard attachment mount; the fracture surfaces exhibited signatures consistent with overload. The outboard aileron attachment mount was separated, and the fracture surfaces exhibited signatures consistent with overload. The flap was observed partially extended and would rotate freely when moved by hand. The main fuel tank fuel cap was in place and secure; the fuel cap was opened and a blue colored liquid consistent with 100 LL was present.

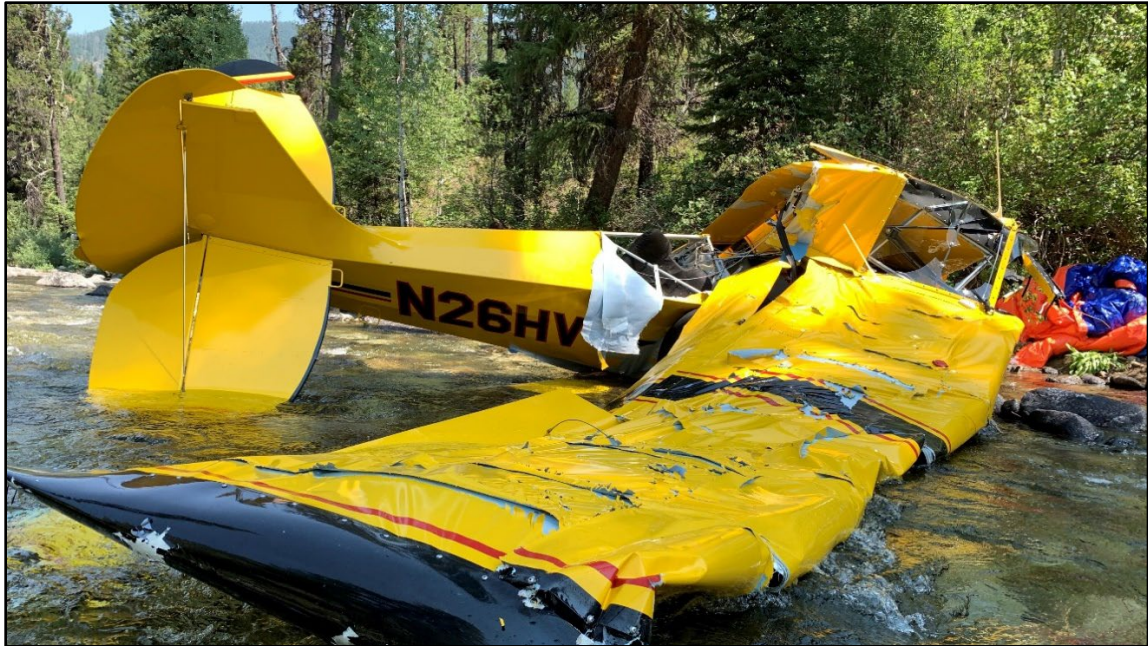
**Figure 4: View of airplane right wing**

The right wing remained attached to the fuselage. Crushing and bending was observed throughout the wing. The right flap remained attached via its mounts. The right aileron remained attached via its inboard attachment mount. The outboard aileron attachment mount was separated, and the fracture surfaces exhibited signatures consistent with overload. The flap was observed partially extended and would rotate freely when moved by hand. The main fuel tank fuel cap was in place and secure; a blue colored liquid consistent with 100 LL was observed leaking from the fuel tank.

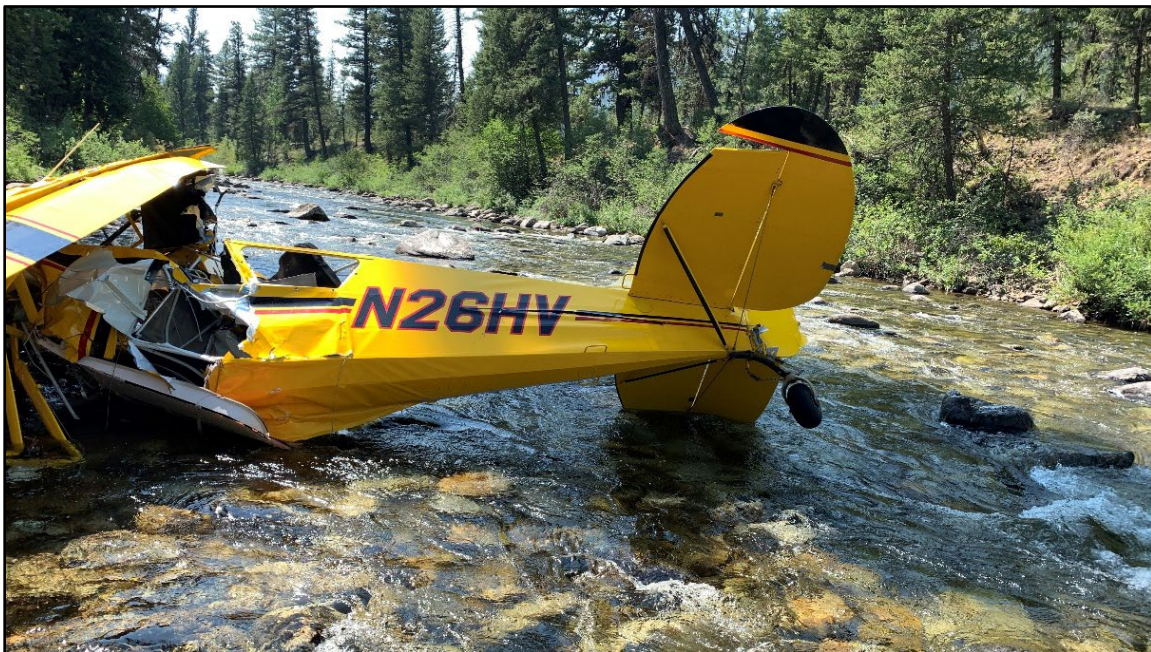
**Figure 5: View of airplane empennage**

The fuselage structure aft of the cabin area exhibited minor bending and crushing. The vertical stabilizer, rudder, horizontal stabilizers, elevator, and elevator trim tabs remained attached and secure to their respective mounts. Both elevator and rudder flight control cables remained attached to their respective mounts; the control cables were traced to the center of the fuselage, where they had separated from the flight controls.

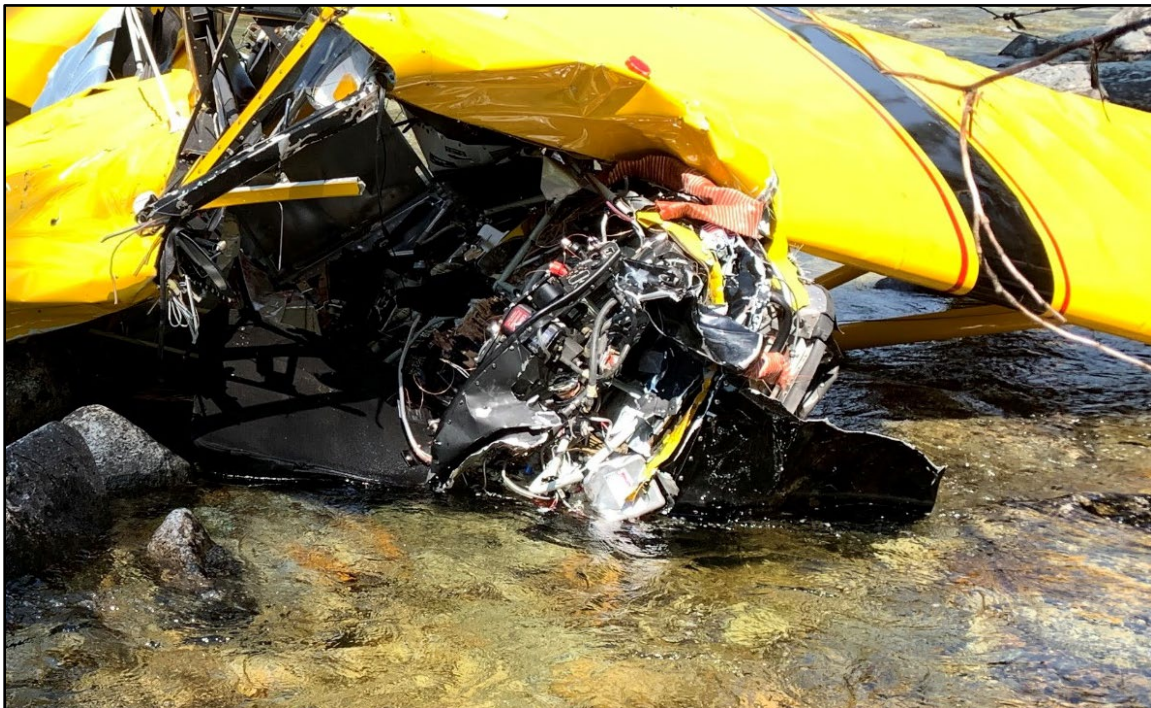
**Figure 6: View of airplane engine**

The engine remained attached to the engine mount, displaced to the left, and came to rest adjacent to the main wreckage. Impact damage was observed to all four engine mounts. The engine was partially submerged in creek water. All four cylinders and engine accessories remained attached to the engine. The propeller governor remained attached to the engine and exhibited impact damage.

The carburetor separated from the engine and a small section of the carburetor flange remained attached to the plenum. The carburetor remained tethered to the engine via the throttle, mixture control cables and fuel line. The carburetor flange fracture surfaces exhibited signatures consistent with overload. The intake and exhaust remained attached to the engine, bending and crushing was observed throughout.
