# National Transportation Safety Board

WPR22FA309

## **AIRFRAME AND ENGINE EXAMINATION REPORT**

Location: Watsonville, California  
Date: August 18, 2022  
Time: 1455 Pacific daylight time  
Airplane 1: Cessna 340A / N740WJ  
Airplane 2: Cessna 152 / N49931

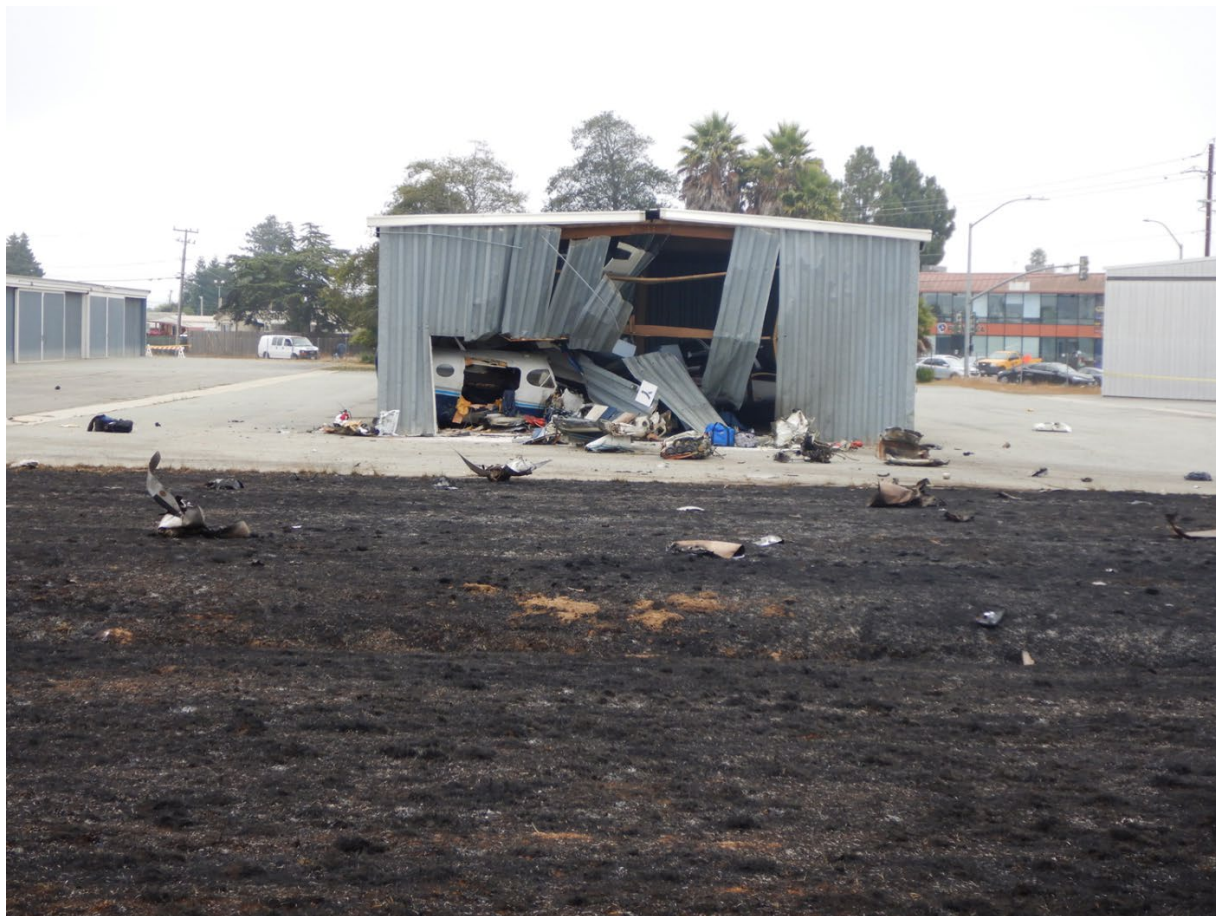
Fuselage. The fuselage was substantially damaged throughout. The nose section exhibited substantial crushing and fragmentation to the windshields. Both windshields were shattered. The body of the fuselage remained intact. The fuselage aft of the cabin space was extremely crushed and wrapped around the left side of the cabin. The left side of the fuselage forward of the left wing exhibited accordion style aft crushing. The left-side windshield framework was absent and exhibited damage from where the left horizontal stabilizer penetrated the windshield structure. The left and right-side engine nacelles were fragmented, and both separated from the wings. Both left and right engines separated from their respective wings at their mounts. The right-side engine was located outside of the hangar and the left engine was located inside the hangar. Both propellers and propeller flanges separated from their respective engine crankshafts.

**Figure 3. N740WJ in hangar.**

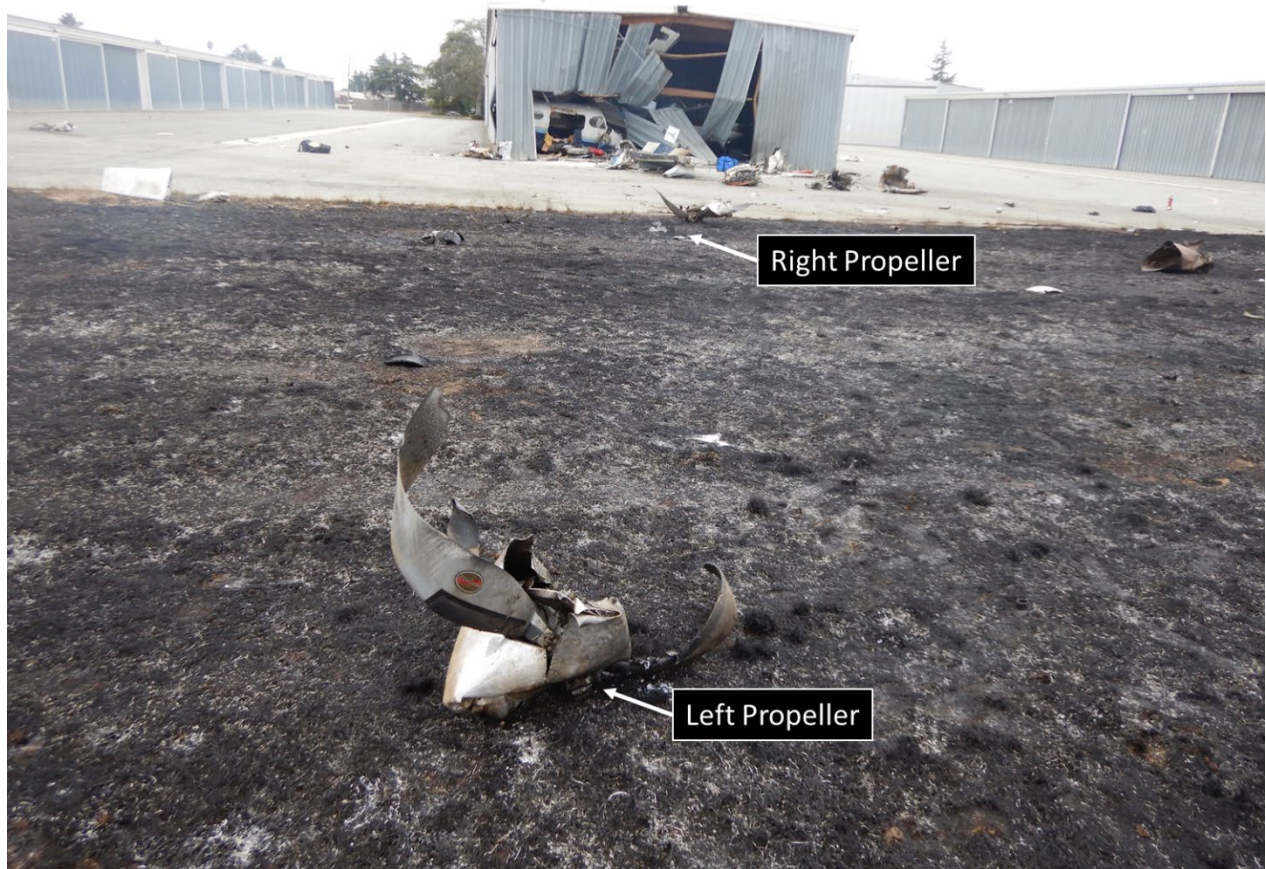
Propeller. The right-side propeller and propeller flange separated from the engine. The three-bladed propeller exhibited S-bends, chord-wise bends, and tip curling. One blade exhibited a chord-wise aft bend. The left propeller and propeller flange separated from the engine. The three-bladed propeller came to rest near the taxiway. The three blades were twisted, bent aft, and exhibited significant rotational score marks near the tip of each blade.

**Figure 6. Left propeller. Right propeller in background.**

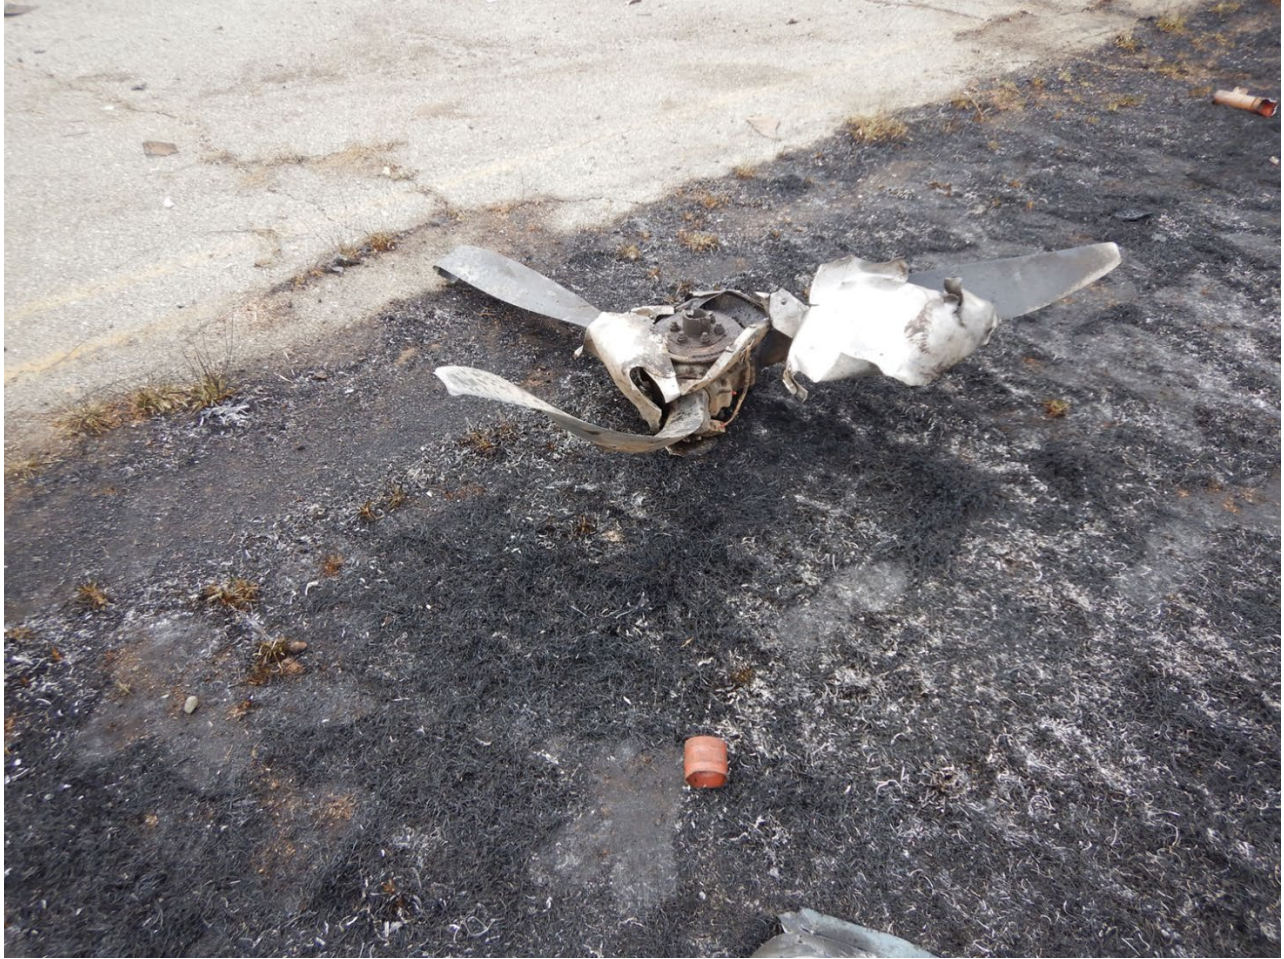
The right-side propeller and propeller flange separated from the engine. The three-bladed propeller exhibited S-bends, chord-wise bends, and tip curling. One blade exhibited a chord-wise aft bend.

**Figure 7. Right Propeller**

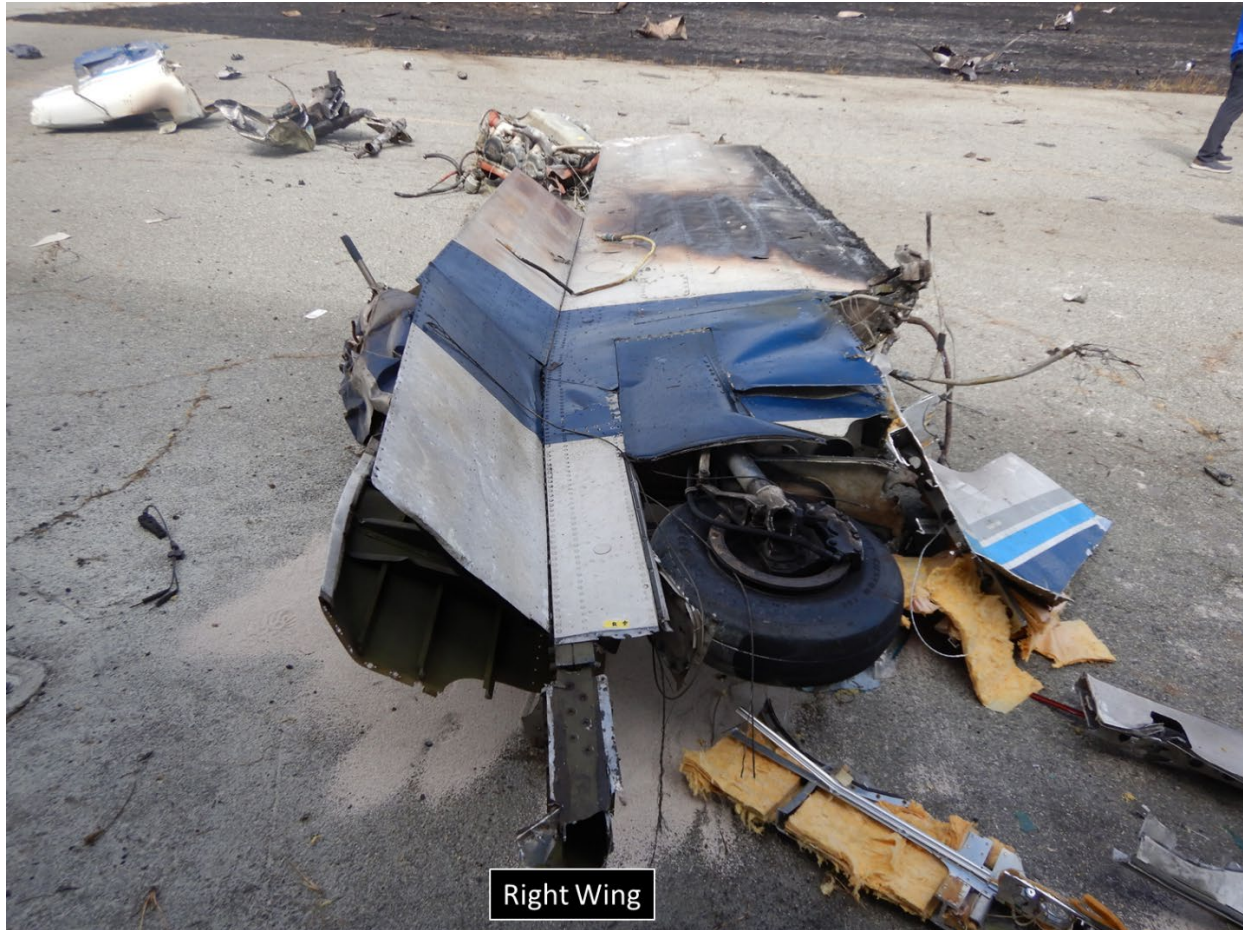
The right wing separated from the fuselage at the wing root and came to rest upside down about ten ft outside of the hangar. The wing exhibited thermal damage throughout. The right-wing tip tank (right main tank) had separated from the wing. The outboard tip exhibited impact damage running from the leading-edge inboard. The leading edge of the wing, from damaged tip to the right-wing engine nacelle,

**Figure 10. Right Wing.**

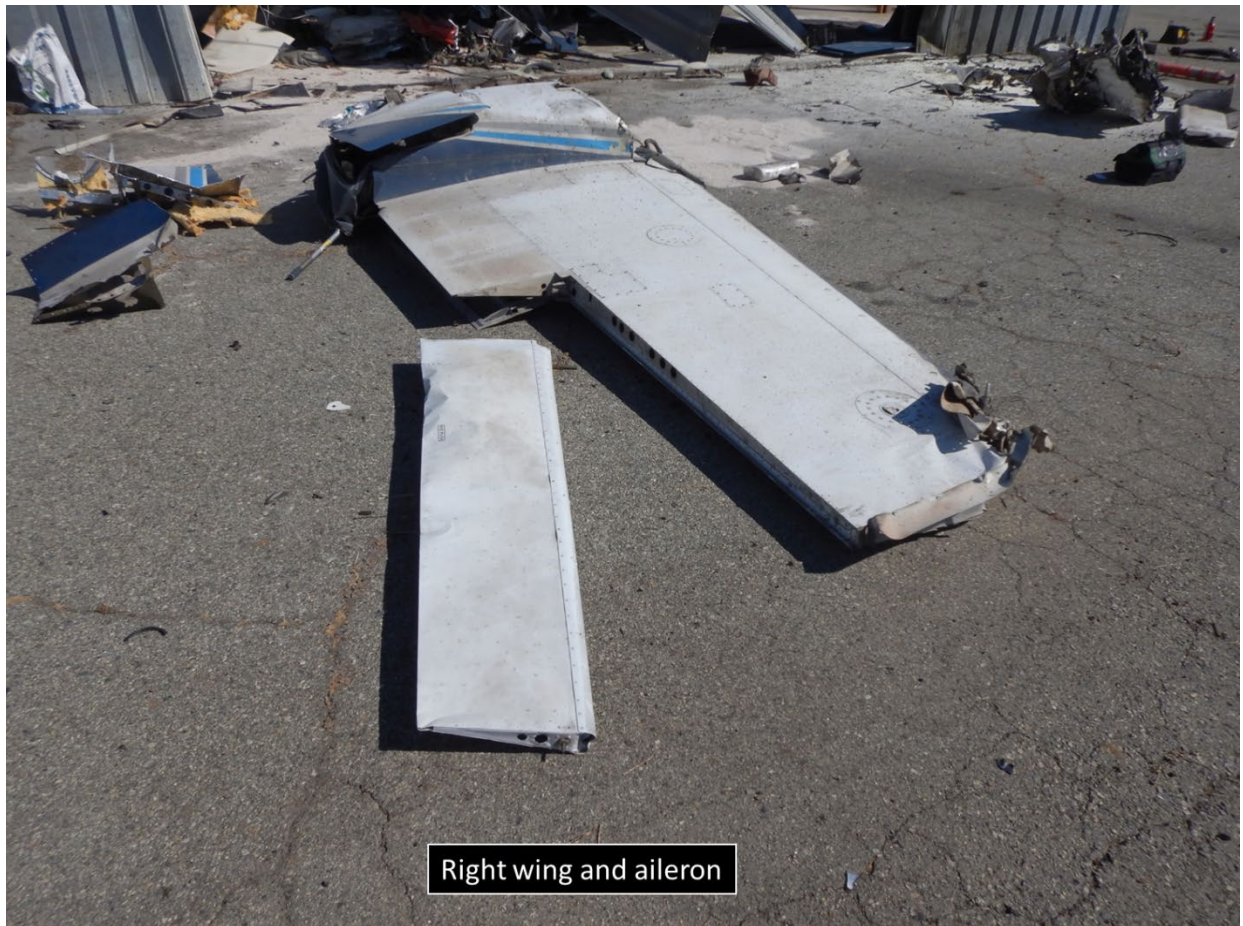
exhibited thermal damage to the rubber boot but no impact damage. The engine and engine nacelle separated from the wing. The main wing spar fractured at the inboard location of the right-wing engine nacelle. The right aileron separated from the wing and was in the nearby debris area. The aileron remained intact with minimal damage. The airplane was equipped with split flaps that deployed in two sections per wing. The right-side flaps remained attached to the underside of the wing and were free to travel and exhibited minimum damage to the flap surfaces. While the flaps appeared to be fully extended, the controlling device had been sheared. The right-wing tip tank fractured into multiple sections and exhibited crushing at all the sections along with inward crushing on the nose of the tank. There were thermal damage signatures on the nose section. The fuel cap remained secured to the tank. When opened, the cap exhibited a functional vent and a soft rubber seal.

**Figure 11. Right wing and aileron.**

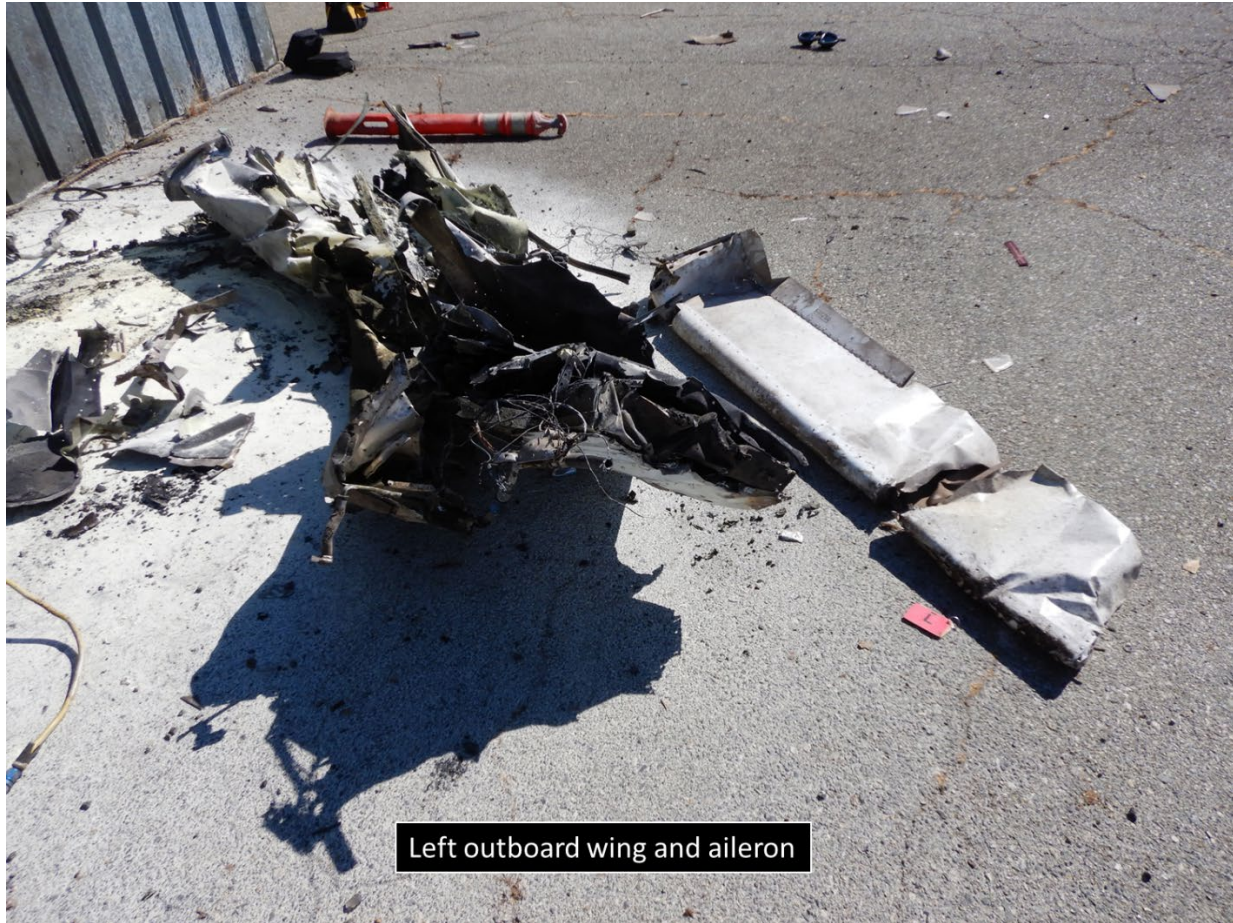
The left wing, from the outboard side of the engine nacelle to the tip, separated from the airplane near the root and was located about 10 to 15 ft outside the hangar. The remainder of the wing remained attached to the fuselage. The wing exhibited extreme fractures and fragmentation along with thermal damage. The left aileron separated from the wing and fractured into two pieces. The left flaps remained attached to the wing. The left-wing tip tank separated from the wing and fractured into multiple sections. The sections exhibited thermal damage. The fuel cap remained secured to the tank. When opened, the cap exhibited a functional vent and a soft rubber seal. The aft fuselage, from aft of the cabin to the empennage, separated from the cabin and was crushed when it was forced 180° around to the left side of the fuselage. All structural integrity was lost as the aft fuselage was compressed against the left side of the cabin area.

**Figure 12. Left wing and aileron.**

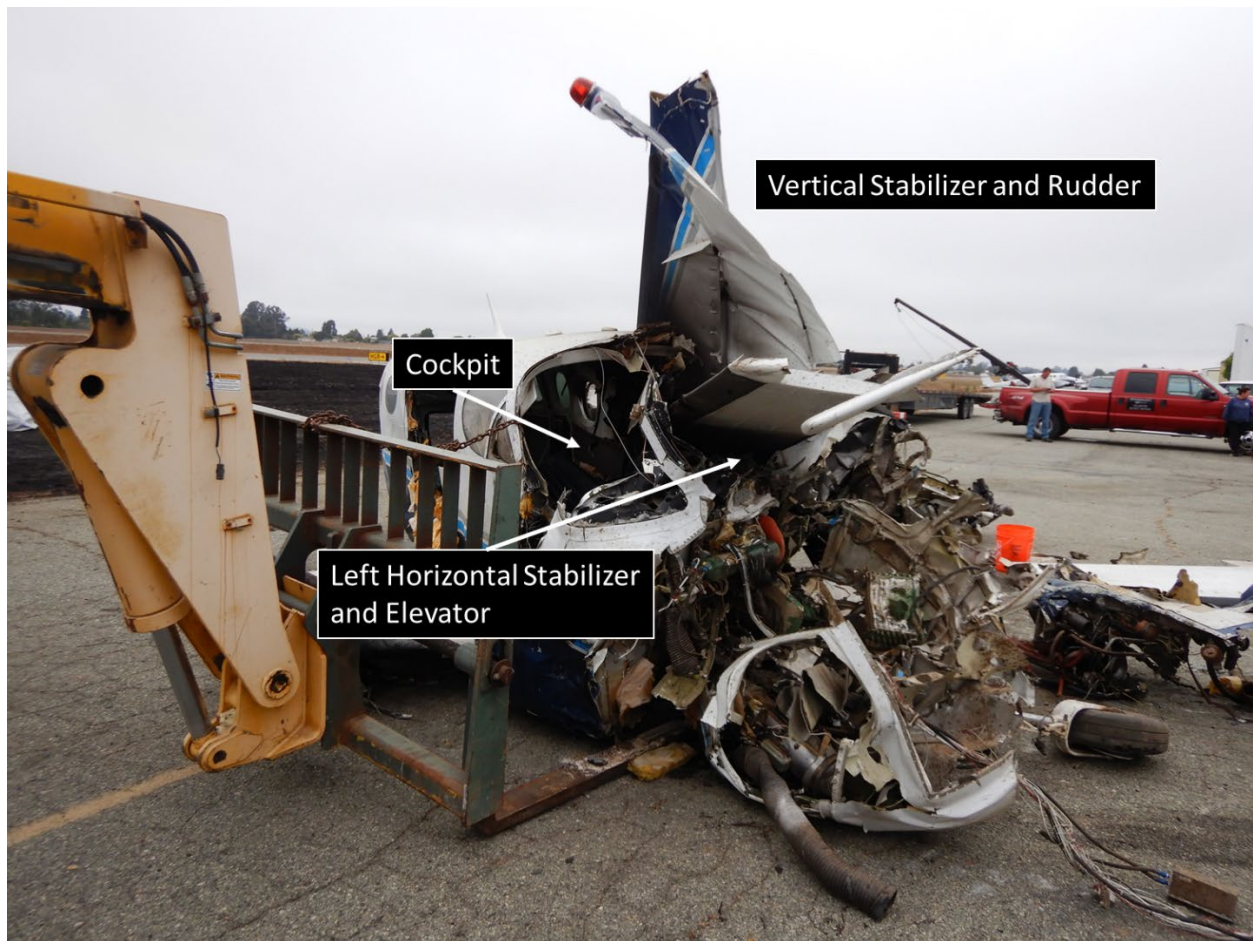
Empennage. The empennage was substantially damaged. The left and right horizontal stabilizer assembly remained partially attached to the fuselage and exhibited crushing and tearing of the sheet metal. The left and right elevators remained attached to the horizontal stabilizers and exhibited similar crushing and tearing. The vertical stabilizer remained attached to the fuselage and exhibited substantial damage in the form of bending and sheet metal damage yet retained its structural integrity and shape. The rudder separated from the vertical stabilizer at the top hinge and remained attached at the bottom hinge. The rudder was substantially damaged.

**Figure 15. Empennage.**

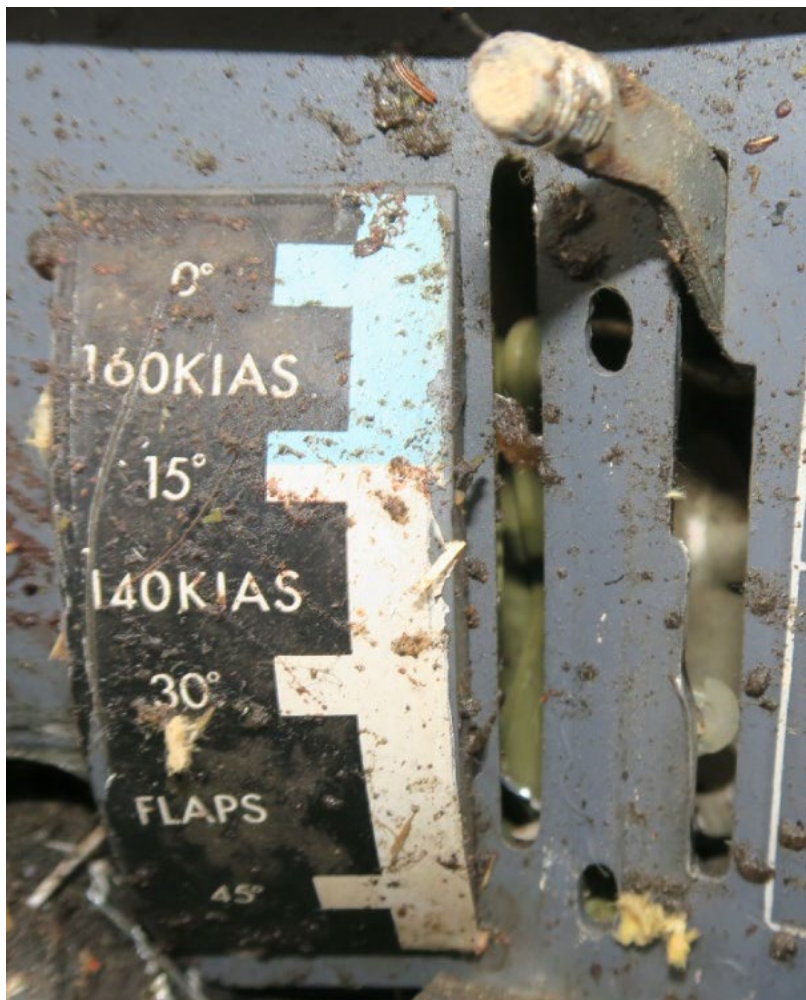
Cockpit Documentation. The cockpit was substantially damaged. The floor was crushed upwards and inwards greatly reducing the lower area available space. The left seat was partially pulled back, likely during the recovery efforts. The right seat remained partially attached at the rails. The instrument panel remained partially attached to the cabin. The flap control lever was in the full up position. The flap indicator had a witness mark near the full up position.

**Figure 16. N740WJ flap extension handle. Photo Textron.**

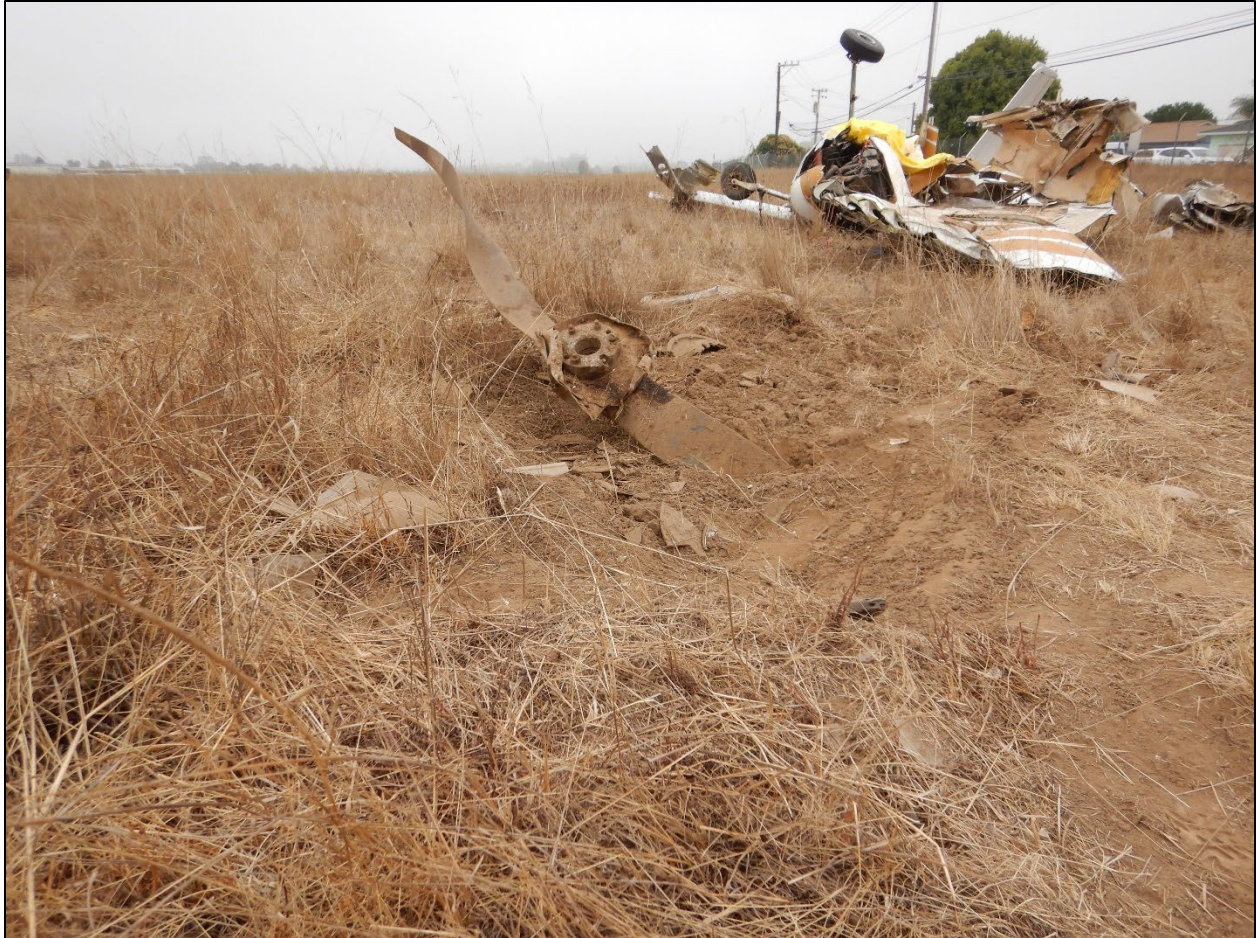
The main wreckage of the Cessna 152 was on airport property about 800 ft North from the threshold of runway 20. The debris field was about 750 ft long and on a magnetic heading of about 234 degrees. The first identified parts in the debris field were sections of the left wing, left elevator and left horizontal stab, that were found on a neighborhood street adjacent to the airport property. Other sections of the left wing were found further in the debris field on the airport property. A Cessna 340 left wing tip tank nose cap and a section of the wing left tip tank trailing edge fairing with an attached static wick were also found in this area. Several wing sections revealed blue transfer marks near the severe impact areas. About 460 ft further in the debris field, near the main wreckage, an initial impact crater and ground scars were identified. The crater was about 10 inches deep and about 4 ft in diameter.

**Figure 18-Accident site, view to the southwest, impact crater and Cessna 152 main wreckage.**

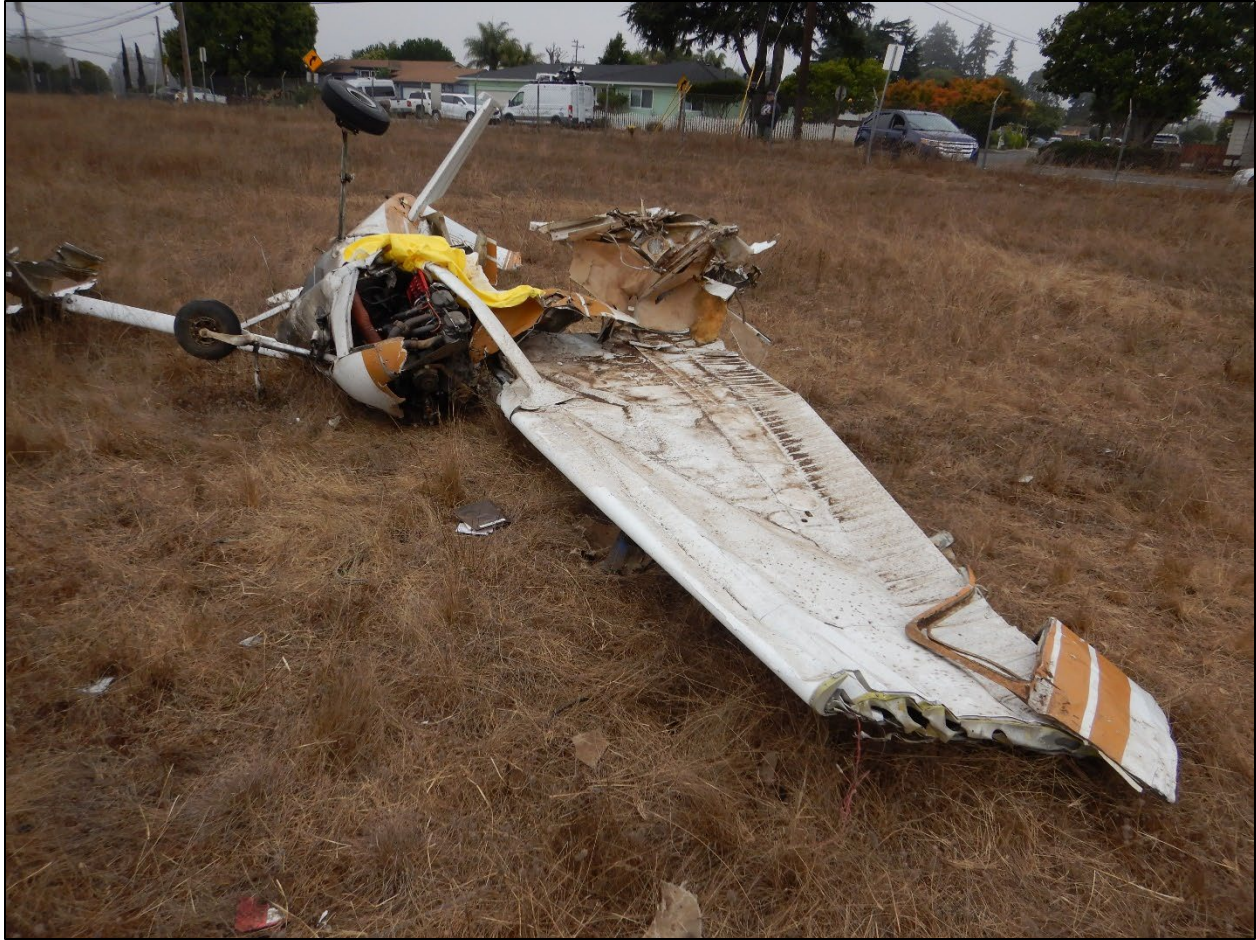
The right wing was on the ground inverted and had crush damage. The right-wing flap and aileron flight controls remained attached to the wing. The right-wing tip fairing separated from the wing and was found near the main wreckage.

**Figure 19-Main wreckage and right-wing view.**

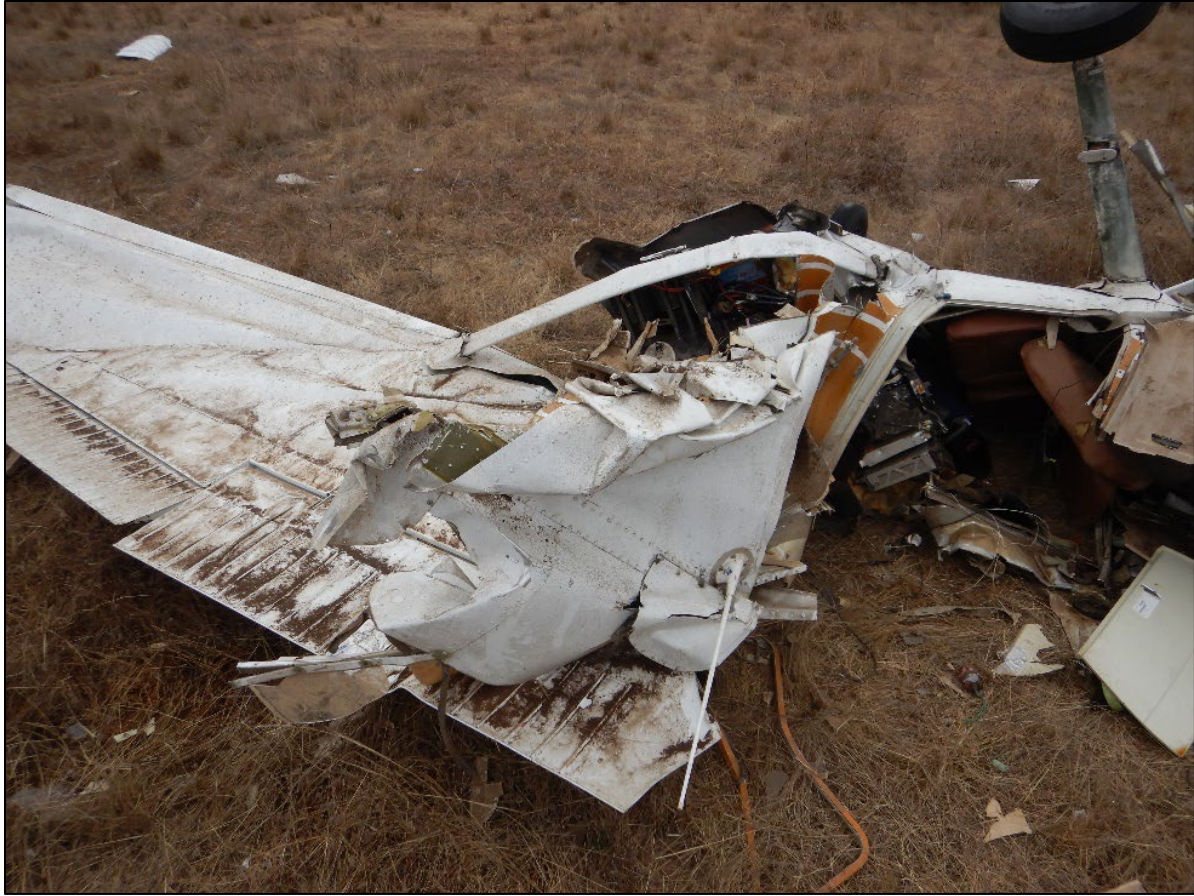
The main wreckage came to rest on its left side on a magnetic heading of about 50 degrees. The right wing remained partially attached to the main wreckage through the side strut and fuselage wing attachment. The cabin roof remained attached to the right wing. It was undetermined if first responders removed the roof section from the fuselage. The left cabin seat shoulder harness was cut, and the left seat lap belt was undamaged and was unbuckled.

The forward fuselage and cabin area were crushed and distorted to its right side. The cabin roof separated from the fuselage and remained partially attached to the forward left window post. An emergency locator transmitter (ELT) was installed in the

**Figure 20-Main wreckage, view of the cabin, cabin roof and right wing.**

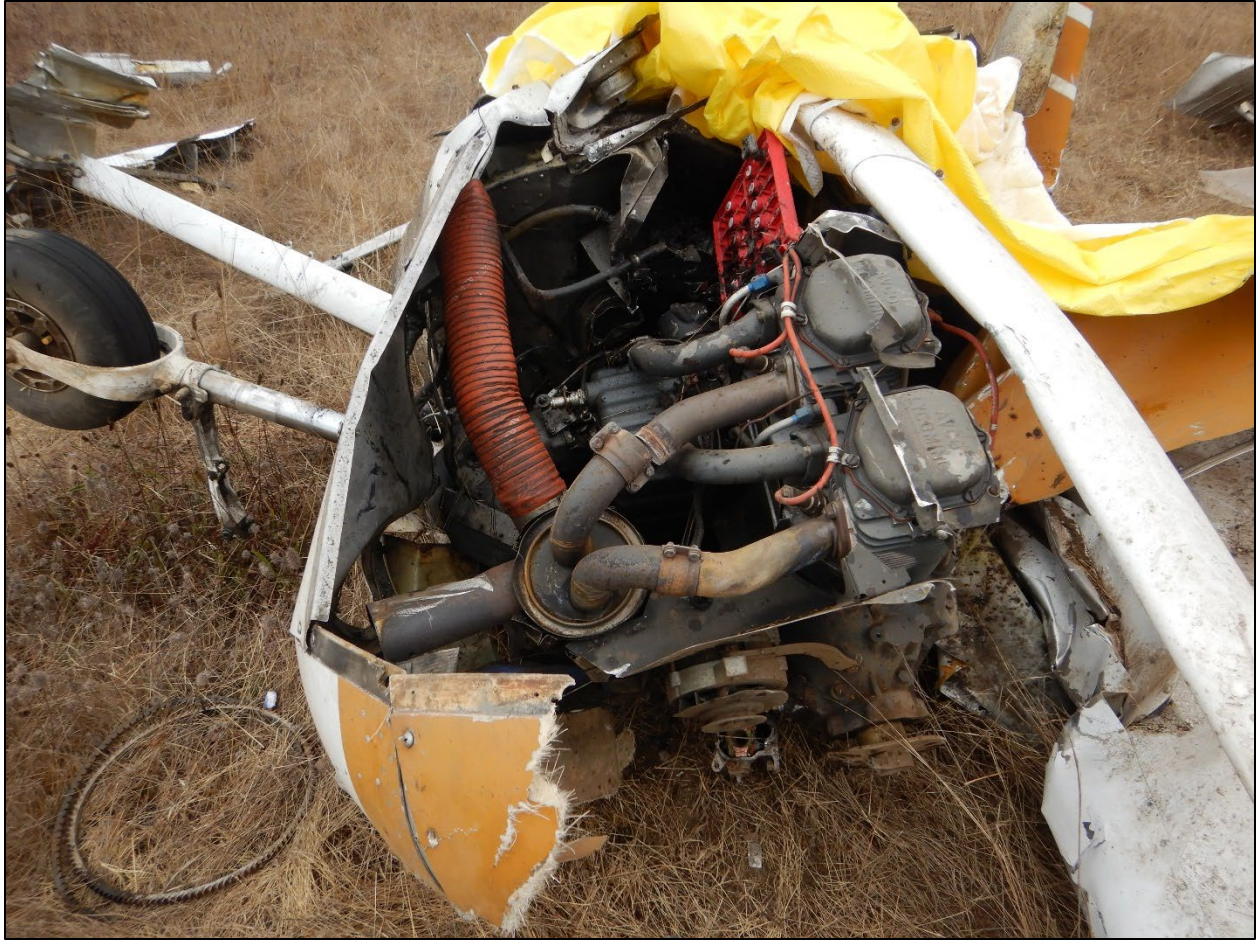
The engine cowling had impact damage and most of the upper cowling had separated. The lower cowling remained partially attached. The engine remained attached to the fuselage and the engine carriage mount assembly was distorted. The forward side of the engine had impact damage and the crankshaft propeller flange was damaged. The forward mounted belt driven alternator had impact damage.

**Figure 22-Main wreckage, engine assembly.**

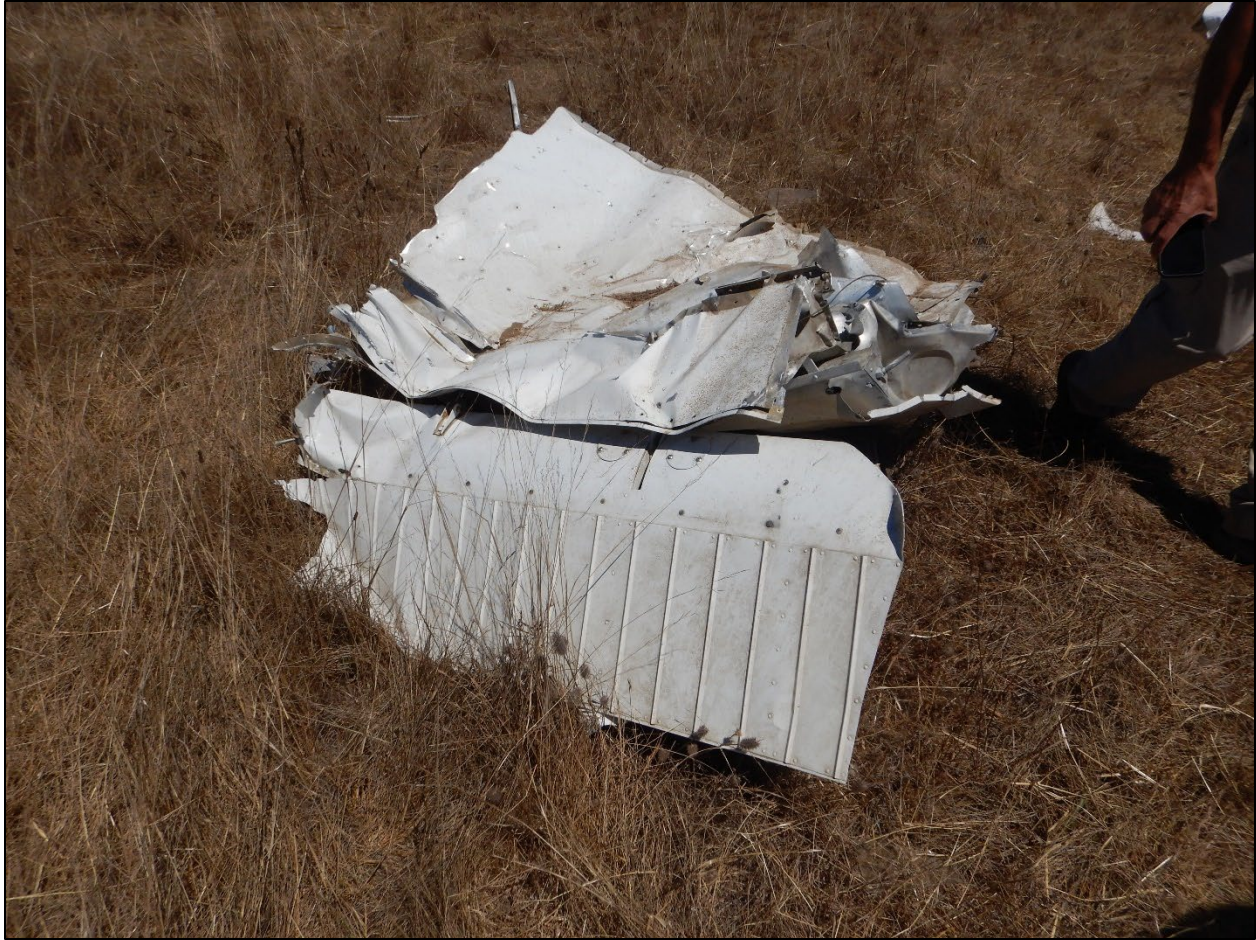
The first identified parts in the debris field were sections of the left wing, left elevator and left horizontal stab, that were found on a neighborhood street adjacent to the airport property. Other sections of the left wing were found further in the debris field on the airport property. An inboard section of the left wing [about 4 ft in length] was found near the main wreckage. The inboard section contained the left fuel tank and attached inboard flap section. The wing tank cap was undamaged and did not have a chain lanyard. The outboard separated side of the wing and flap had impact damage consistent with impact from the rear. Blue paint transfer marks were visible in this area. The trailing edge wing stiffener at the outboard side was curved in a circular pattern and had a radius of about 5 inches.

**Figure 23-Left wing inboard section.**

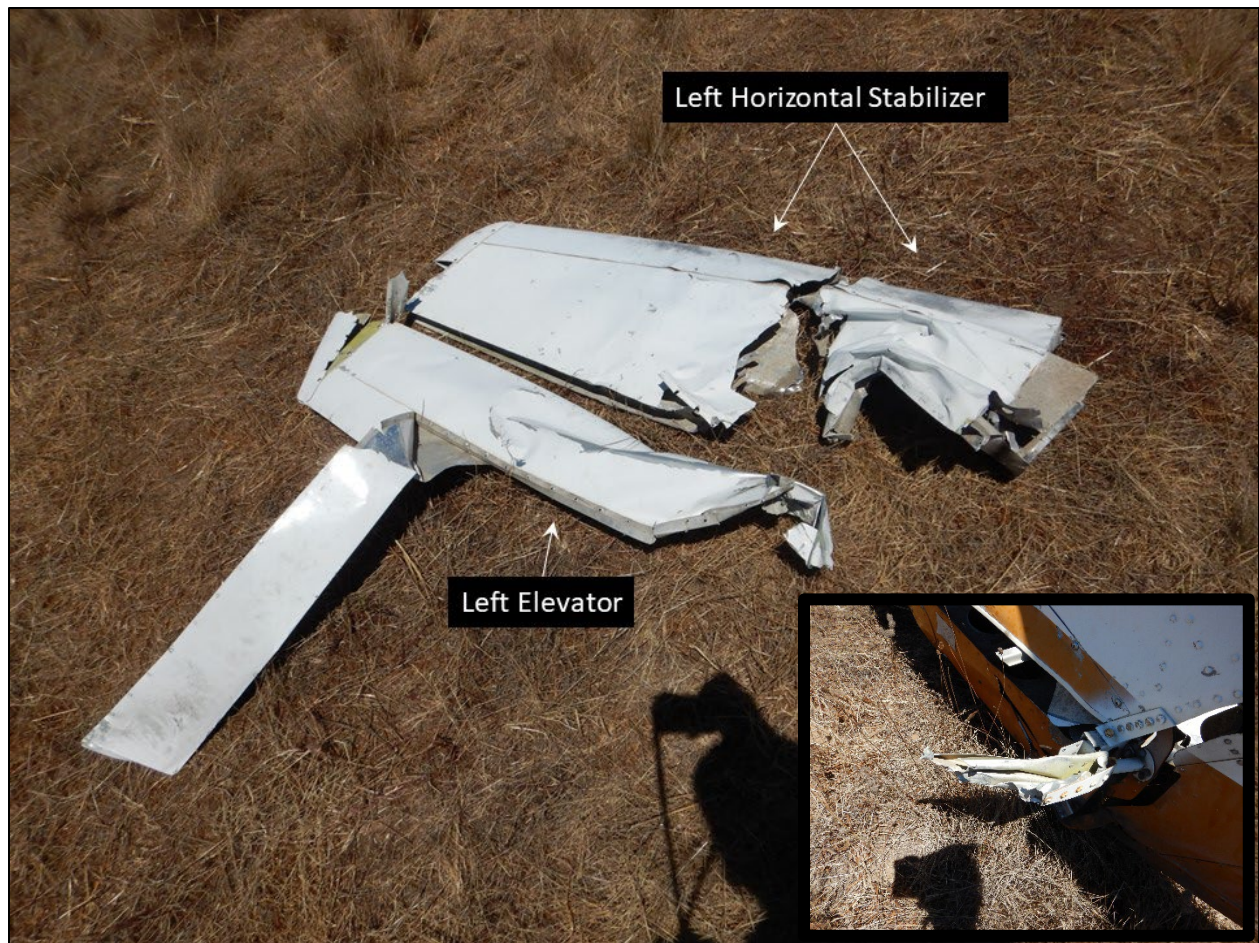
The stabilizer was found in two sections. The elevator inboard side separated and was found on the elevator interconnect control rod that remained attached to the main wreckage. The impact signatures found were consistent with impact from the rear. Blue paint transfer marks were visible at the separation areas.

**Figure 24-Left elevator [left elevator section] and left horizontal stabilizer sections.**

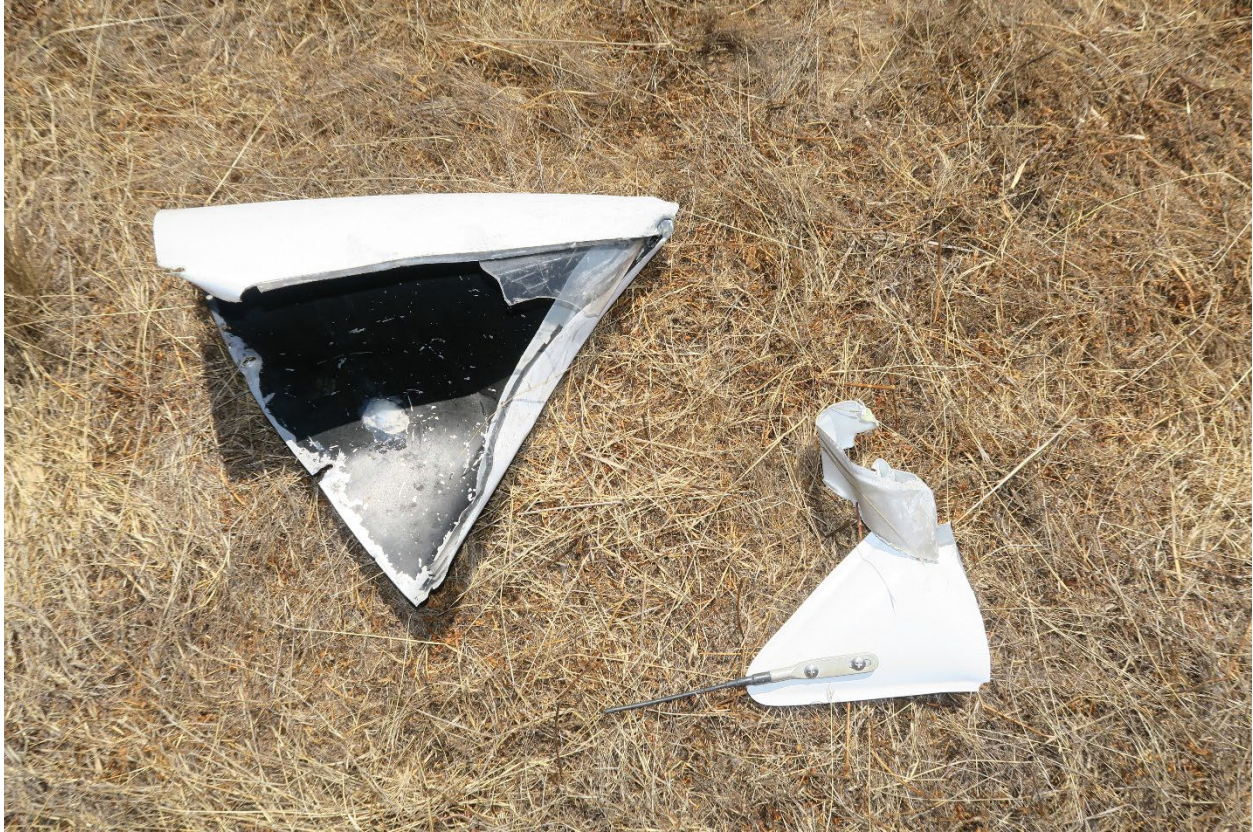
**Figure 26. Two sections of the Cessna 340's left-wing tip tank. Photo Textron.**
