National Transportation Safety Board

WPR22FA331

**INVESTIGATIVE SUPPLEMENTAL MATERIAL**

Location: Wichita Falls, Texas  
Date: August 20, 2022  
Time: 1331 central daylight time  
Airplane: Smyth Sidewinder TD

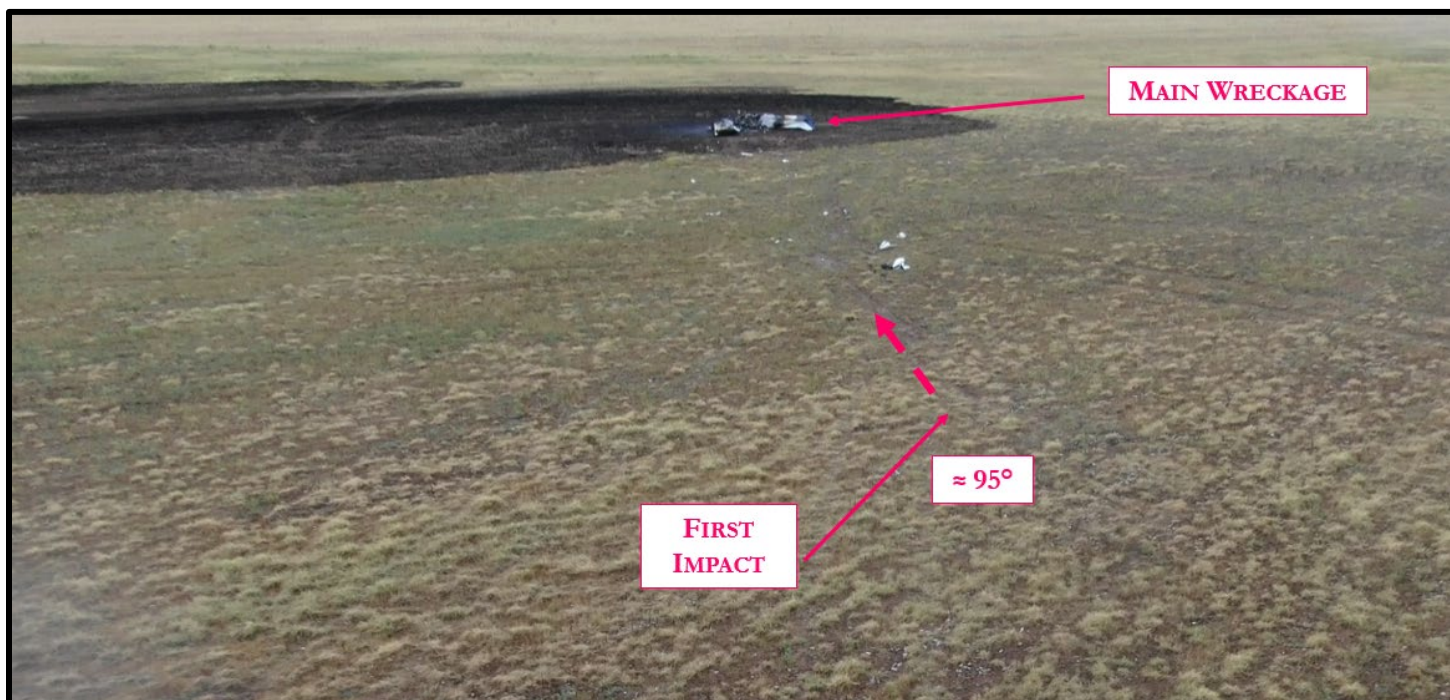
Figure 4: Accident Site Referencing Main Wreckage

The first identified point of contact consisted of disrupted dirt and paint chips. An approximate 6-inch-wide ground scar from the initial impact was continuous for about 19 ft, consistent with the left wing dragging along the terrain. Thereafter, there was an approximate 14 ft path of disrupted dirt. The remaining 25 ft to the wreckage the disrupted dirt ended. In that debris field, there was part of the propeller, right wing tip, and numerous pieces of fragmented canopy.

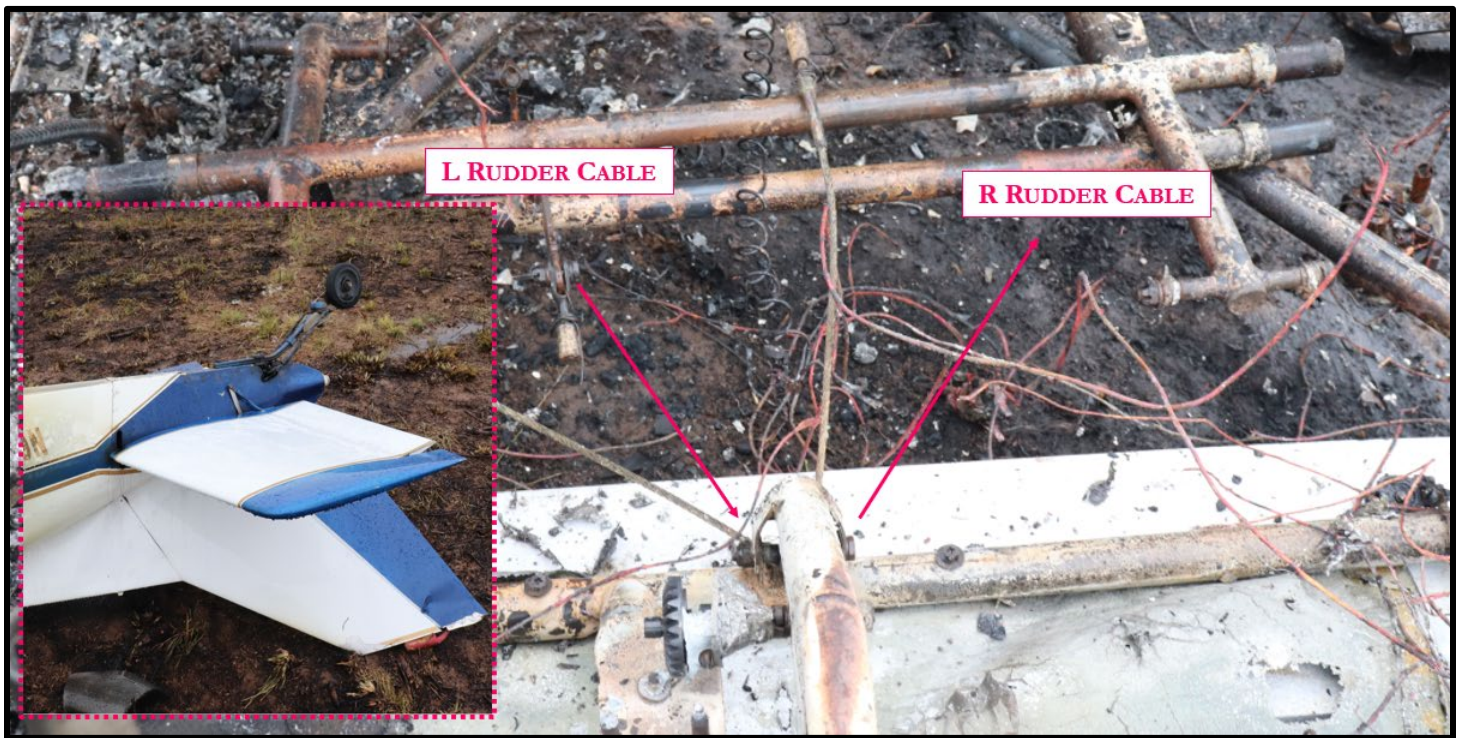
Figure 11: Rudder Cable Attachment

Complete control continuity could not be verified due to the extent of the thermal damage to the cockpit. The forward rudder-control-cables were attached to their respective turnbuckles that were melted at the rudder pedal bar. The cables were continuous, through the pulleys, and attached at the aft control horn. Examination of the airframe found control continuity from the cockpit controls to all control surfaces. The horizontal stabilizer trim was found in a mid-range position.

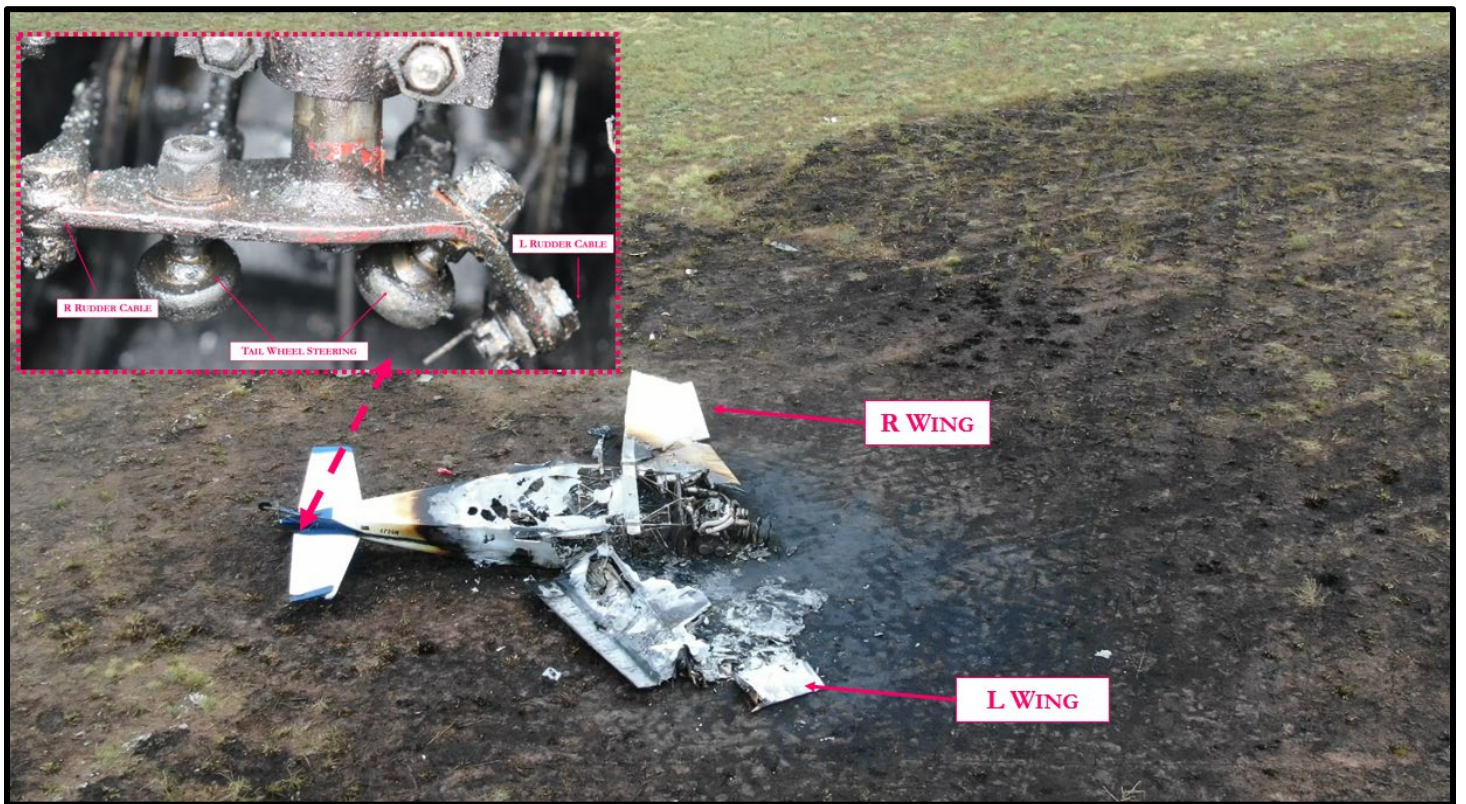
Figure 12: Rudder Control Horn

The rudder horn was bent downward on the left side with the left rudder cable attach point on a different plane than the right side. The paint and deflection was consistent with the damage having occurred years prior to the accident. It is unknown if the deflection had any effect of the rudder mobility.

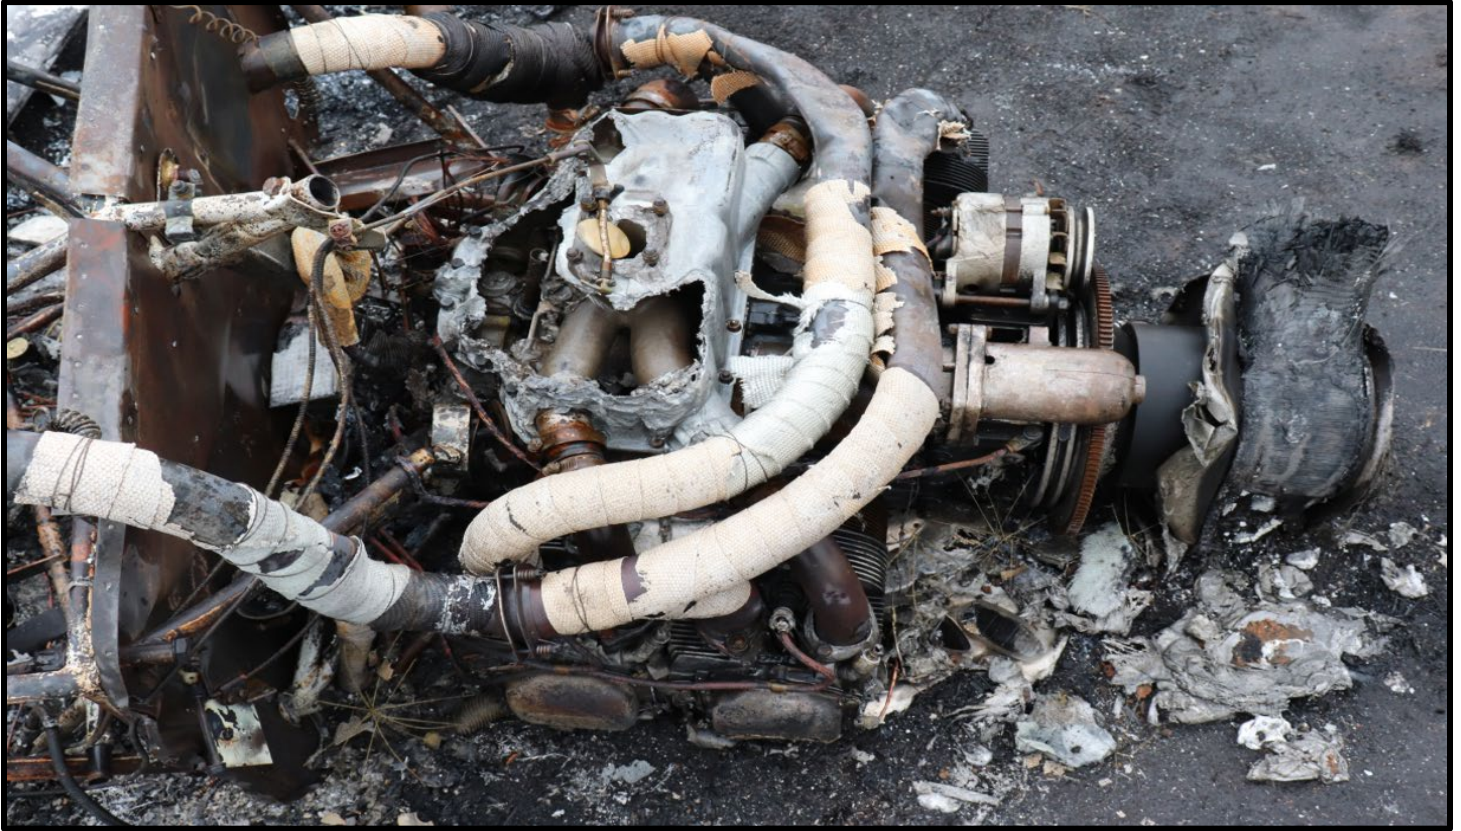
*Figure 13: Engine at Accident Site*

The Lycoming engine O-320-E2D, serial number L-43950-27A, remained attached to the airframe by the engine mounts. The engine had been displaced left from its normal position due to the absorption of impact energy. Visual examination of the engine revealed that the engine sustained post-impact fire damage with no evidence of pre-impact catastrophic mechanical malfunction.

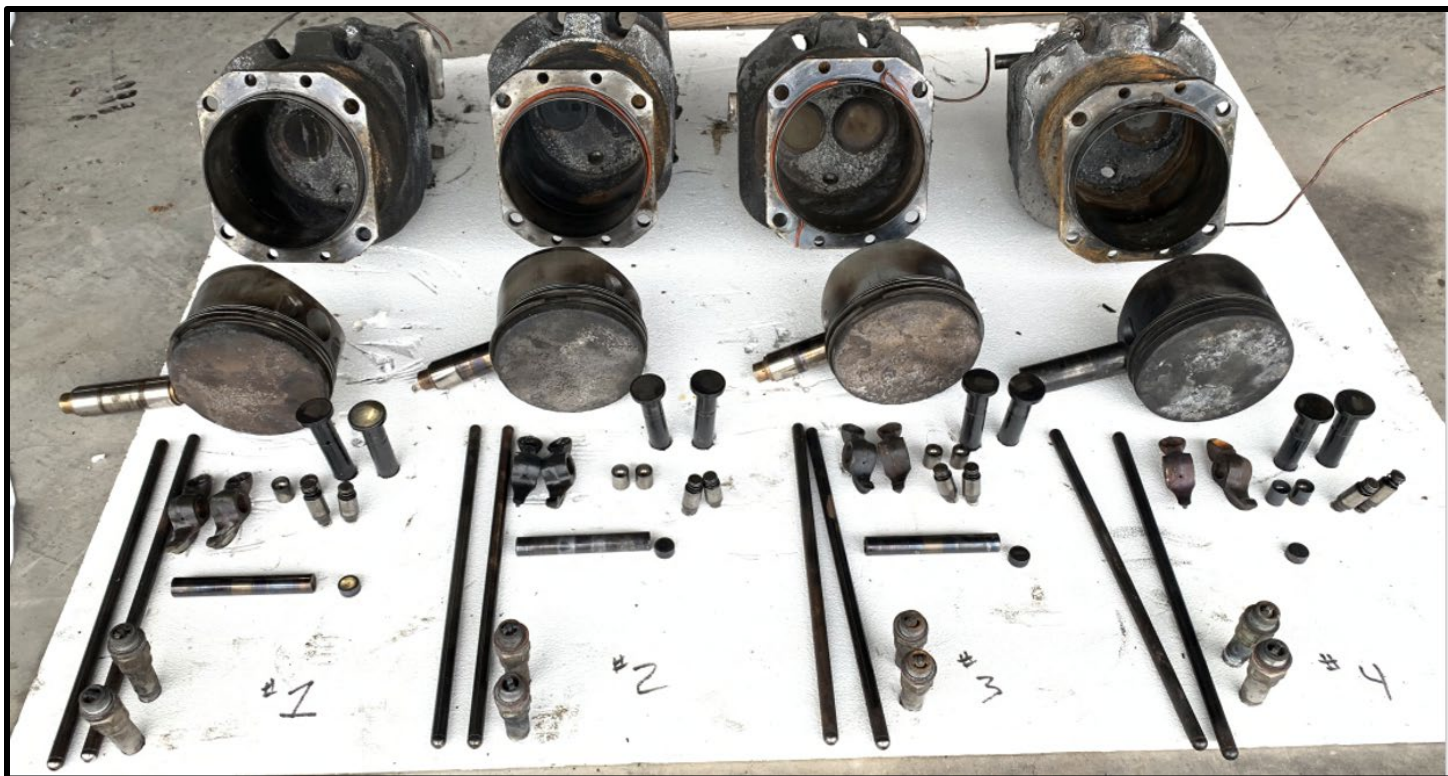
Figure 15: Engine Parts After Disassembly

Investigators completely disassembled the engine. The cylinder's combustion chambers remained mechanically undamaged, and there was no evidence of foreign object ingestion or detonation. The valves were intact and undamaged. There was no evidence of valve-to-piston face contact observed. The gas path and combustion signatures observed at the spark plugs, combustion chambers, and exhaust system components displayed coloration consistent with a post-crash fire.

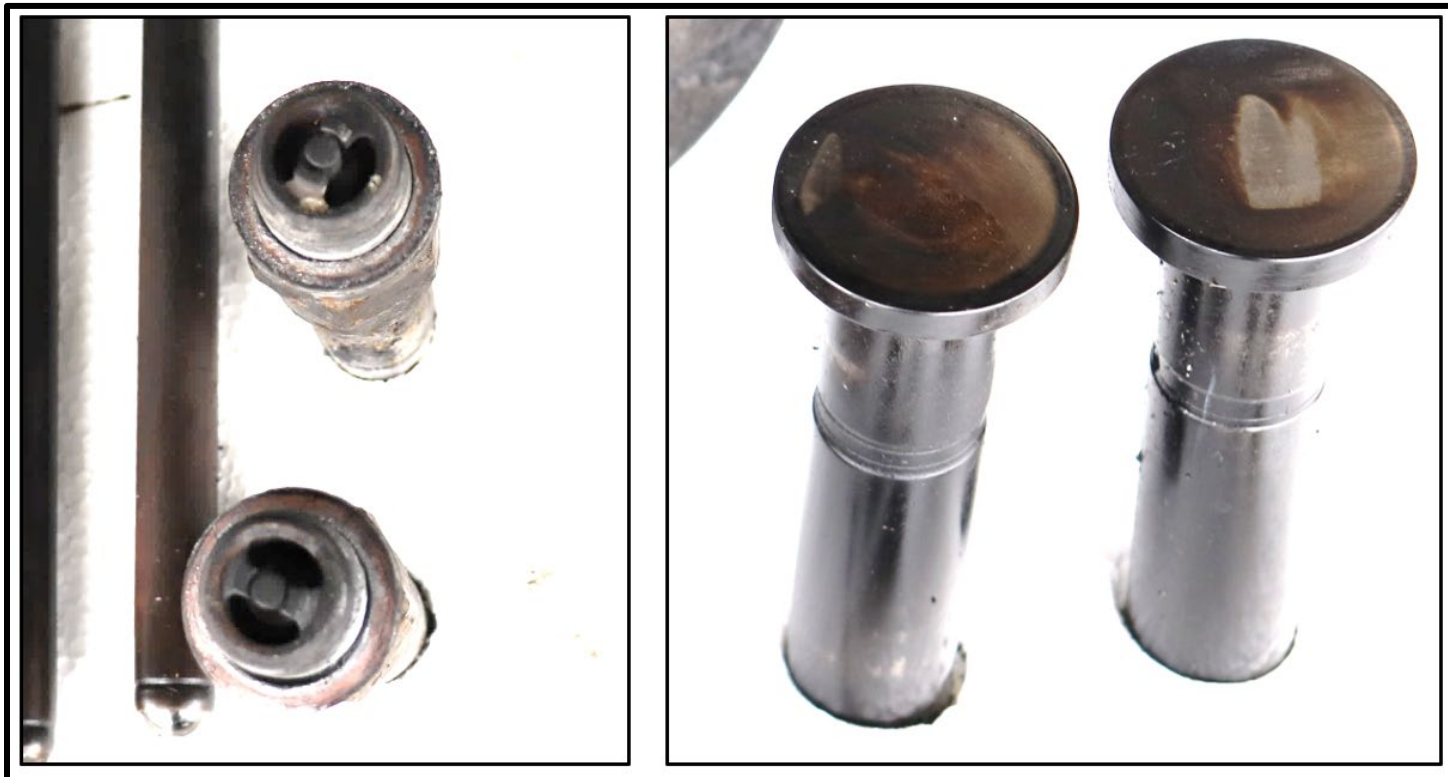
Figure 16: Cylinder No. 1 Spark Plugs and Lifter Faces

The spark plugs were secure at each position with their respective spark plug lead attached. The top spark plugs were removed, examined and photographed. The spark plug electrodes remained mechanically undamaged, and according to the Champion Spark Plugs Check-A-Plug chart AV-27, the spark plug electrodes displayed coloration consistent with normal operation.

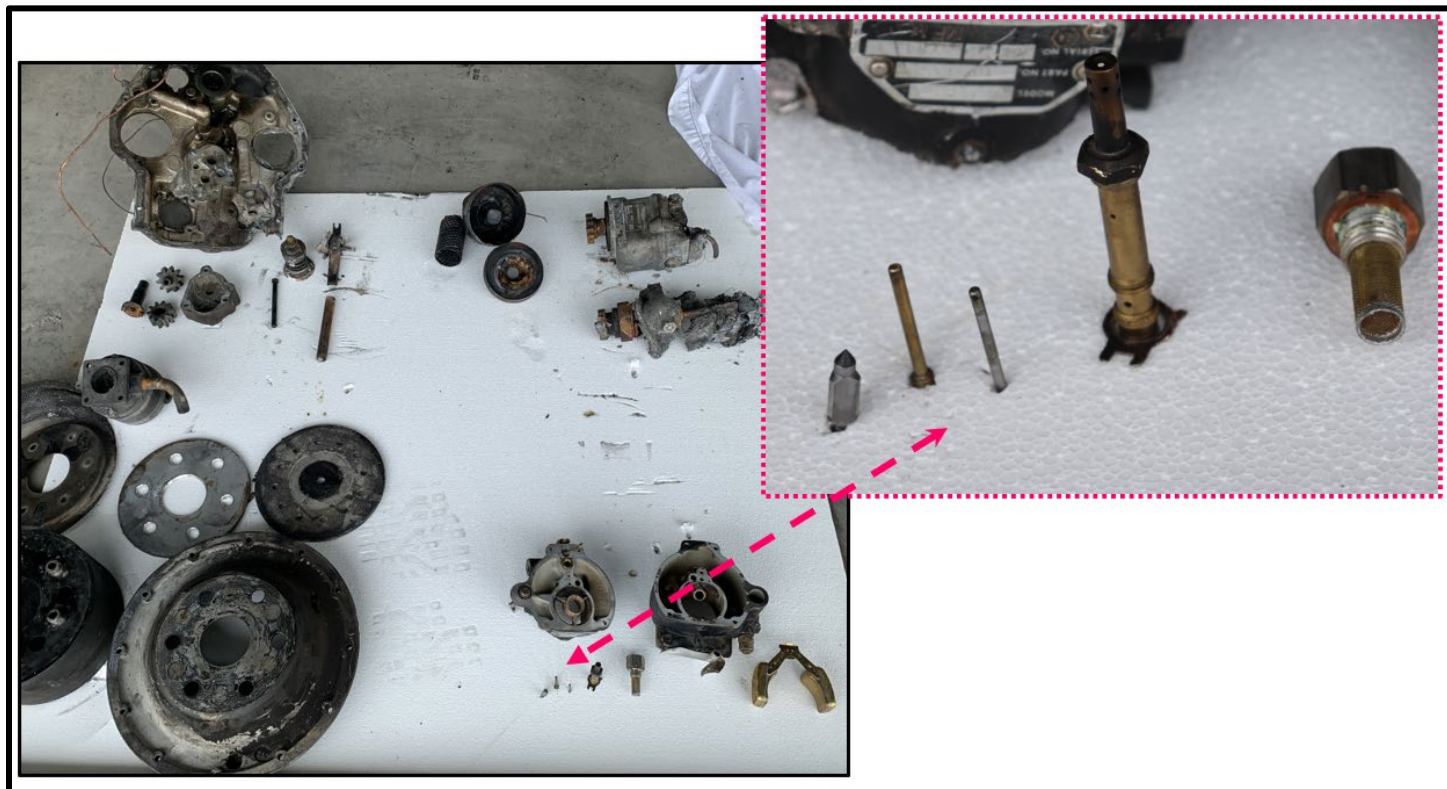
Figure 17: Carburetor Disassembled

The left and right magnetos were thermally consumed and timing could not be ascertained. The carburetor was secured at the mounting pad. The throttle/mixture controls were found securely attached at their respective control arms. The metal float pontoons exhibited moderate hydrodynamic crushing, consistent with there being fuel in the bowl at the time of impact.
