# National Transportation Safety Board

WPR22FA331

## **ACCIDENT SITE EXAMINATION**

Location: Shafter, California  
Date: September 2, 2022  
Time: 1100 Pacific daylight time  
Airplane: N5943, Yakovlev Yak-11

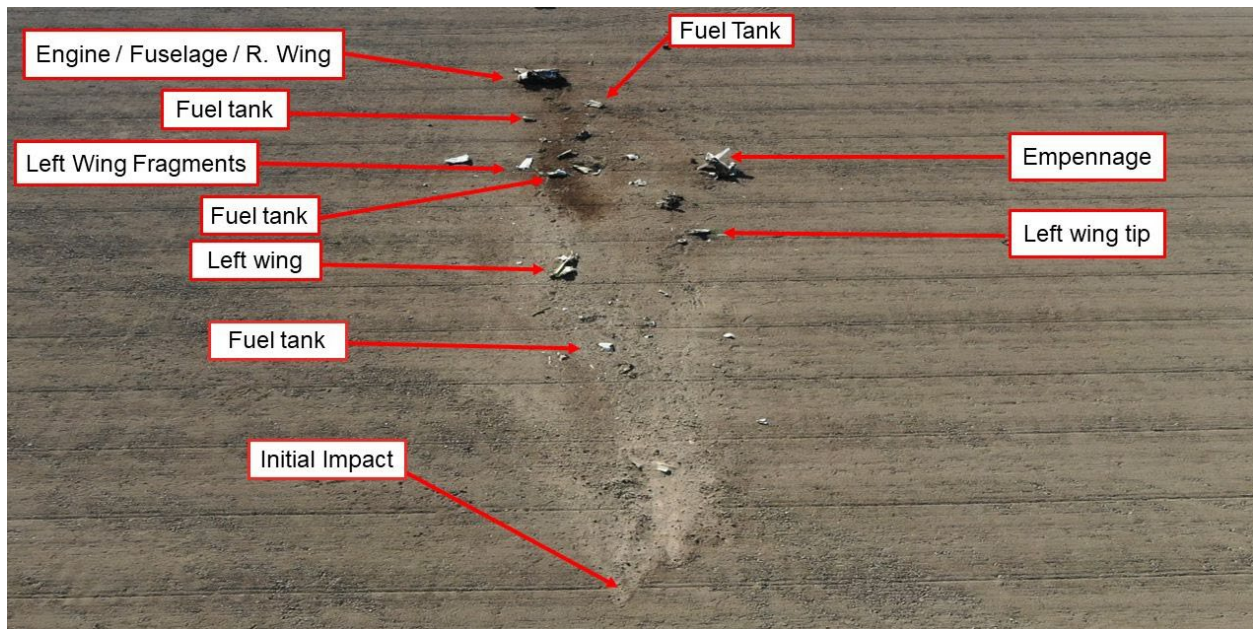
**Figure 1: Wreckage Diagram. Aerial photo courtesy of Kern County Sheriff.**

Examination of the accident site revealed that the airplane impacted an open field on a heading of about 127° magnetic about 3,777 ft northwest of the approach end of runway 12 at an elevation of 397 ft mean sea level (msl). The wreckage debris path was about 392 ft in length and 60 ft wide, oriented on a heading of about 127° magnetic. The first identified point of contact (FIPC) with terrain was a large swath of freshly disturbed dirt, which extended about 32 ft to an impact crater that was about 17 ft wide. Within the crater was 2 of the 4 propeller blades. The empennage was separated from the fuselage and was located about 170 ft from the FIPC. The forward portion of the fuselage, which included the instrument panel, engine, and right wing, was located about 244 ft from the FIPC. All major structural components of the airplane were located within the debris path.
