## Air Safety Investigations Aircraft Incident/Accident Technical Report

| Aircraft Incident/<br>Accident Information | Year: 1985 | Make: Beechcraft | Model: 58 |
| | Serial number: TH-1458 | | Registration: N142DR |
| Location: Galt, CA | | Date: 09-04-22 | Time: 1245 PDT |

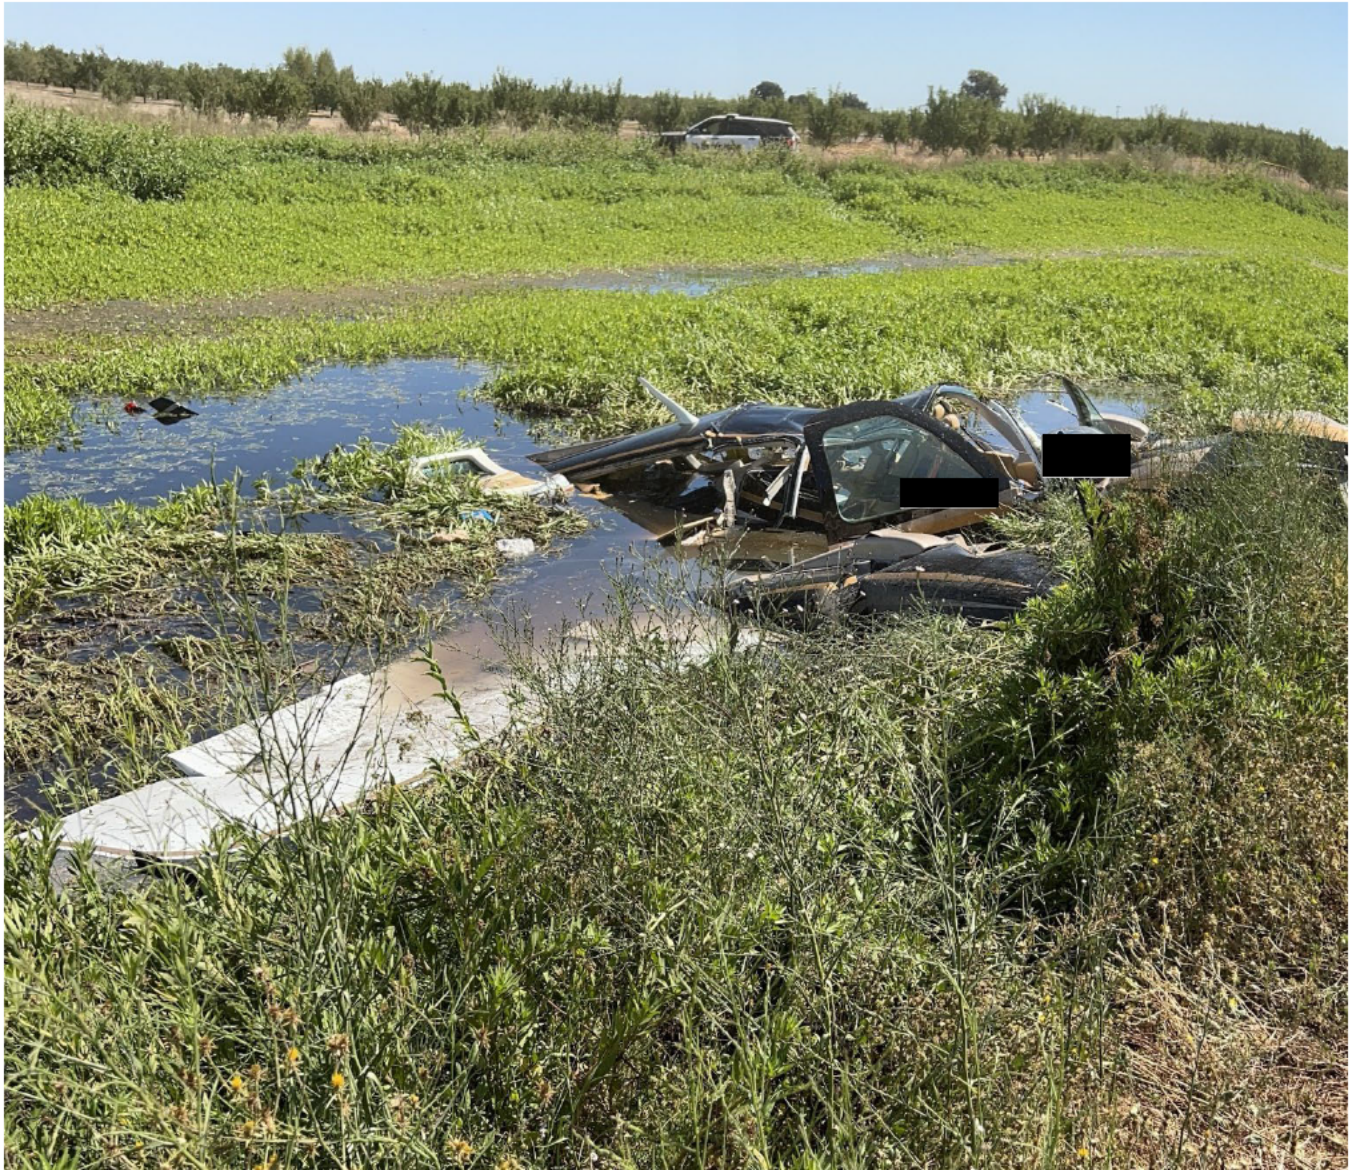
The aircraft descended vertically into a water filled slough in a wings level and nose low attitude with no impact signatures indicating forward momentum and became partially submerged. The aircraft remained intact. All flight control and stabilizer surfaces remained attached and intact. The fuselage was segmented by recovery personnel at approximate fuselage stations 72, 151, and 233.

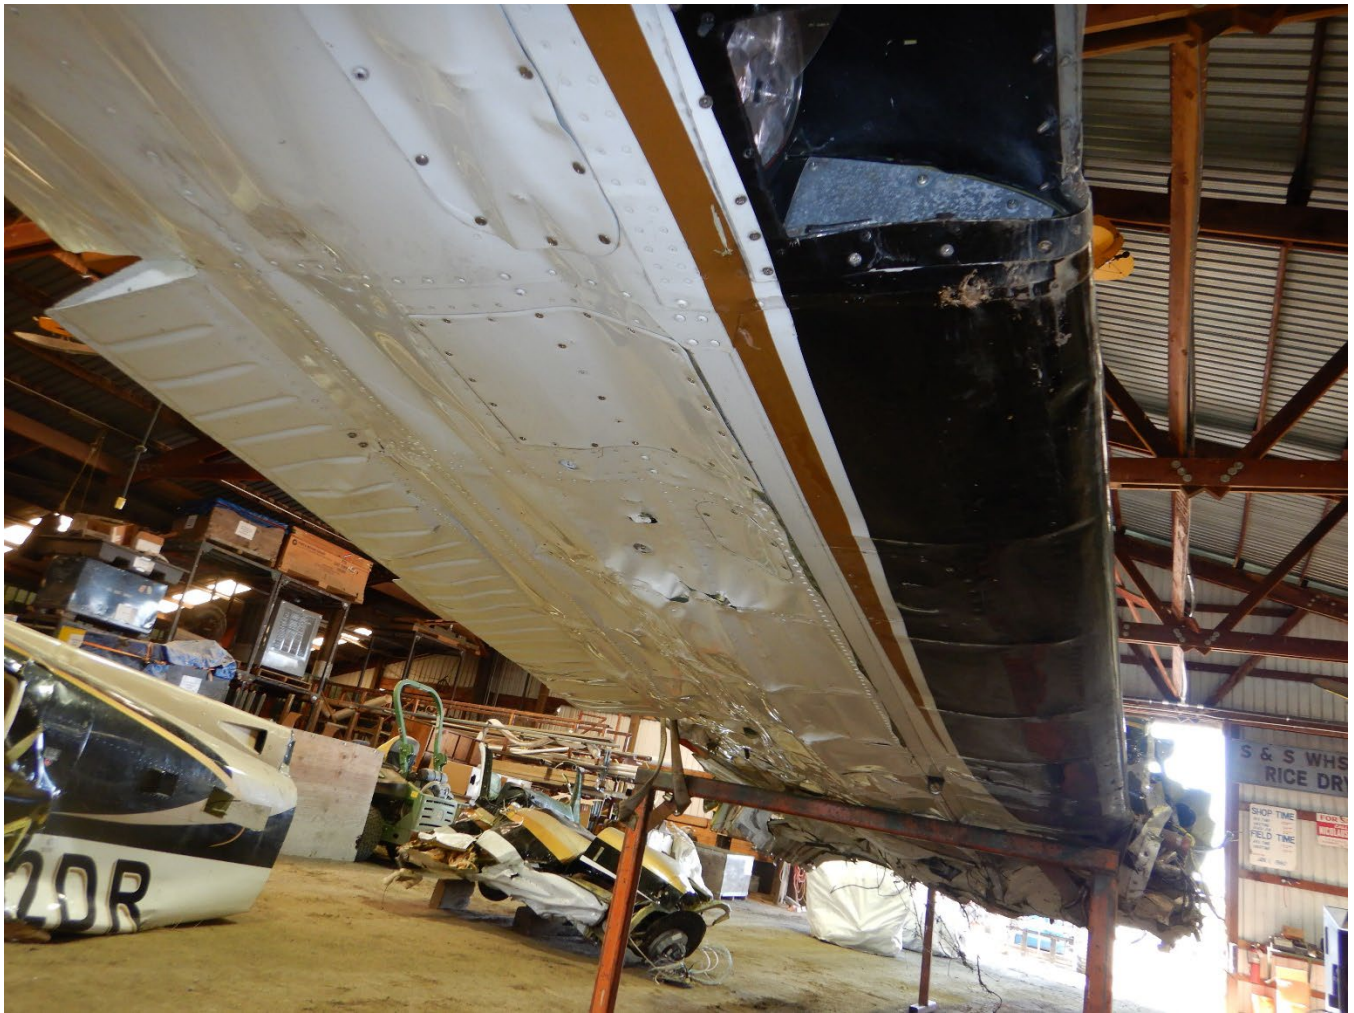
The wing bladder type fuel tanks were breached. The tank sump drains were removed and approximately one gallon of mud, water, and fuel drained from the right tank. Approximately one pint of mud, water, and fuel drained from the left tank fuel sump. The lower wing skins were compression deformed upward, reducing wing tank volume. The fuel cap seals were clean and pliable.

ASI-22-CA-019 (Lower Wing Skin Compression)

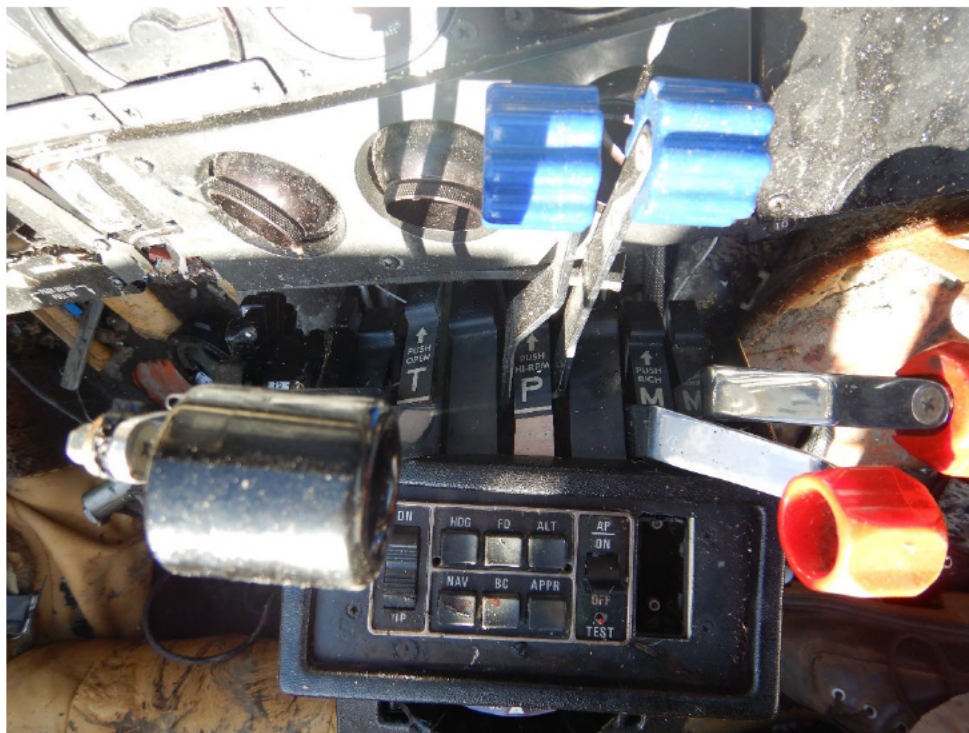
The throttle quadrant structure was deformed during the impact sequence. Engine control settings were not reliable due to impact damage.

ASI-22-CA-128 (Throttle Quadrant)

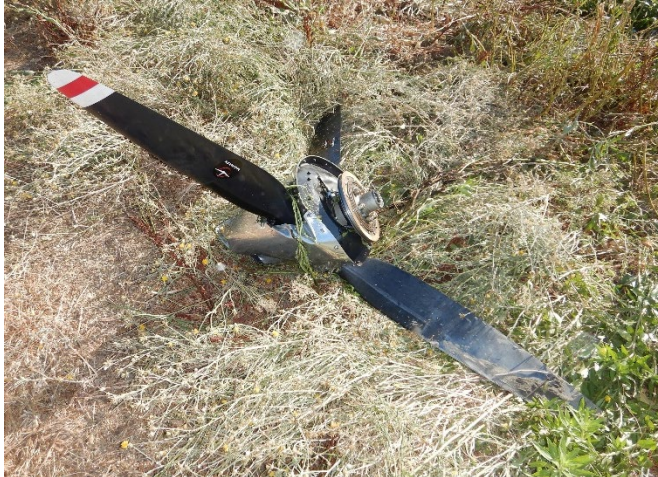
Both propellers appeared to be in the feathered position. The right propeller remained attached to the engine. Blade A and B remained straight. Blade C was bent aft approximately 30 degrees, midspan. The left propeller impact separated at the crankshaft propeller flange. All left propeller blades remained straight.

ASI-22-CA-014 (Left Propeller) (Cropped)
