National Transportation Safety Board  
Office of Aviation Safety  
Washington, DC 20594

WPR22FA332

## ENGINE AND AIRFRAME EXAMINATION

Location: Galt, California  
Date: September 4, 2022  
Time: 0840 Pacific Daylight Time  
1540 Universal Coordinated Time  
Airplane: Beech 58 / N142DR

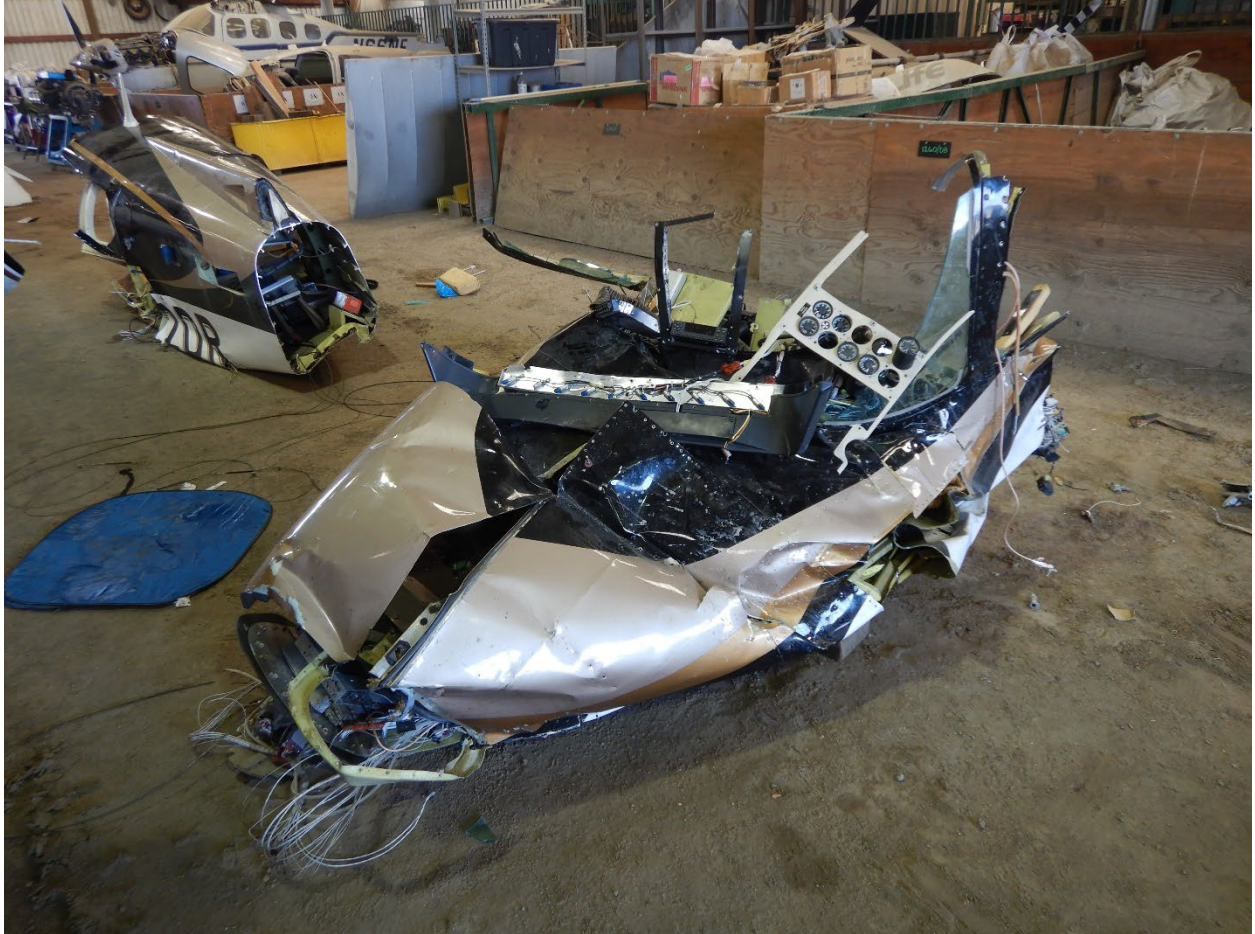
Figure 1. Cabin, rear, looking forward.

The cabin exhibited substantial damage throughout. The floor of the cabin had been crushed upward to the bottom of the seats. The control yokes were removed during recovery. The instrument panel remained attached and exhibited damage beginning at the bottom of the panel and decreasing in severity towards the top of the panel. A JP Instruments EDM 760 display was recovered from the instrument panel. The left side of the instrument panel held a two-screen electronic flight display. Three SDM cards for the electronic flight displays were recovered. One was labeled "Garmin 142DR", one "650 DR", the other "142DR" in red ink.

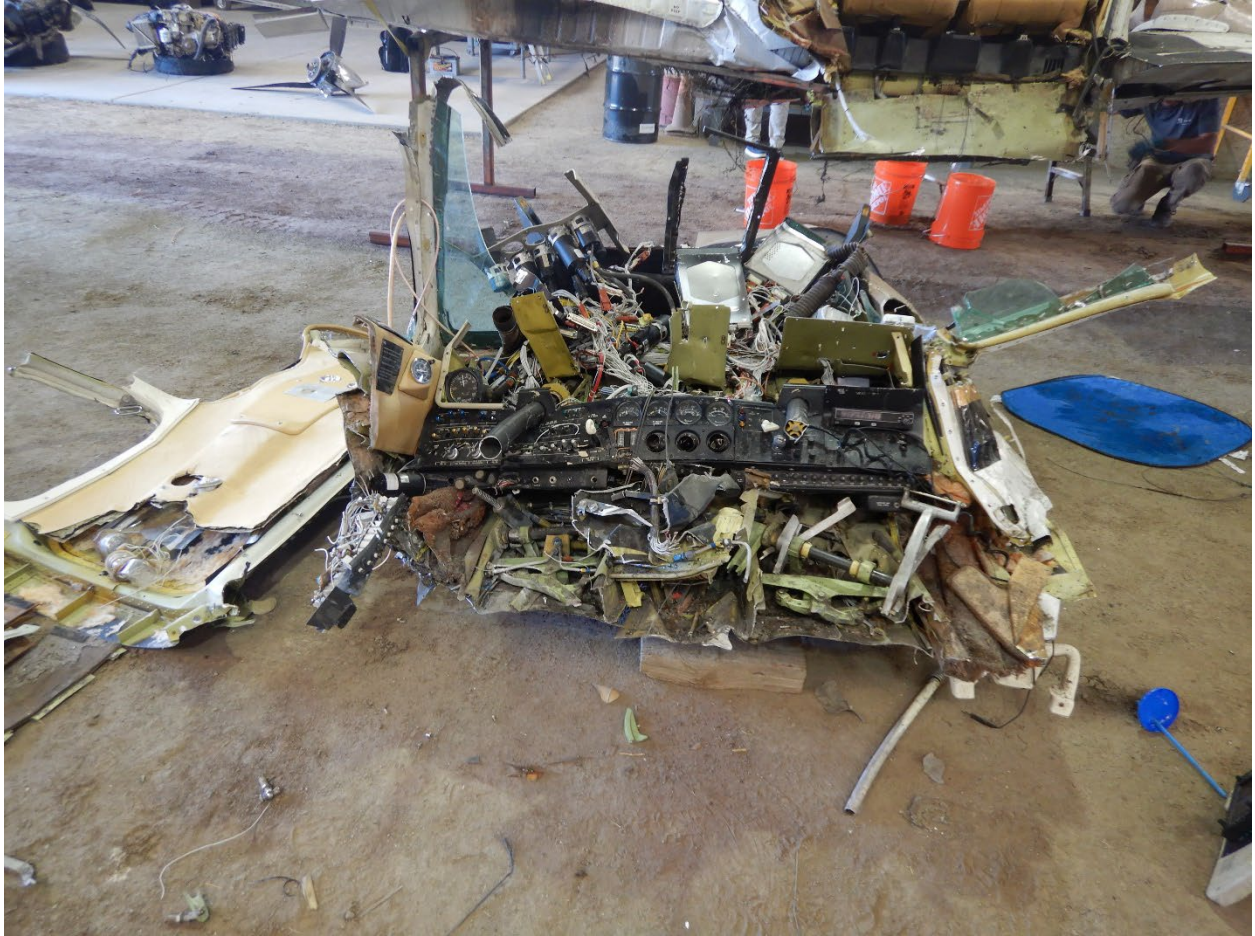
Figure 2. Instrument panel.

The throttle quadrant was displaced into the instrument panel and the throttle, prop, mixture positions could not be determined with accuracy, but all, except for the right mixture, appeared to be pulled full aft. The right mixture was slightly forward of full aft.

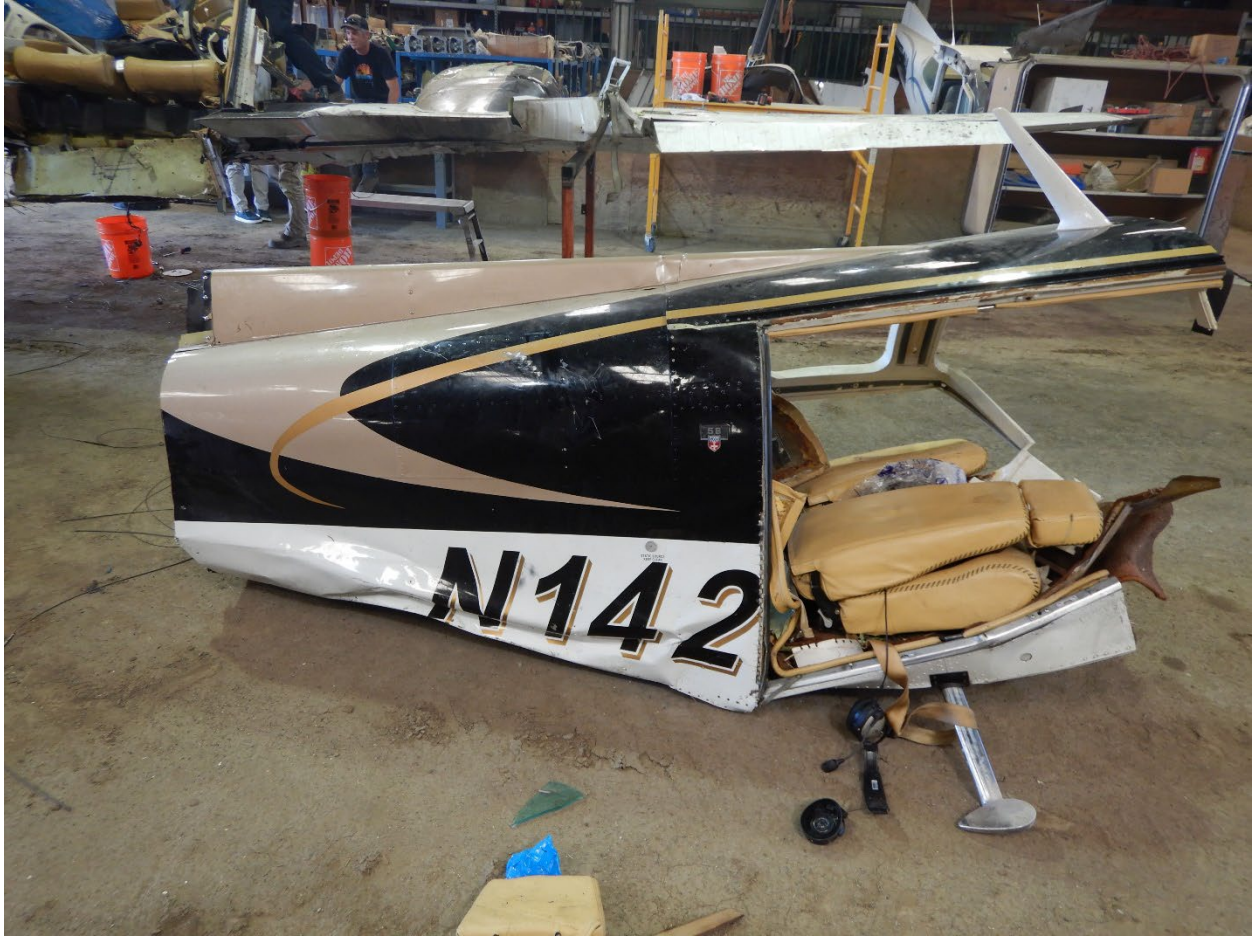
Figure 3. Fuselage, mid-section.

The cabin and mid-section of the fuselage exhibited the same upward crushing. The top of the mid-section exhibited considerably less damage than the bottom section. There was a large crack that ran across the top of the cabin section roof.

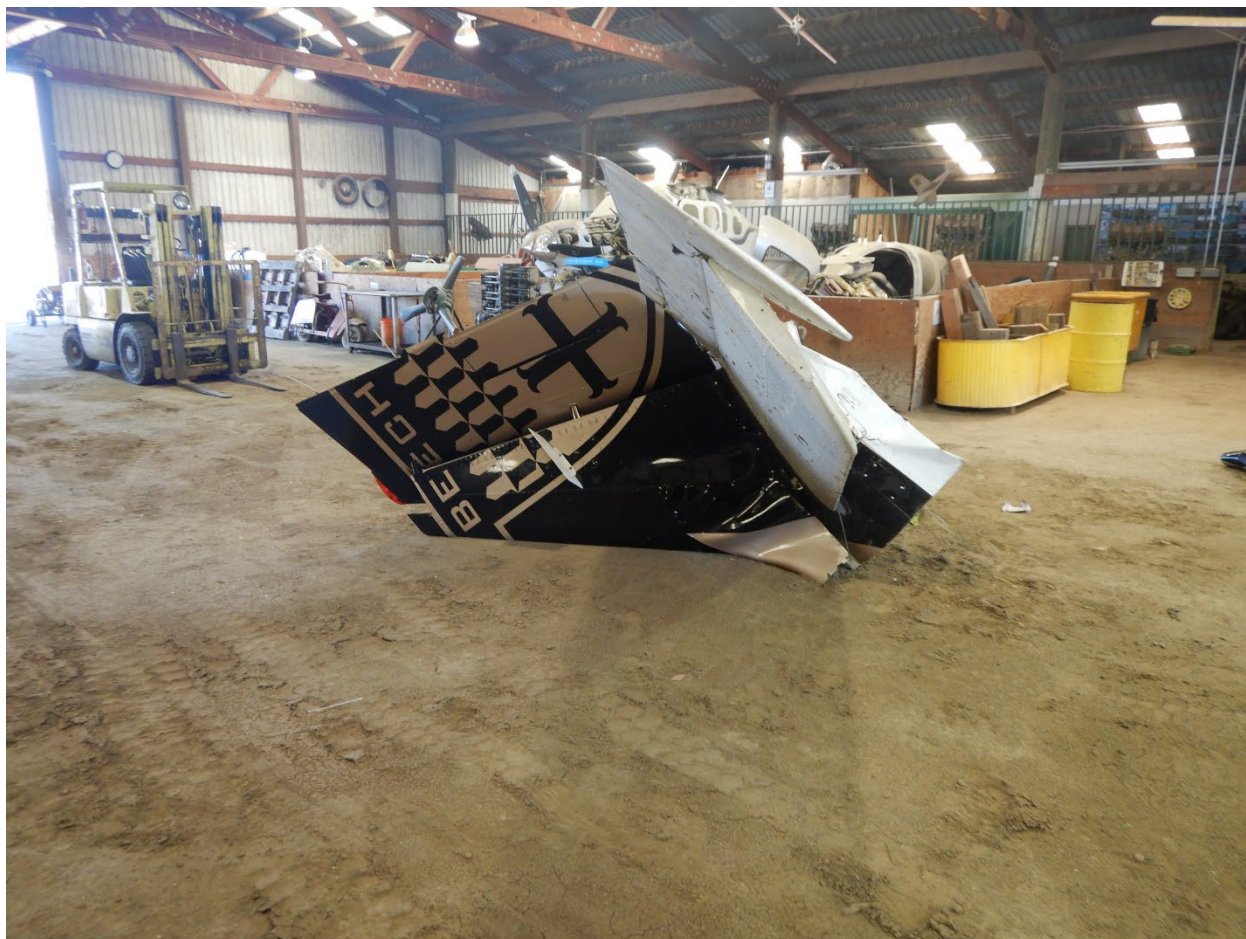
Figure 5. Empennage.

The empennage remained attached to the aft fuselage but was cut for recovery. It exhibited significantly less damage than the fuselage. The horizontal and vertical stabilizers remained attached to the fuselage. The elevators remained attached to the horizontal stabilizers, and the rudder remained attached to the vertical stabilizer. Vortex generators were observed on the left side of the vertical stabilizer. The elevator bellcrank protruded out from the bottom of the fuselage.

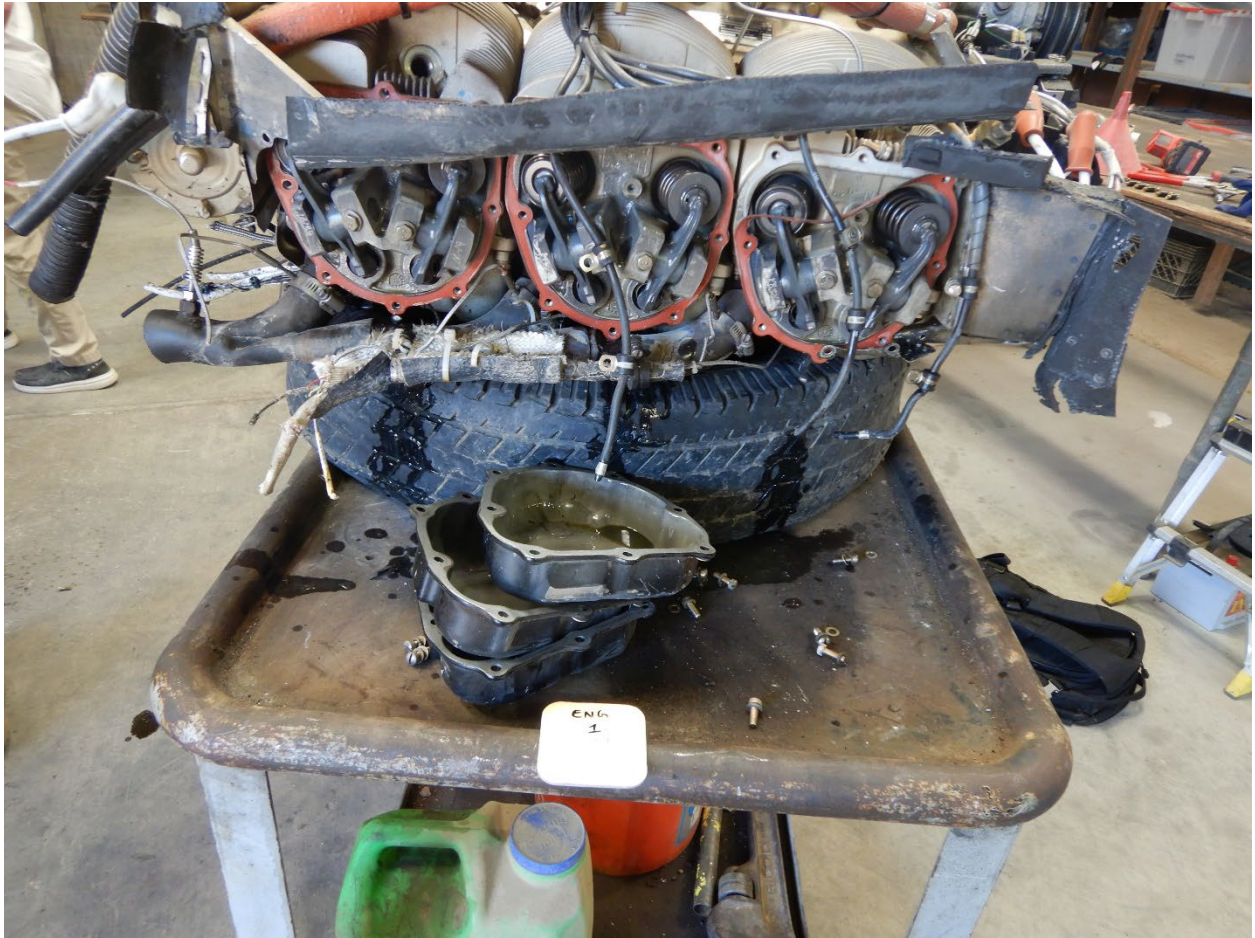
Figure 8. Number 1, Left engine.

Left engine (number 1). The fuel pump was removed from the rear of the engine. The frangible drive was intact, and the pump appeared to have minor damage. The top spark plugs were removed and examined. All spark plugs, when compared to the Champion Check-A-Plug chart, appeared normal. The cylinders all exhibited thumb force compression. All rocker arms moved normally and about the same distance. All rocker box chambers exhibited a wet, and oil-soaked appearance. The valve train exhibited normal smooth movement. Both magnetos remained attached at their mounts and produced a spark at all terminals. The spark plug leads appeared in good condition. The oil had a clean appearance. The oil filter was not opened. The fuel flow divider was opened, and the diaphragm was intact. The screen was clear and some fluid with the consistency and smell of aviation fuel was present. All the fuel injectors were free of clogs.

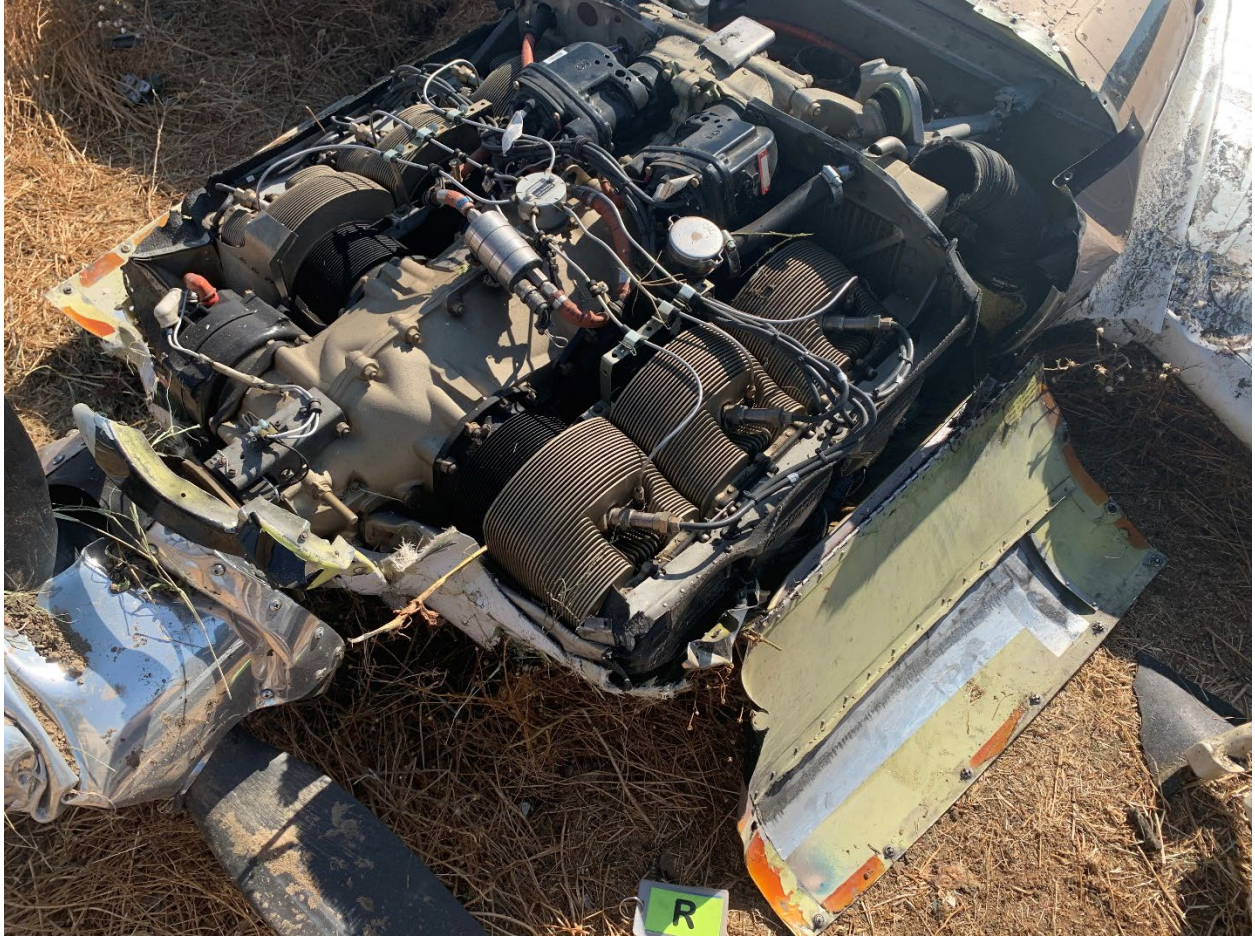
Figure 14. Number 2 engine.

Right engine (number 2). The fuel pump was removed from the rear of the engine. The frangible drive was intact, and the pump appeared to have minor damage. The top spark plugs were removed and examined. All spark plugs, when compared to the Champion Check-A-Plug chart, appeared normal but exhibited some corrosion. The cylinders all exhibited thumb force compression. All rocker arms moved normally and about the same distance. All rocker box chambers exhibited a wet, and oil-soaked appearance. The valve train exhibited normal smooth movement. Both magnetos remained attached at their mounts and produced a spark at all terminals. The spark plug leads appeared in good condition. The oil had a clean appearance. The oil filter was not opened. The fuel flow divider was opened, and the diaphragm was intact. The screen was clear and some fluid with the consistency and smell of aviation fuel was present. All the fuel injectors were free of clogs.

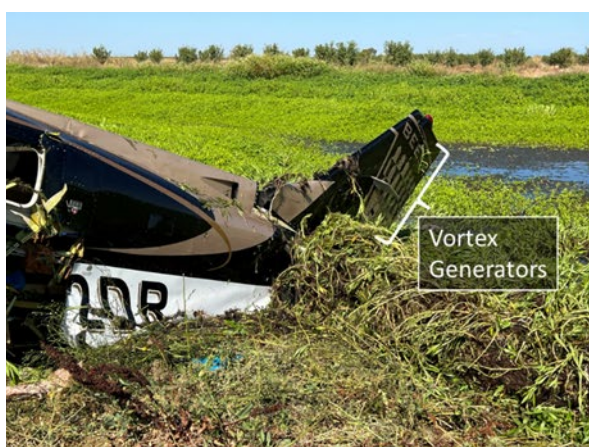
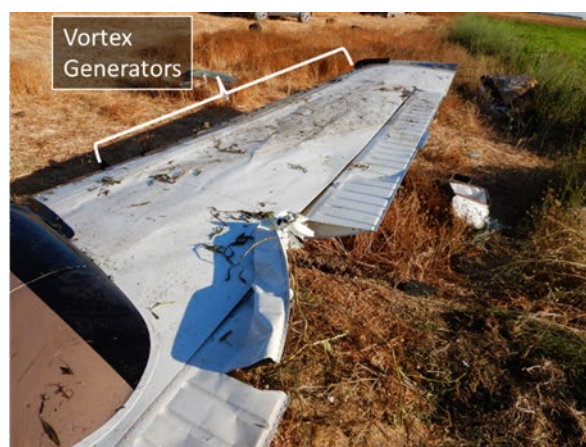
Figure 18. Vortex generators.

The right wing remained attached to the fuselage. The aileron and flap remained attached to the right wing at their respective hinges. The right-wing leading edge exhibited one large wrinkle just outboard of the engine nacelle. The topside of the wing exhibited multiple downward dents. The lower side of the wing exhibited substantial upward crushing throughout the wingspan. The fuel cap was secure in the port. When opened no fuel was present. The fuel cap was secured to the wing with a chain. The seal was soft and pliable. There were vortex generators installed on the topside of the wing, aft of the leading edge. Some vortex generators were absent, with fresh paint at the install locations, consistent with a recent separation.

The left wing remained attached to the fuselage. The aileron and flap remained attached to the right wing at their respective hinges. The left-wing leading edge exhibited multiple wrinkles throughout. The topside of the wing exhibited multiple downward dents which could have occurred during the recovery process. The lower side of the wing exhibited a substantial downward bulge outboard of the engine nacelle. The fuel cap was secure in the port. When opened no fuel was present. The fuel cap was secured to the wing with a chain. The seal was soft and pliable. There were vortex generators installed on the topside of the wing, aft of the leading edge. Some of the vortex generators were absent, with fresh paint at the install locations, consistent with a recent separation.
