National Transportation Safety Board

WPR22FA335

## INVESTIGATIVE MATERIAL SUPPLEMENT

Location: Columbia, California  
Date: September 05, 2022  
Time: 0948 Pacific daylight time  
Airplane: Rutan Varieze

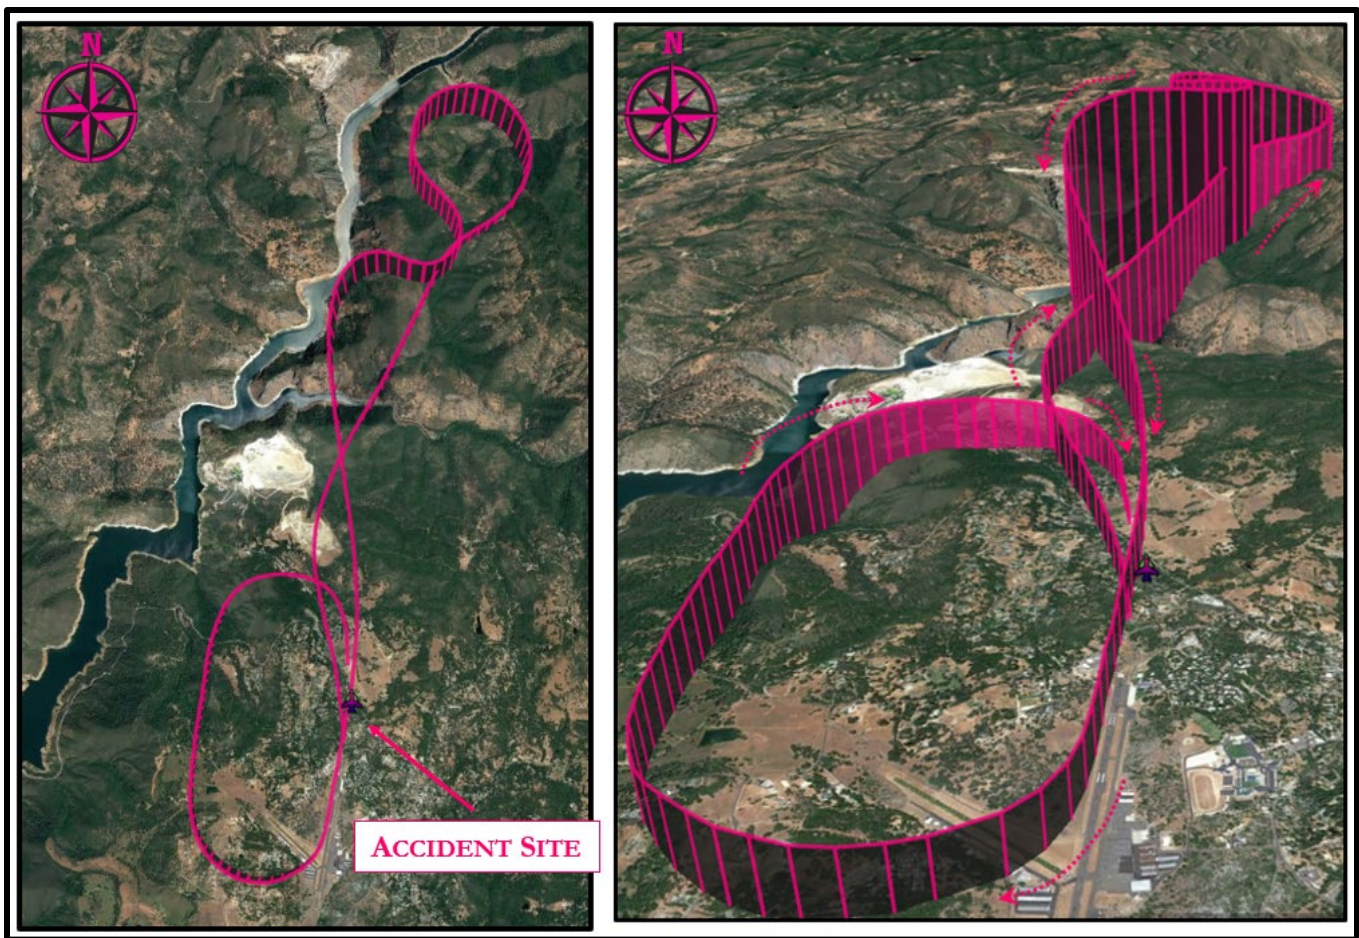
Figure 1: Recorded ADS-B Data from the End of the Accident Flight

The airplane made a high-speed pass over runway 35 and then continued north-northeast for about 5 nm. Thereafter, the airplane returned back to the airport and around 0945, it passed over the center of the airport at an altitude of 2,850 ft (see Figure 1 below). The airplane turned right and joined the right traffic pattern for runway 17. At 0946:56, the airplane turned onto the base leg and the airspeed decreased.

The recorded data further disclosed that at 0947:25, when the airplane was about 1.25 nm north of the runway, at an altitude of about 680 ft above ground level (agl), it turned onto final approach at an airspeed of about 70 kts. The remaining data stretched over a distance of 3,200 ft in 24 seconds, equating to a derived ground speed of about 66 knots and a descent of about 400 ft. The last ADS-B point was at an altitude of 195 ft agl and about 1,800 ft north of the accident location.

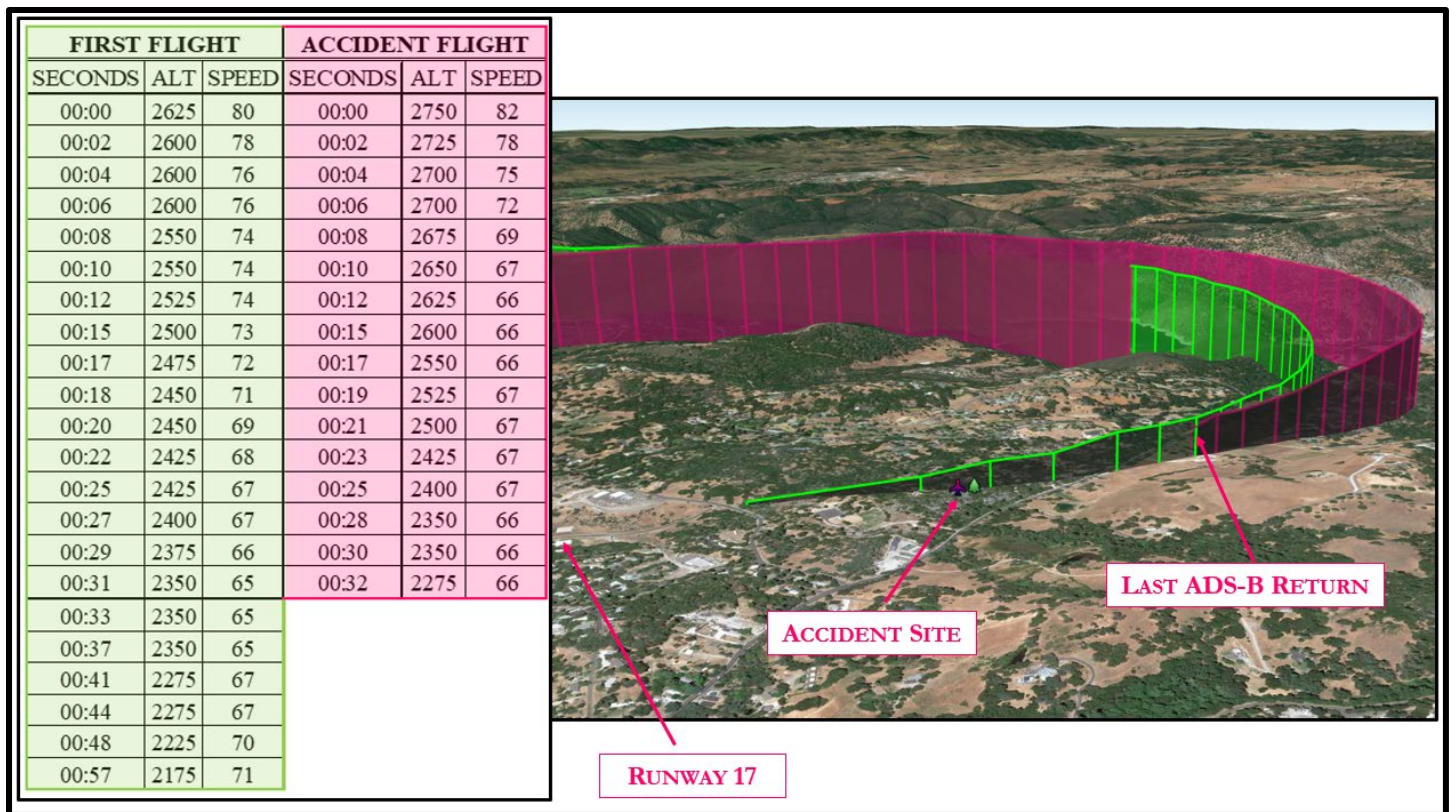
Figure 2: Comparison of Flights with Speeds

A comparison of the first flight and the accident flight revealed that the speeds were similar during the landing approach. The first flight passed near the location of the last recorded ADS-B return about 75 ft higher (see Figure 2 below).

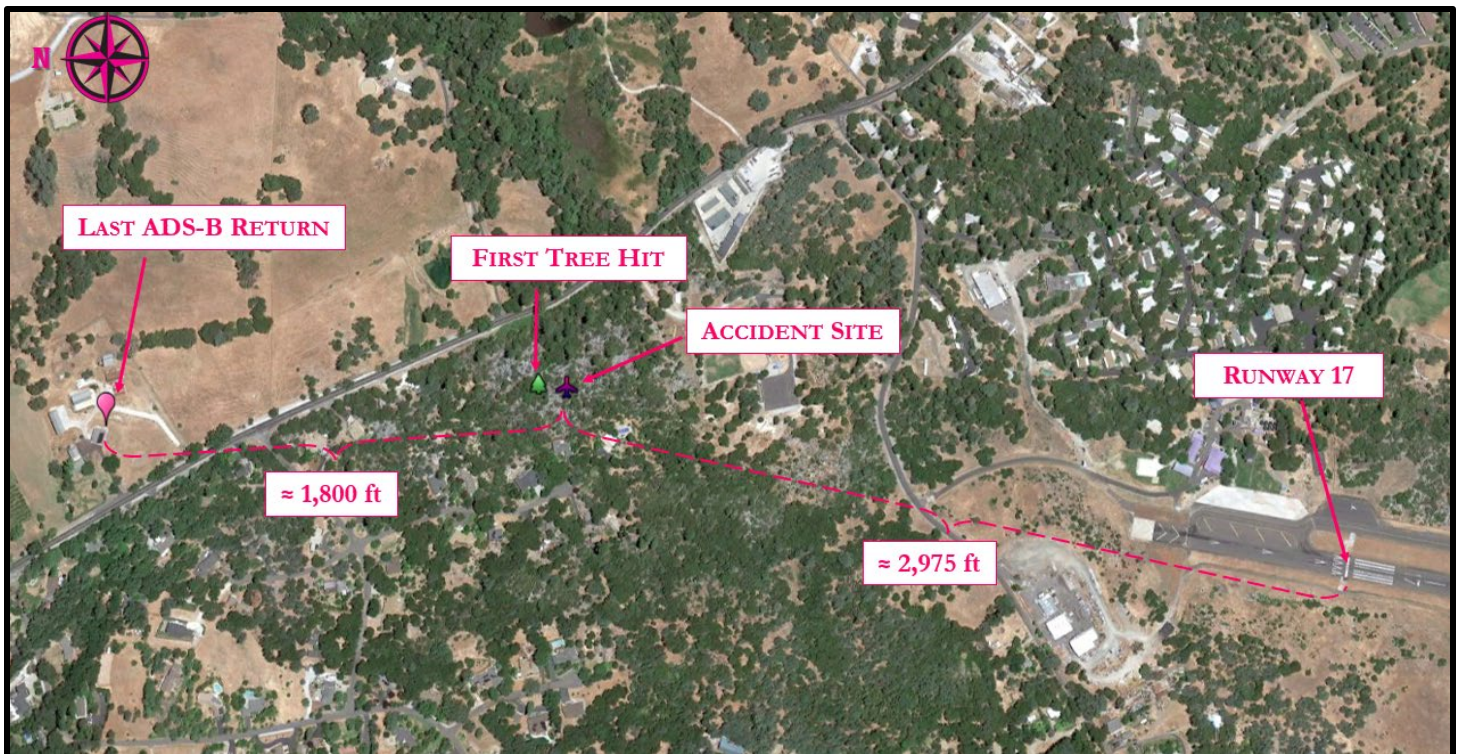
Figure 4: Wreckage Site in Reference to the Last ADS-B

The accident site was located in a sparsely populated residential neighborhood in uneven terrain made up of large boulders, loose rocks, and numerous trees and brush. The main wreckage, consisting of a majority of the airframe and engine, was about 0.5 nautical miles north of the runway threshold at 38.043051,-120.409957. There was a northwest-southeast oriented main-road located 375 ft east of the accident site and numerous other streets in the immediate area.

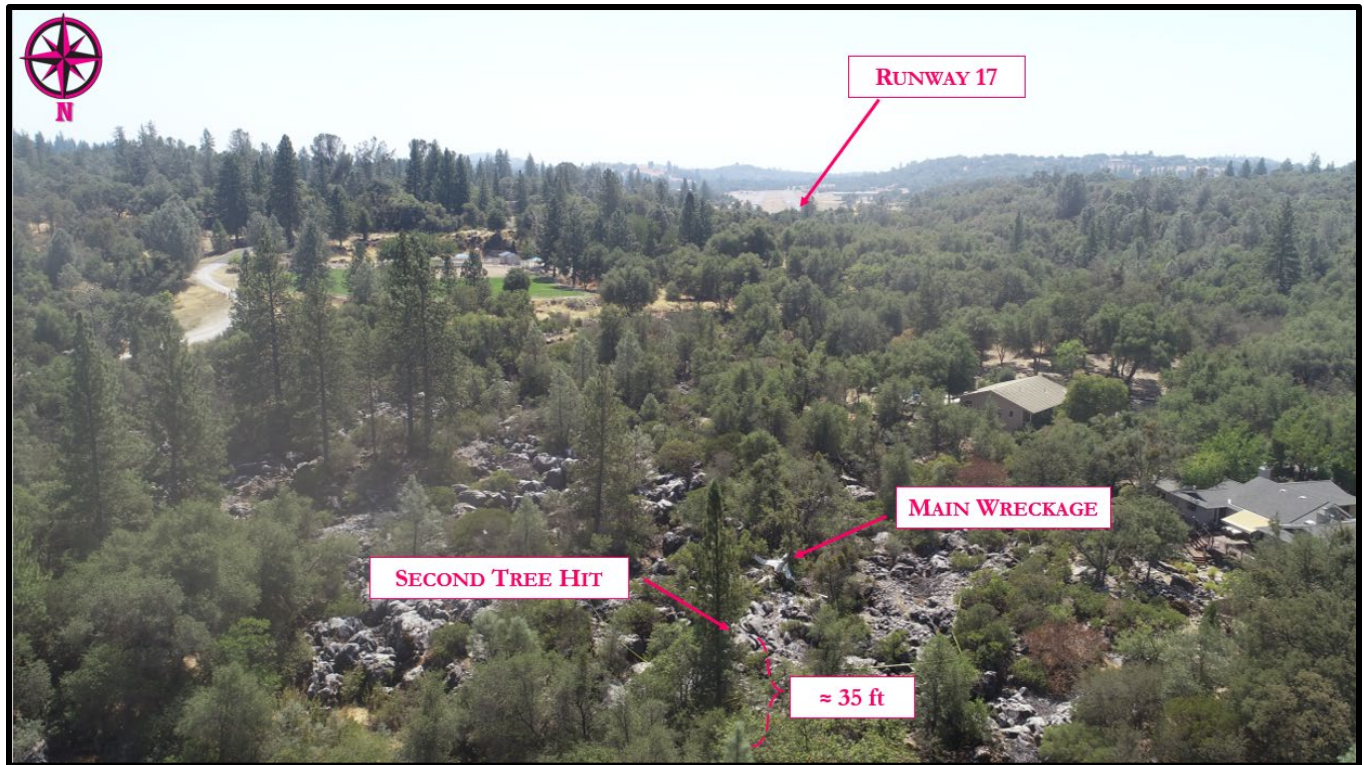
Figure 5: Wreckage Site in Reference to the Runway

The first identified point of impact was a 50-ft maple tree about 110-ft from the main wreckage on a bearing of 185°; the top of the tree had several severed limbs. Adjacent to the tree was a small portion of the outboard right wing cuff. The second point of impact was a large 80-ft tall fir tree located 90-ft from the wreckage on a bearing of 201°; there were severed branches about 35 ft up the tree. Pieces of the nose and forward undercarriage were about 30 ft from the wreckage near a boulder that contained several ground scars. The right and left canards were found fragmented in the debris field around the ground scar and the main wreckage. The airplane fuselage came to rest inverted, and the wings remained attached. The wreckage was consistent with the nose gear being in the down position. The keys were not in the ignition, which was in the “off” position.

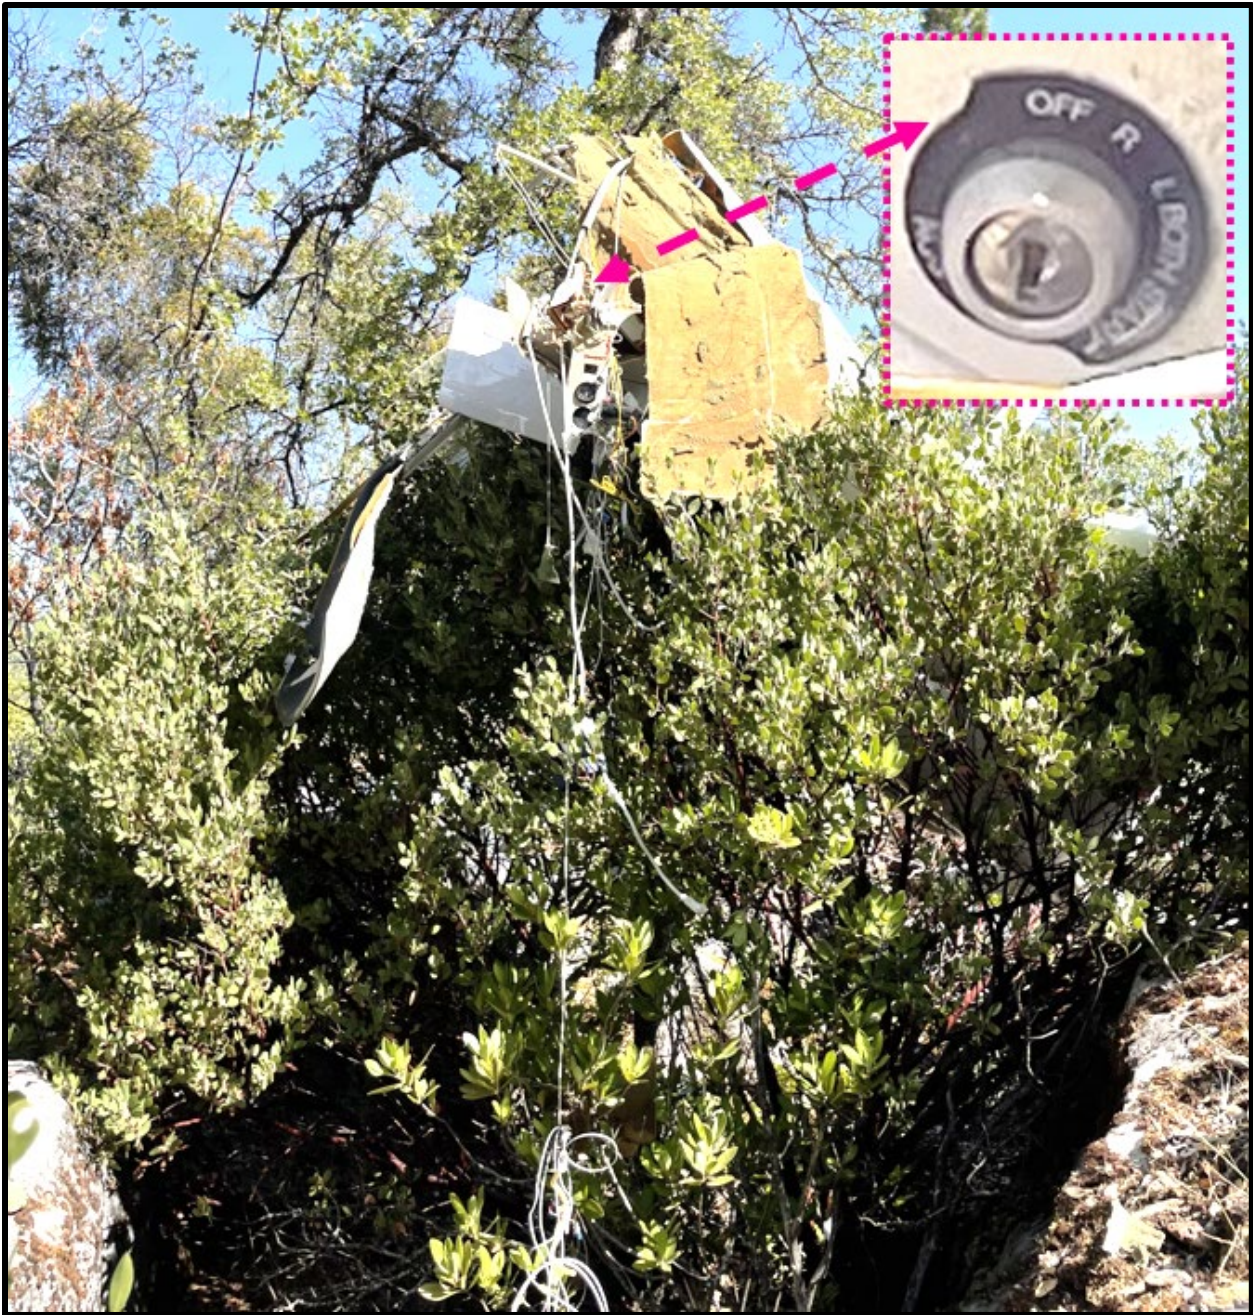
*Figure 6: Front of Airplane*

Complete control continuity could not be verified due to the extensive impact-related damage. The airplane sustained major crush damage to the front cockpit. The wiring in the front was hanging over a boulder.

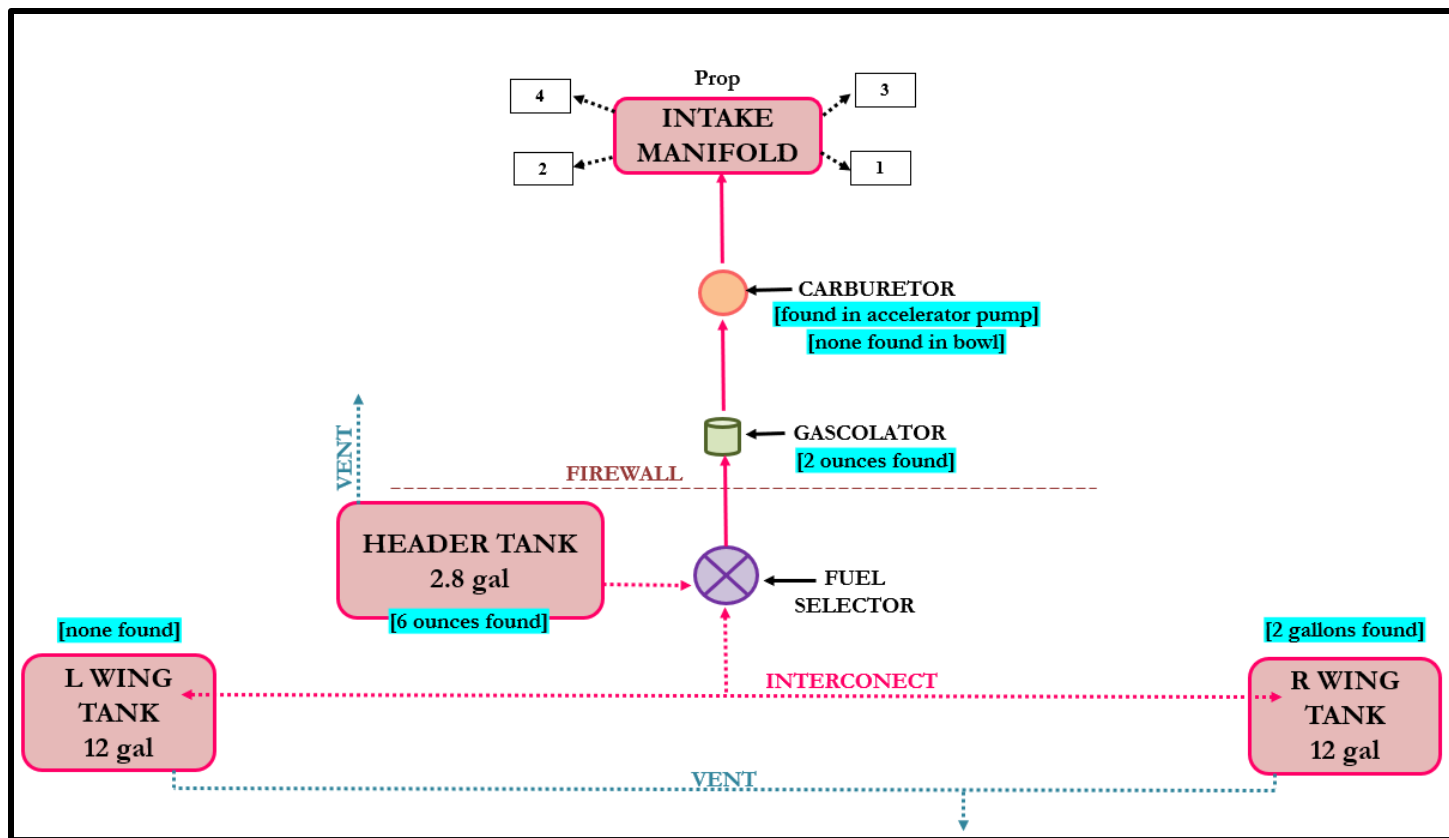
Figure 7: Fuel System Diagram

The fuel tanks were all intact and there was no evidence of a breach. There was no fuel found in the left tank; about 2 gallons found in the right tank; and about 6 ounces in the header tank. The fuel found was free of water and debris. There was evidence of seepage out of the vented cap in the header tank (blue staining). The same liquid was found when activating the accelerator pump in the carburetor, but the bowl was dry. The impact damage made it not possible to determine the total fuel quantity at the time of impact.

If engine failure occurs when there is less than one gallon of fuel in one or both fuel tanks, or during a long, sustained, steep descent with low fuel (less than two gallons in each tank), the most probable cause is fuel starvation. Select fuselage tank. If wing fuel starvation occurred during descent, the wings may have one to two gallons of fuel that is still usable during level flight or climb.

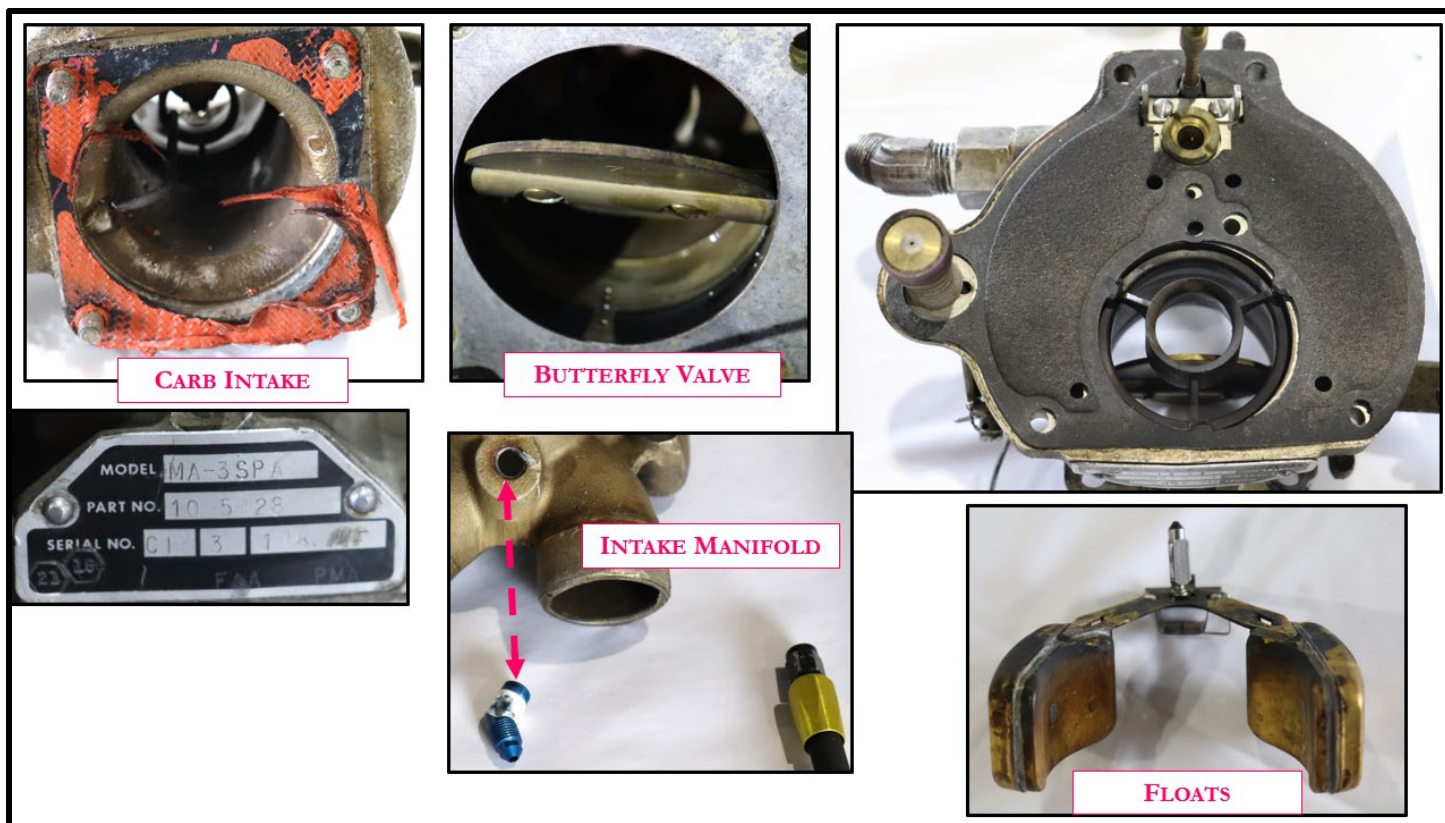
Figure 8: Carburetor (Showing Shooting)

The carburetor was a Precision model MA-3SPA. The carburetor remained intact and was attached at the mounting pad. The throttle/mixture controls were found securely attached at their respective control arms on the carburetor and continuity to the cockpit was established. The engine compartment fuel lines were found to be in place and secure at their respective fittings. The fuel bowl of the carburetor contained no fluid; upon activation of the accelerator pump, fluid jet out. The metal float pontoons were not damaged. The butterfly valve was in the near-closed position there was a black outline on the intake.

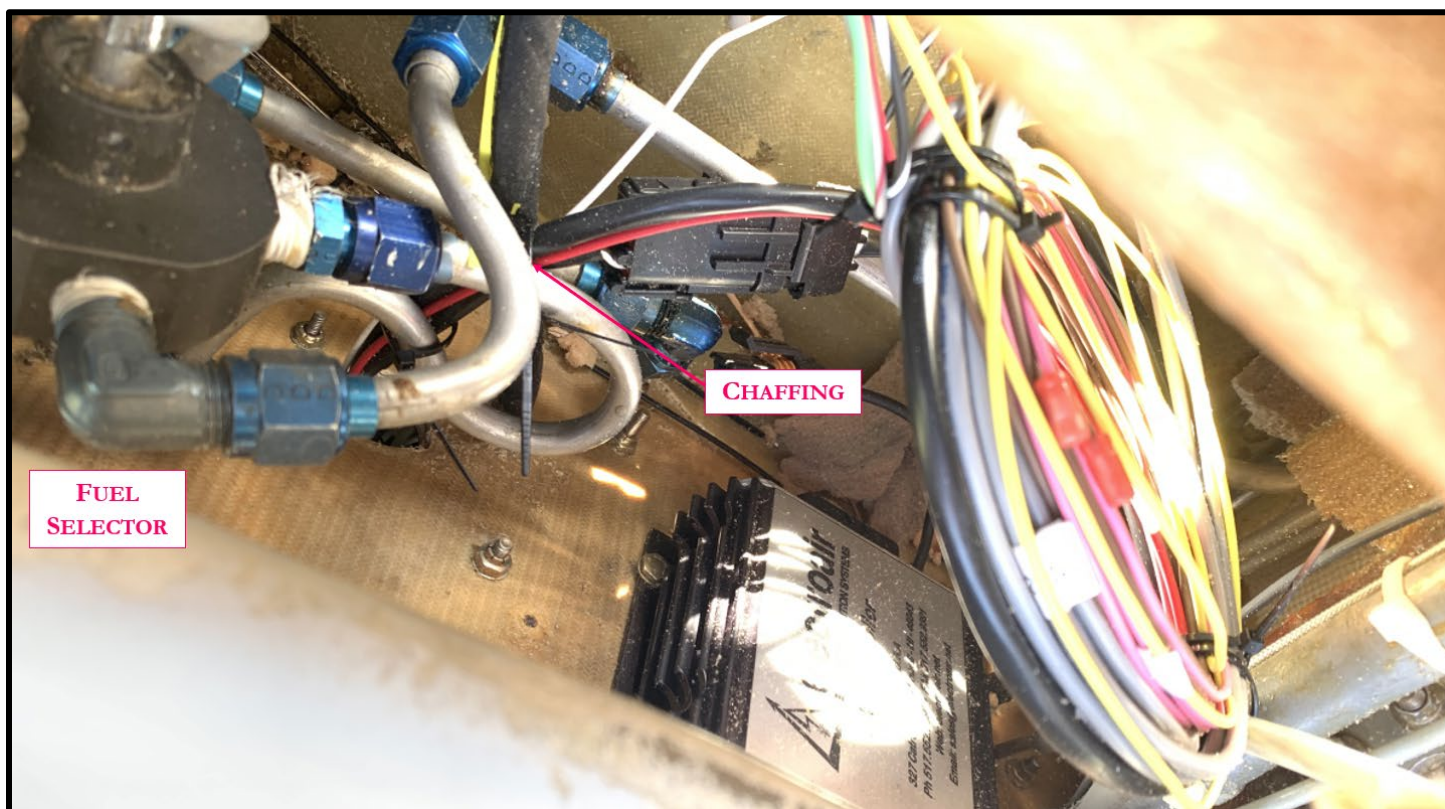
Figure 9: Fuel Selector Connected to Wiring

The fuel selector position could not be confirmed due to the damage from the cockpit handle to the selector located aft of the cockpit. There was wiring ty-wrapped to fuel lines at the fuel selector and chaffing was seen on the insulation.

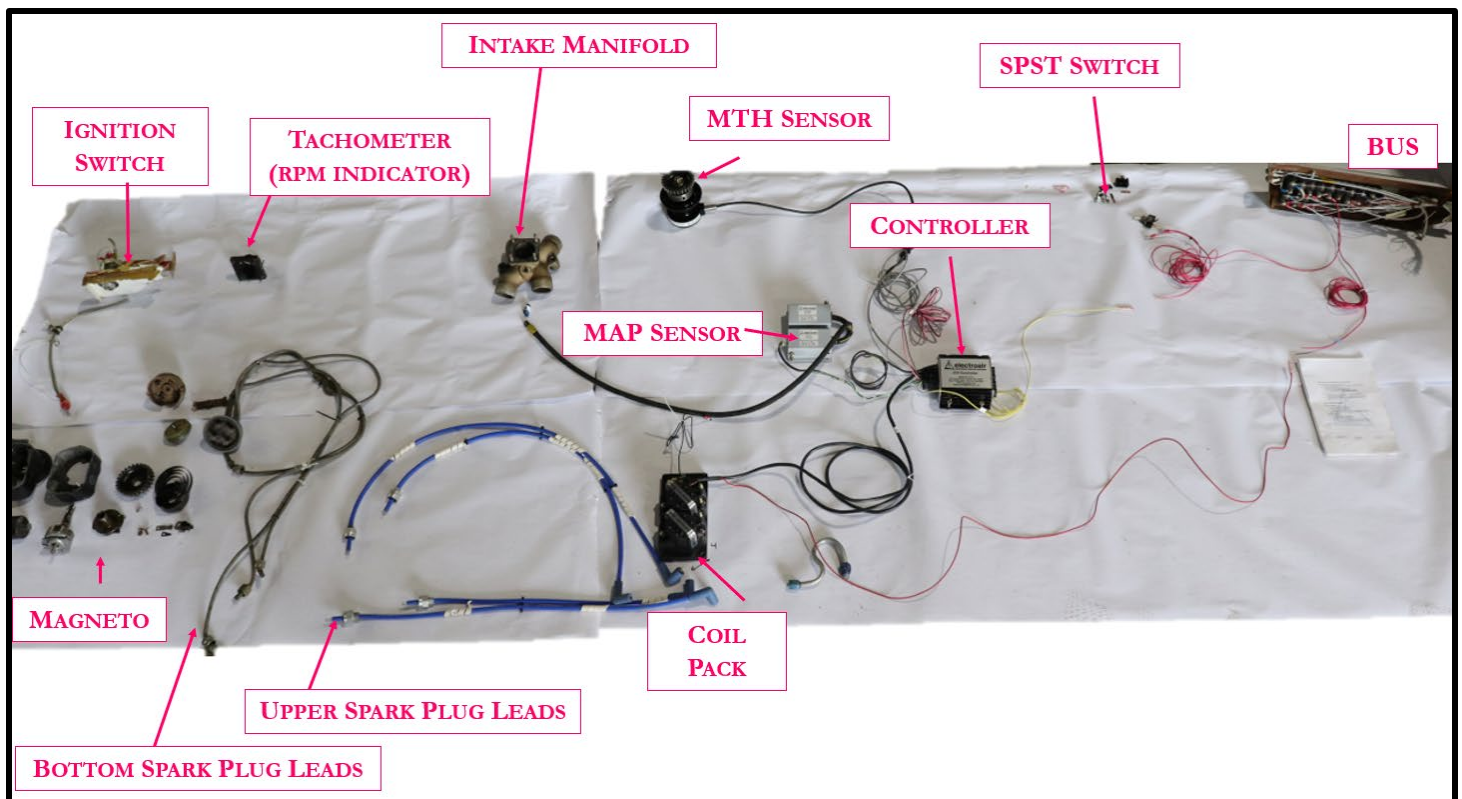
Figure 10: Ignition System

The airplane was equipped with a dual ignition system that the pilot had configured in the month prior; there was one electronic ignition and one magneto installed at the time of the accident.

The ignition system was configured with the Electroair routed to the top spark plugs and the left magneto to the bottom spark plugs. The timing of the magneto was 24° before top-dead center (BTDC); the electronic ignition was internally timed to 22°(BTDC). The magneto was turned on by a keyed ignition and the electric ignition was operated by a single-pole single-throw (SPST) switch.

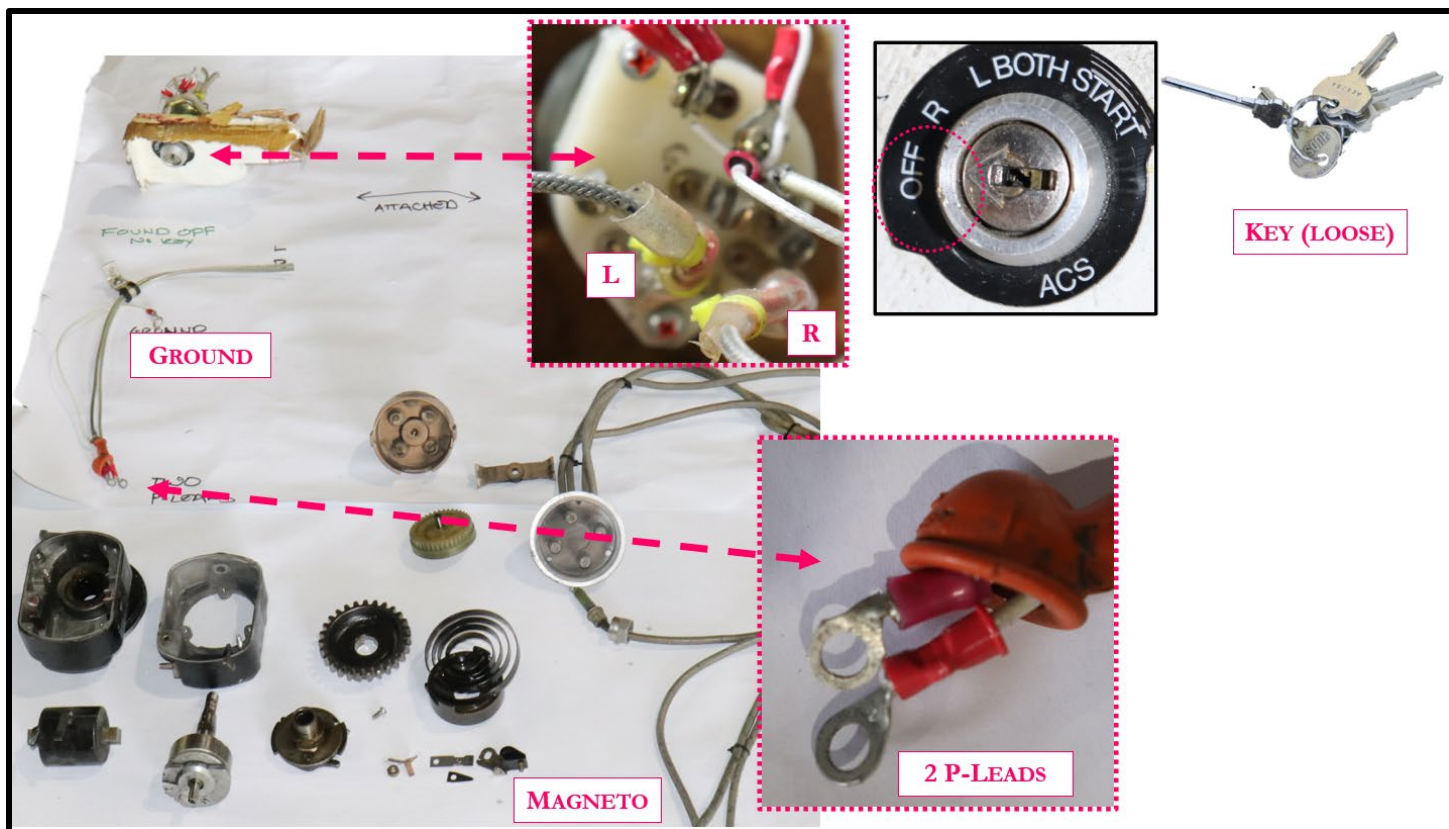
Figure 11: Wiring To/From the Magneto

The magneto had two P-leads connected. Both wires were routed to the keyed-ignition switch: one attached to the “right” and one to the “left” position. This would have made the magneto not operable for all positions (OFF, RIGHT, LEFT) except the BOTH position.

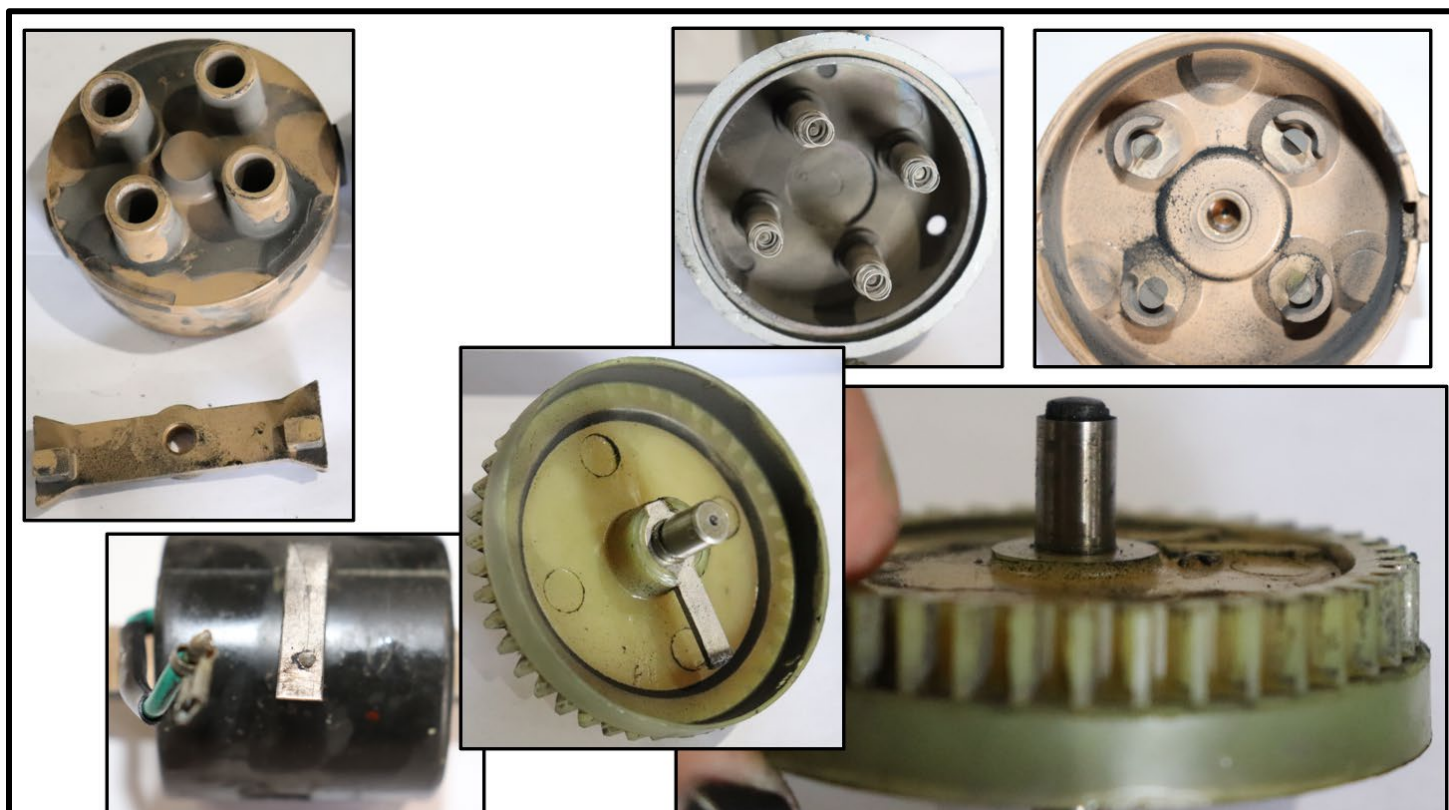
Figure 12: Magneto

Disassembly of the magneto revealed a fine carbon dust in the housing and the distributor brush was worn.

2. Magnetos - remove, inspect, repair as required. These are well past the 500 hour mark for inspections and refurbishment, with unknown time on each. I recommend: <http://aeroacc-vny.com/> for magneto service, but there are many other shops as well

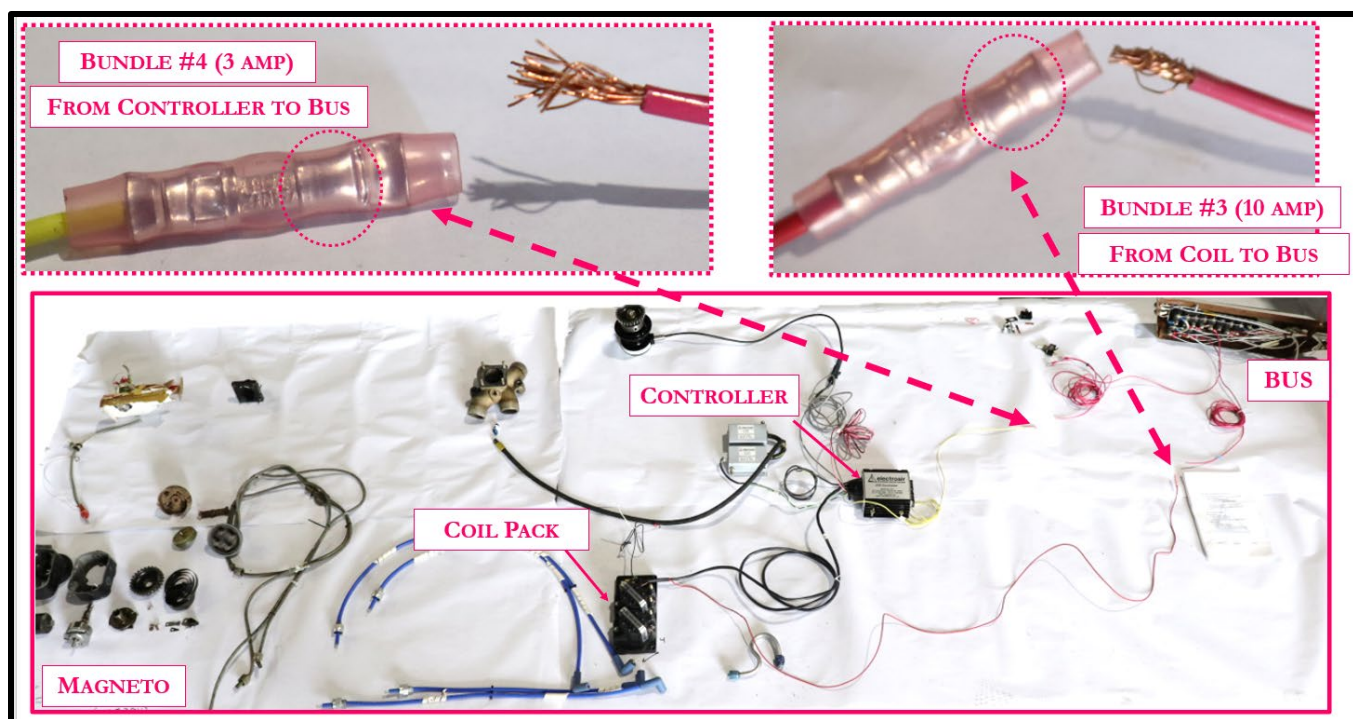
Figure 13: Electrical System Showing Wire Separation

The Electroair unit was removed from the airplane. The wire from the coil pack to the bus (10 amp) was separated at the butt splice and had not been properly crimped on one side (the barrel was not depressed on one side); the wire was also chaffed

where it had been routed along the fuel lines. The wire from the controller to the bus (3 amp) was also separated and not properly crimped. The SPST ignition switch on that wire had a tang bent and one wire was not connected; the switch was broken internally. It is unknown if the switch was damaged prior to impact.

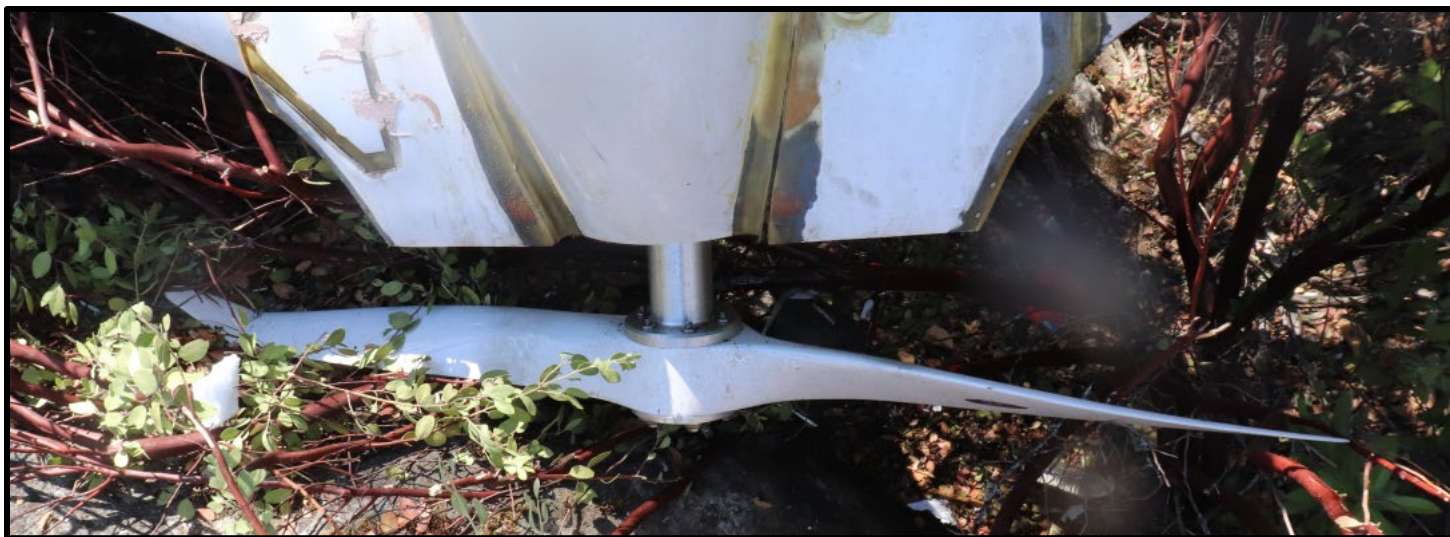
Figure 14: Propeller at Accident Site

The propeller remained intact and attached to the engine with no visible chordwise scratches or leading edge damage. One blade was cracked at the tip as a result of coming to rest on a rock.
