# National Transportation Safety Board

WPR22FA345

## **WRECKAGE EXAMINATION**

Location: Seligman, Arizona  
Date: 9/13/2022  
Time: 1100 MST  
Airplane: Piper PA-46-310P

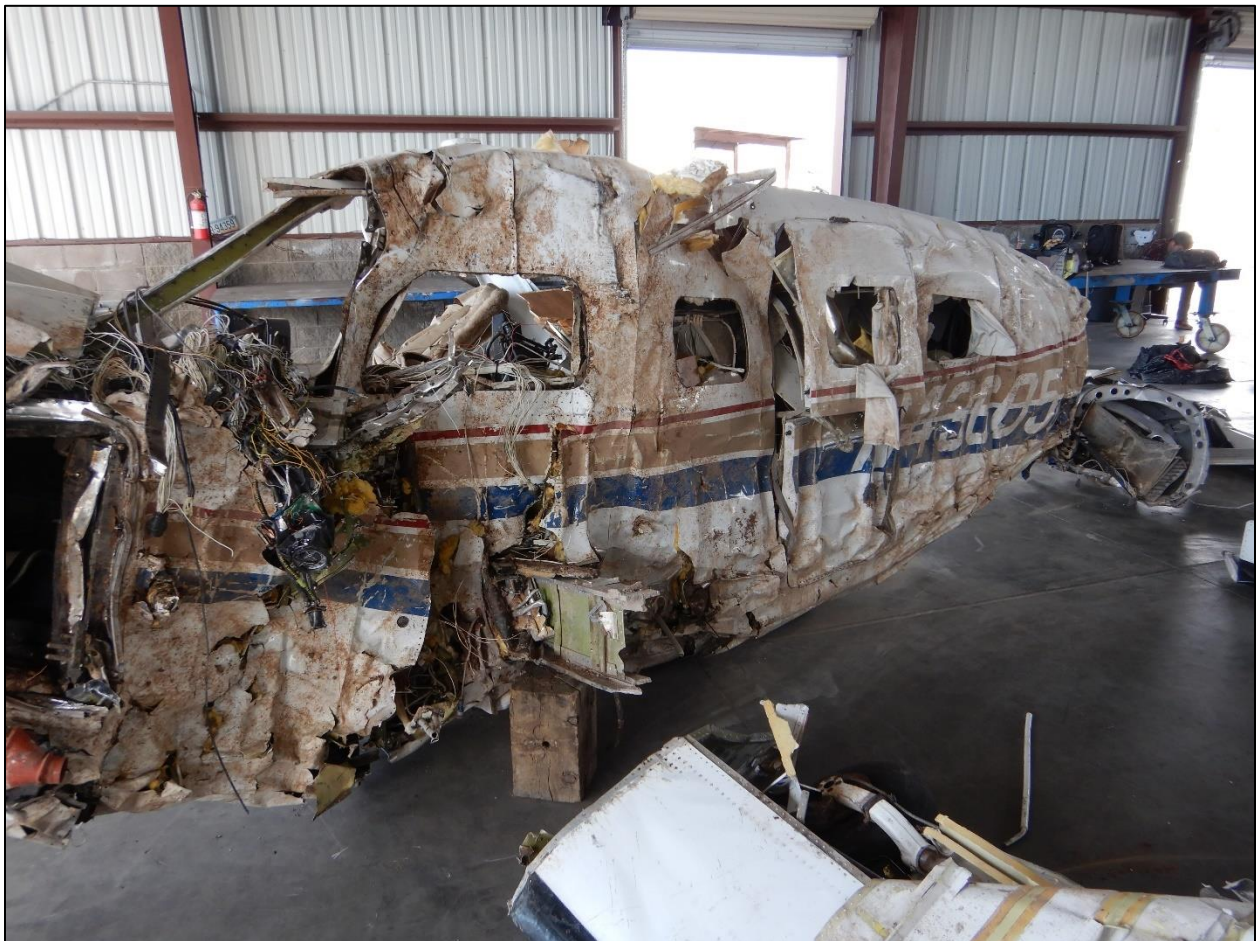
The fuselage was crushed laterally along the left side of the fuselage reducing the width of the cabin area to about half. The engine remained attached to the fuselage and had impact damage to the left side. The propeller assembly separated from the engine crankshaft propeller flange. The propeller blades remained attached to the hub and showed no impact signatures that would suggest power at ground impact. The spinner was crushed on one side. The main cabin door remained attached to the fuselage and the nose baggage door separated. The occupied seats and instrument panel were crushed. Examination of the instruments revealed no nonvolatile memory, and all cabin switch positions were undetermined. The fuselage upper exterior surface revealed black rubber transfer marks. Control cable continuity could be established from near cabin to the control surfaces, though overload separations were noted to the aileron control cables. Damage and compression of the fuselage structure precluded continuity determination within the cabin.

**Figure 1-The left side of the fuselage and left wing spar inboard section.**

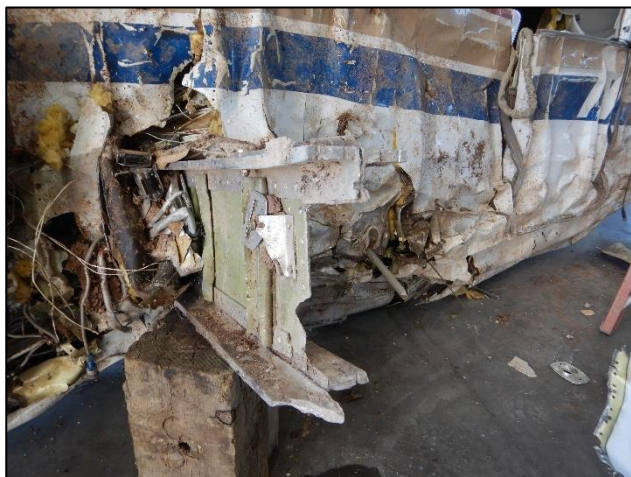
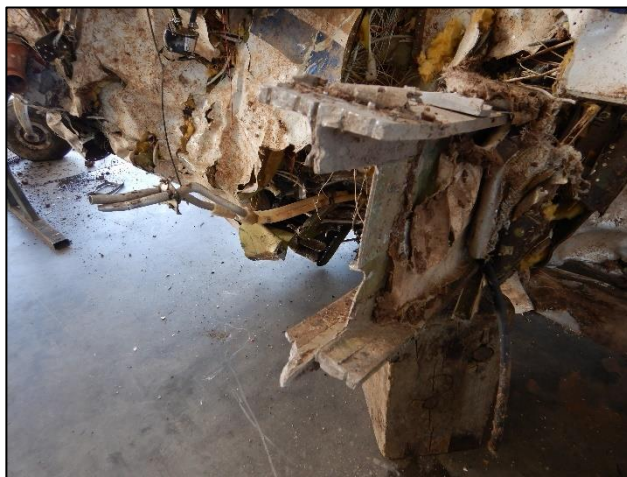
The left wing separated at the wing root area. The left wing spar inboard section was visible and remained attached to the main wreckage. The spar end revealed separation signatures of positive wing loading. The fracture surfaces had angled, dull, grainy appearances consistent with overstress separation. The inboard upper spar cap was deformed upwards near the separation.

**Figure 2-The left main wing spar separation.**

**Figure 3-The left main wing spar separation.**

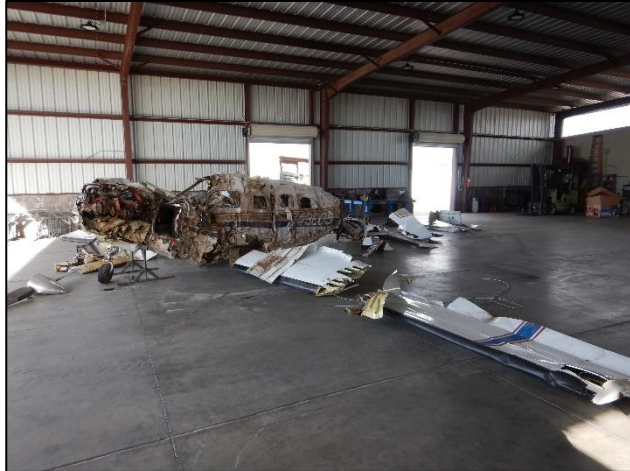
The separated outboard left wing was recovered in two large sections and separated near wing station (WS) 135. The inboard section of the wing had trailing edge damage and the flap was not attached. The main landing gear remained attached to the inboard section. The aileron remained attached to the outboard wing section and had impact damage to the tip. The upper wing skin was damaged and curled outboard from the separation. The fracture surfaces between the two outboard left-wing sections had angled, dull, grainy appearances consistent with an overstress separation or positive wing loading.

**Figure 6-Forward view of the left wing and main wreckage.**

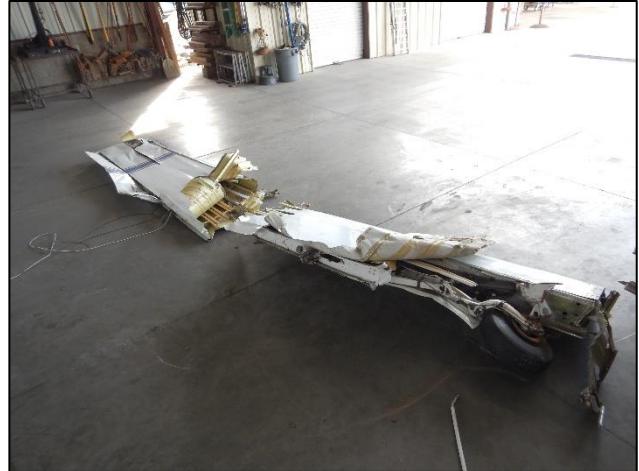
The left aileron cables remained attached to their respective components and were separated near the wing root with the ends exhibiting a splayed, broomstraw appearance consistent with tension overload. The left flap separated from the wing and was not found during the recovery efforts.

**Figure 7-Aft view of the left wing sections.**

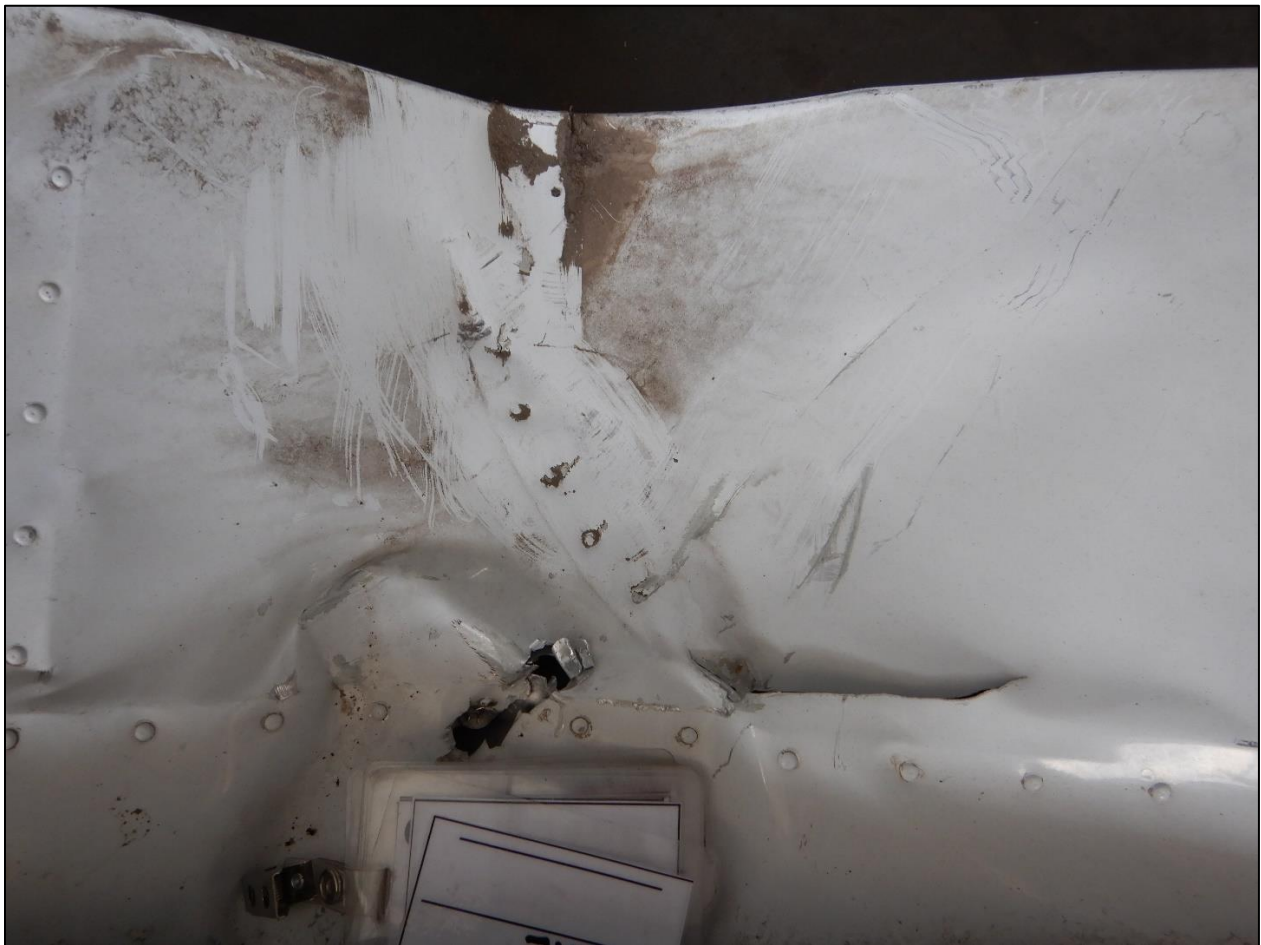
The lower surface of the left aileron displayed an imprint, located about 20 inches from the inboard end, consistent in appearance with button head rivets spaced about 1 inch apart.

**Figure 4-The left aileron rivet imprint.**

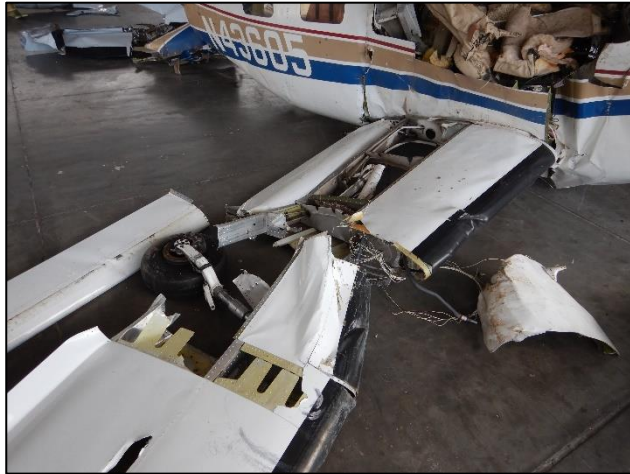
The right wing separated near WS 86, leaving about 4 ft of the wing attached to the fuselage. Both the main and the aft wing spars were deformed upwards at the fracture location consistent with positive wing loading. The fracture surfaces had angled, dull, grainy appearances consistent with overstress separation. The wing had leading edge damage near WS 156.

**Figure 6-Right wing separation.**

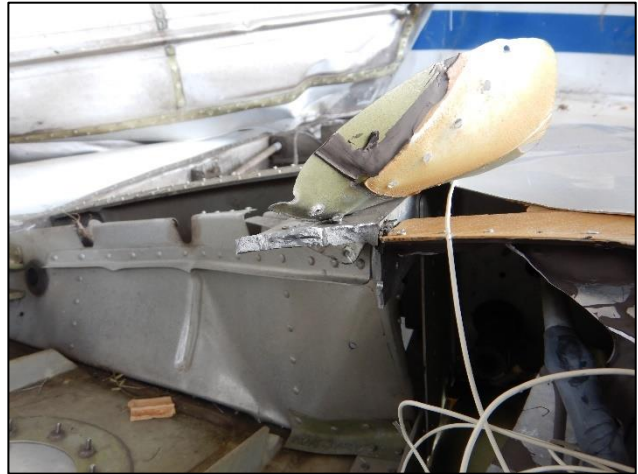
**Figure 7-Right wing main spar separation.**

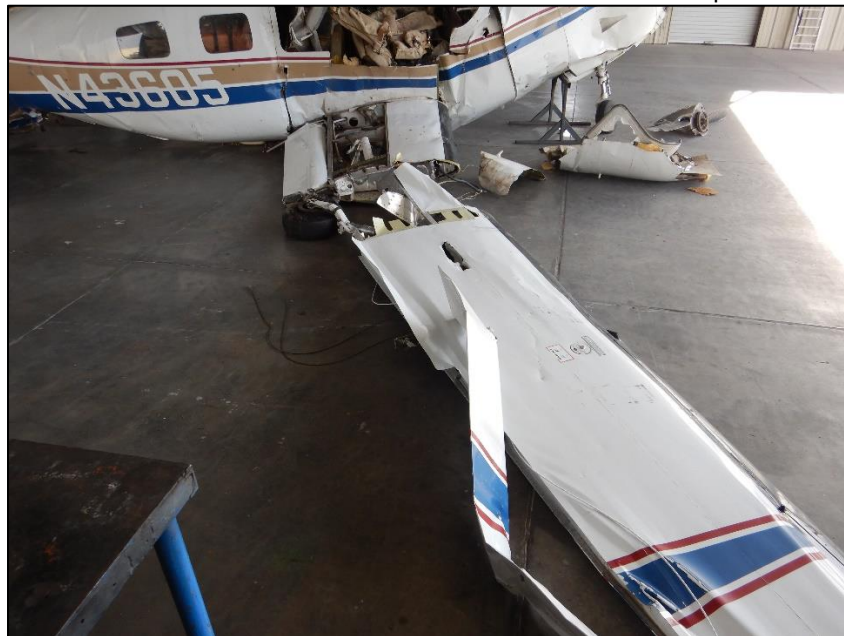
The right aileron was separated from the wing and had impact damage. The aileron cables remained attached to their respective components and were separated near WS 100 with the ends exhibiting a splayed, broomstraw appearance consistent with tension overload. The flap was found in two sections and the inboard portion remained attached to the inboard wing section that was attached to the fuselage. The outboard flap section was found in the debris field and had impact damage.

**Figure 5-Right wing and flap.**

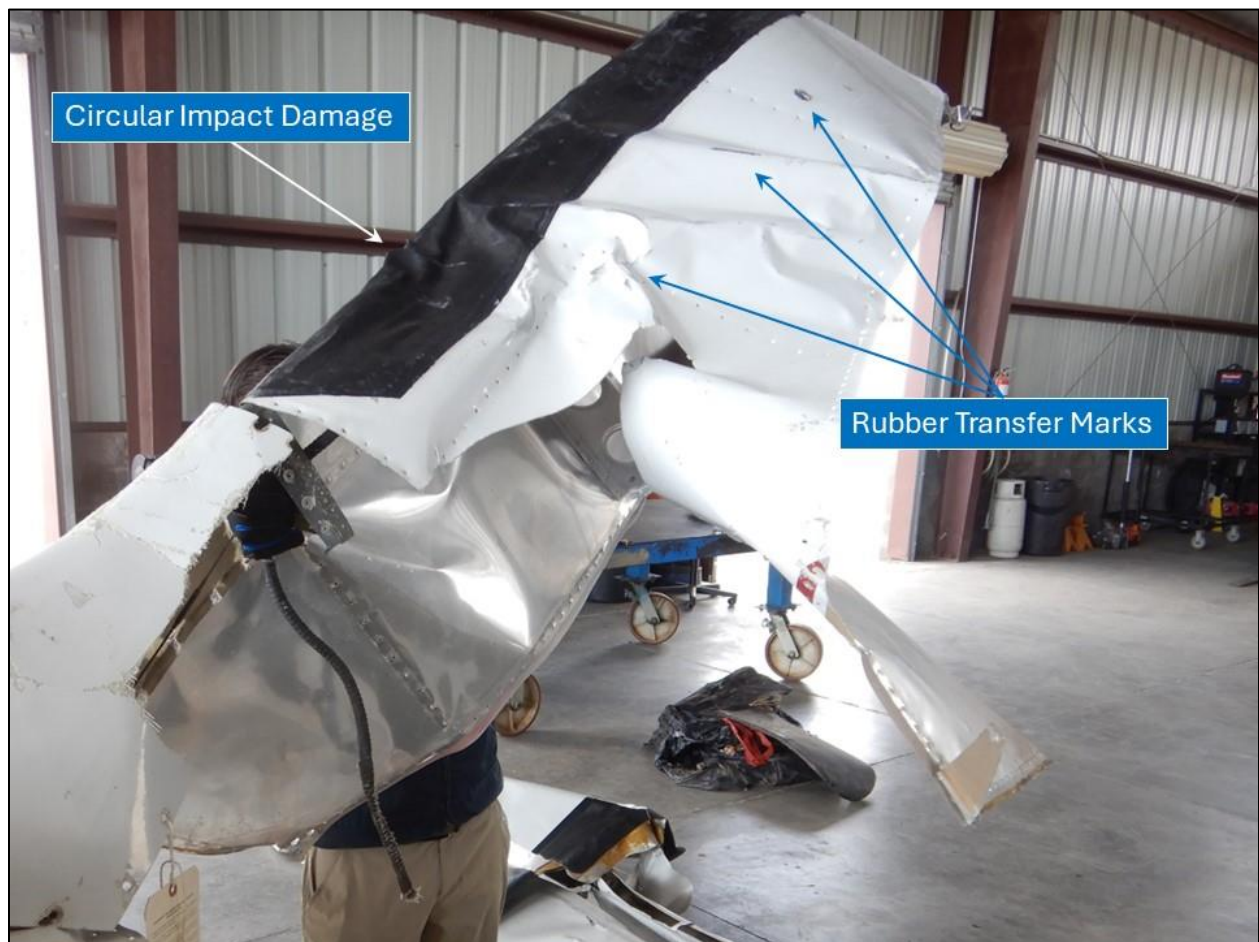
The vertical stabilizer forward and aft spars separated from the empennage at the roots. The vertical stabilizer skin separated from the spars. There was a circular impact mark and rubber transfer marks near the left side of the leading edge about 51 inches up from the root.

**Figure 6-Vertical stabilizer skin held in place relative to its normal position on the empennage.**

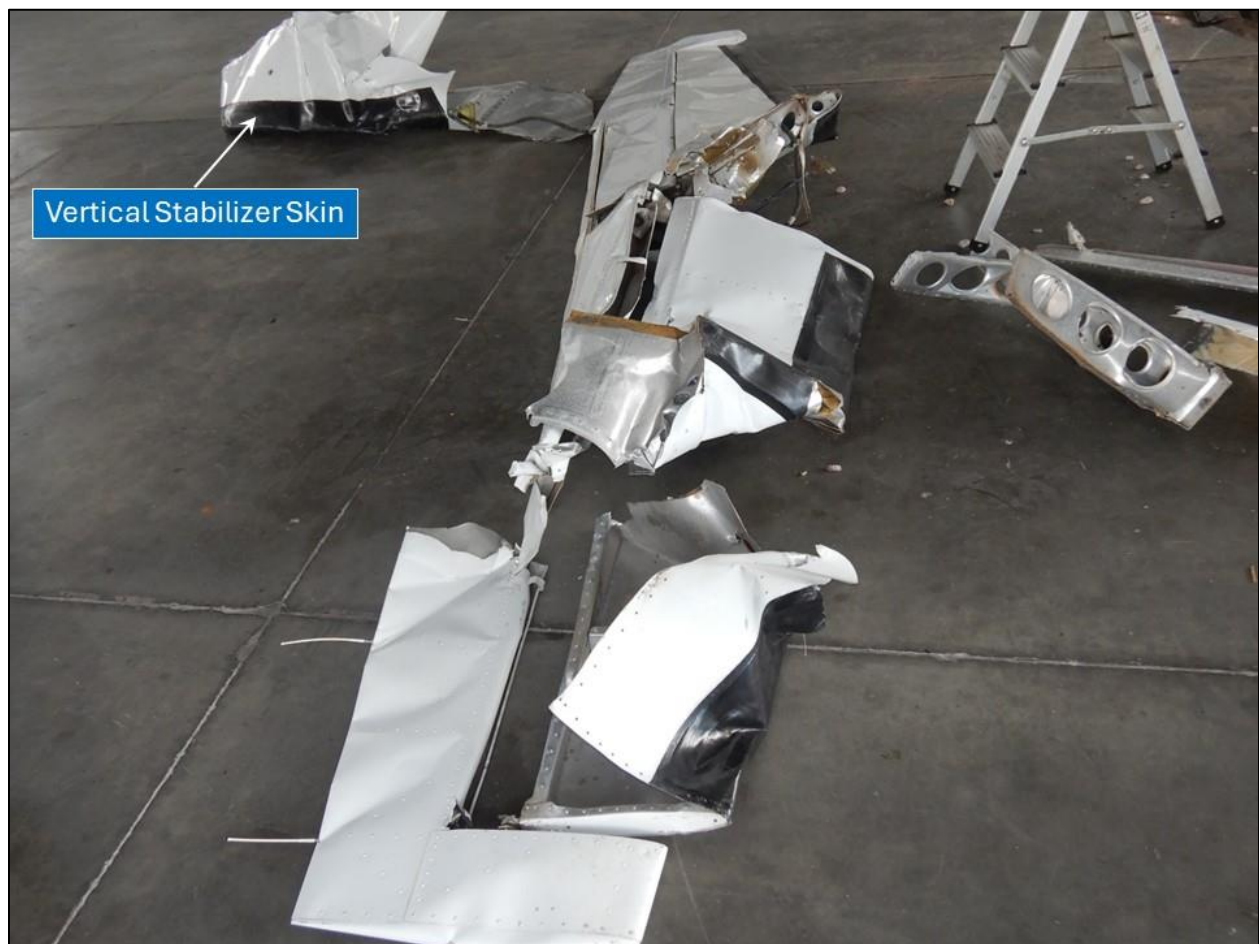
The horizontal stabilizer, most of the elevator, elevator tab and the FS 327 frame had separated from the empennage as one unit. The left side of the stabilizer was buckled, and the inboard leading edge was deformed upward. The right side of the stabilizer was separated about midspan; the leading edge was deformed upward and aft, and the outboard skin was impact separated. Several white paint transfer marks and black rubber transfer marks were noted to the de-ice boot and upper skin of the stabilizer. The right side of the elevator had impact damage. The elevator control stops remained mounted to the control rod and were unremarkable. The FS 327 frame displayed a semi-circular crush impression consistent with contact by the elevator control rod, above where the rod passed through to the elevator. The tail tiedown loop remained mounted to the FS 327 frame and had deformed to the left.

**Figure 7-Horizontal stabilizer and elevator.**
