## **NATIONAL TRANSPORTATION SAFETY BOARD**

# **ACCIDENT SITE EXAMINATION REPORT**

**WPR22FA345**

| Aircraft: | Piper PA46, N43605 |

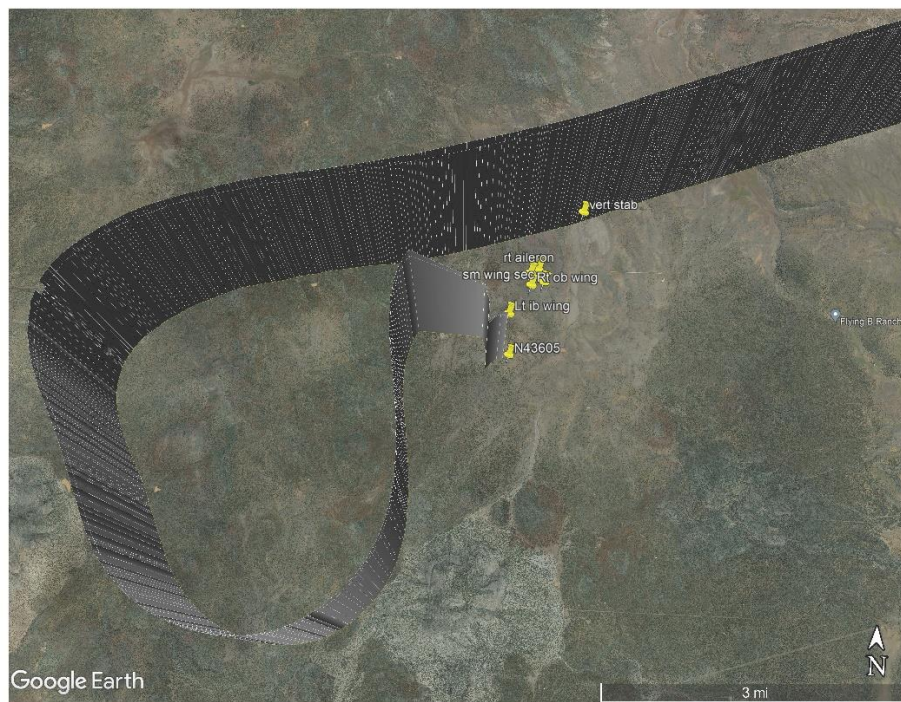
Figure 1-Google Earth view of the radar track and accident site location.

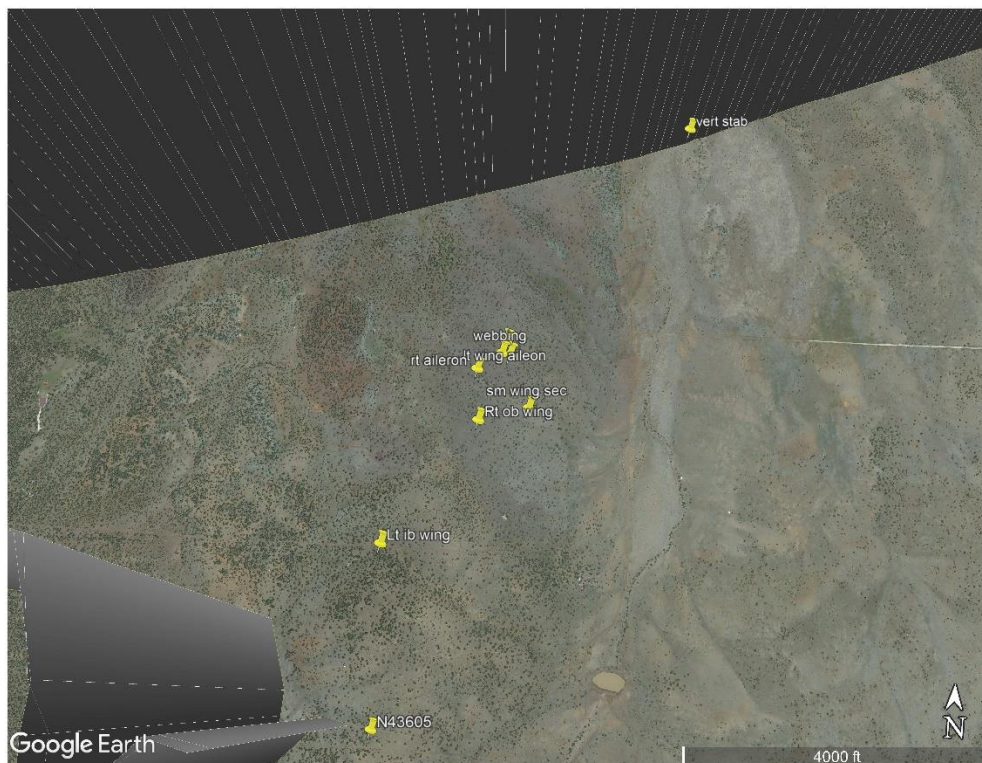
The last radar target was above the main wreckage location.

Figure 2-Google Earth view of the debris field.

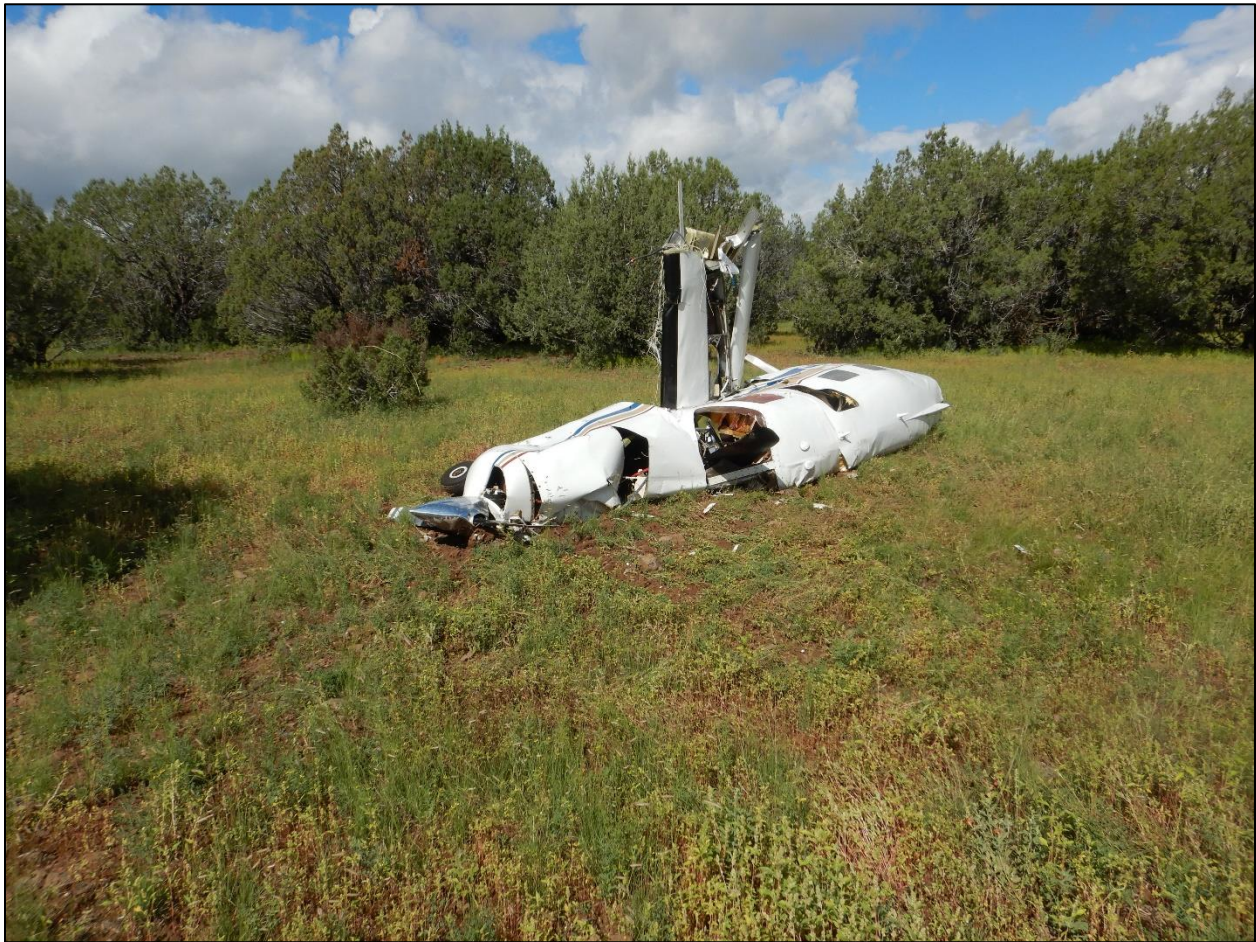
A postaccident examination of the accident site revealed that a debris field was located across desert terrain with sparsely spaced juniper trees. The main wreckage consisted of the airplane's fuselage, engine and propeller, which came to rest on its left side on a directional heading of 165 degrees magnetic. The right inboard wing section, flap and right landing gear remained partially attached. The right side windshield was broken out and windshield fragments were spread from the main wreckage to about 80 ft in an eastward direction. The cabin glareshield was partially protruding from the broken windshield. The aft fuselage including the vertical spar was partially attached to the main wreckage by wires and tubing. The vertical spar end was damaged and bent forward. There was no ground disturbance. The debris field was about 2 miles long and on a directional heading of 24 degrees magnetic. The left inboard wing section including the left main landing gear was about 1/2 mile to the north of the main wreckage. The remaining wing section were found near the middle of the debris field. The vertical stabilizer was the furthest from the main wreckage. The left flap and rudder were not located during the recovery efforts.

**Figure 3-Accident site, main wreckage.**
