# National Transportation Safety Board

WPR22FA350

## **ONBOARD IMAGE RECORDER**

Location: Reno, NV  
Date: September 18, 2022  
Time: 15:44 Pacific daylight time (PDT)  
Airplane: Aerovodochody L-29 Delfin

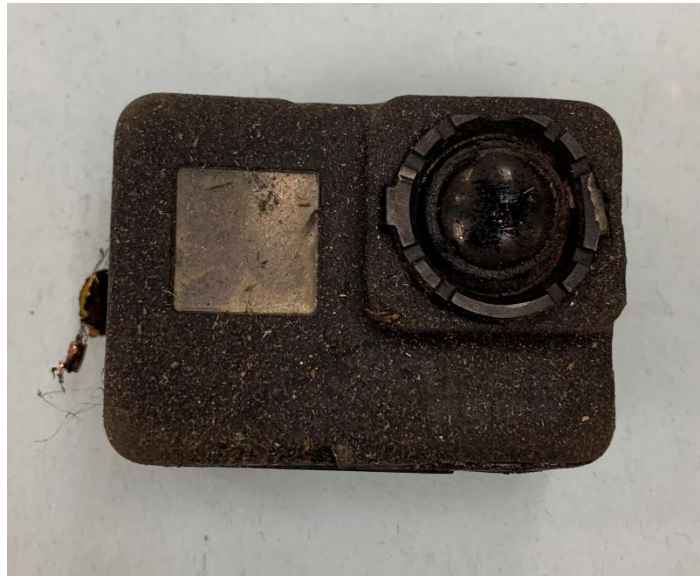
The device was damaged in the event. The device was located separately from the SanDisk 128 GB microSD card which is discussed below in this report. The extent of the damage to the GoPro is shown in Figure 1. The device's battery compartment was heavily damaged in the accident and the remnants of the compartment were opened. The battery compartment contains the chassis to hold the device's removable memory device. In this case, the internal memory device is a microSD card. Figure 2 shows the GoPro's microSD card chassis. The chassis was empty. No data was recovered from the device.

**Figure 1.** GoPro Hero, as recovered.

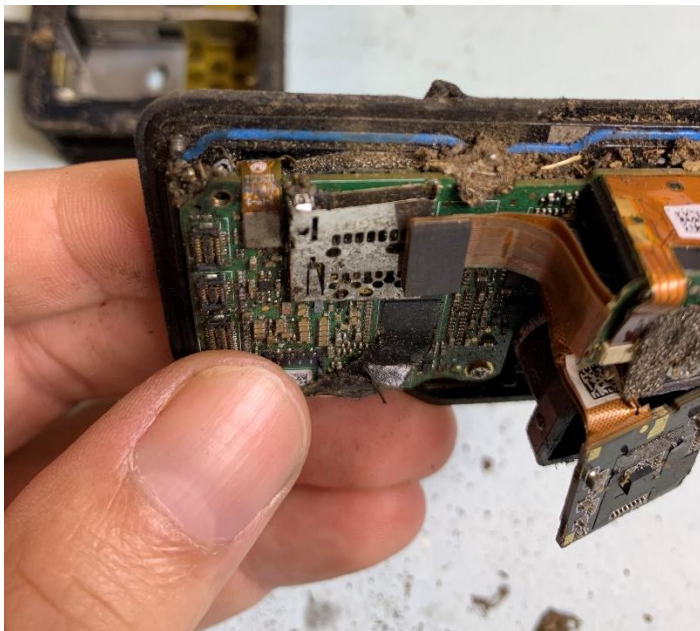
**Figure 2.** Inside the camera's battery compartment. The silver chassis which holds the microSD card. The chassis was empty.

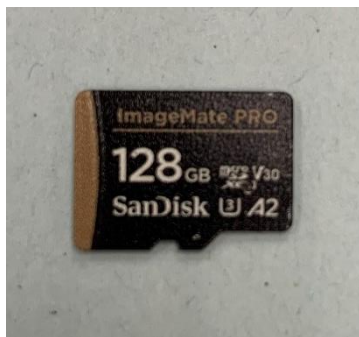
The device is pictured in Figure 3. The device appeared undamaged upon an initial visual inspection. The device was then examined with a digital stereoscopic microscope. An image from the stereoscopic microscope is shown in Figure 4. The device contained a crack along the length of the entire microSD card. Figure 5 shows a portion of the same crack at a greater magnification.

**Figure 3.** The microSD card, as received.

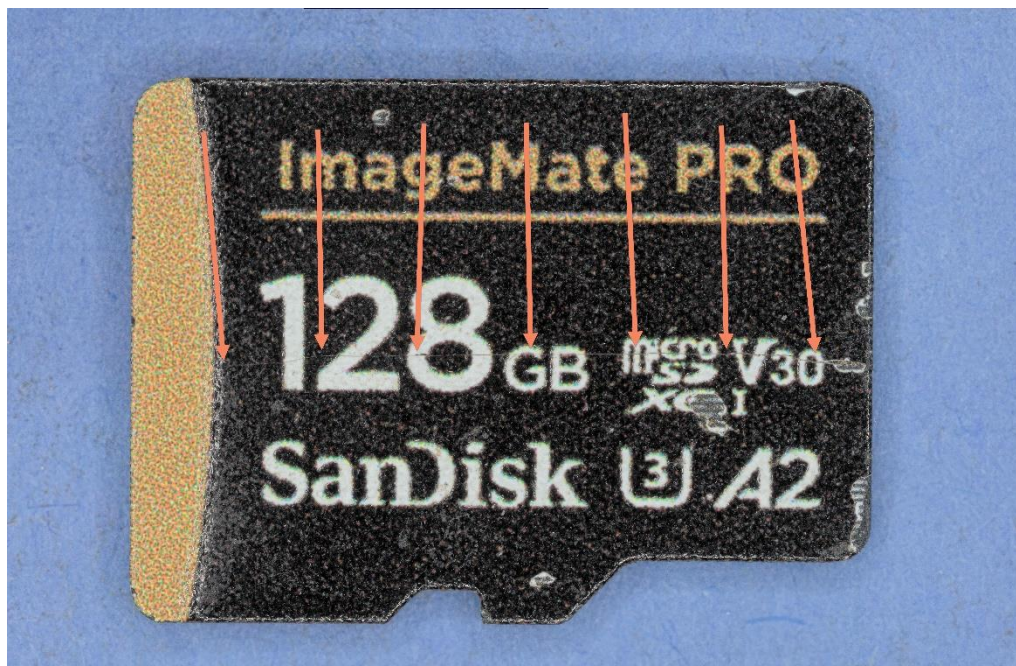
Typically, a crack in a microSD card indicates that the card sustained a flexure event. When this occurs, the device's internal silicon die can be damaged.

**Figure 4.** A stereoscopic microscopy image showing a longitudinal crack on the device. Orange arrows show the region of the crack.

The operator of the aircraft stated there were two GoPros in the cockpit on the day of the accident. One damaged GoPro was received and was found to have no microSD card. Separately, a loose microSD card (the SanDisk 128 GB microSD card discussed in this report) was found at the crash site. The loose SanDisk card contained a crack which precluded the recovery of any GoPro data.

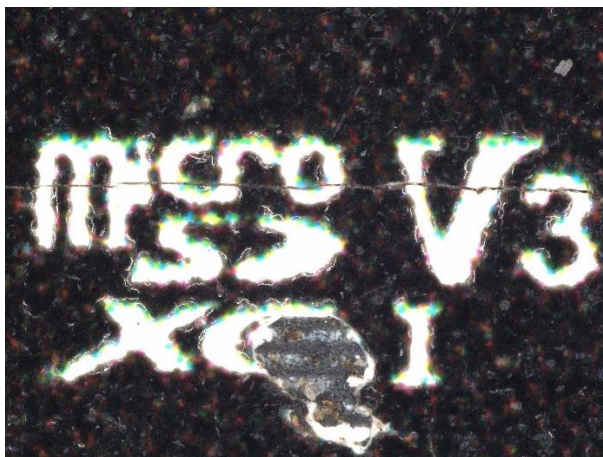
**Figure 5.** A higher magnification of a portion of the same crack.
