# National Transportation Safety Board

WPR22FA350

## **ACCIDENT SITE AND WRECKAGE EXAMINATION**

Location: Reno, Nevada  
Date: September 18, 2022  
Time: 1544 Pacific daylight time  
Airplane: N129MM, Aerovodochody L-29 Delfin

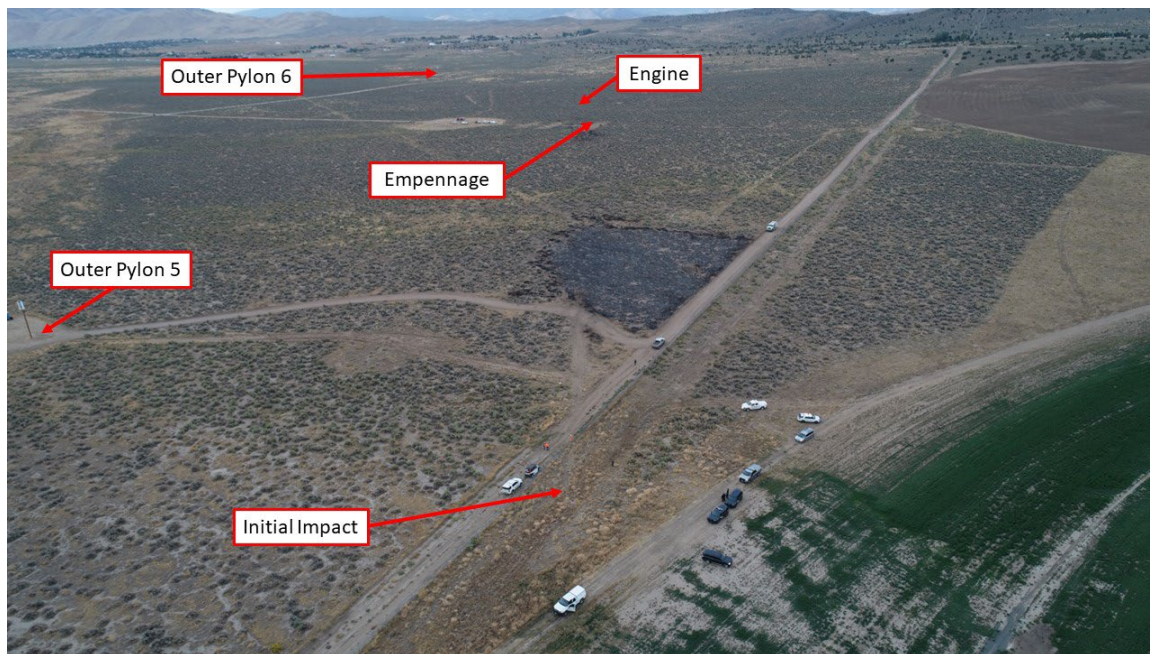
Examination of the accident site revealed that the airplane impacted terrain on a heading of about 229° magnetic. The first identified point of contact (FIPC) with terrain was a swath of freshly disturbed dirt, consistent with a left wing impact. The swath of disturbed dirt continued for about 180 ft to a large burn area. The 2,200 ft long debris path continued along a heading of about 242° degrees magnetic and contained various fragments of wreckage along with portions of both wings, empennage, and engine. The wreckage was recovered to a secure location for further examination.

Figure 1: Aerial view of the accident site provided by Nevada State Patrol, with annotations of pylon and wreckage locations.
