WPR22FA350

## INVESTIGATION PHOTOGRAPHS

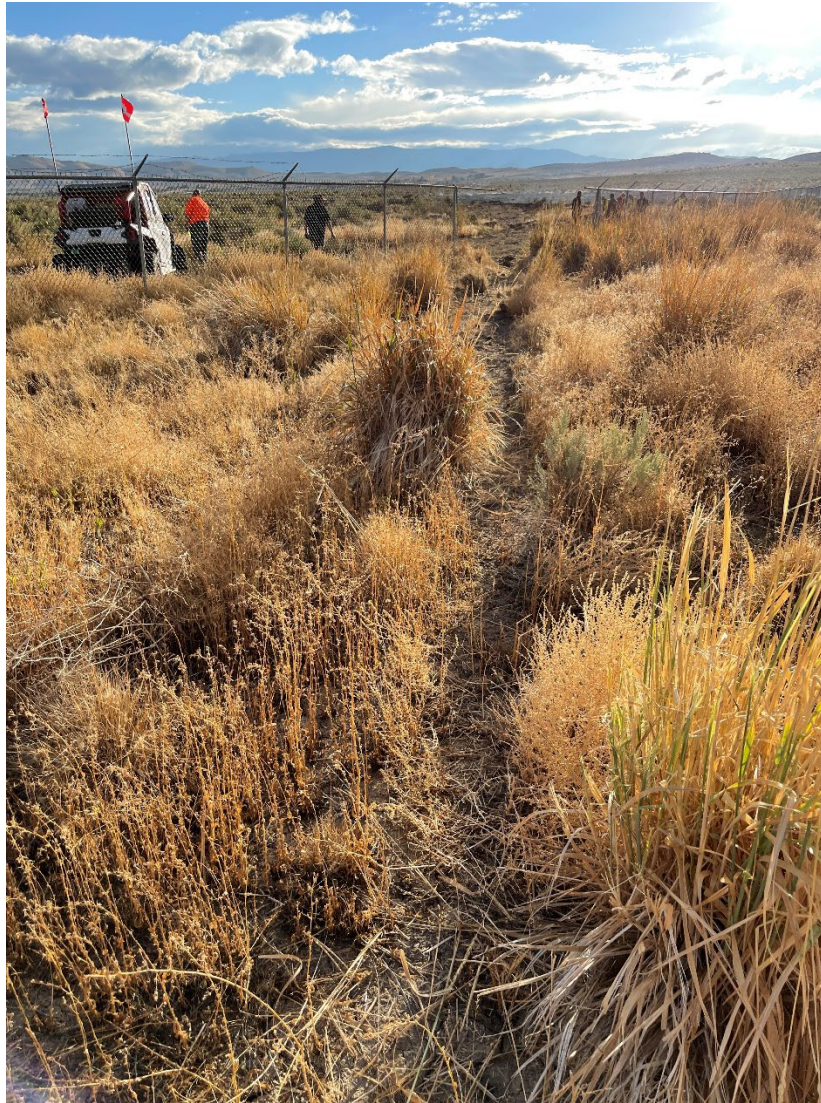
**Photograph 1 - Initial impact point.**

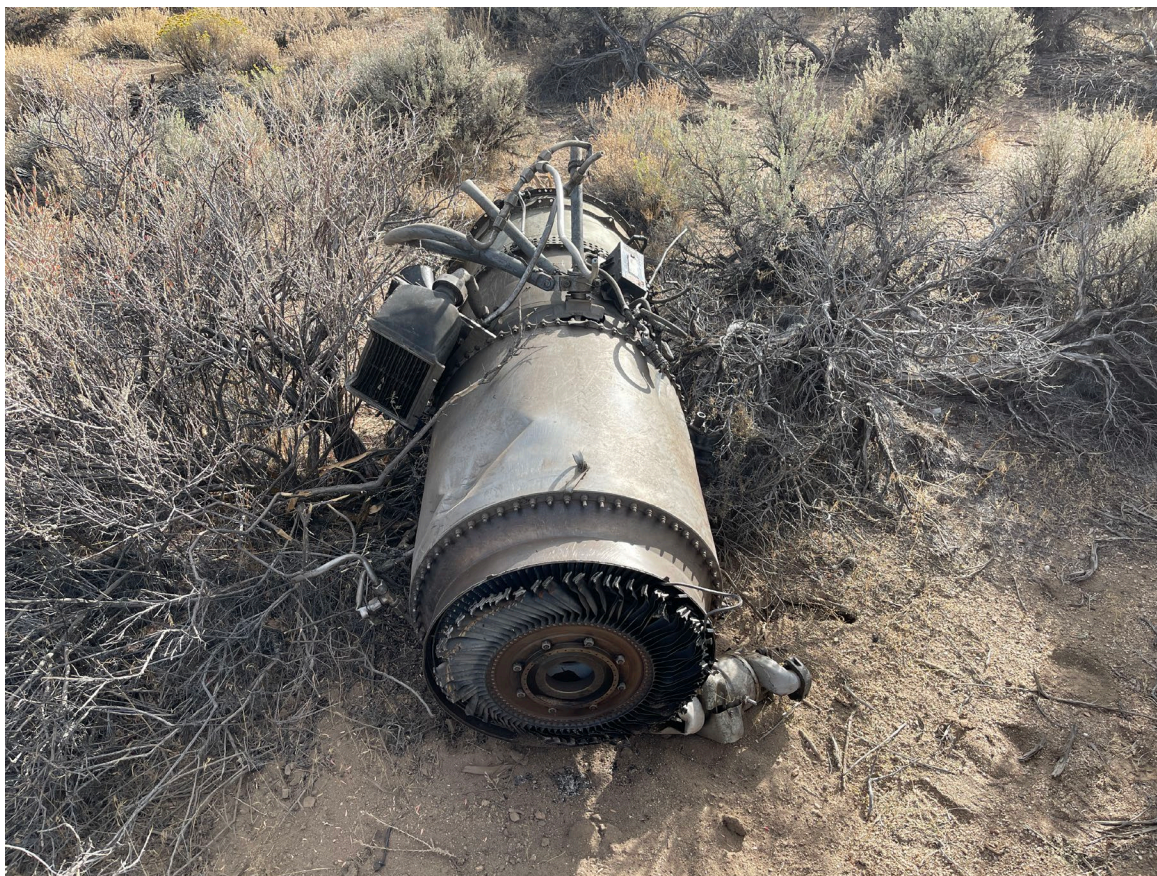
**Photograph 2 - Engine within the debris path.**

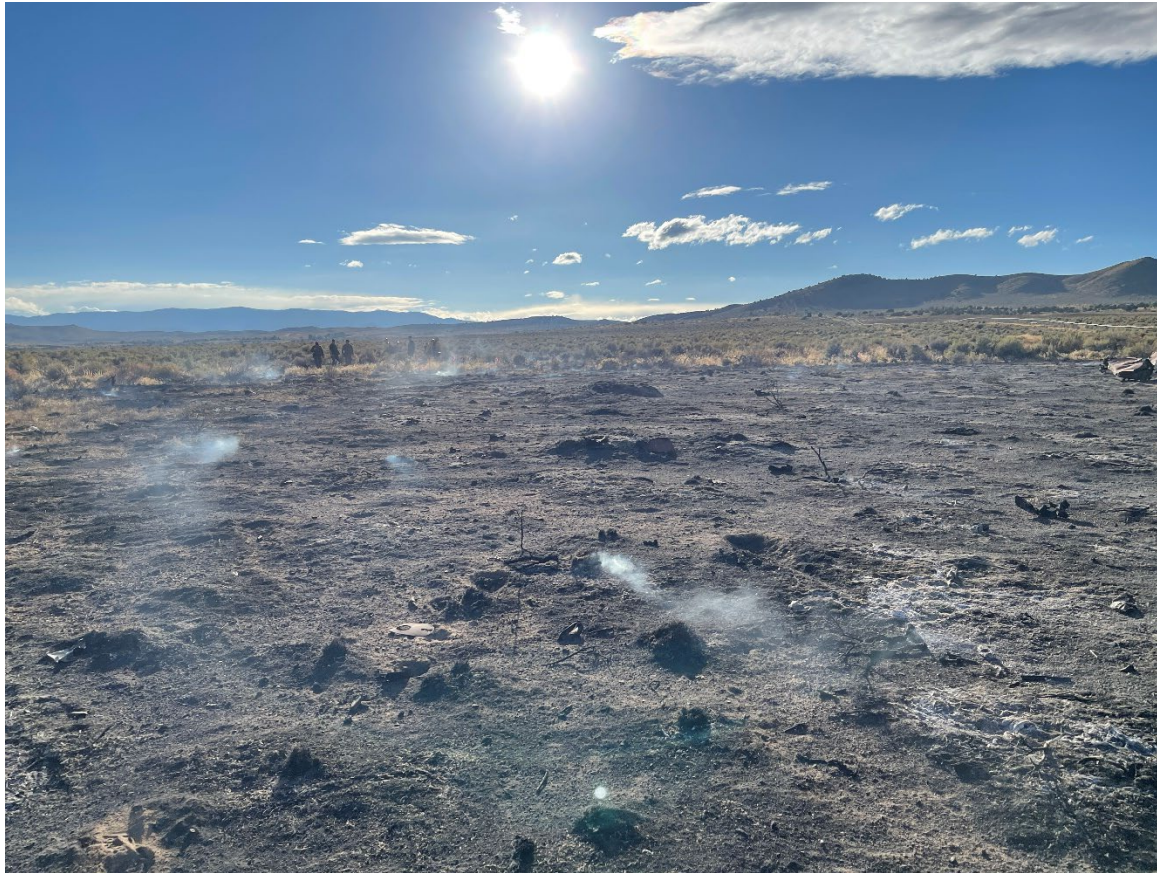
**Photograph 3 - Wreckage debris area.**

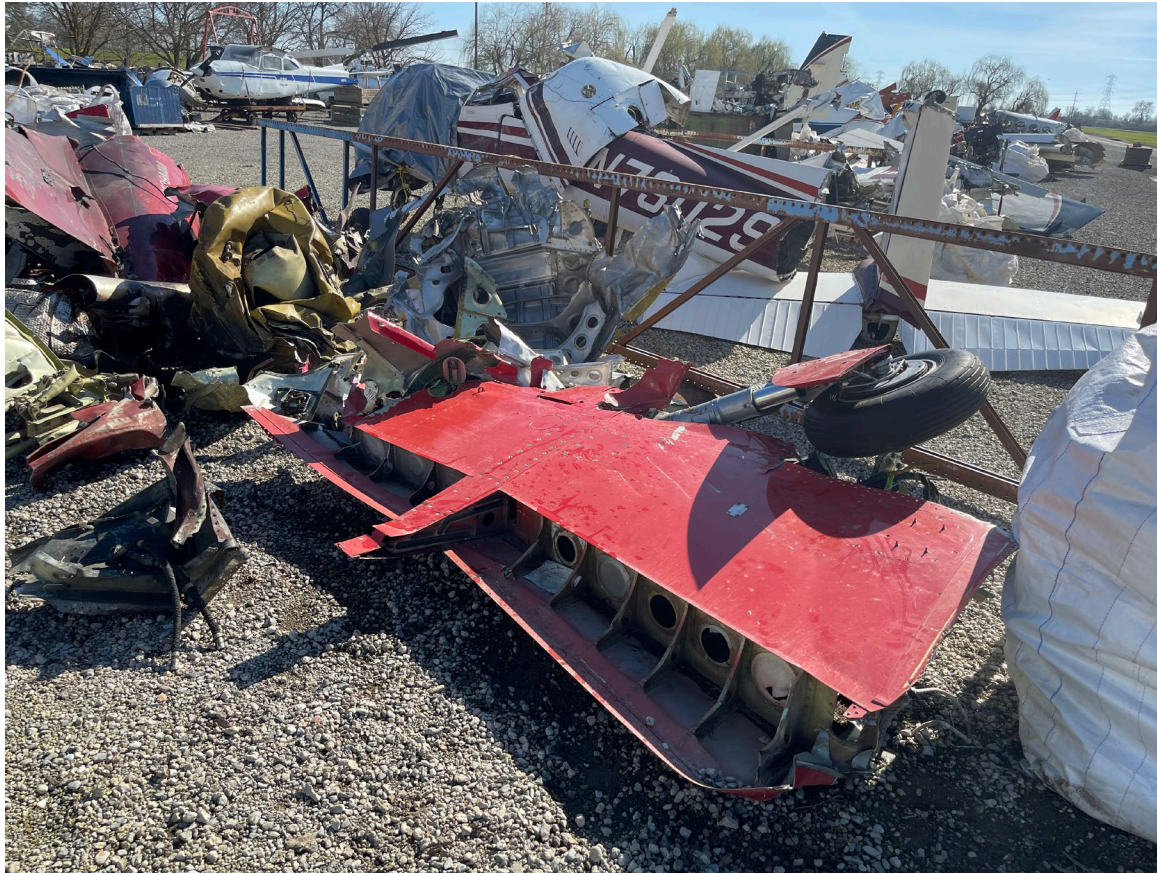
**Photograph 4 - Recovered wreckage.**

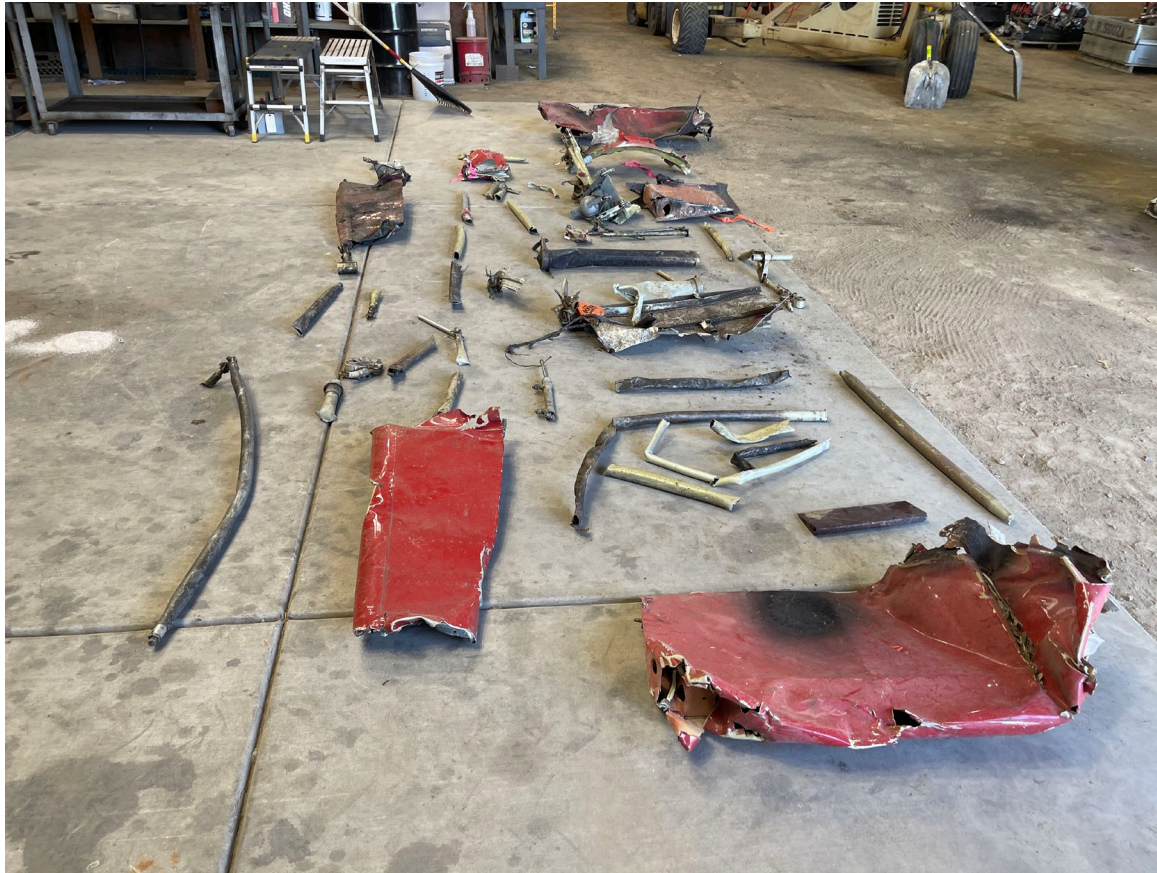
**Photograph 5 - Recovered wreckage.**

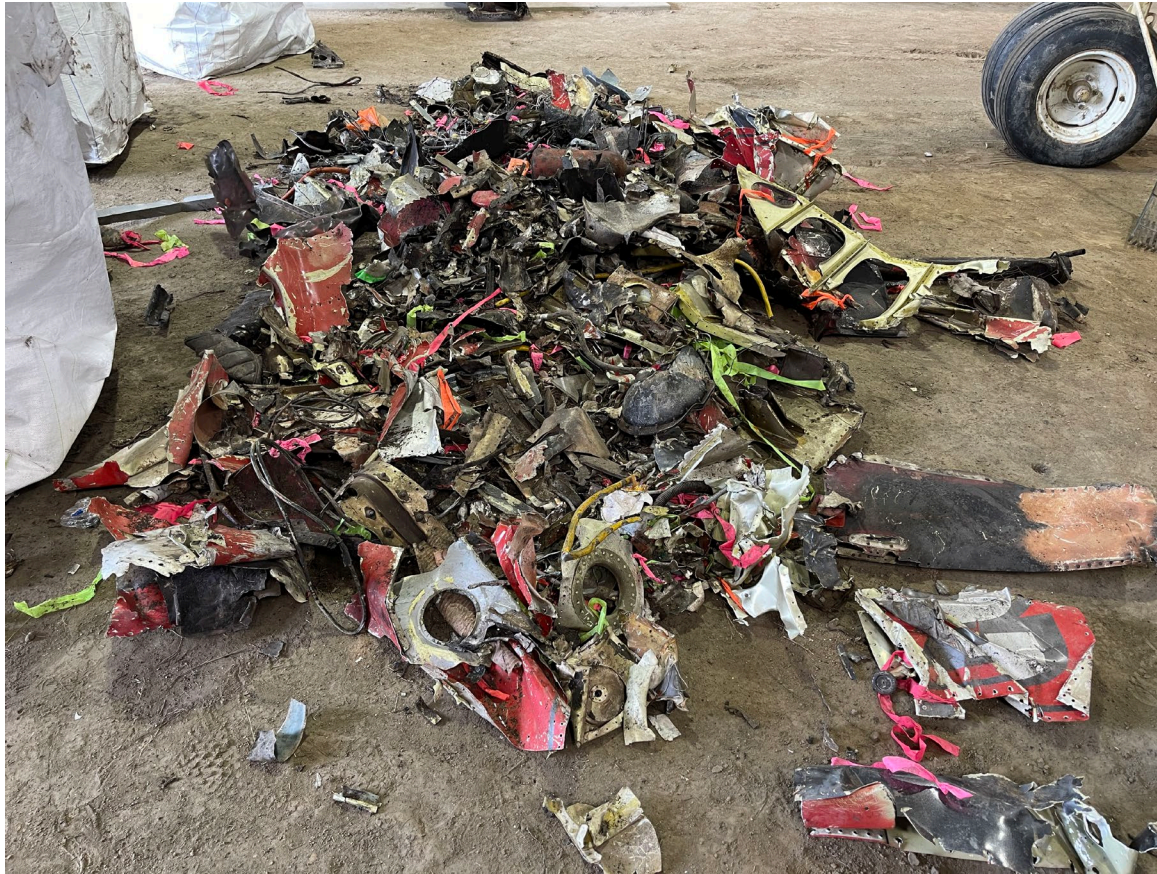
**Photograph 6 - Recovered wreckage.**

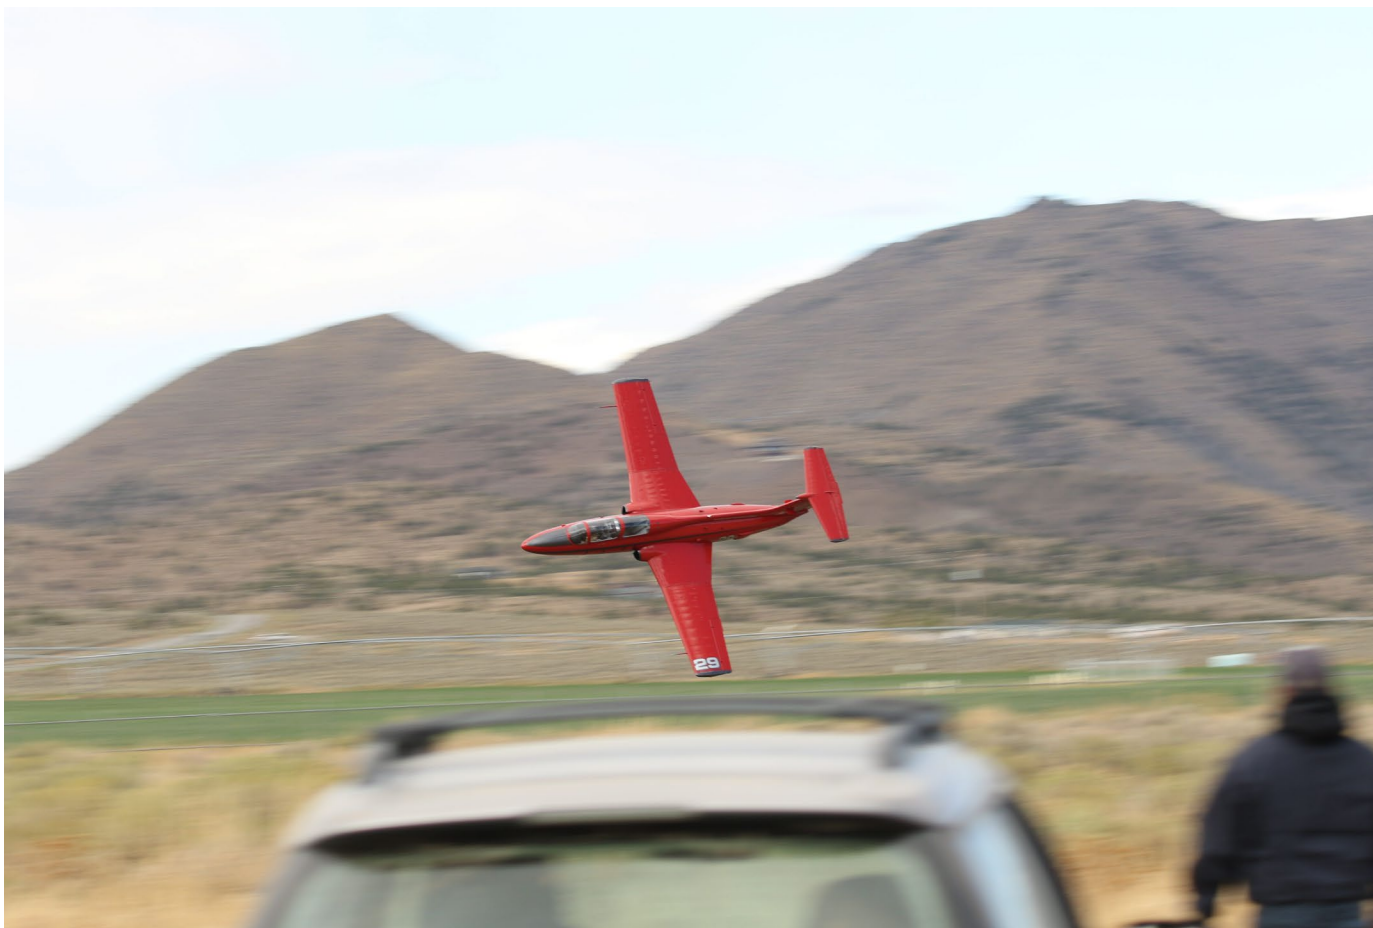
**Photograph 7 - Accident sequence photo. (Courtesy of A. Taylor)**
