# National Transportation Safety Board

WPR22FA354

## **MATERIALS LABORATORY**

Factual Report 23-050

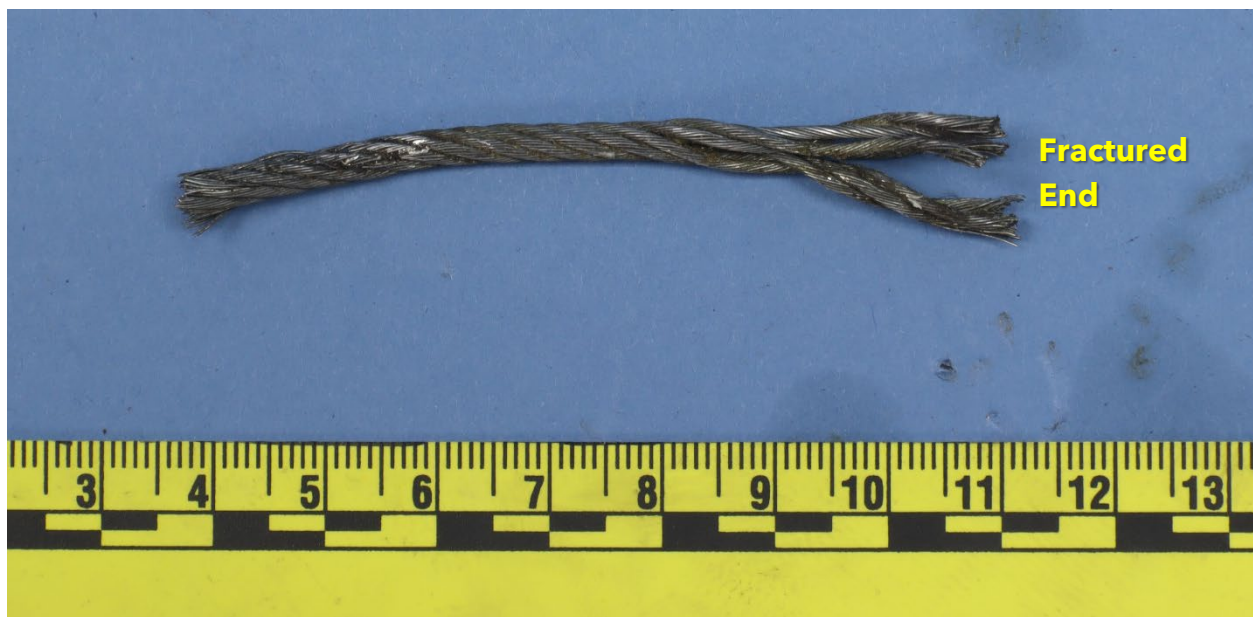
Two sections of aileron control cable were sent to the NTSB Materials Laboratory. Figure 1 illustrates the section from the left aileron control cable. The cable measured 2.87 inches long and comprised six strands with a central core. The average outer diameter of the wire measured 0.141 inches.

**Figure 1.** Section of the left aileron control cable.

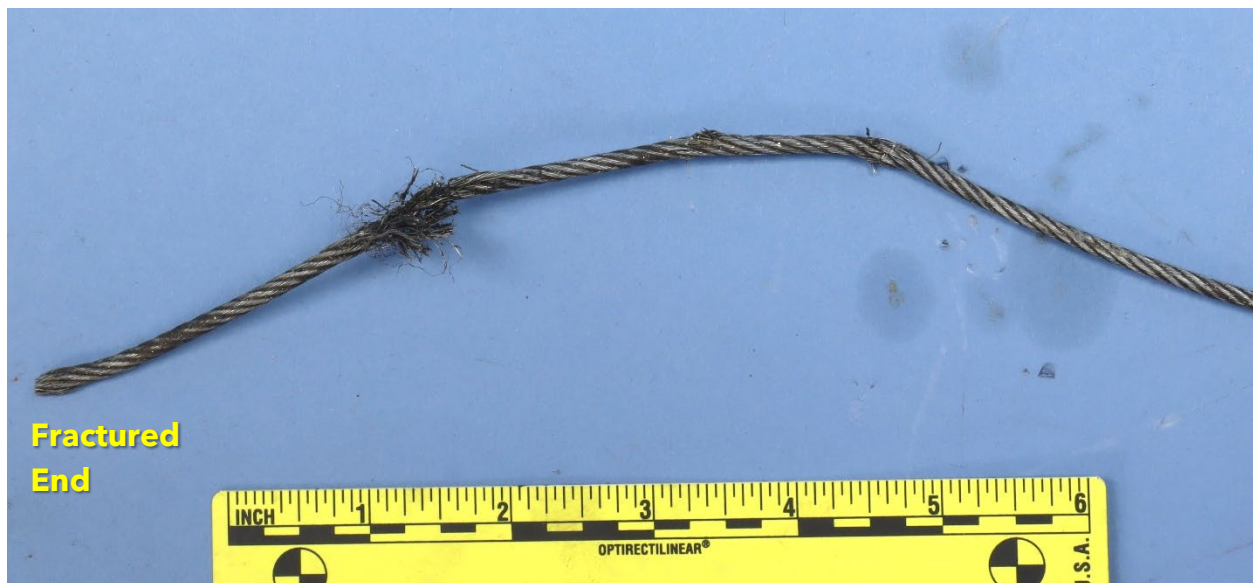
The section of the right aileron control cable is shown in Figure 2. This cable measured 8.00 inches in length, with an average outer diameter of 0.132 inches. Like the left aileron cable, the right cable comprised six strands with a central core. Unlike the right aileron cable, there was a region of frayed and deformed strands located approximately 2.75 inches from the fracture surface or 5.25 inches from the sectioned end (see Figure 3). Several wires had fractured in this area, although the wire was still intact and able to bear loads when pulled in the laboratory without continued fraying or deformation. As such, the average outer diameter of the cable between the fracture and frayed area was 0.153 inches.

**Figure 2.** The section of the right aileron control cable.

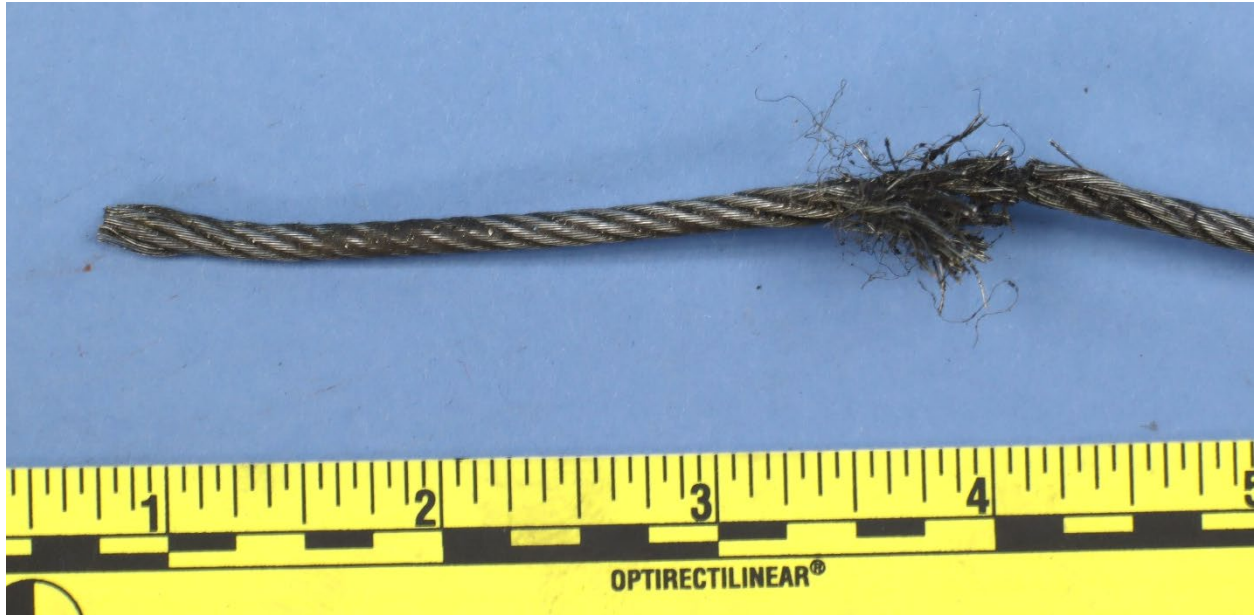
**Figure 3.** Closer view of the fractured end of the right aileron control cable from Figure 2.

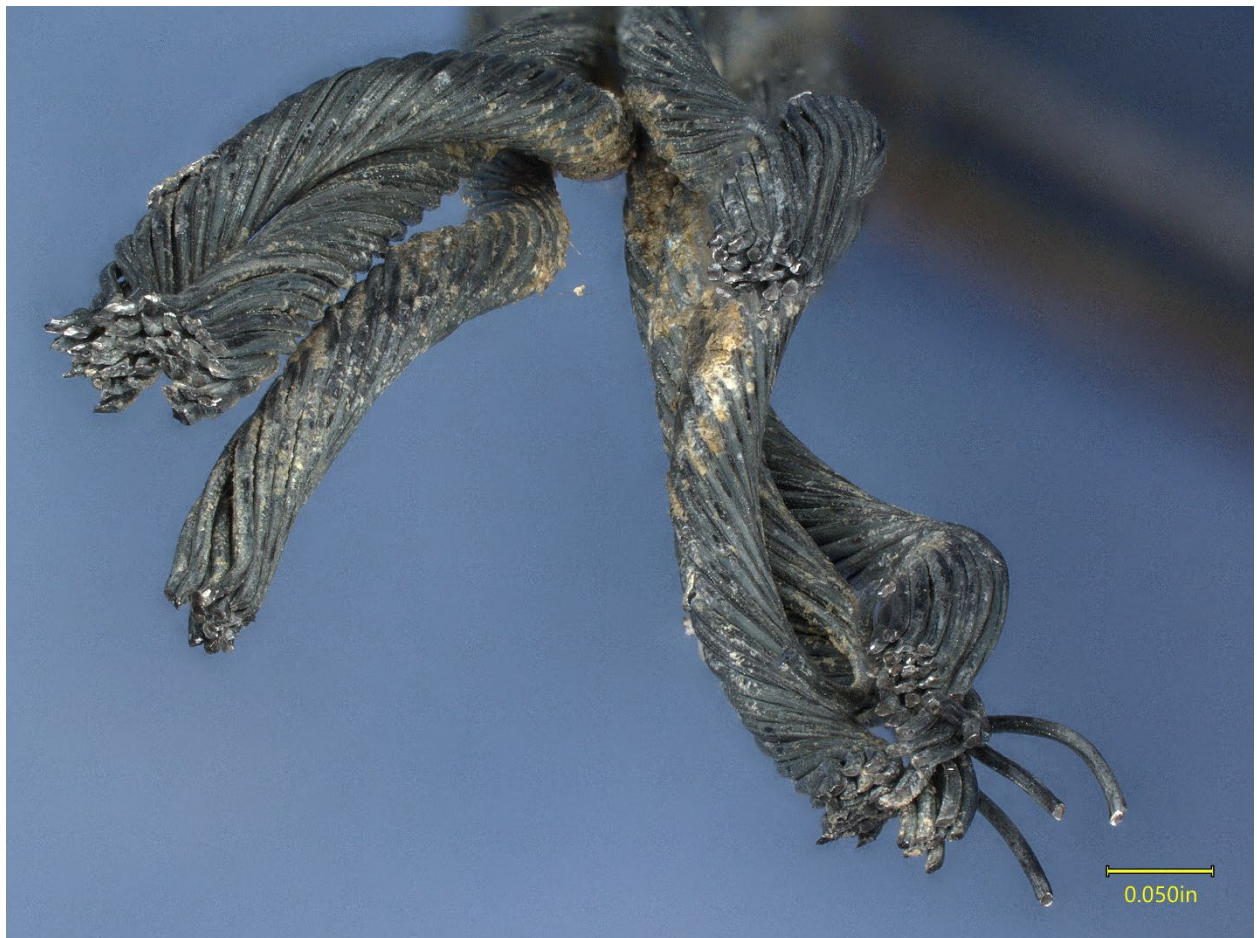
The fractured end of the left aileron cable, showing the fracture surfaces of the wires, is shown in Figure 4. The strands were labeled 1 through 5 counterclockwise for this report. Figure 5 shows the fractured ends of strands 1 and 2. These fractured wires were located consistently near each other, with no indications of longer or shorter wires in these strands.

**Figure 4.** The fractured wire ends of the strands of the left aileron cable.

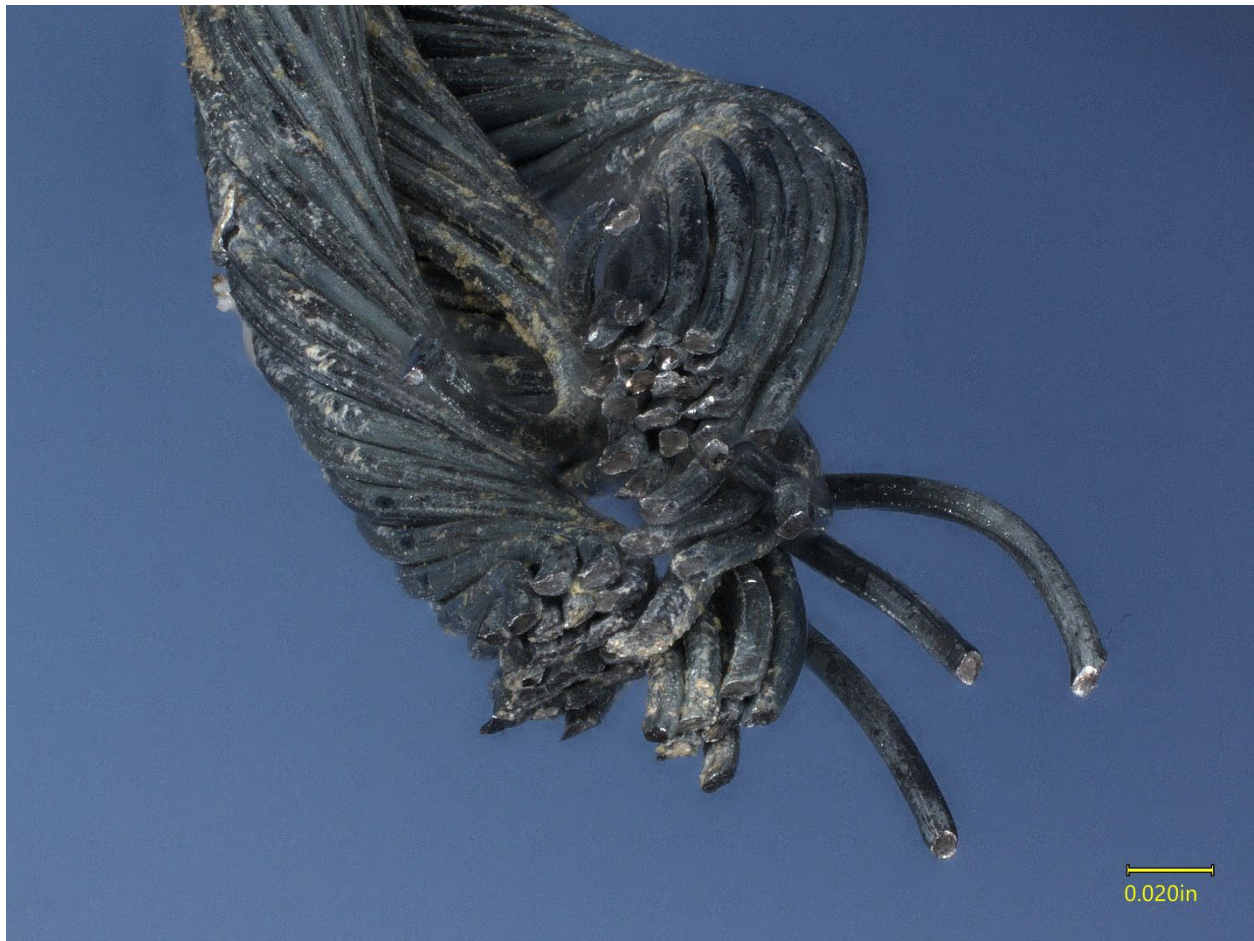
**Figure 5.** Fractured wires of strands 1 and 2 of the left aileron cable.

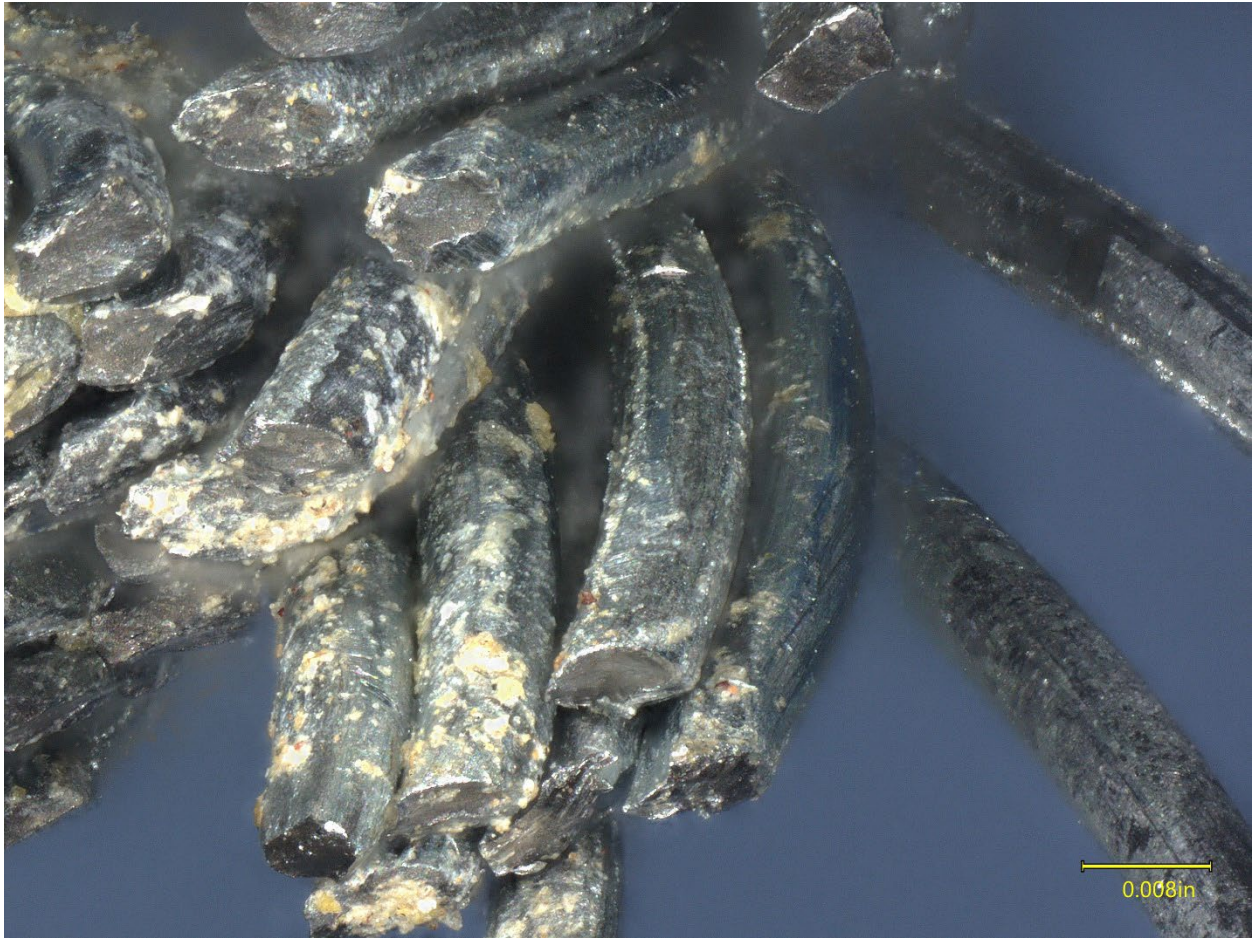
Figure 6 shows a closer view of the strand 1 wires, which exhibited a white substance on the exterior surfaces, consistent with salt deposits from marine environments. Later examination using energy-dispersive x-ray spectroscopy (EDS) found these substances to be primarily sodium, potassium, and chlorine, consistent with salt deposits. These salt deposits were removed by cleaning the wire section in an ultrasonic bath of acetone.

The wire fracture surfaces were generally slanted in orientation, with indications of necking and protruding shear lips (see the upper wire fractures in Figure 6). After cleaning, the wire fracture surfaces were more pronounced, exhibiting a dull brownish-metallic luster, in contrast to the more reflective surfaces, consistent with post-fracture smearing and impact damage (Figure 7).

**Figure 6.** Closer view of the left aileron strand 1 wire fracture surfaces.

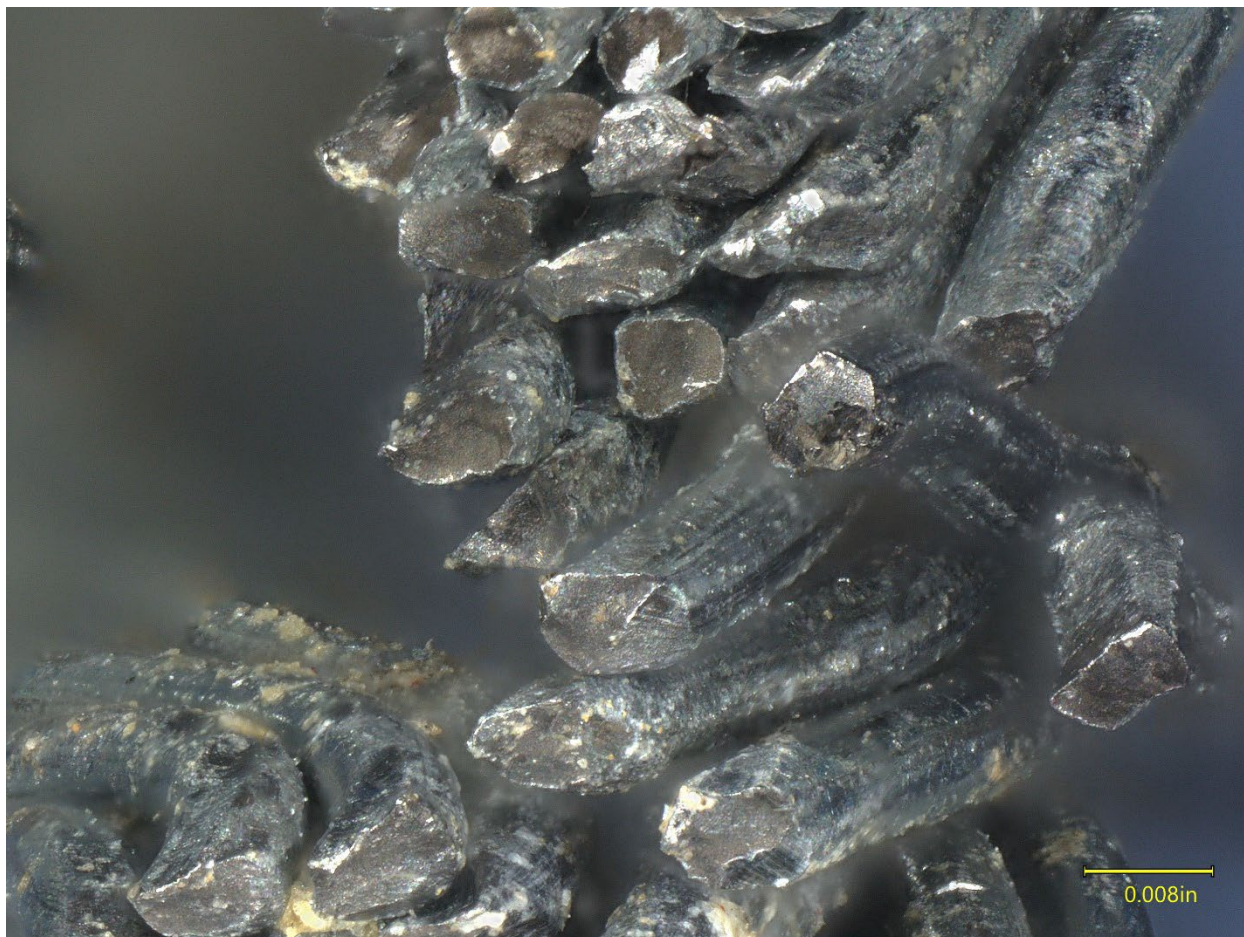
**Figure 7.** Fractured wires from strands 1 and 2 in the left aileron control cable.

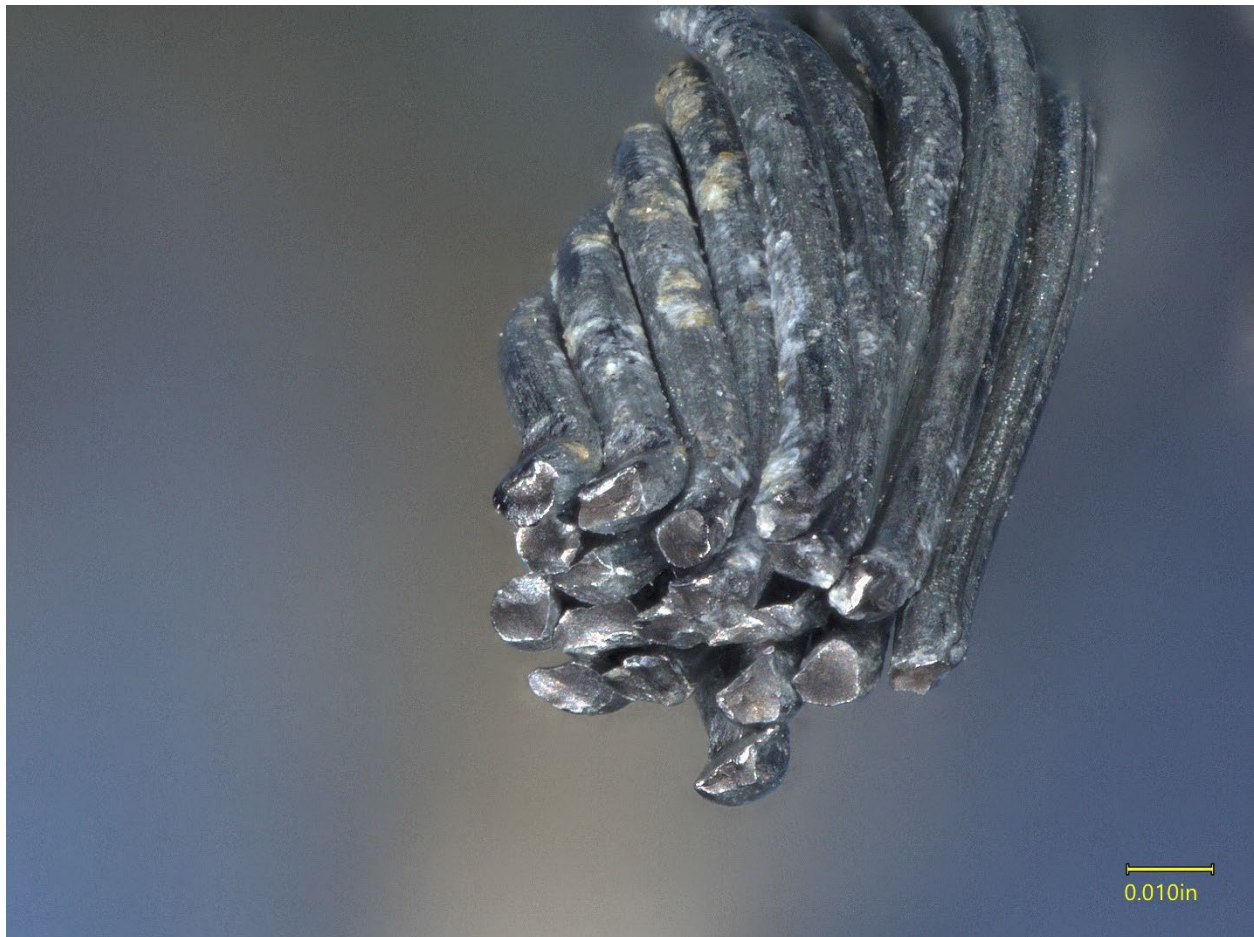
Strand 3 from the left aileron cable is shown in Figure 8. These wires had all fractured at the same location, and the strand exhibited a V-shaped downward buckle with the wire bent upward along the fracture. Some of the fractured wires showed slanted orientations, and others exhibited local thinning or necking near the fracture. A similar morphology was observed in strands 4 and 5 of the left cable, shown in Figure 9. These features on the wire fractures and strand overall were also observed in strand 6, shown in Figure 10. These fractured wires were inconsistent with the opposite, cut side of the left aileron cable, illustrated in Figure 11. This end exhibited a reflective luster, with flat, streaky features consistent across almost all wires.

**Figure 8.** View of the fractured wire ends of strand 3 from the left cable.

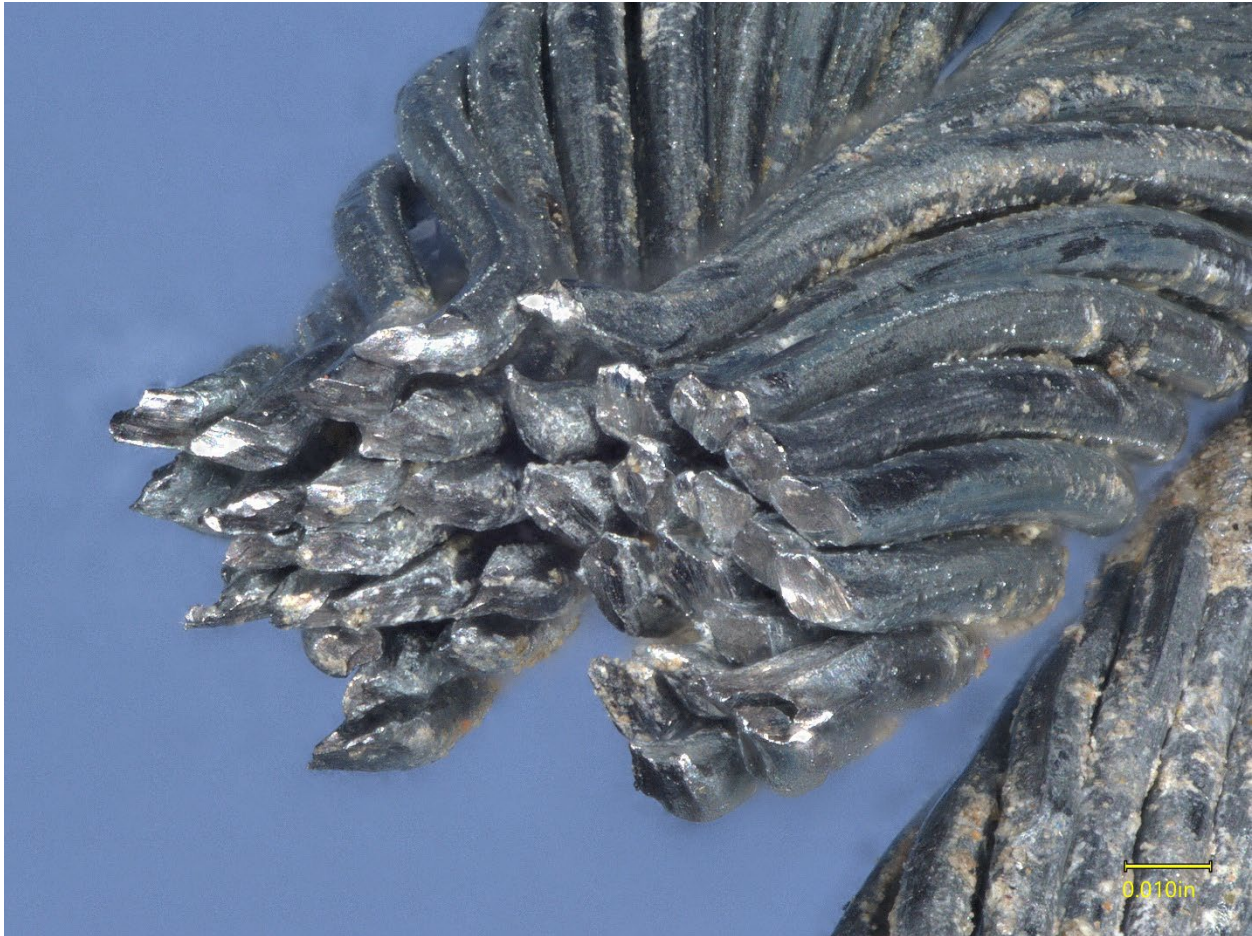
**Figure 9.** Slanted fracture surfaces of the wires from strands 4 and 5 from the left aileron control cable.

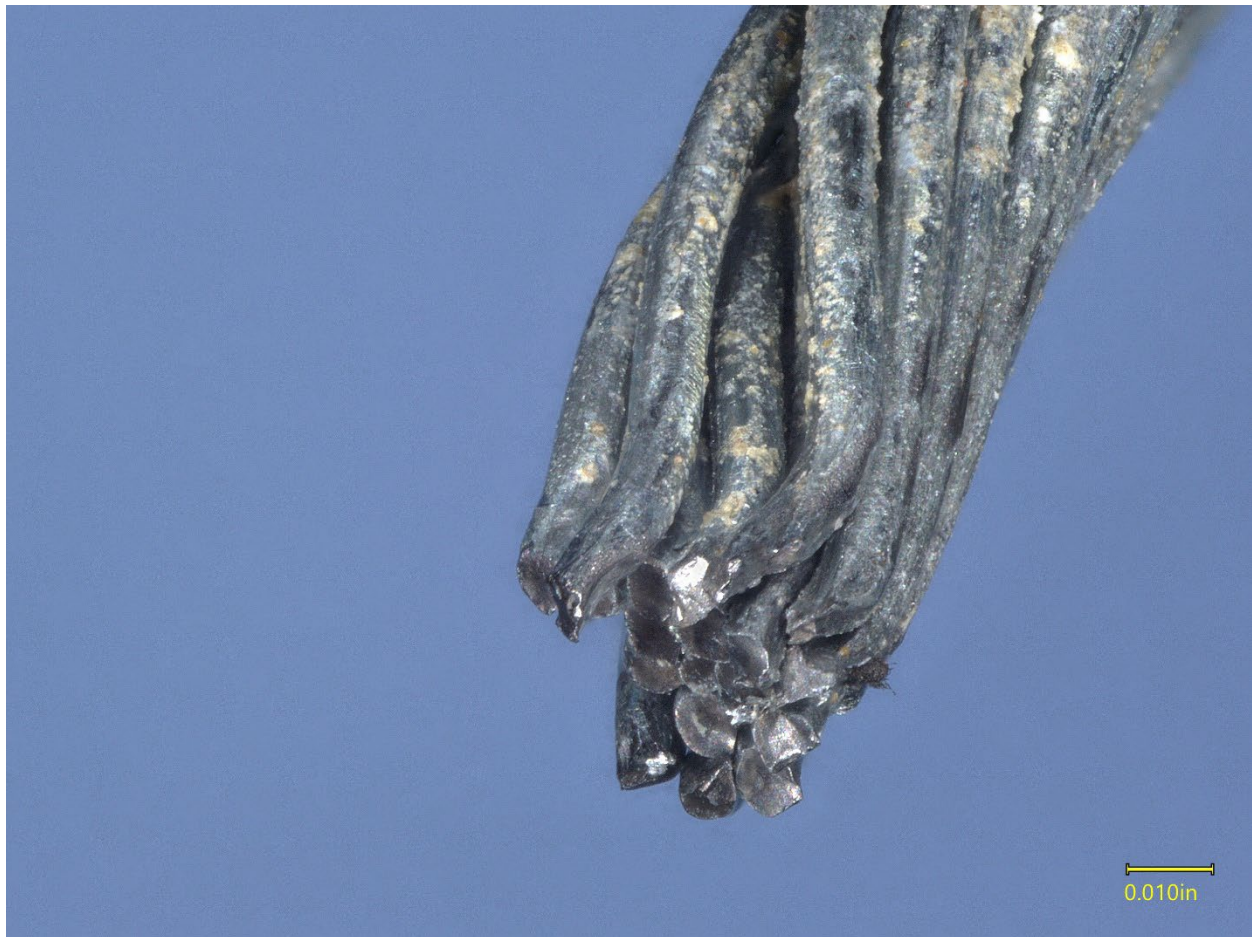
**Figure 10.** View of the fracture surfaces of the strand 6 wires from the left cable.

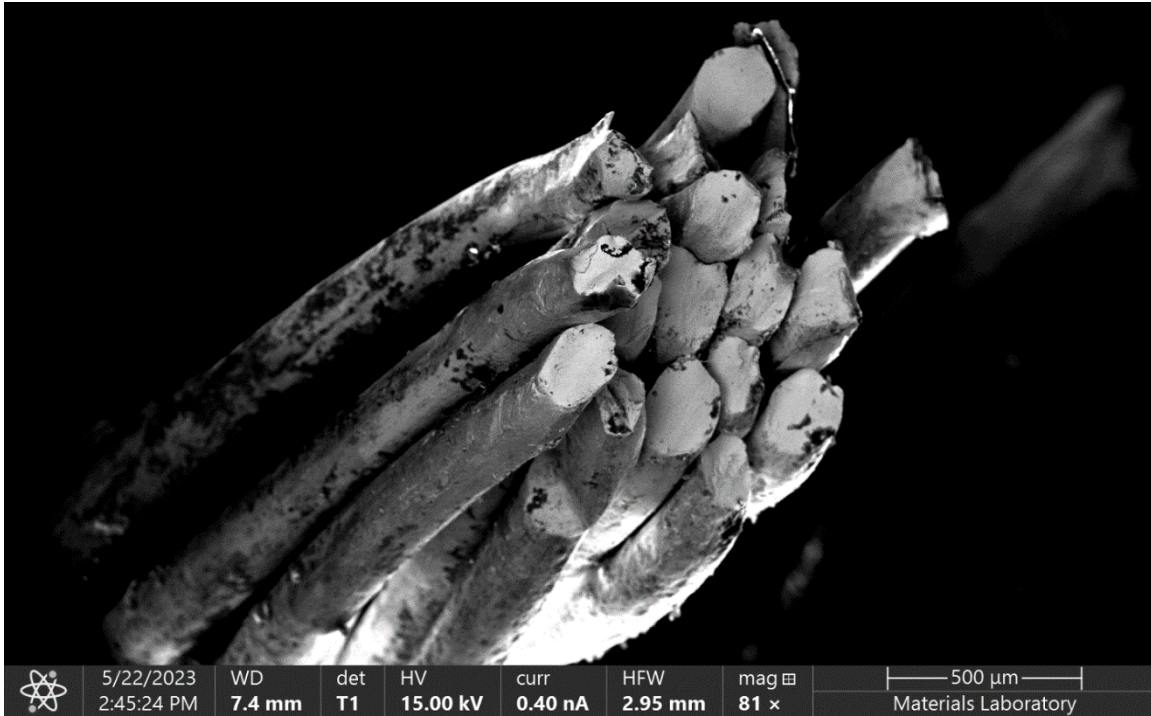
The fractured wire ends from the left aileron cable were examined using a field emission scanning electron microscope (SEM). The fracture surfaces of the wires from strand 3 are illustrated in Figure 12. As shown in the figure, the location of the wires' fracture surfaces was consistent with each other.

**Figure 12.** Backscattered electron (BE) micrograph of strand 3 fractured wire surfaces from the left cable.

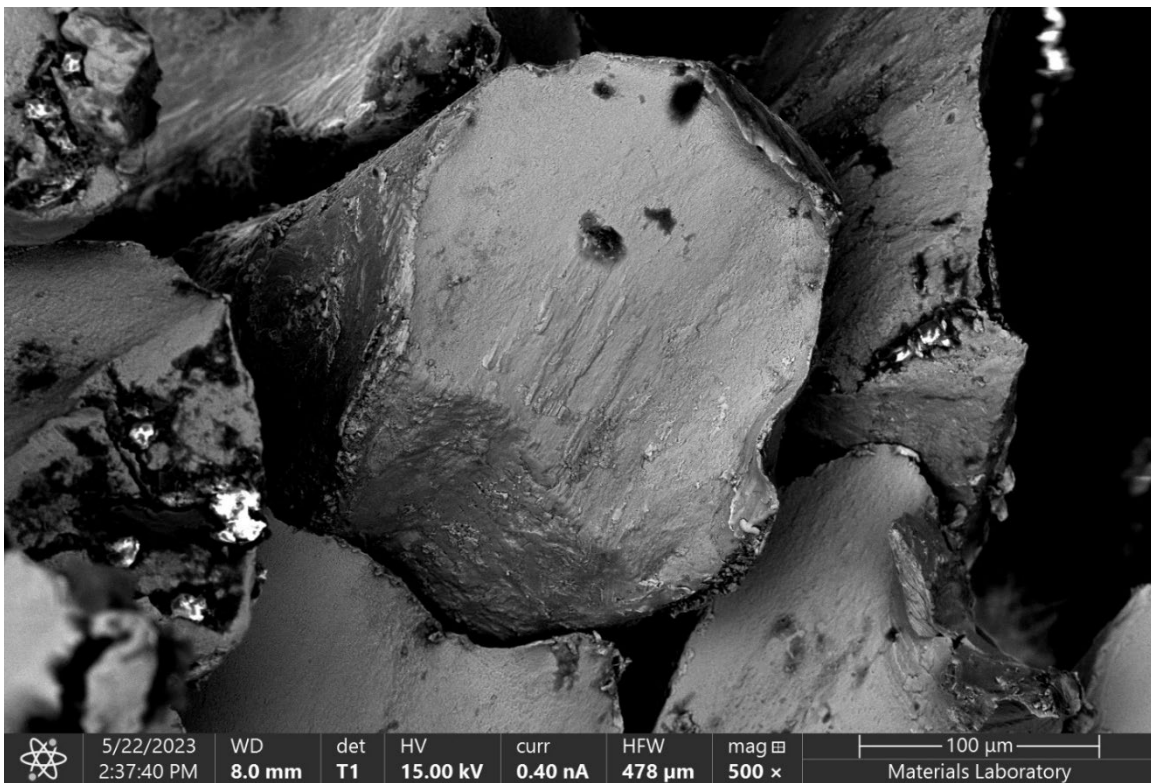
Figure 13 shows a closer view of one of the center wire fractures. The surface exhibited two slanted surfaces, with protrusions along the periphery of the fracture edges. The adjacent fractured wire in the lower left mirrored the lower left diagonal areas of the fracture surface. A closer view of this fracture surface, shown in Figure 14, revealed dimpled rupture, consistent with overstress fracture of the wire.

**Figure 13.** BE micrograph of a typical fractured wire in strand 3 from the left cable.

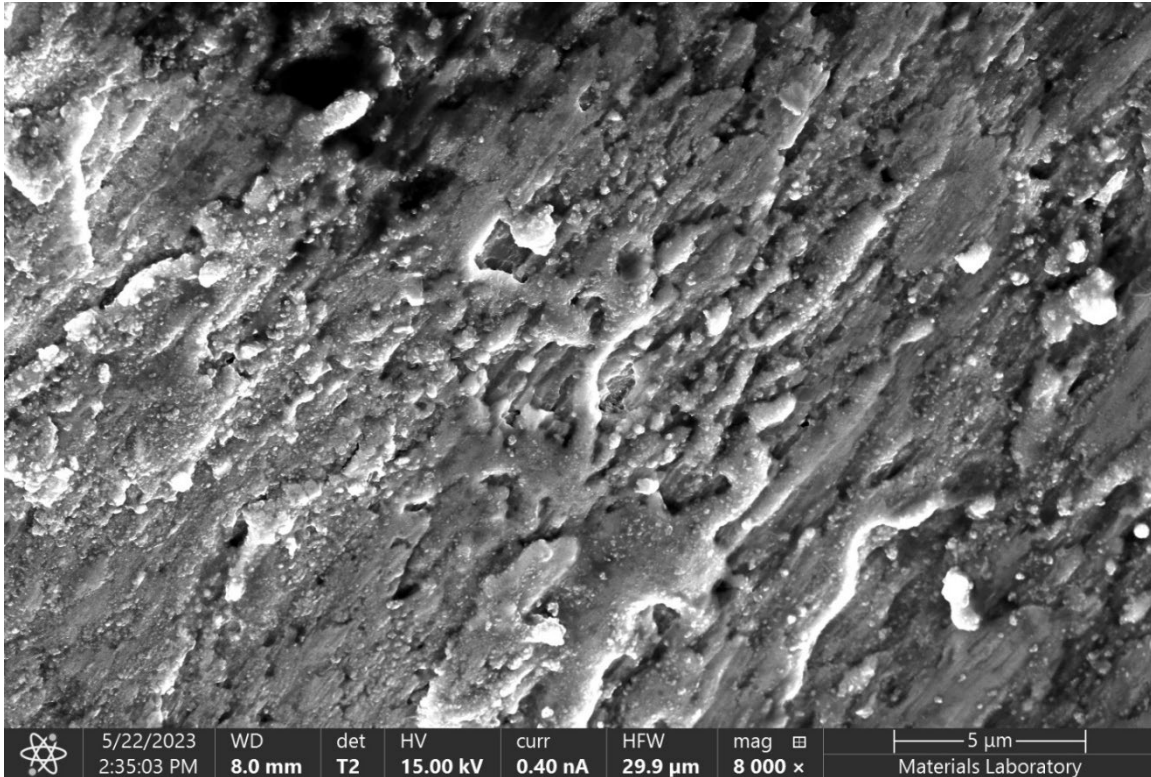
**Figure 14.** Secondary electron (SE) micrograph of a closer view of the fracture surface in **Figure 13**.

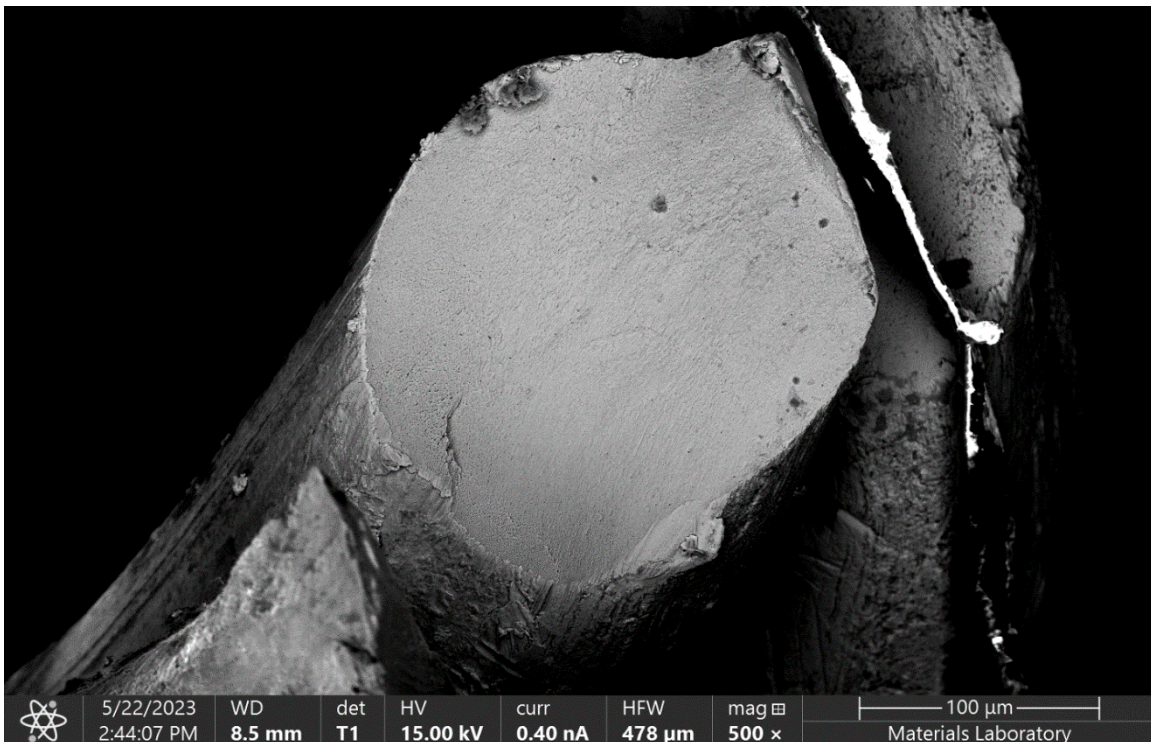
Likewise, Figure 15 illustrates another fractured wire with a distinct slant-oriented surface. The upper right of the figure exhibited a protrusion consistent with a shear lip, which folded back towards the fracture surface. The surface exhibited river

patterns consistent with fracture from the bottom of the figure towards the upper right. The area of initiation, shown in Figure 16, displays flow marks upward and a flatter edge. A closer view of this area revealed a slanted dimpled rupture, consistent with shear overstress of the wire (Figure 17). These features were consistent along the wire fracture surface.

**Figure 15.** BE micrograph of a second wire from the strand 3 in **Figure 12**.

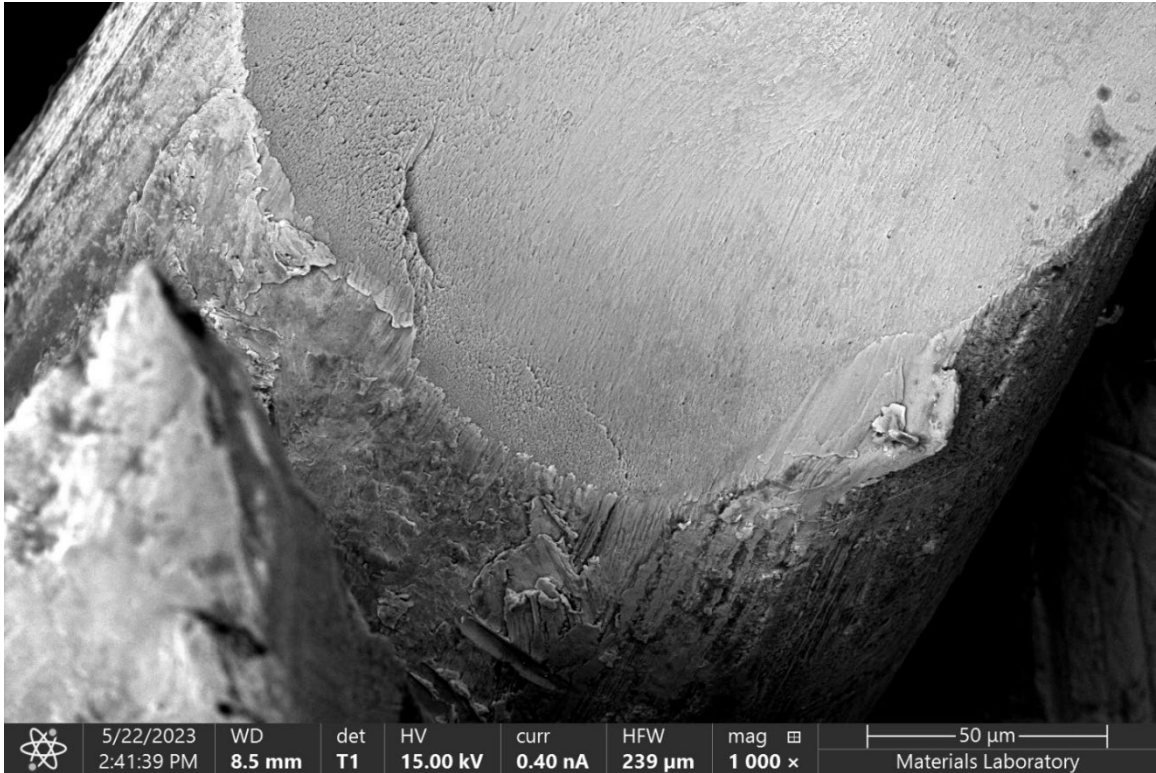
**Figure 16.** BE micrograph of the fracture edge of the wire in **Figure 15**.

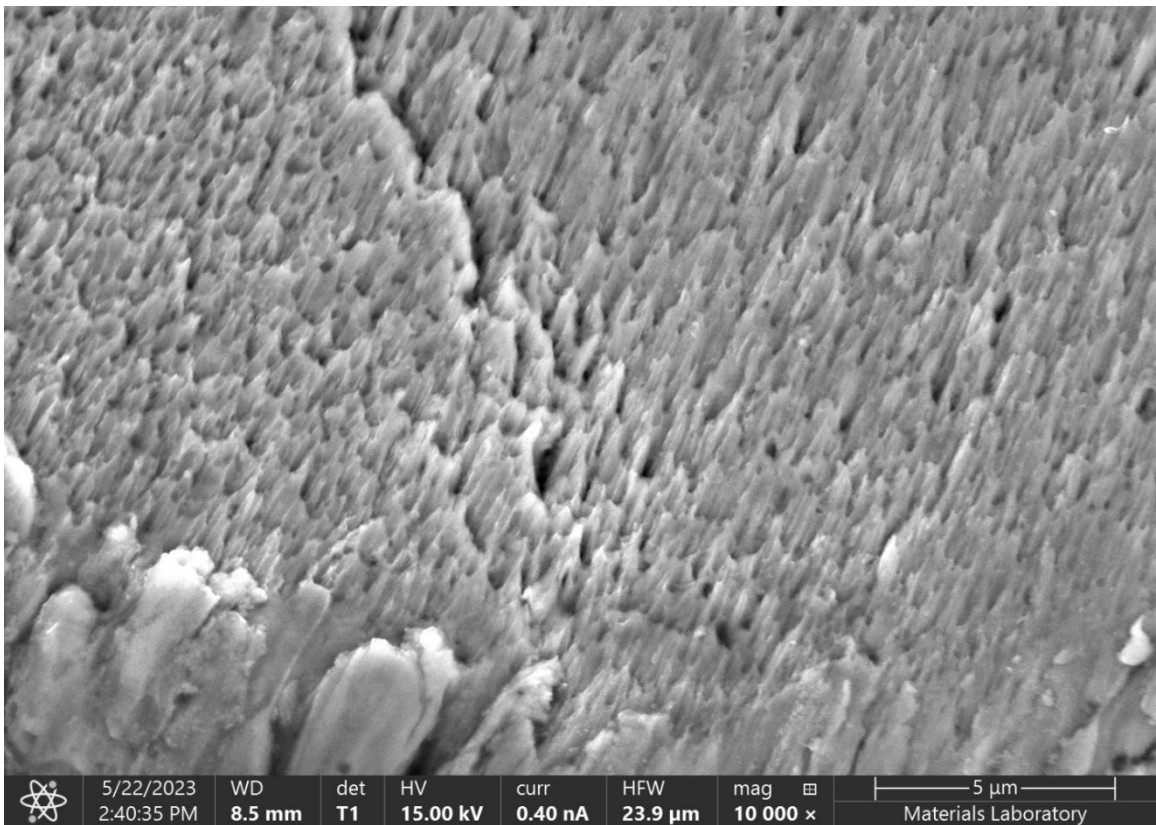
**Figure 17.** BE micrograph of slanted dimple rupture on the area in **Figure 16**.

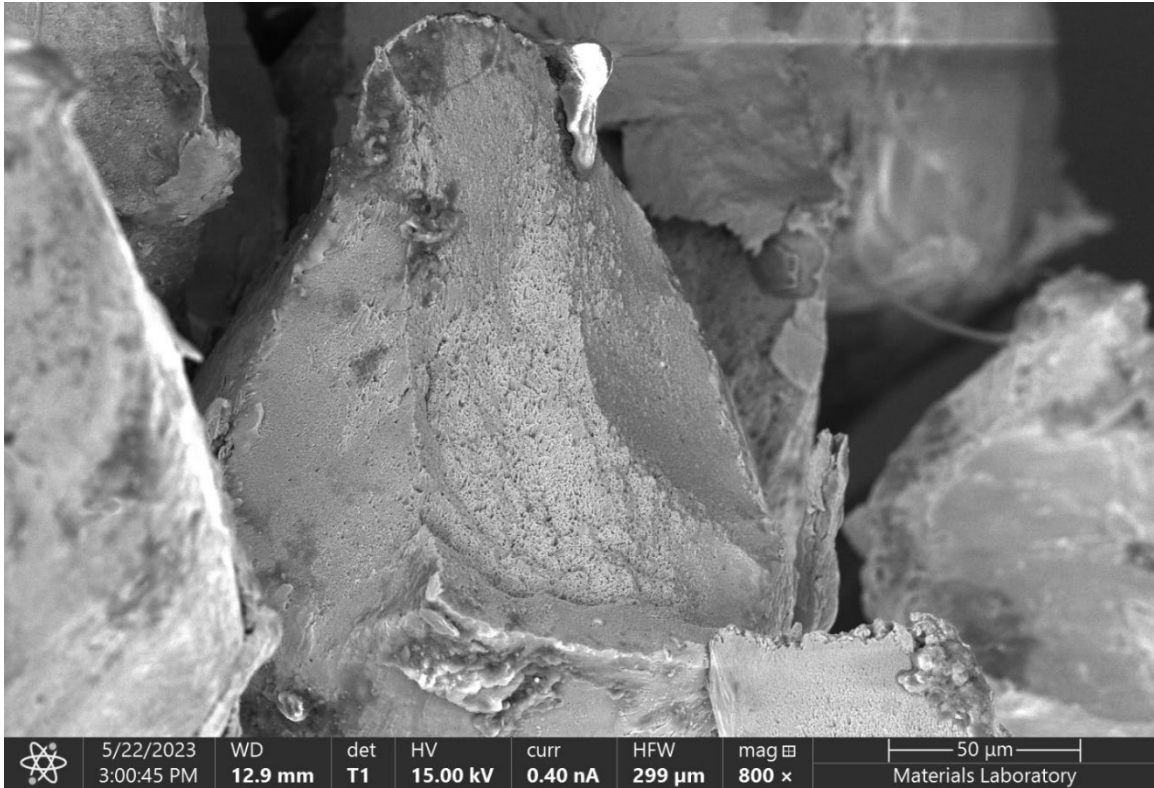
Figure 18 shows an angled wire from strand 5. This surface exhibited an upward apex along the center of the fracture surface, with a smaller perpendicular ridge along the edge on the bottom of the figure. Examination of the ridge and the rest of the fracture surface revealed dimpled rupture, as shown in Figure 19. Similar wire fracture features and orientations were prevalent on those wires in strands 4 and 5, shown in Figure 20. Figure 21 shows a fractured wire with two opposite-facing outer slanted surfaces and outward deformation at 90° to the surfaces on the top and bottom of the figure. Examination of the fracture surface, illustrated in Figure 22, showed slanted dimpled rupture or indications of post-fracture damage (smearing). No other features were observed on the fracture wires of the left aileron control cable.

**Figure 18.** BE micrograph of angled fractured wires from strand 5 of the left cable.

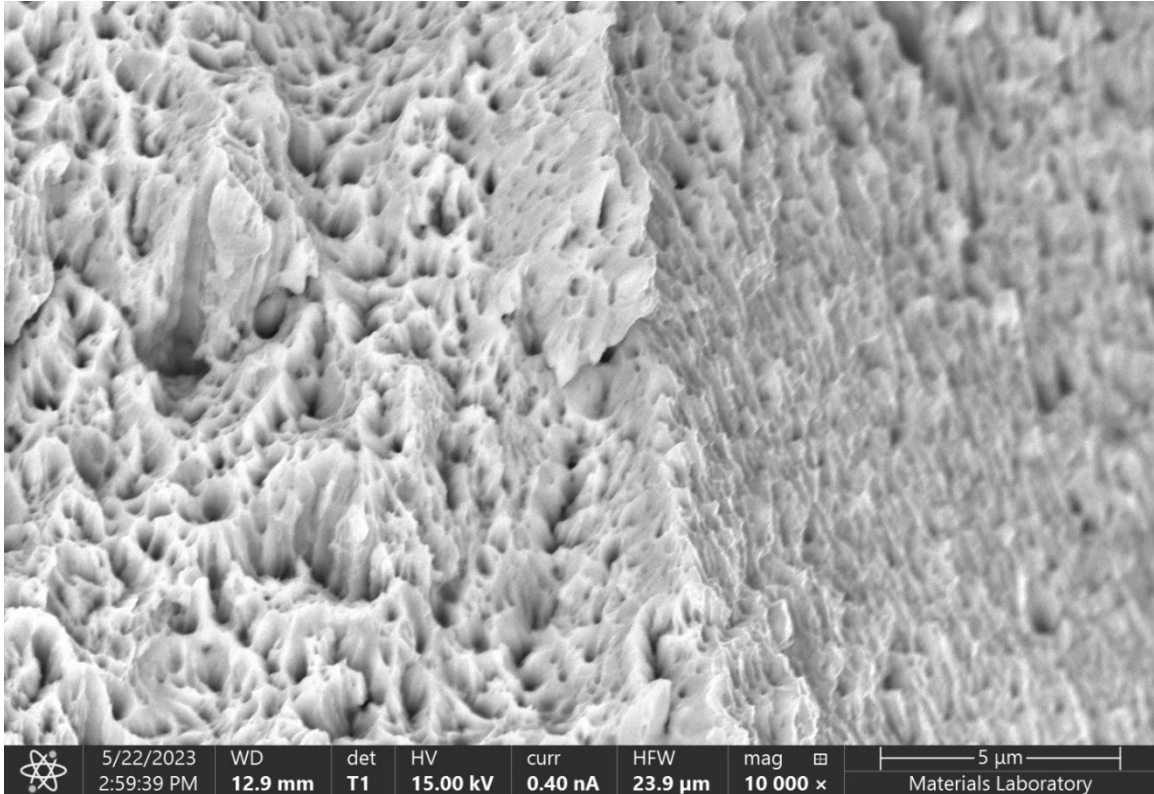
**Figure 19.** BE micrograph of the wire ridge in **Figure 18**, showing dimpled rupture.

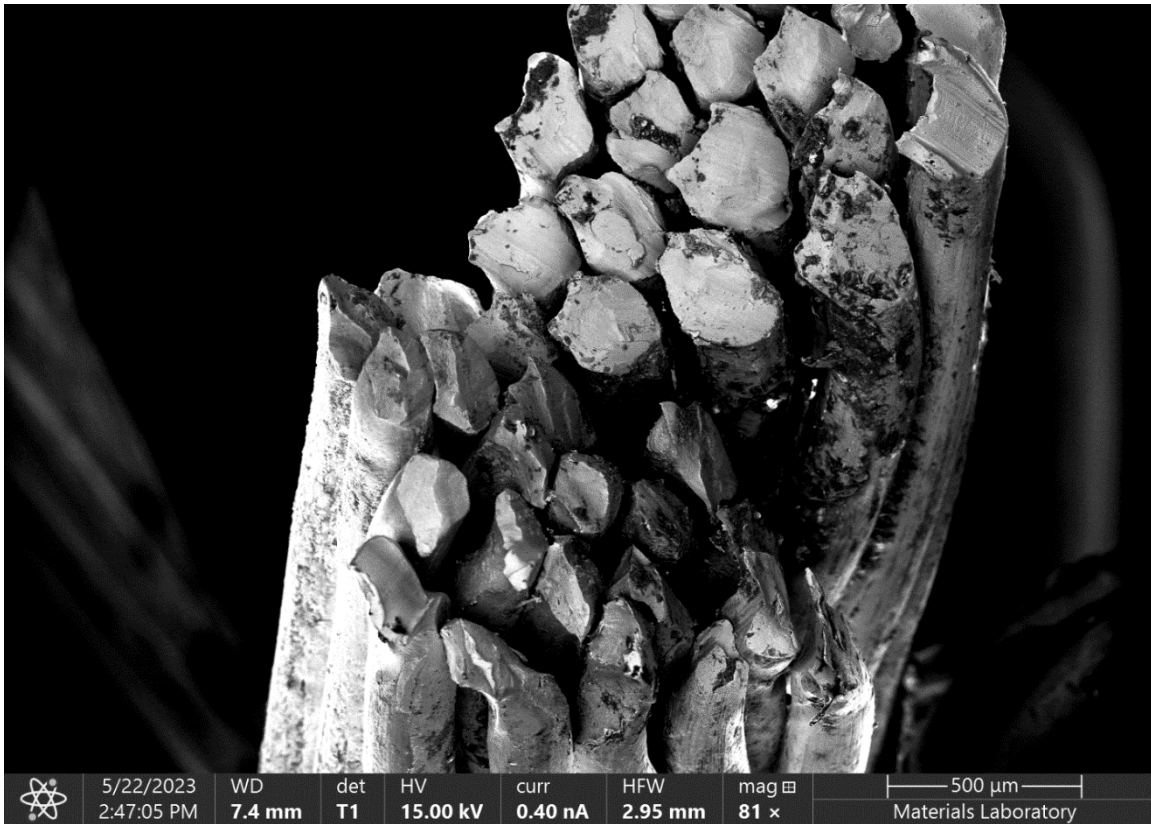
**Figure 20.** BE micrograph of the fourth and fifth wire strands from the left cable.

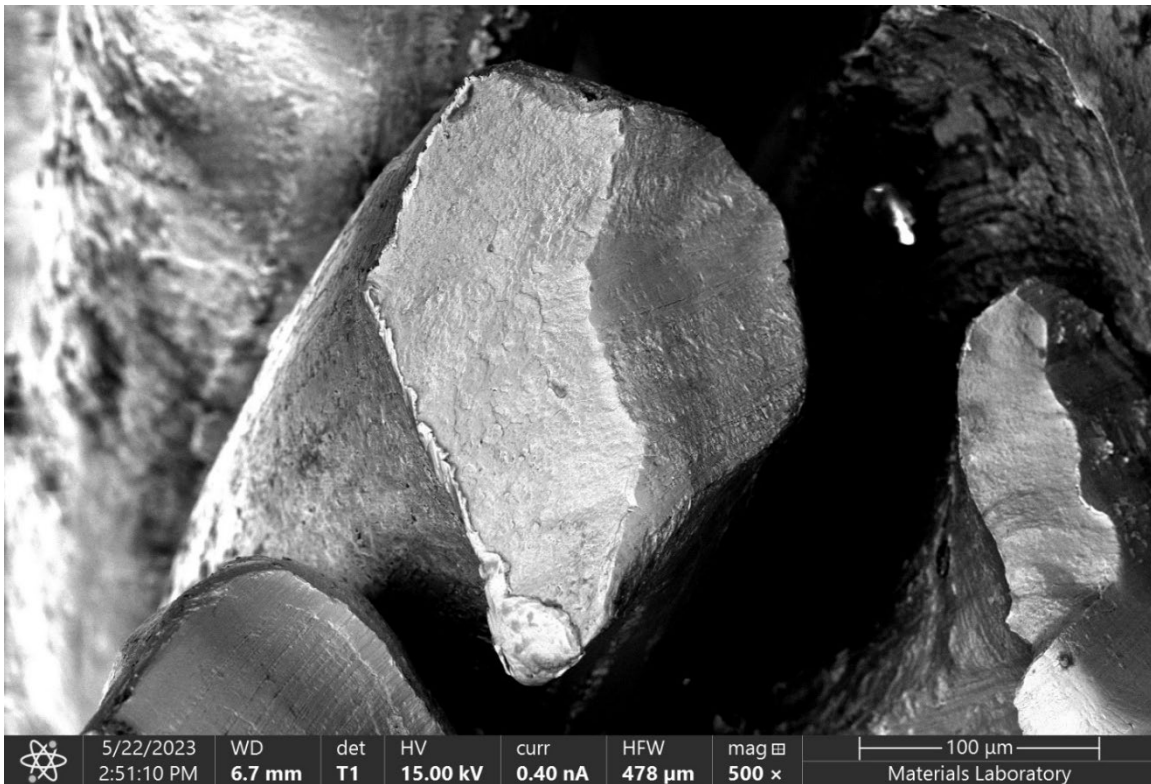
**Figure 21.** BE micrograph of a deformed wire from Strand 4 in **Figure 20**.

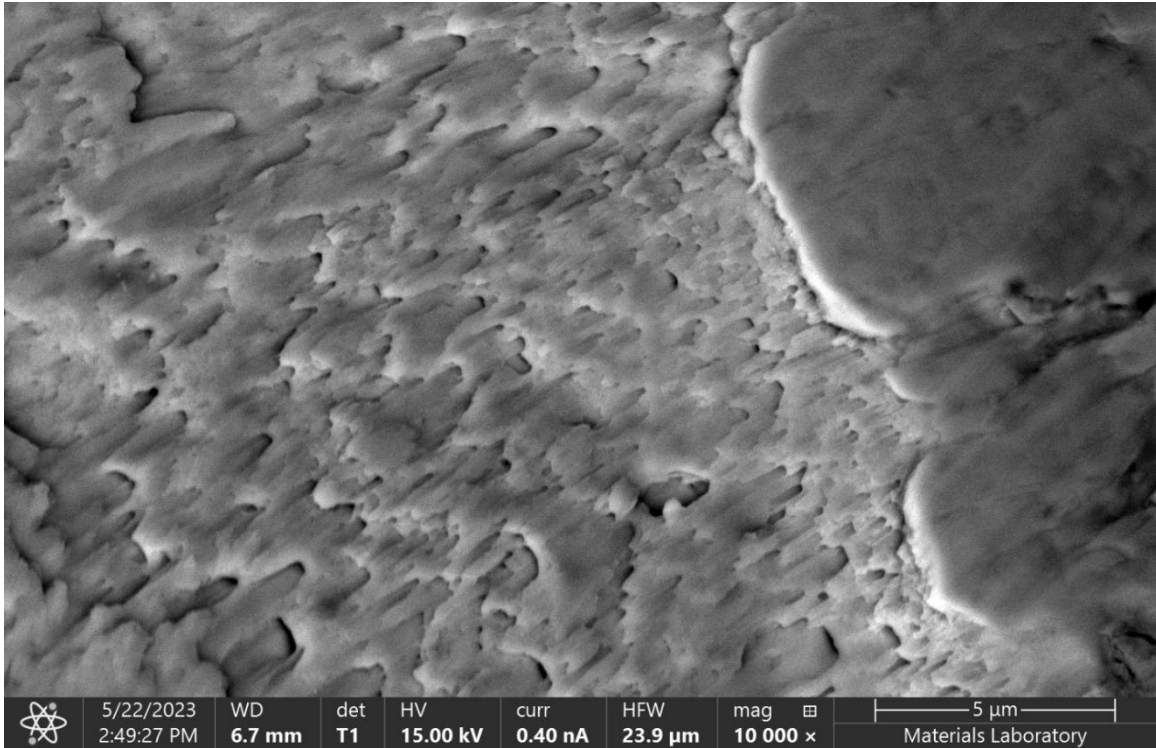
**Figure 22.** BE micrograph of slanted dimpled rupture from the left half of the wire in Figure 21.
