# National Transportation Safety Board

WPR22FA354

## **MATERIALS LABORATORY**

Factual Report 23-050

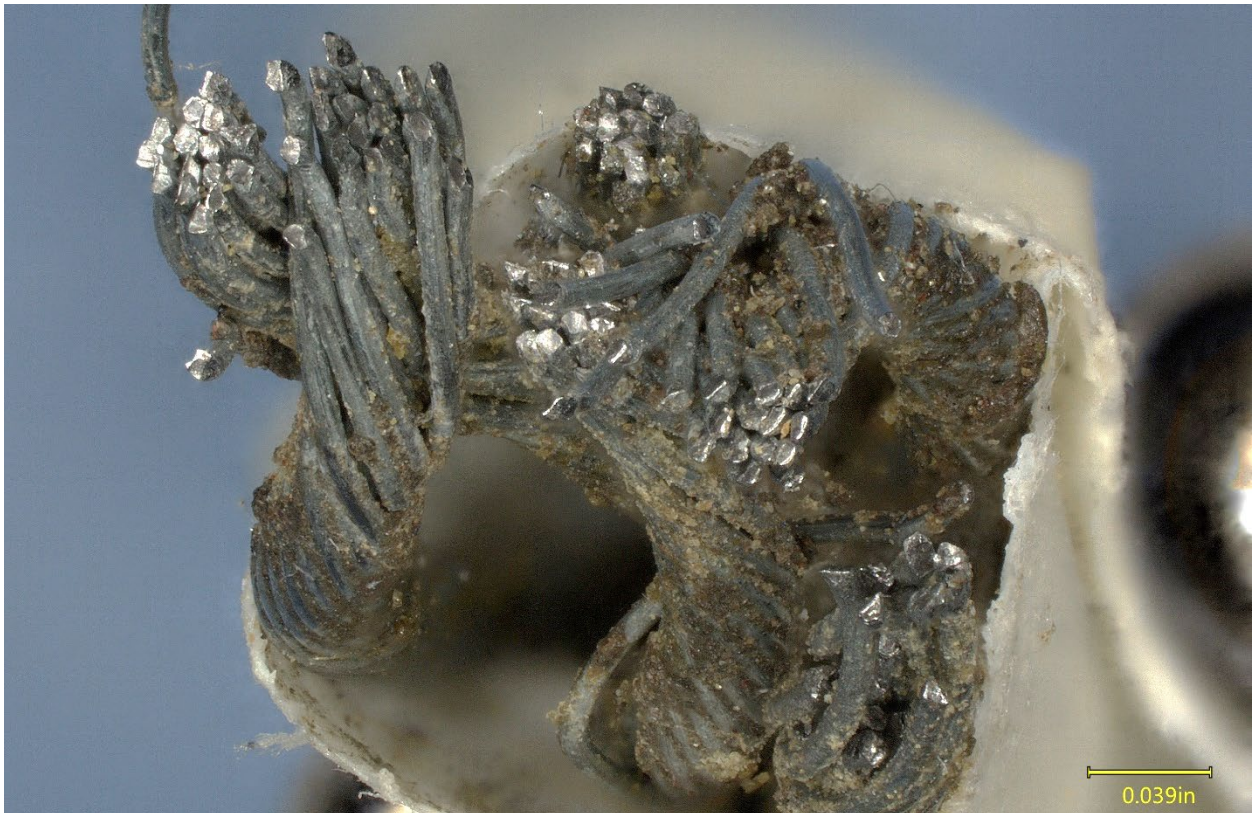
Figure 23 illustrates the fractured wires of the right aileron cable as received. Like the left aileron control cable, the wire fractures were generally located in the same area, with no wires significantly longer or shorter than the others. This end did exhibit some strands that had bent outward, as demonstrated in the figure. The strands were also labeled 1 through 6 counterclockwise in Figure 23 for this report.

**Figure 23.** The fractured end of the right aileron cable, showing the fractured wires.

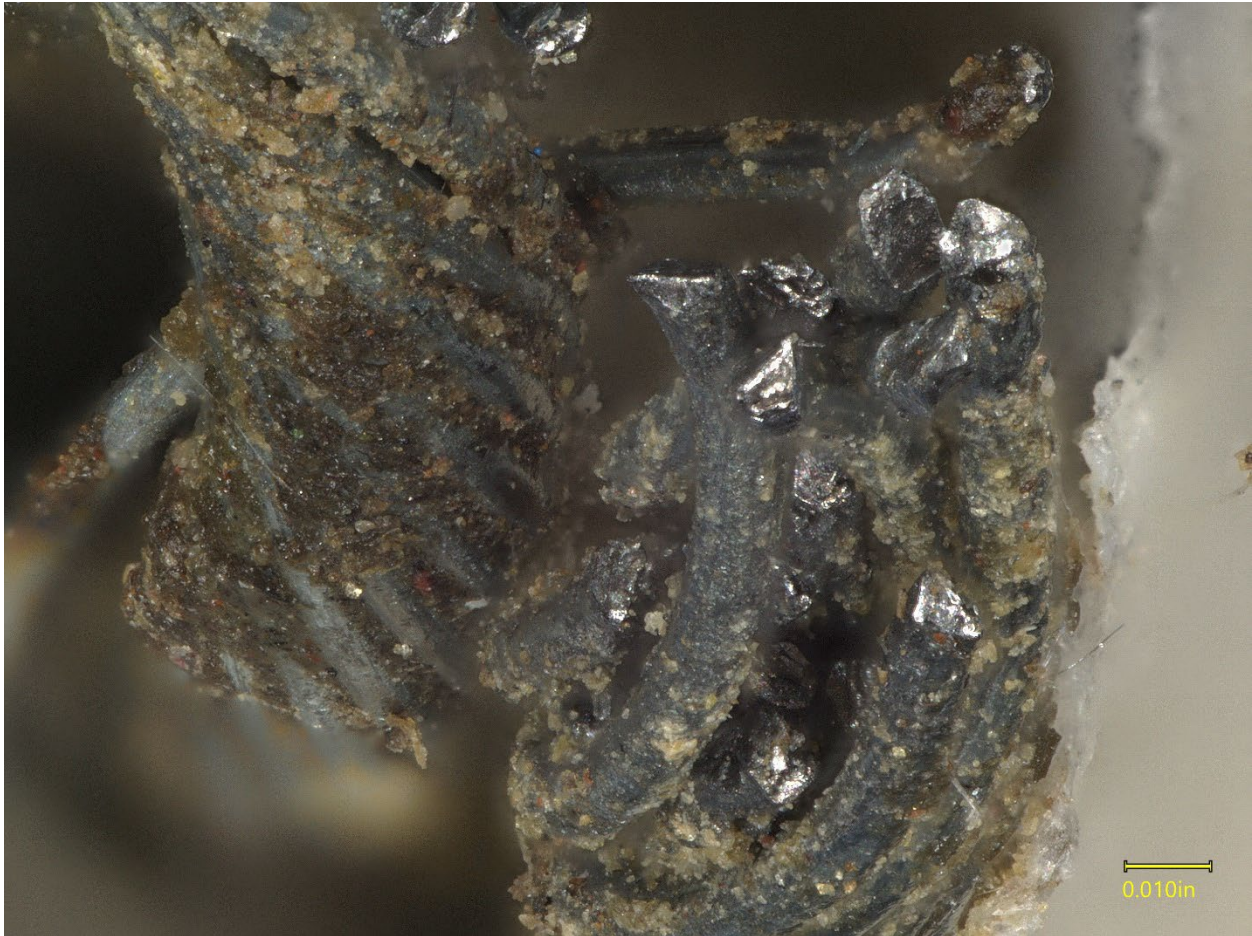
Figure 24 shows a closer view of strand 1 and some of strand 2 from the right aileron cable. The wires did exhibit a blocky, brownish material on the surface, later determined to be consistent with the salt deposits discussed earlier. The other strands of fractured wires from the right aileron cable are illustrated in Figures 25 and 26. These wires exhibited consistent fracture features, as detailed below.

**Figure 24.** Closer view of fractured wires of strand 1 from the right aileron cable.

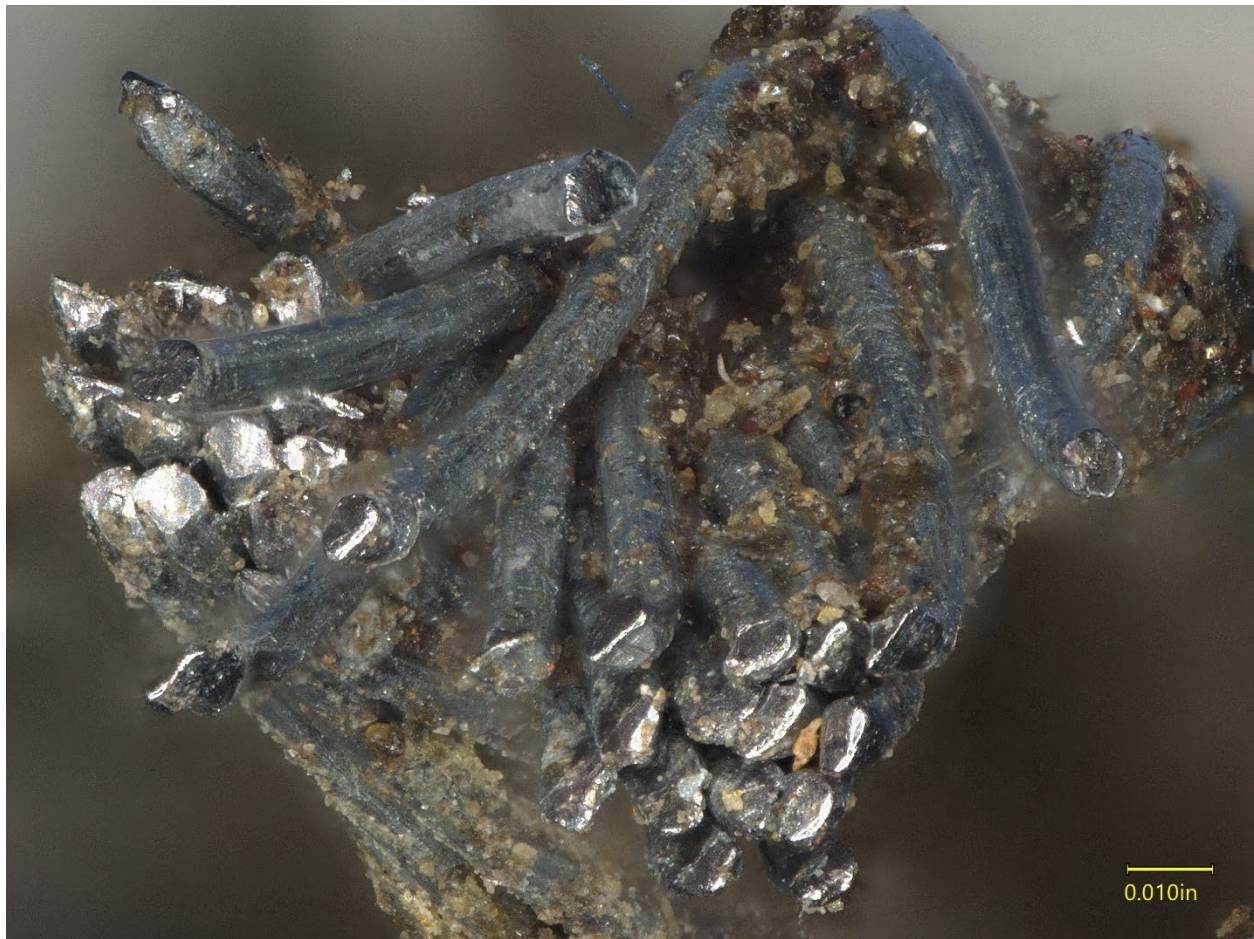
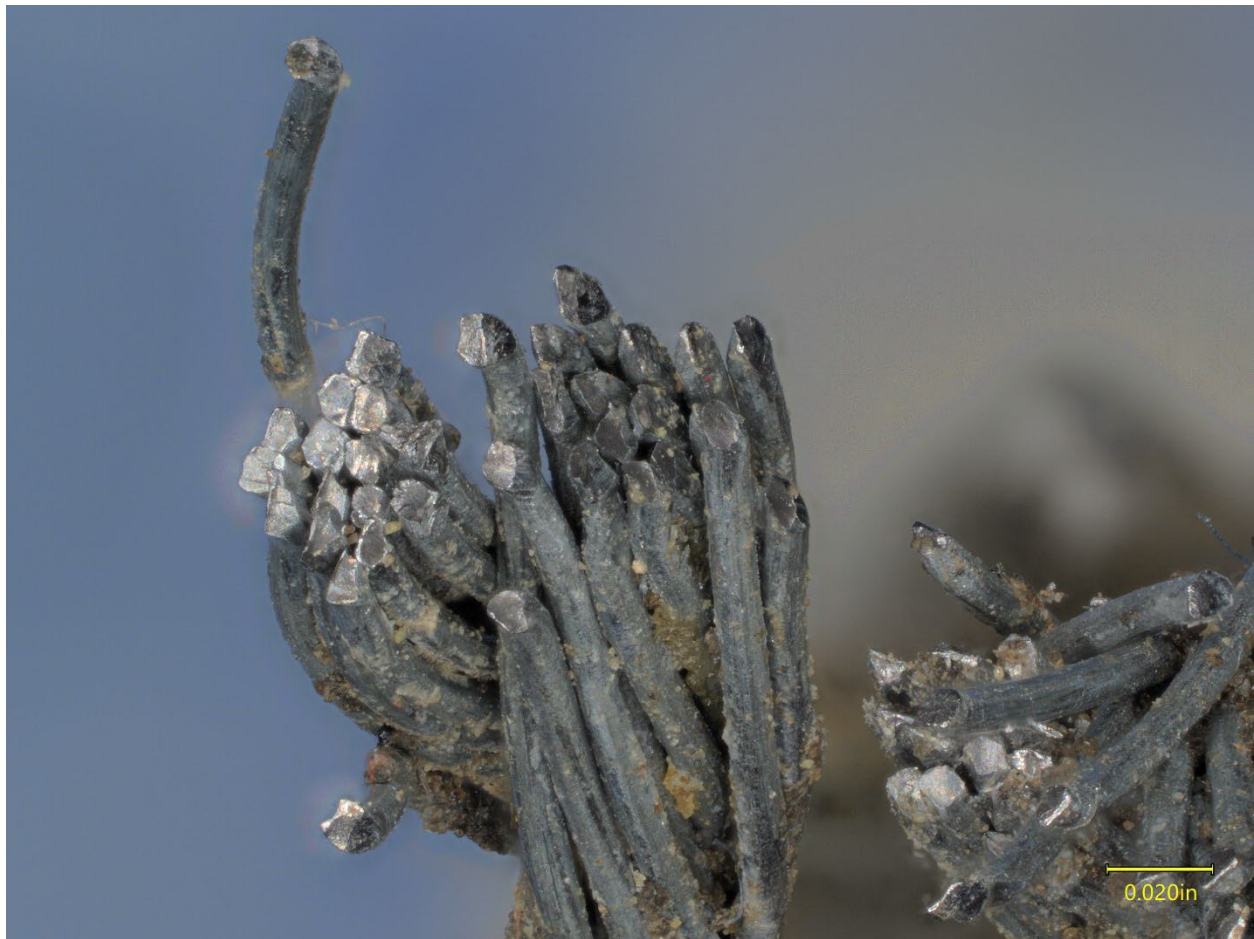
**Figure 25.** The fractured ends of strands 2 and 3 from the right aileron cable.

**Figure 26.** The fractured ends of strands 5 and 6 from the right aileron cable.

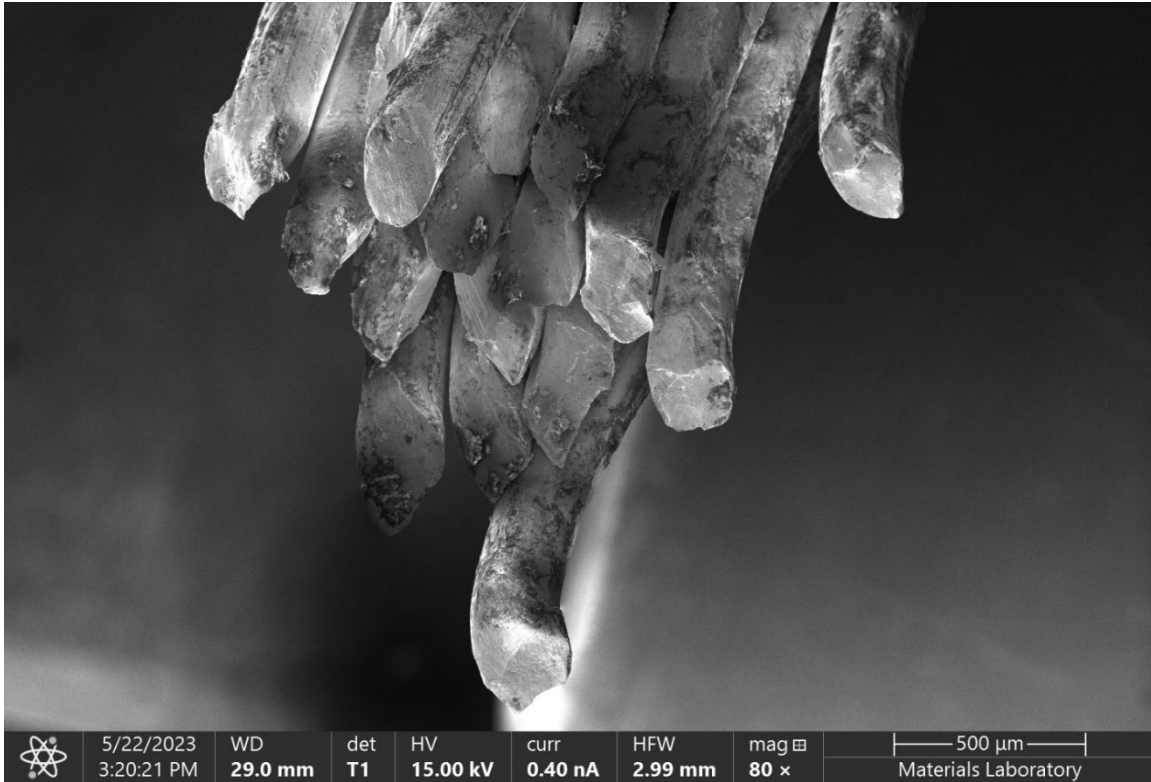
The right aileron control cable fracture was cleaned in an ultrasonic bath with acetone and examined using a field-emission SEM. Figure 27 shows some of the wires from strand 5, which exhibited fracture surfaces slanted in orientation. Figure 28 shows a closer view of one of the fractured wires, displaying protruding shear lips along the right and bottom edges, with an area of post-fracture smearing in the upper left. The overall undamaged fracture surface exhibited parallel linear features towards the lower right. A closer view found these features to be dimpled rupture, oriented along the grain direction consistent with the wire drawing direction.

**Figure 27.** BE micrograph of the fractured wire ends of strand 5 from the right cable.

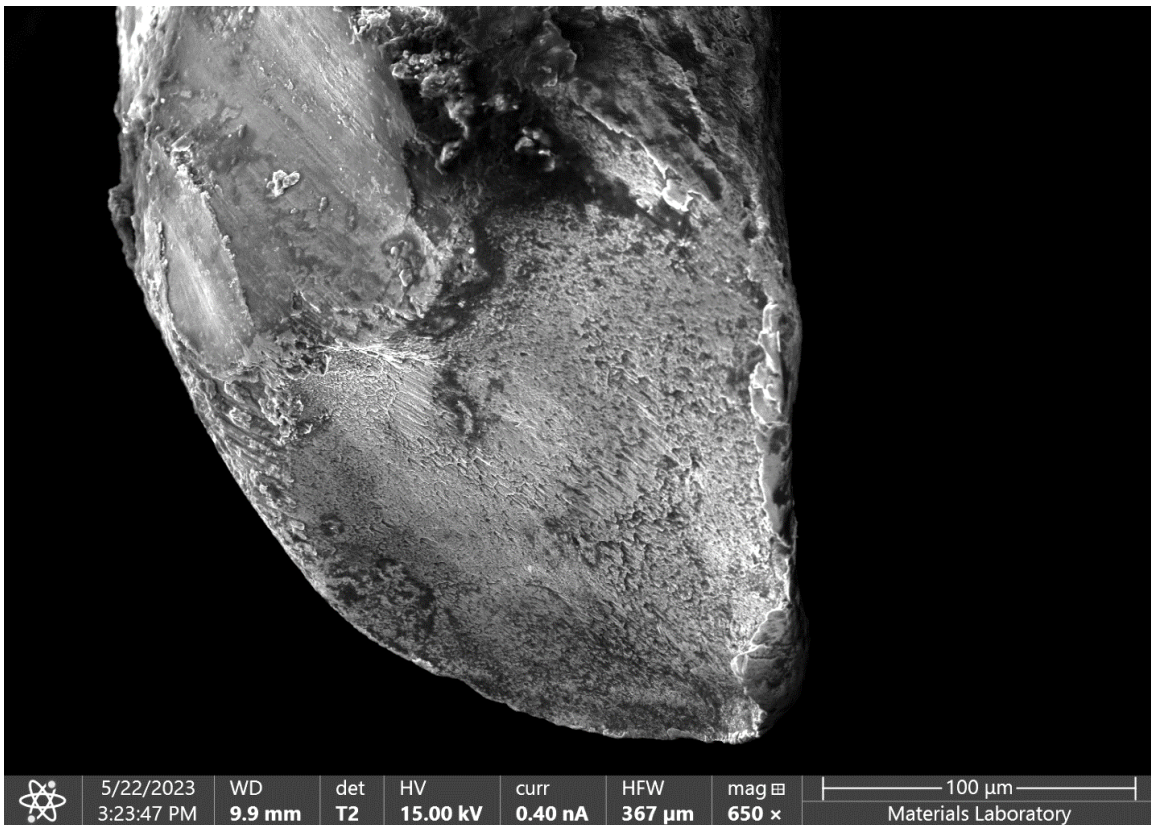
**Figure 28.** SE micrograph of the center left wire from strand 5 in **Figure 27**.

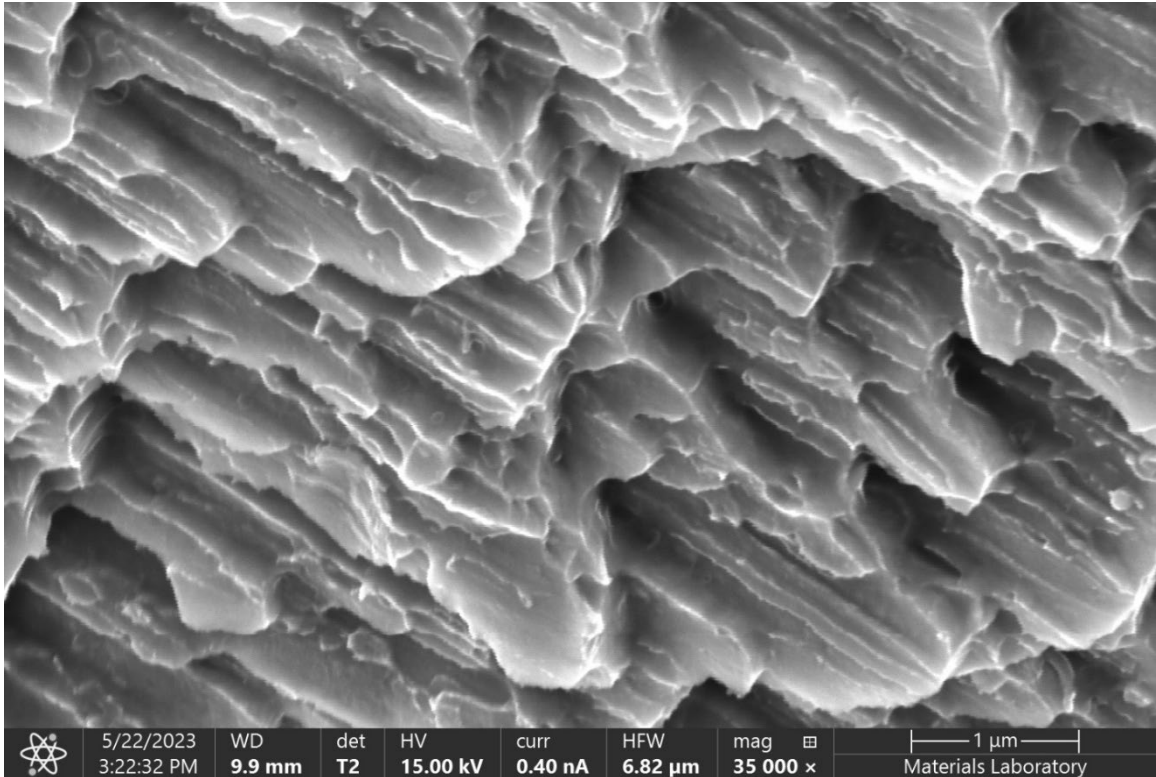
**Figure 29.** BE micrograph of dimpled rupture features from the wire surface in Figure 28.

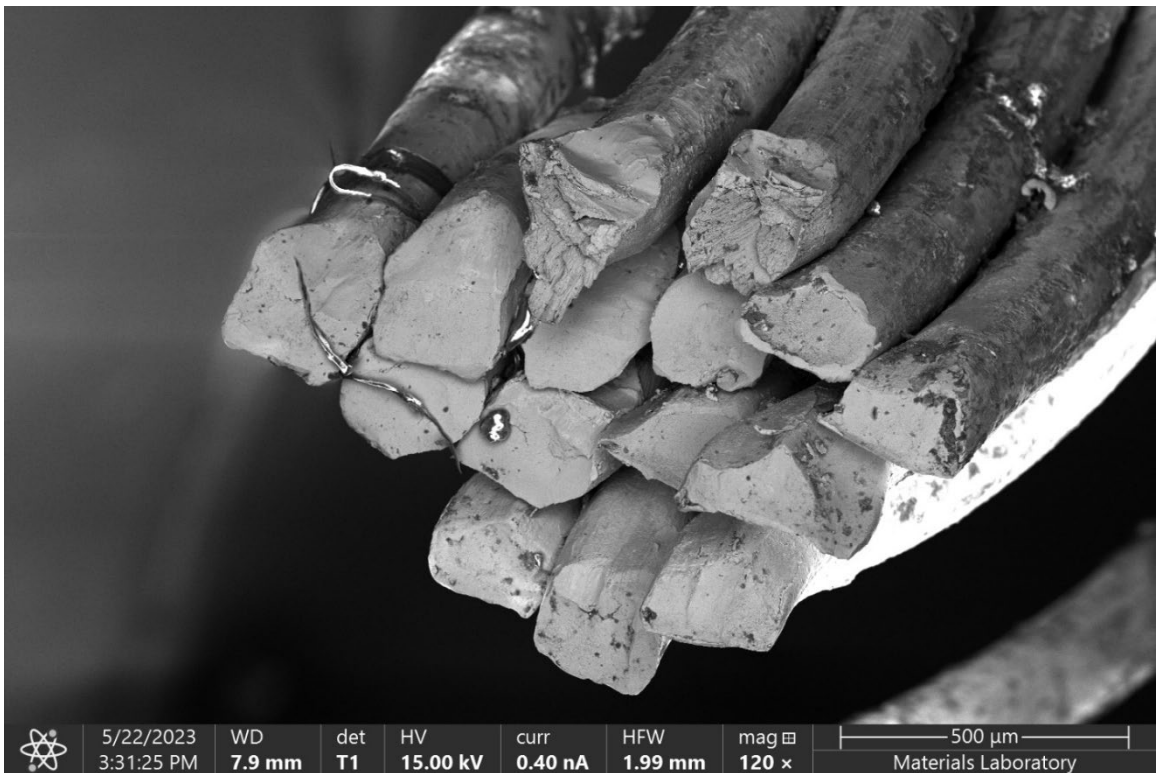
Figure 30 shows the fractured wires of strand 6. Most of the broken wires exhibited a slanted fracture orientation, with an area of another surface (facing upward in the figure) consistent with post-fracture rubbing or smearing damage. Several wires from the top of the figure exhibited perpendicular secondary tears. One of these wires is highlighted in Figure 31, showing the fracture features between two tears. All the

**Figure 30.** BE micrograph of the fractured wires of strand 6 from the right cable.

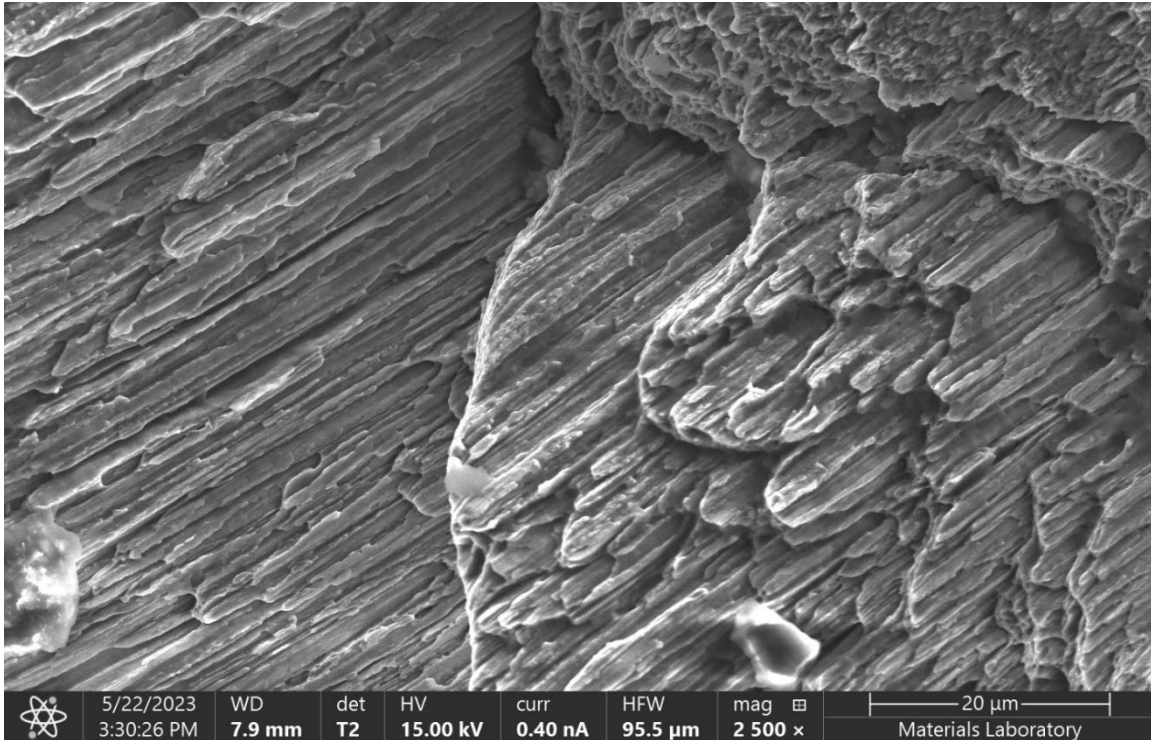
areas revealed dimpled rupture—along the tear surfaces, the dimples were more equiaxed in shape, whereas on the primary fracture, they were elongated, consistent with the grain direction of the wire.

**Figure 31.** BE micrograph of the upper right wire fracture surface in **Figure 30**, showing ductile tearing and dimpled rupture along the elongated grain direction.

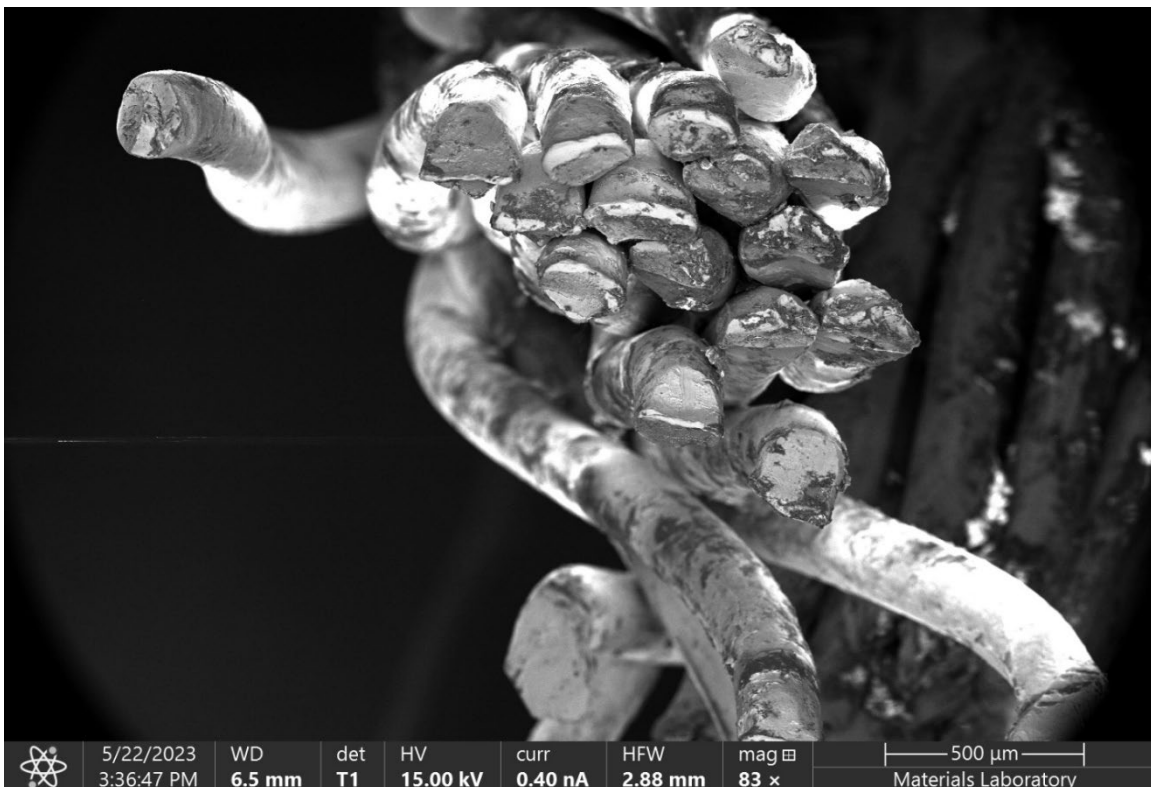
Figure 32 shows some of the fractured wires from strand 3. These wires exhibited localized thinning or necking deformation adjacent to their fractured surfaces. These wires revealed dimpled rupture, as illustrated in Figure 33. The wire in Figure 33 also exhibited post-fracture smearing damage on half of the fracture. The orientation of this smearing damage was consistent on most of the wires in this strand.

**Figure 32.** BE micrograph of the fracture wires from Strand 3 of the right aileron cable.

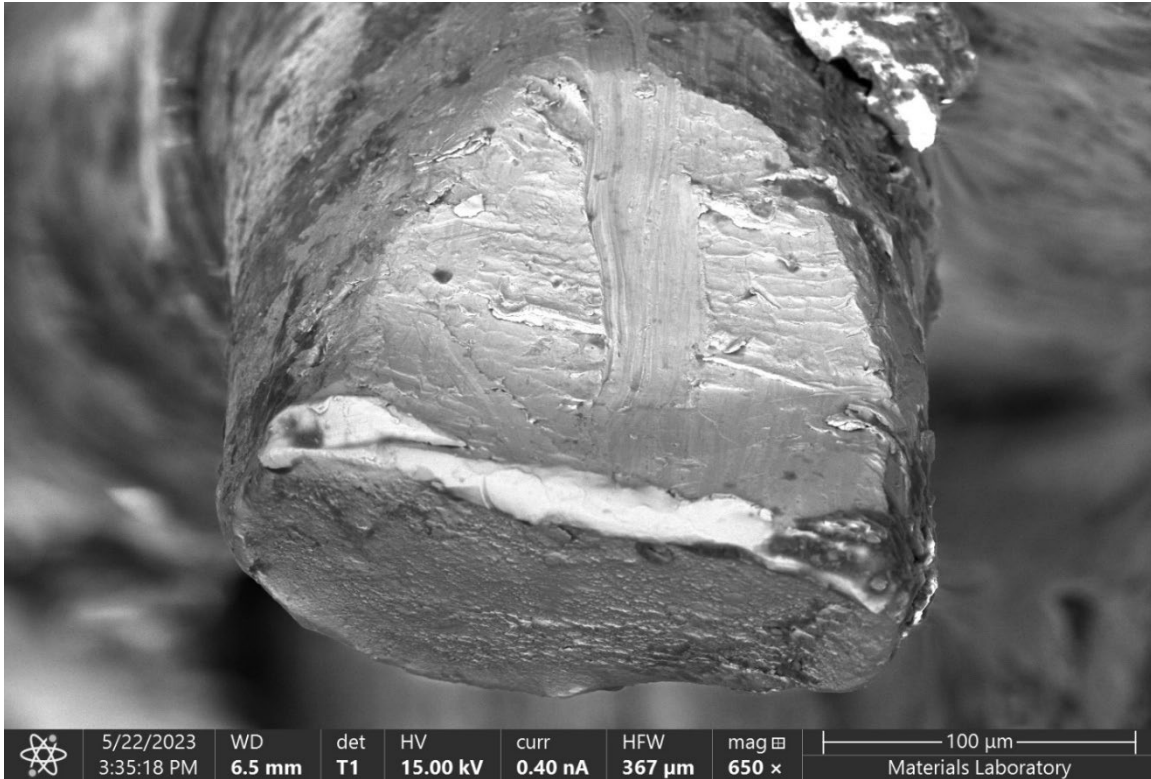
**Figure 33.** BE micrograph of a fractured wire from **Figure 32**, showing smearing (top) and dimpled rupture (bottom),

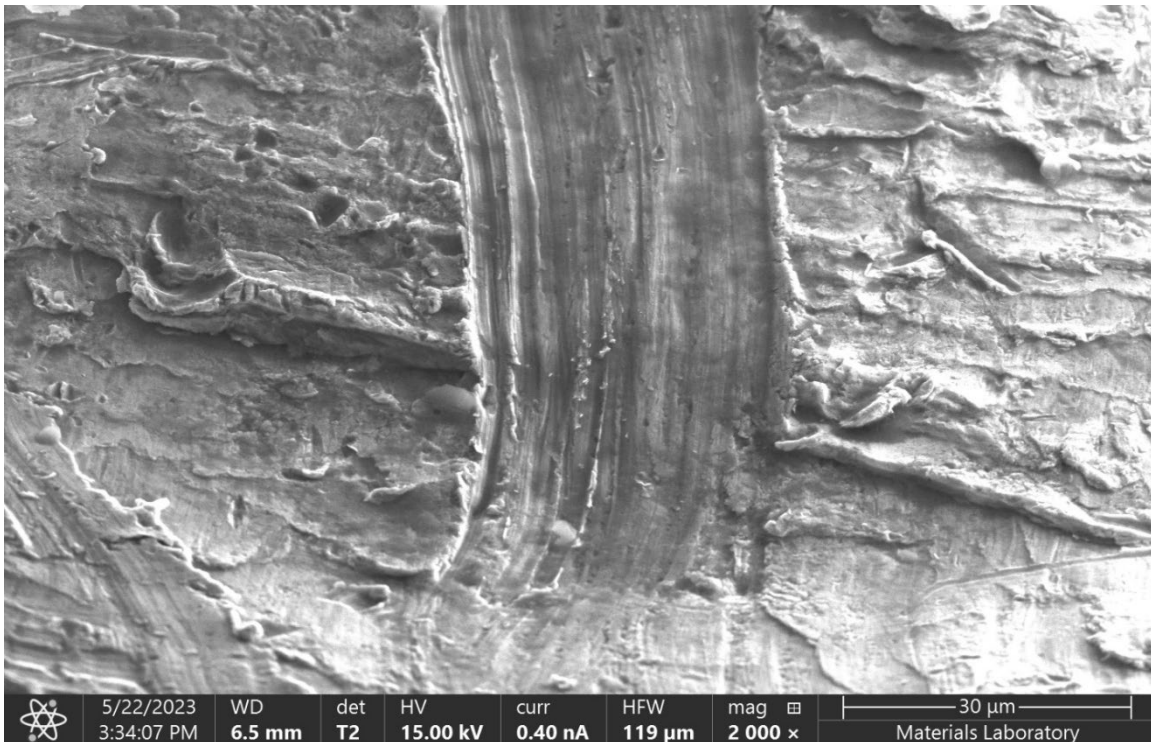
Further, the smearing and deformation on the wire fractures were oriented both horizontally and vertically, as shown in Figure 34. These features were consistent with rubbing or wear of the fractured wires repeatedly after fracturing. The fracture features were consistent with overstress fracture in tension.

**Figure 34.** BE micrograph of the post fracture damage and smearing to part of the wire fracture surface in **Figure 33**.
