**NATIONAL TRANSPORTATION SAFETY BOARD**  
Office of Aviation Safety

**Wreckage Examination Group Field Notes**

**A. ACCIDENT      WPR22FA354**

Location:            Sisters, Oregon  
Date:                September 22, 2022  
Time:                1439 PDT  
Operator:           Private  
Aircraft:            Piper PA-28-140  
Registration:       N7063R

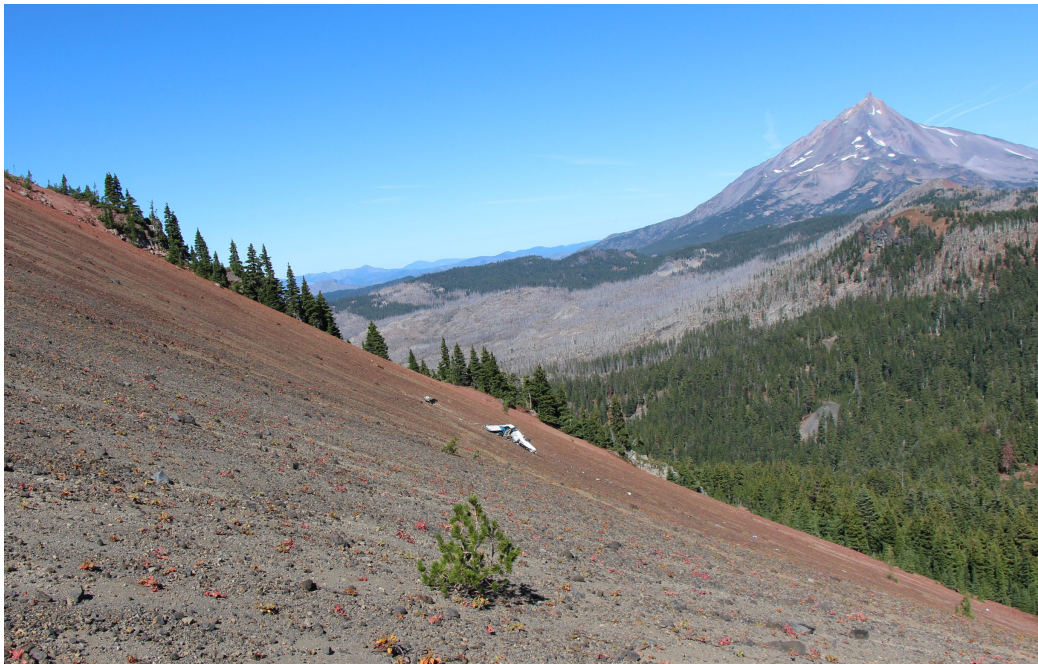
*Photograph 1: Accident site on slope of South Cinder Peak (2 days after the accident)*

The airplane came to rest on a 60° slope on the northeast side of South Cinder Peak in the Jefferson Wilderness at a field elevation of about 6,500 ft mean sea level. All four corners of the airplane were accounted for at the accident site. The first point of impact (FPI) was about 500 ft from the top of the peak and was marked by a large ground scar about 6 feet wide. The main

wreckage was located down the hill about 20 ft northeast of the FPI and was comprised of both wings, the fuselage and empennage. The engine was collocated with the FPI.

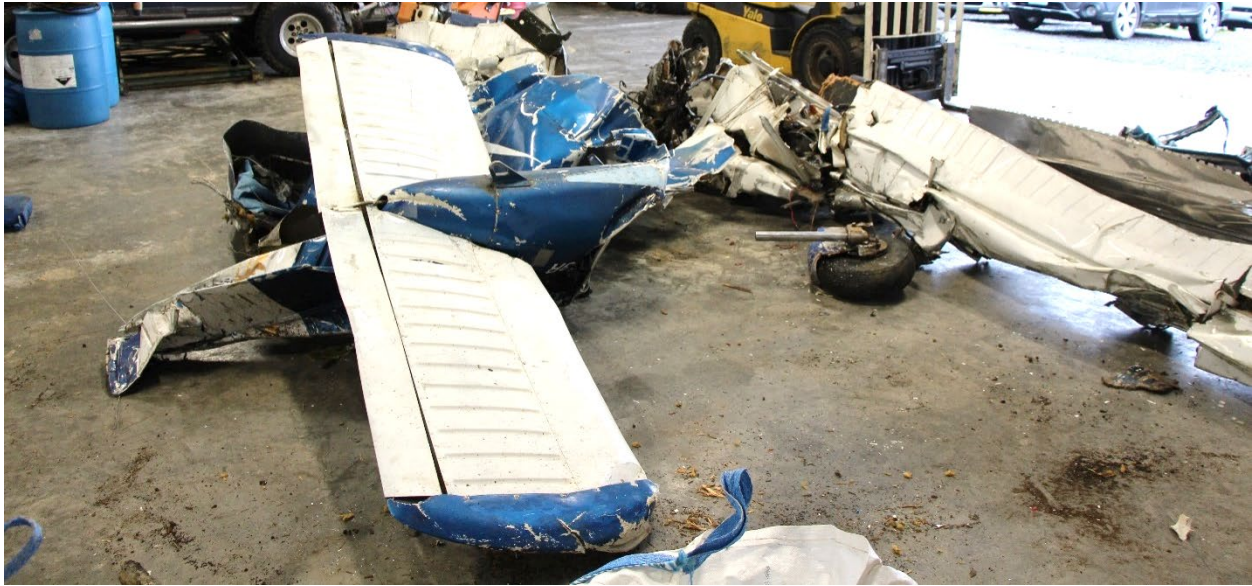
*Photograph 2: Accident airplane prior to examination*

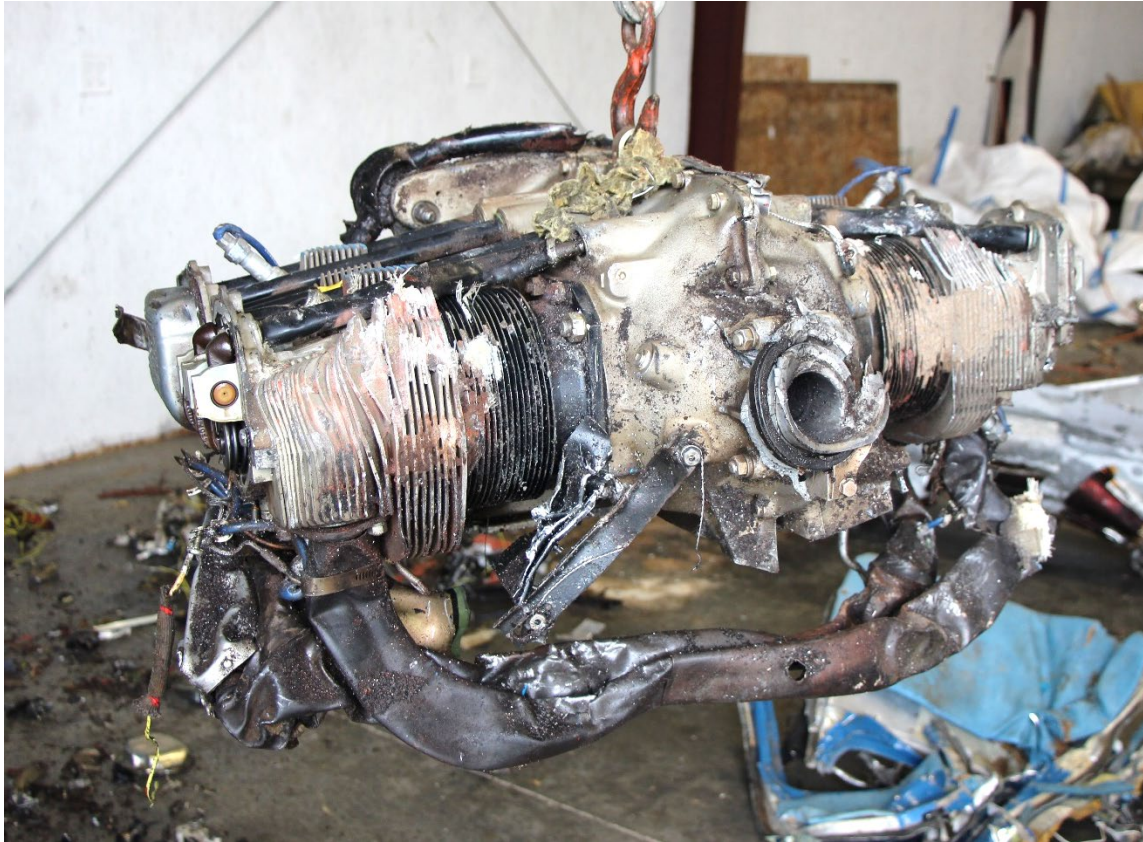
accordance with FAA supplemental type certificate SE367CH (according to logbook records). Additionally, the engine had separated from the airframe and engine firewall. The accessory case housing was breached, which exposed several spur gears and the engine case was cracked. Several of the exhaust and intake tubes were crushed or separated from their respective mounts. The oil sump was separated from the engine case. The exhaust shrouds had separated.

*Photograph 3: Engine prior to examination*

Mechanical continuity could not be established throughout the rotating group, valve train and accessory section due to the condition of the engine from the absorption of impact energy. The valve train within the rocker covers was unremarkable. Examination of the cylinders combustion chamber interior components using a lighted borescope revealed normal piston face and valve signatures, and no indications of catastrophic engine failure, detonation, or foreign object ingestion. The crankshaft was examined using an inspection mirror, which was accessed through the accessory section. Combustion signatures observed at the spark plugs, combustion chambers, and exhaust system components displayed coloration consistent with normal operation. The examination did not reveal any evidence of mechanical damage, fragmentation, lubrication deprivation or heat distress as the crankshaft and connecting rods appeared to be intact.

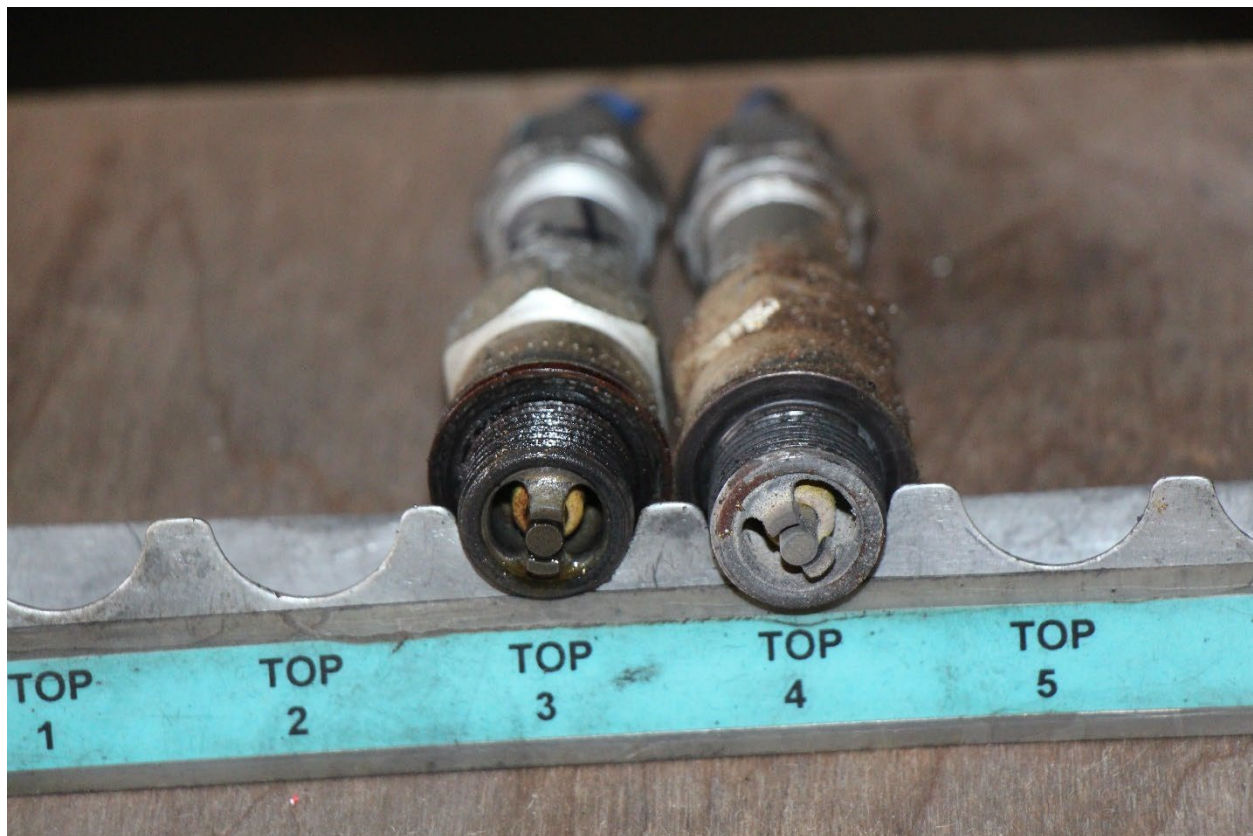
The top spark plugs to cylinder 1 and 2 and the bottom plugs to cylinder 3 and 4 were destroyed. The cylinder 3 and 4 spark plugs and bottom 1 and 2 plugs were removed, all of which were manufactured by Champion, and were model REM40E massive electrode plugs. The bottom plugs to cylinders 1 and 2 were normal in color with dirt at the circumference and the center electrode, the top plug to cylinder 3 was normal in appearance, and the top spark plug to cylinder 4 was normal in appearance with some wear when compared to the Champion Aviation Check-A-Plug Chart, AV-27. The center and ground electrodes for each plug were all intact and free of mechanical damage. The static oil soaking exhibited by the cylinder 1 bottom plug and cylinder 3 top plug were attributed to the engine positioning at the mishap site and recovery. The ignition harness was destroyed.

*Photograph 4: Top spark plugs*

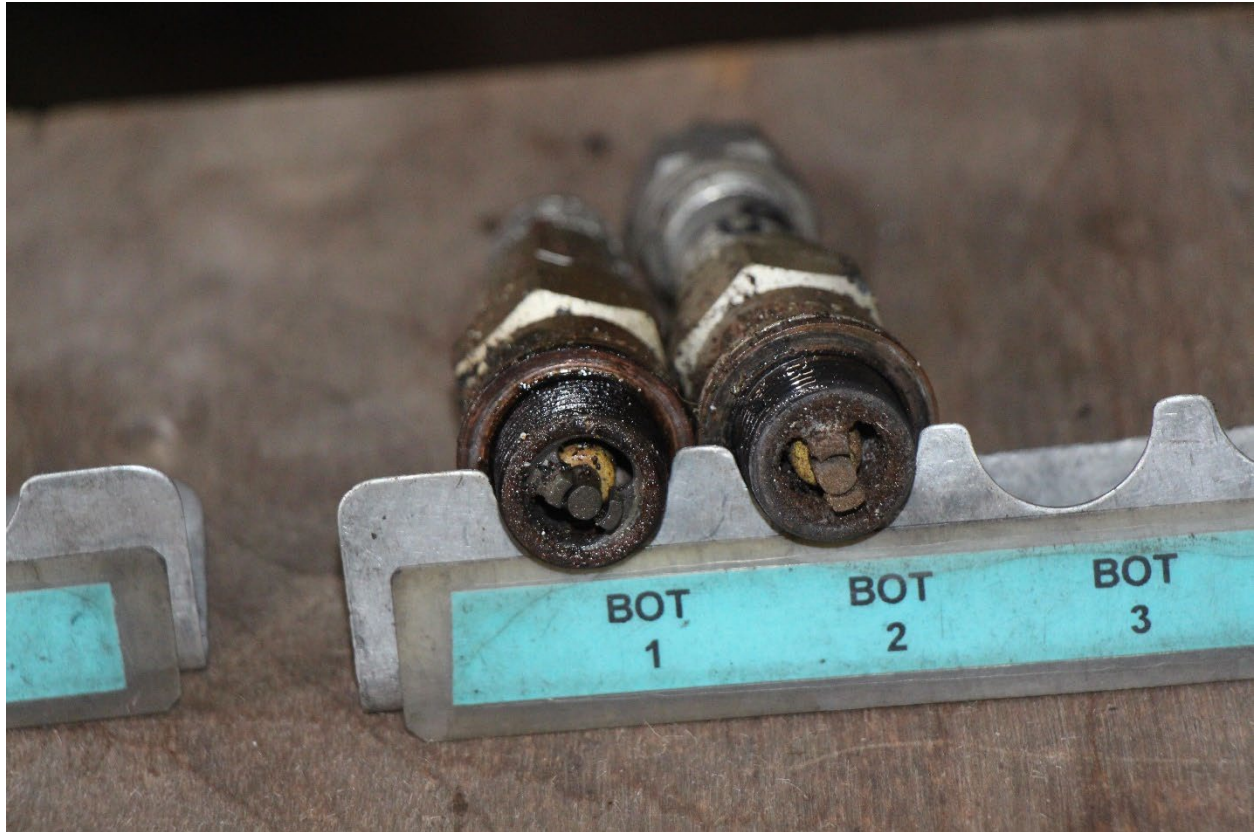
*Photograph 5: Bottom spark plugs*

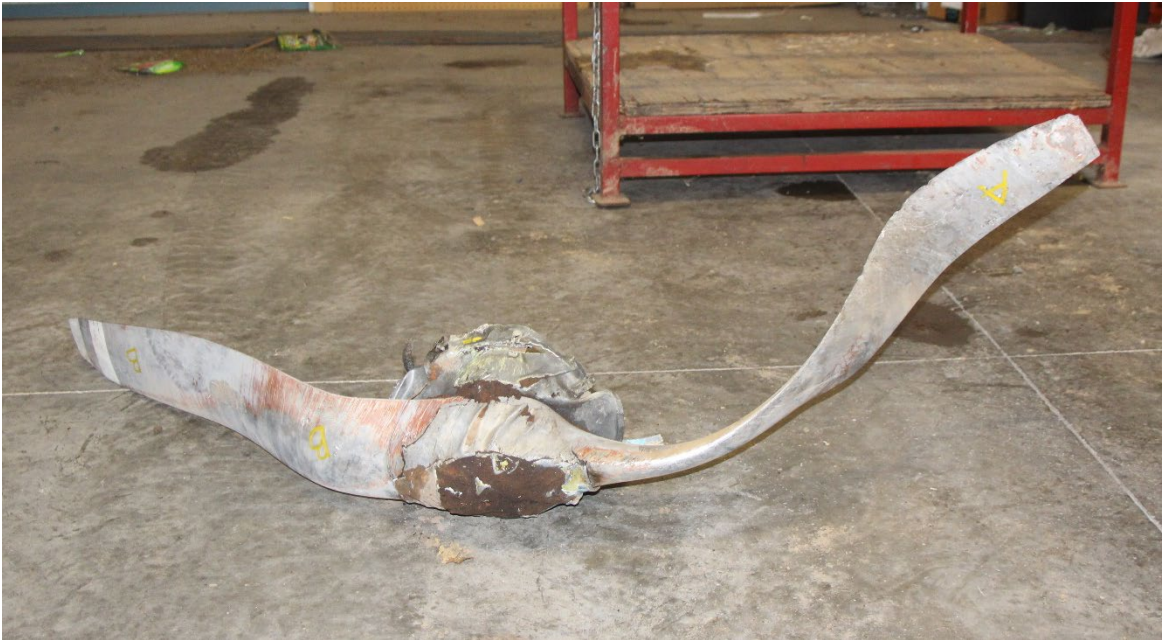
The two bladed fixed pitch propeller and crankshaft flange separated from the engine. Both blades remained attached to the hub and the metal propeller spinner was crushed. One blade

exhibited chordwise scratches, nicks and “S” bending. The other blade was bent towards the camber side of the blade at the blade root and displayed chordwise scratches and gouges near the leading edge.

*Photograph 6: Two bladed propeller from accident airplane*
