**NATIONAL TRANSPORTATION SAFETY BOARD**  
Office of Aviation Safety

**Wreckage Examination Group Field Notes**

**A. ACCIDENT**      **WPR22FA354**

Location: Sisters, Oregon  
Date: September 22, 2022  
Time: 1439 PT  
Operator: Private  
Aircraft: Piper PA-28-140  
Registration: N7063R

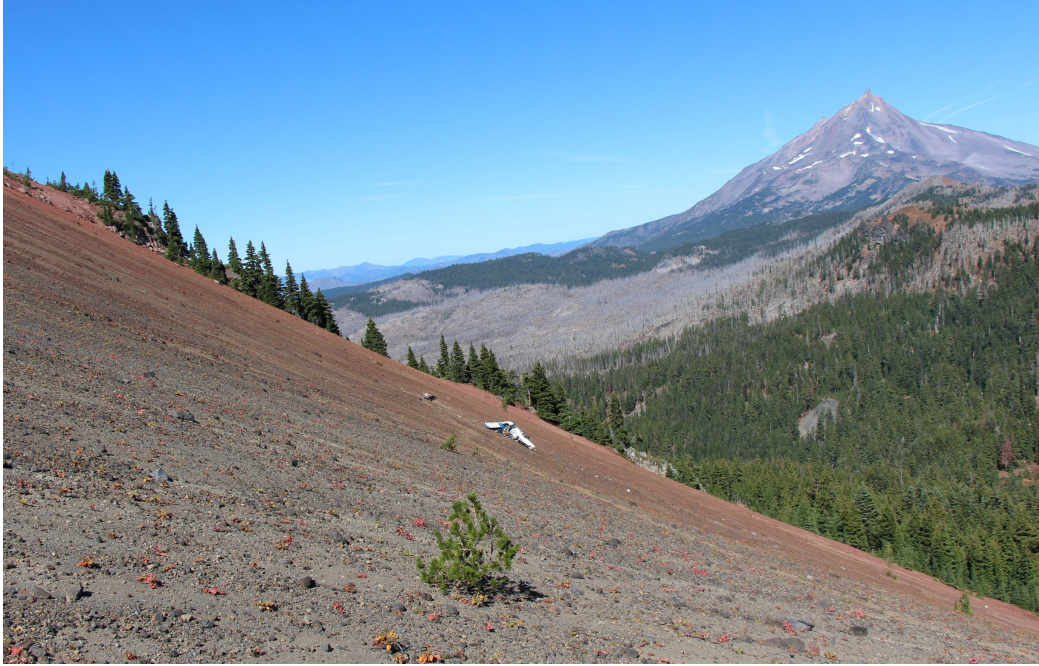
*Photograph 1: Accident site on slope of South Cinder Peak*

The airplane impacted a 60° slope on South Cinder Peak in the Jefferson Wilderness at a field elevation of about 6,500 ft mean sea level. All four corners of the airplane were accounted for at the accident site. The first point of impact (FPI) was about 500 ft from the top of the peak and was marked by a large ground scar about 6 feet wide. The main wreckage was located about 20 ft northeast of the FPI and was comprised of both wings, the fuselage and empennage. The engine was collocated with the FPI.

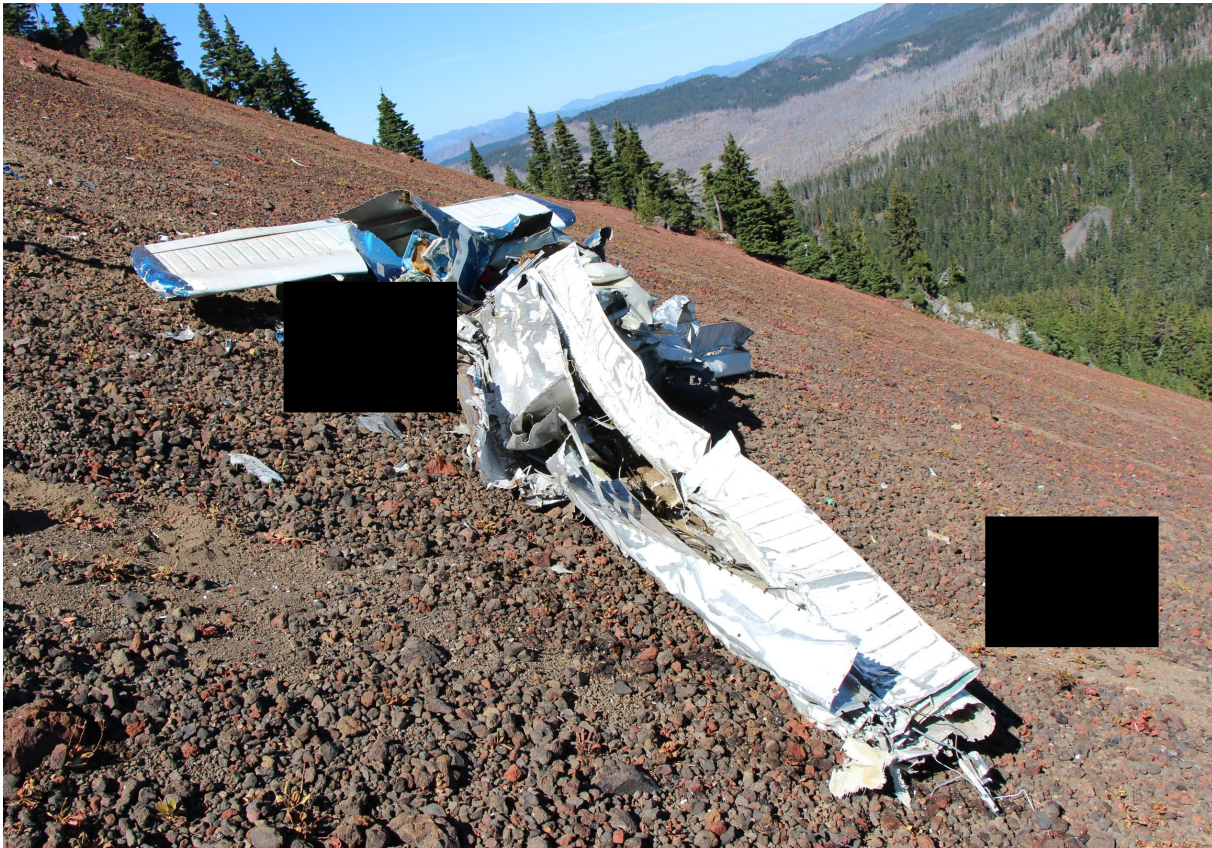
The right and left ailerons were attached to their respective wings, which remained attached at the carry through spar. Both wing leading edge surfaces were crushed chordwise and the leading edge skin forward of the fuel tanks exhibited evidence of hydraulic deformation. The right and left wingtips had separated from their respective wings. The airplane fuselage and cabin were crushed beneath the wings and could not be identified due to their orientation at the accident site. The empennage was inverted and comprised of the anti-servo tab and both stabilators. The vertical stabilizer and rudder assembly were crushed, but remained partially attached to the empennage. Several airframe fragments were distributed along the slope of the peak, below the main wreckage.

*Photograph 2: Main wreckage from the east*

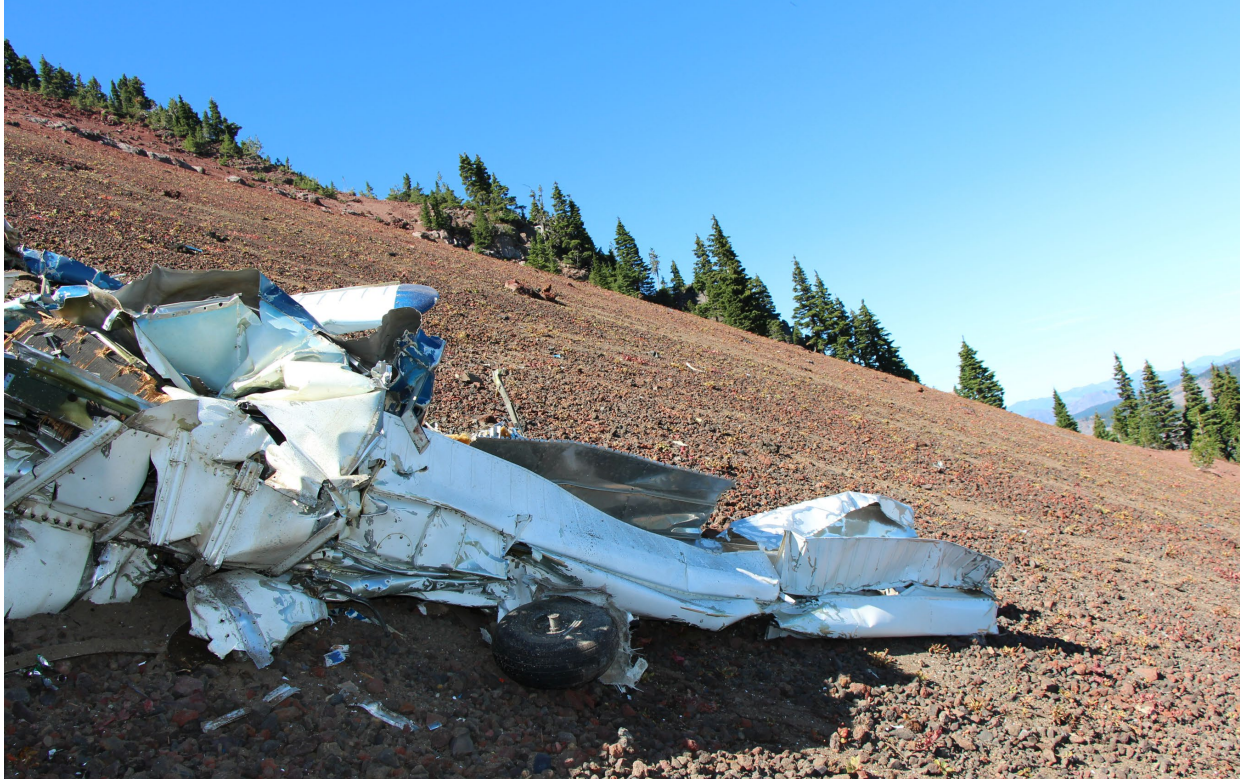
*Photograph 3: View of right wing at accident site*

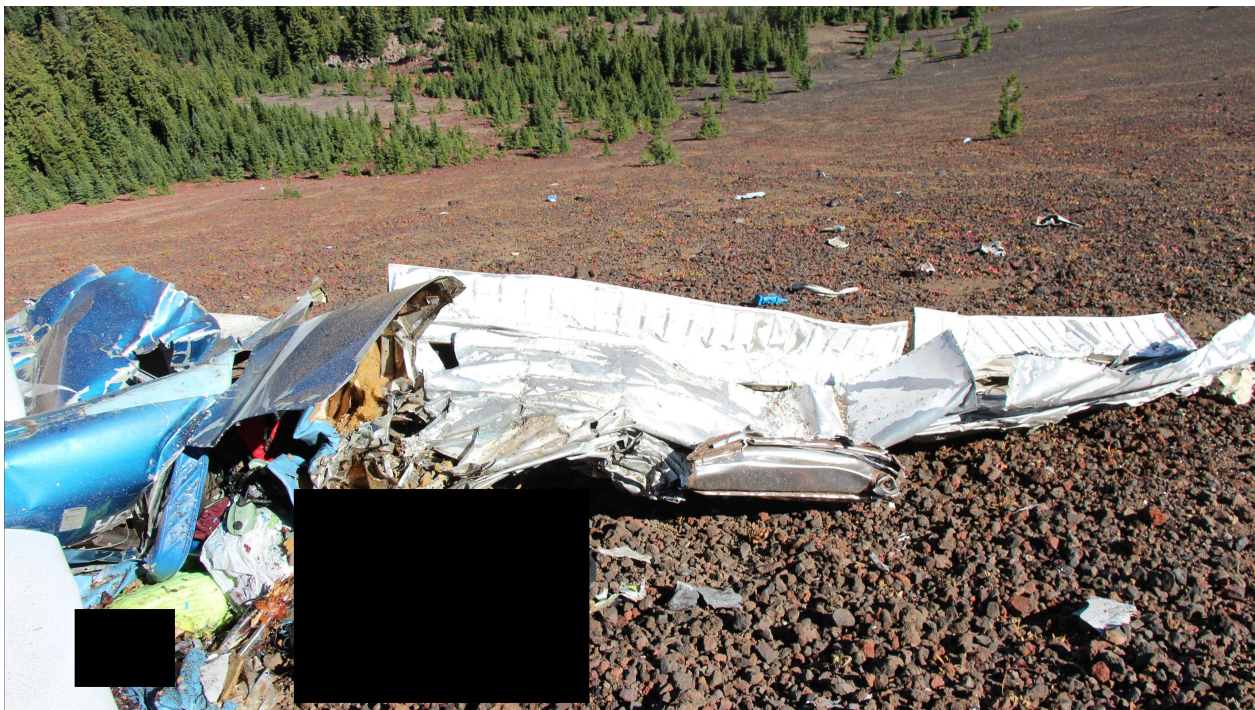
*Photograph 4: View of left wing at accident site*
