# National Transportation Safety Board

WPR22LA005

## **ENGINE EXAMINATION SUMMARY REPORT**

Location: Los Banos, California  
Date: 10/08/2021  
Time: 1904 PDT  
0204 UTC  
Airplane: N7220B, Beech B36TC

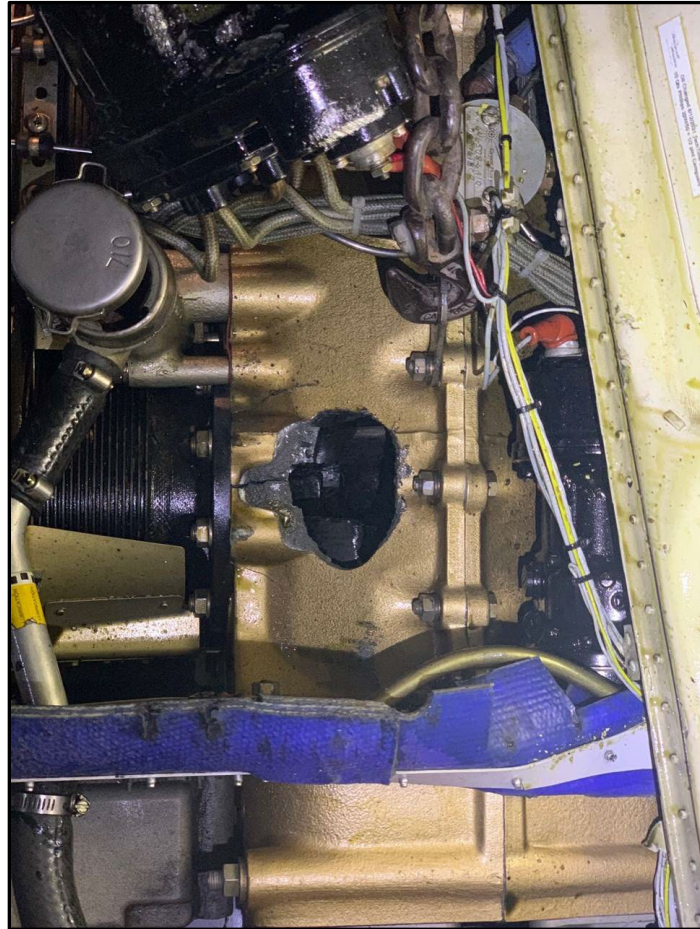
The engine was partially attached from the fuselage and the engine mount assembly remained partially attached to engine because the left and right front mounts were broke. External engine damage was noted by an exit hole near the top of the No. 2 cylinder by about a 2-inch by 3-inch hole. Additionally, cracks were noted in both of the crankcase halves. The left magneto was not attached to the engine and a hole on the left back side was observed that was about 1 inch by 1 inch.

**Figure 1: Hole in engine as viewed from the top.**

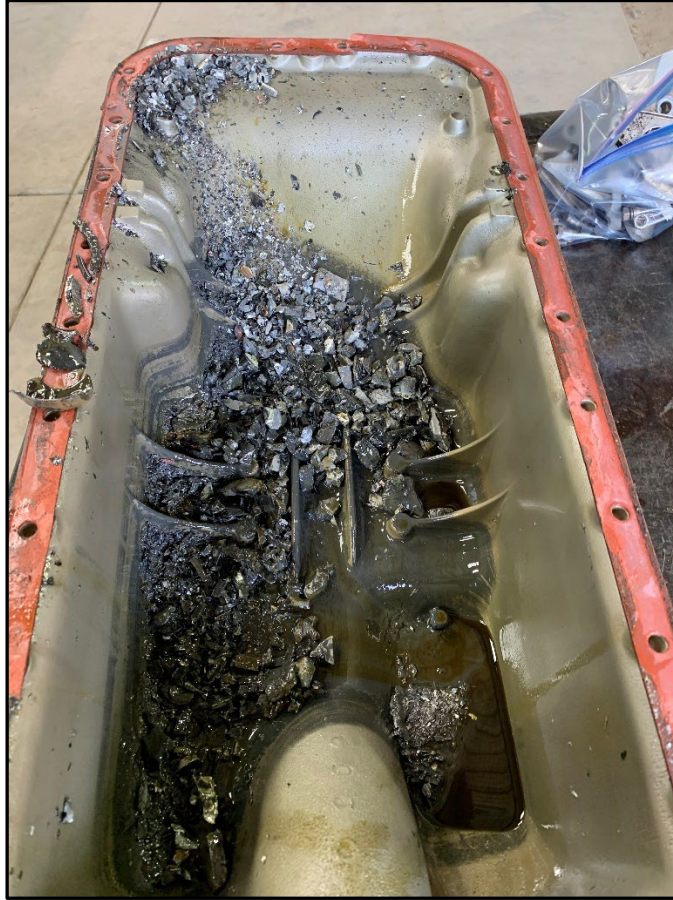
The oil filter was removed and examined, and substantial metal debris (ferrous and aluminum) was present in the pleats. The oil sump was removed and examined; no anomalies were noted. Examination revealed substantial metal debris and an unusable amount of oil was present. The oil sump was intact, and the gasket appeared undamaged.

**Figure 2: Metal debris in oil sump.**

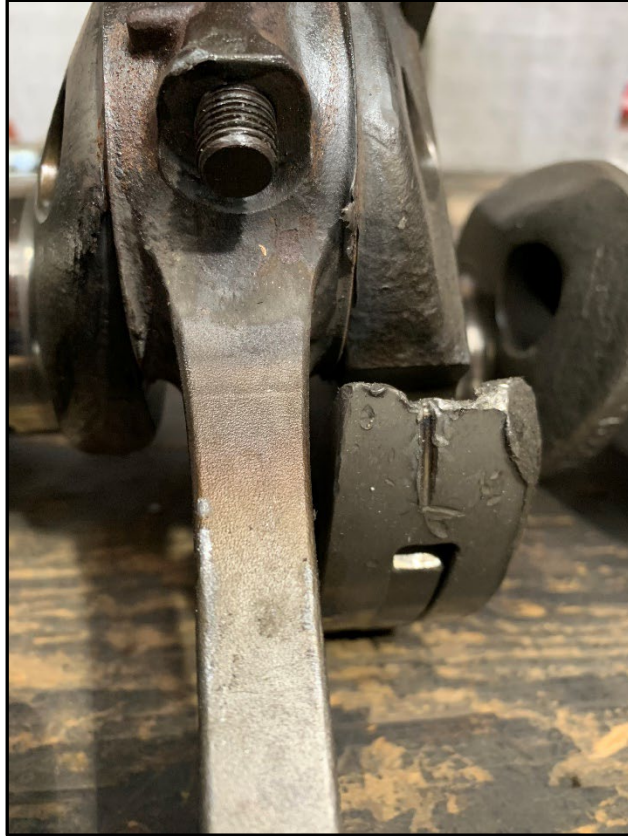
The No. 4 connecting rod bolt on the collar side, was found with the nut missing. The threads appeared undamaged and the thermal damage where it would be located was consistent with the rest of the thermal damage on the connecting rod. The remnants of a connecting rod nut were located in the oil sump. Another connecting rod nut was tightened by hand on the No. 4 connecting rod and revealed that the threads were not damaged. The thermal damage/heat distress in this area appeared to be the most severe sustained by the engine.

**Figure 3: No. 4 Connecting Rod Bolt nut missing.**

The connecting rod remained attached by the other connecting rod bolt and nut which was found secured. However, because of the missing connecting rod nut on the other connecting rod bolt, the connecting rod was not secured properly. Additionally, the associated bearing No. 4 was thermally damaged and a small portion of it remained melted to the collar.
