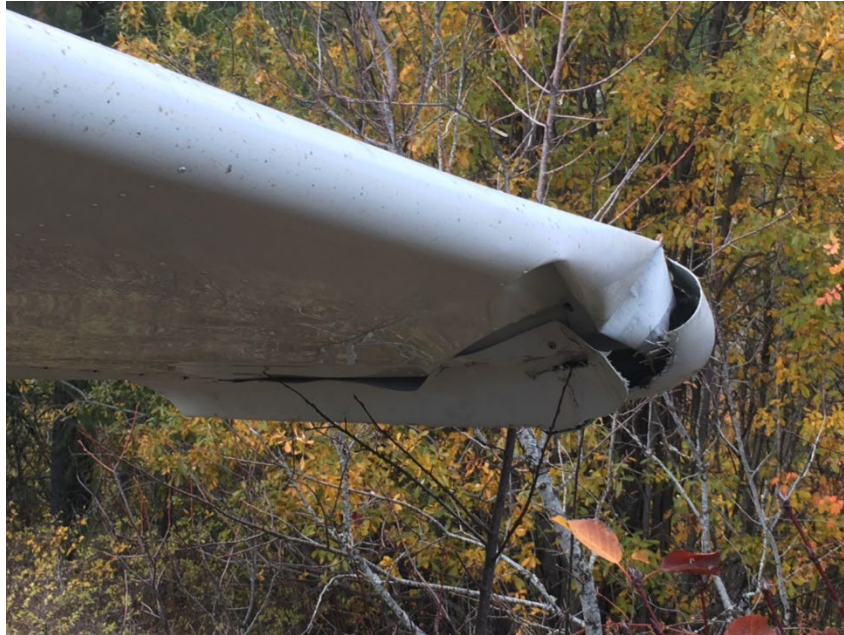
**Photo 1 – View of damage to the outboard left wing and wingtip (Courtesy of FAA)**

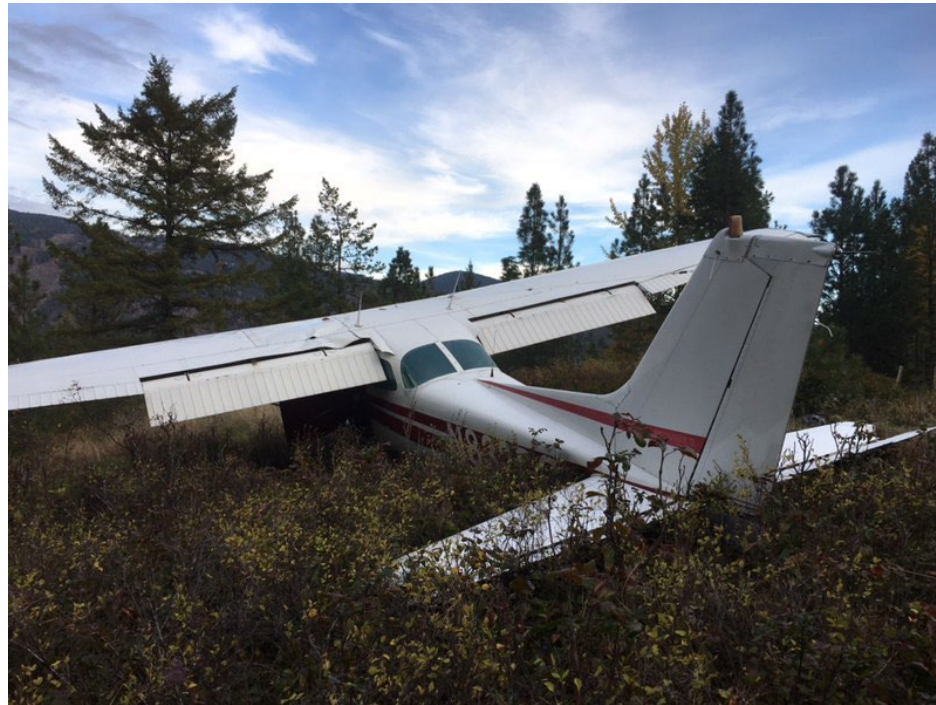
**Photo 2 – View of damage to the inboard left wing and wing and wing root (Courtesy of FAA)**
