## INVESTIGATION SUPPLEMENTAL INFORMATION

On October 14, 2021 at 1600 Pacific daylight time, a WSK Mielec AN-2TD, N857PF, was substantially damaged when it was involved in an accident near Wilton, California. The pilot and one passenger sustained serious injuries and the other two passengers sustained minor injuries. The airplane was operated as a Title 14 Code of Federal Regulations Part 91 personal flight.

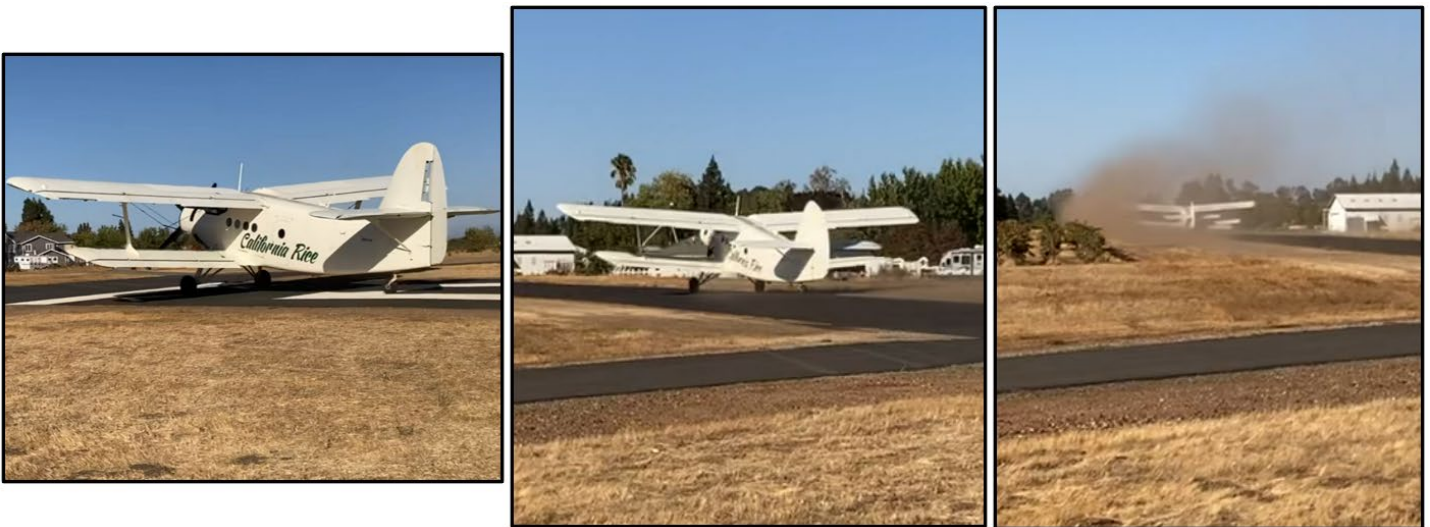
There were two witnesses located at the airport that took videos of the airplane departing. One video showed the airplane just prior to the takeoff roll. The tailwheel is positioned backward and as the airplane starts the roll, the tailwheel swivel and the airplane moves to the right of the runway (see Figure 1 below).

Figure 1: The Airplane Starting the Takeoff Roll

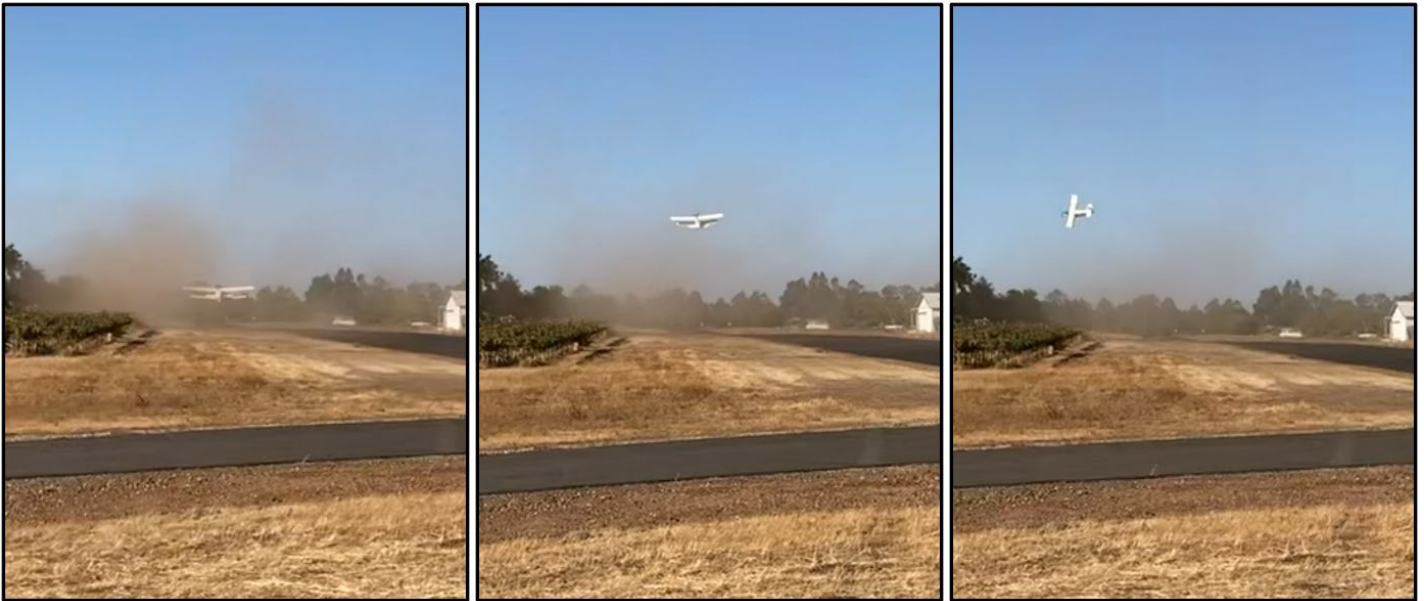
The airplane then veered to the left of the runway and became airborne shortly thereafter. In the approximate 10 seconds that followed, the airplane pitched up at an increasingly higher and higher angle-of-attack. The airplane then made a sharp left turn and goes behind the trees as it descends (see Figure 2 below).

Figure 2: The Airplane Airborne

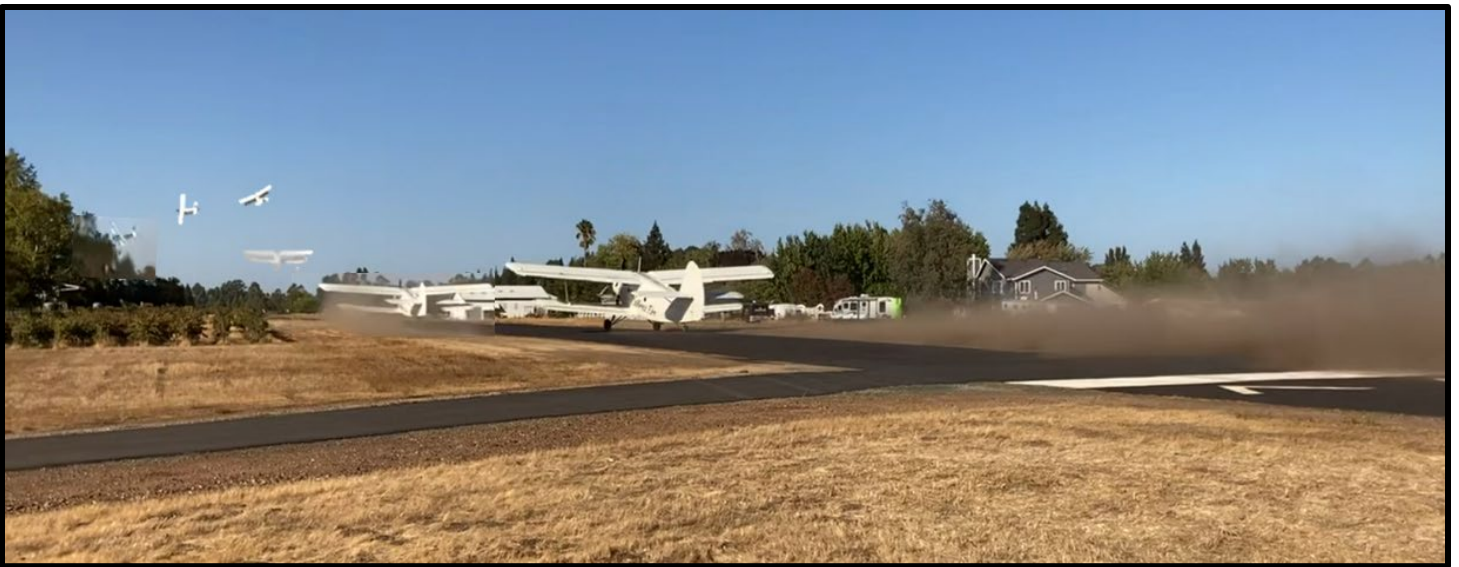
Figure 3: Composite of the Video Images
