## **NATIONAL TRANSPORTATION SAFETY BOARD**

# **AIRFRAME AND ENGINE EXAMINATION**

**WPR22LA016**

Location: Kalispell, Montana  
Date: 10/22/2021  
Aircraft: Cessna 180H / N926LL  
NTSB IIC: Fabian Salazar

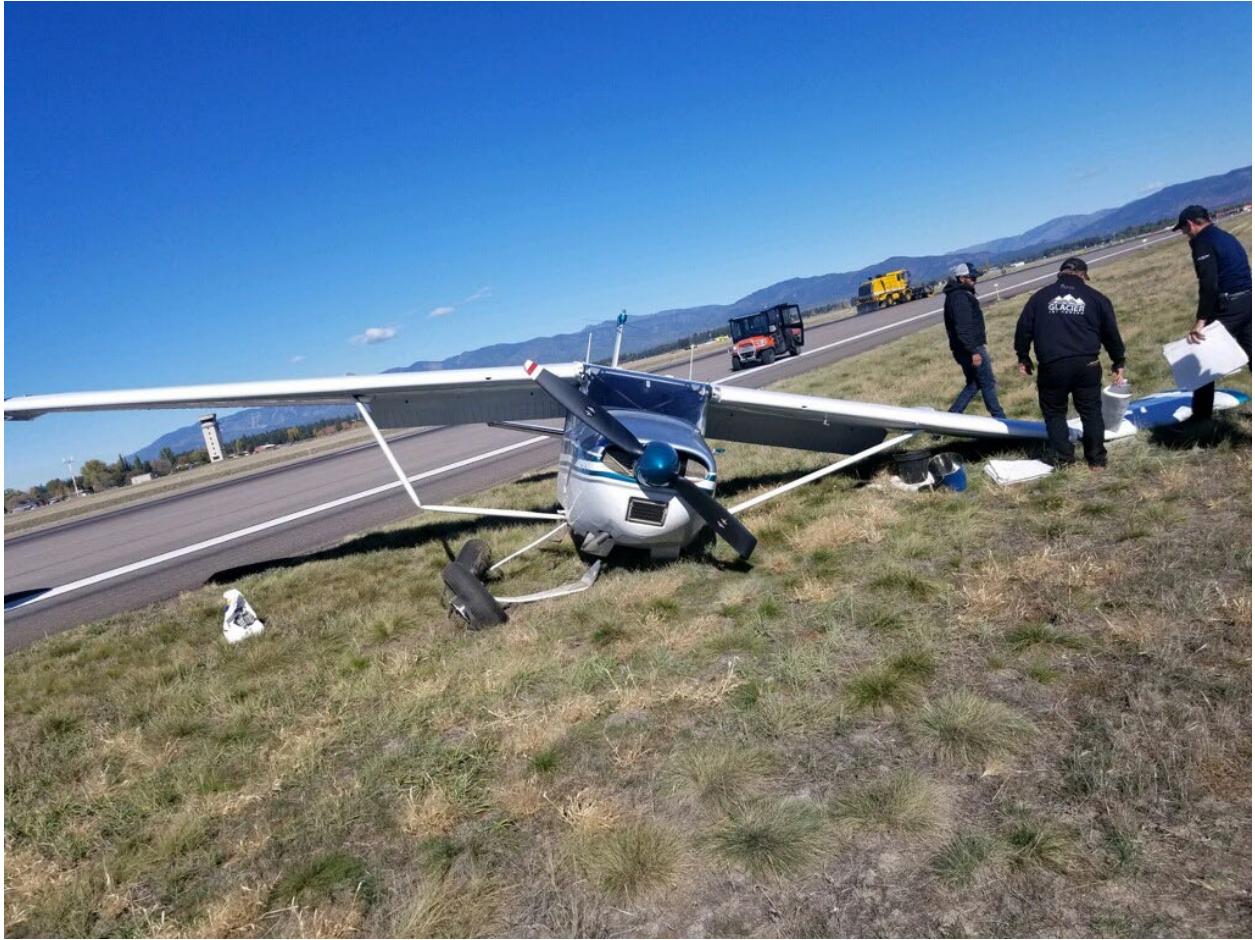
Figure 1. Front view of N926LL. Photo courtesy of the FAA.

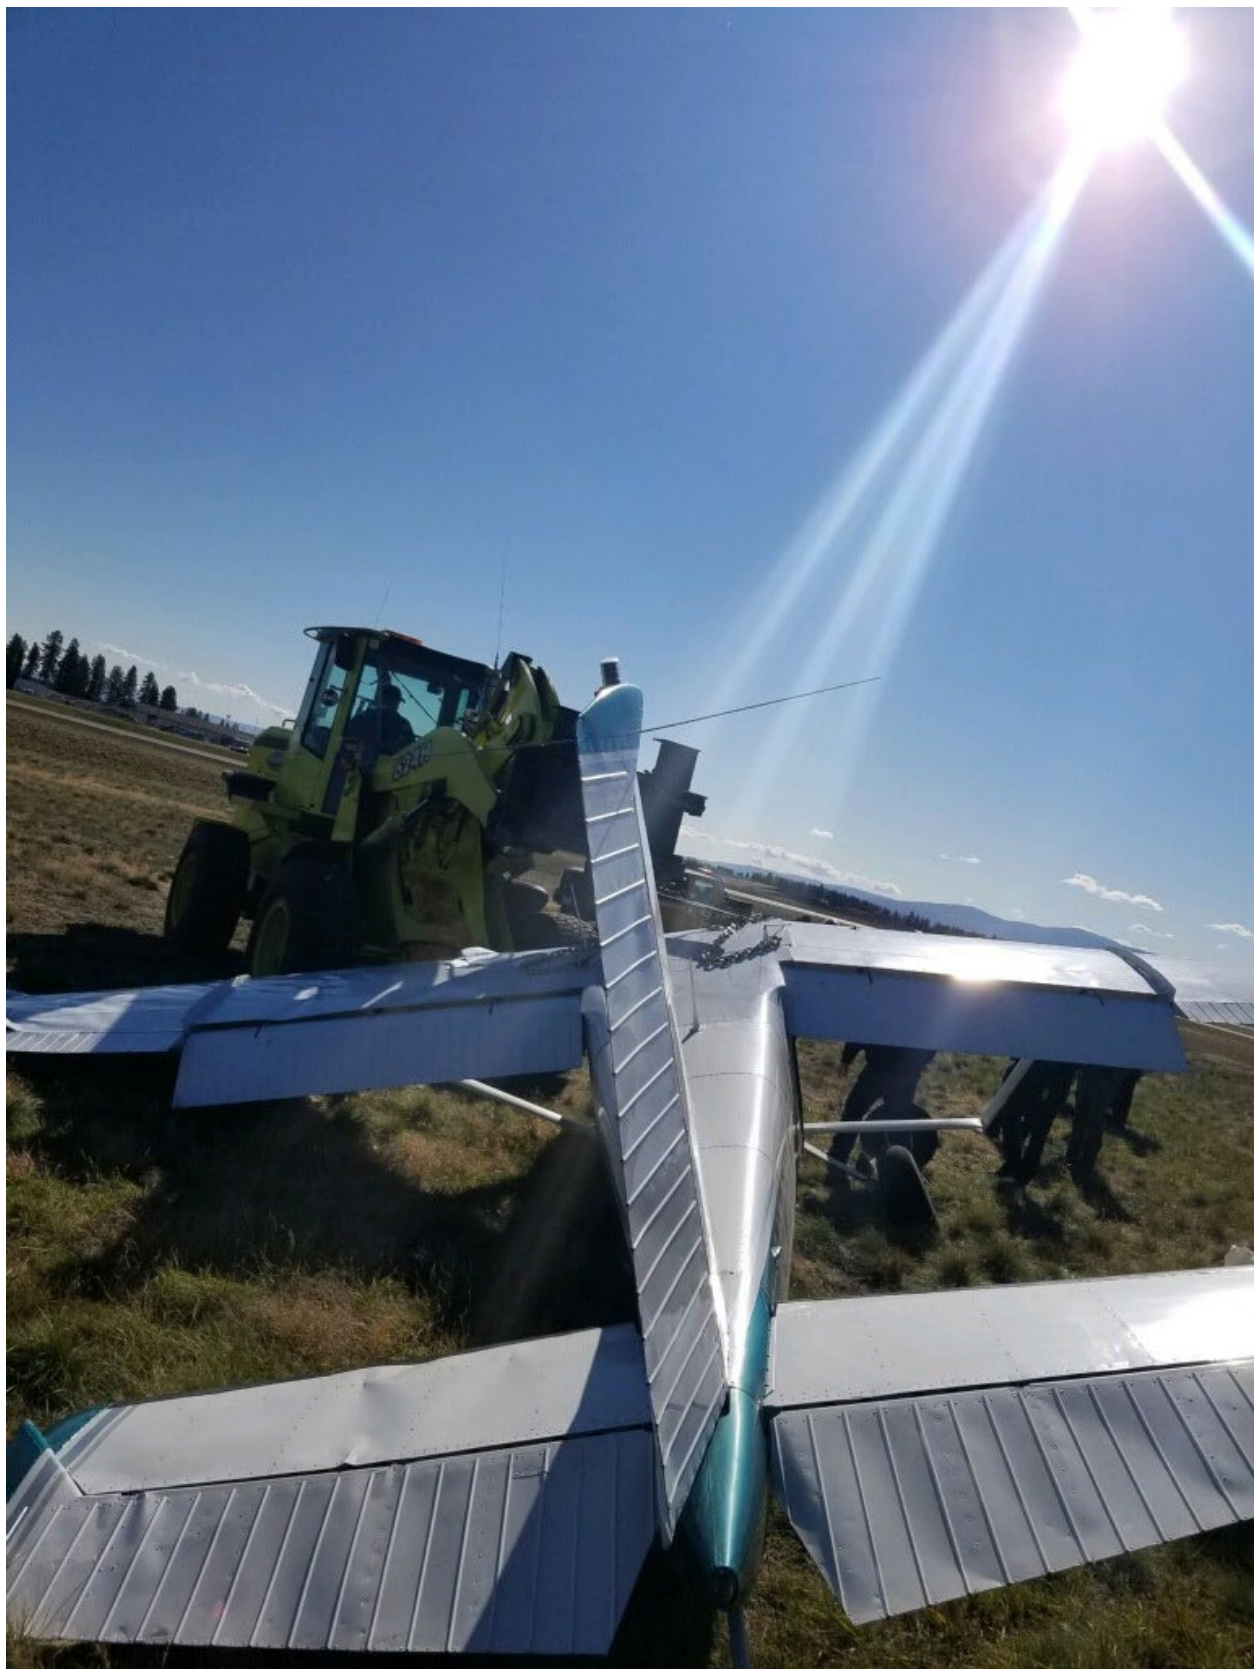
Empennage. The empennage sustained substantial damage. The right-side horizontal stabilizer and elevator we not damaged. The vertical stabilizer and rudder sustained no damage. The left-side horizontal stabilizer and elevator exhibited upwards bends and wrinkling.

Figure 2. Rear view. Photo FAA.

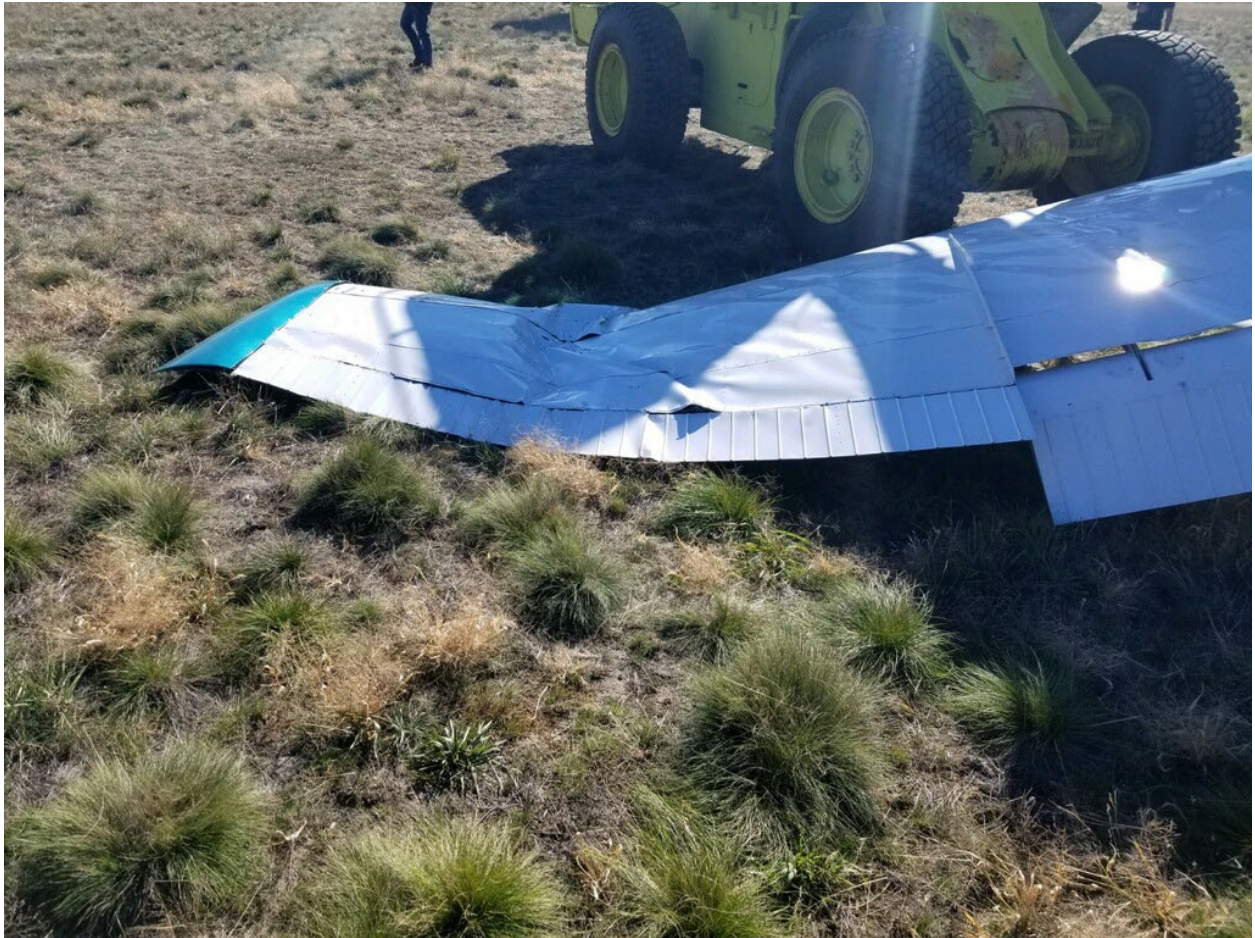
Left Wing. The left wing contacted the ground and sustained substantial damage from the outboard tip inboard to about mid-span. The wing was bent upwards from the wing tip inboard to about the location of the landing light. The left aileron sustained substantial damage and was bent upwards like to wing tip. Inboard of the landing light there appeared to be no damage.

Figure 3. Left wing. Photo FAA.

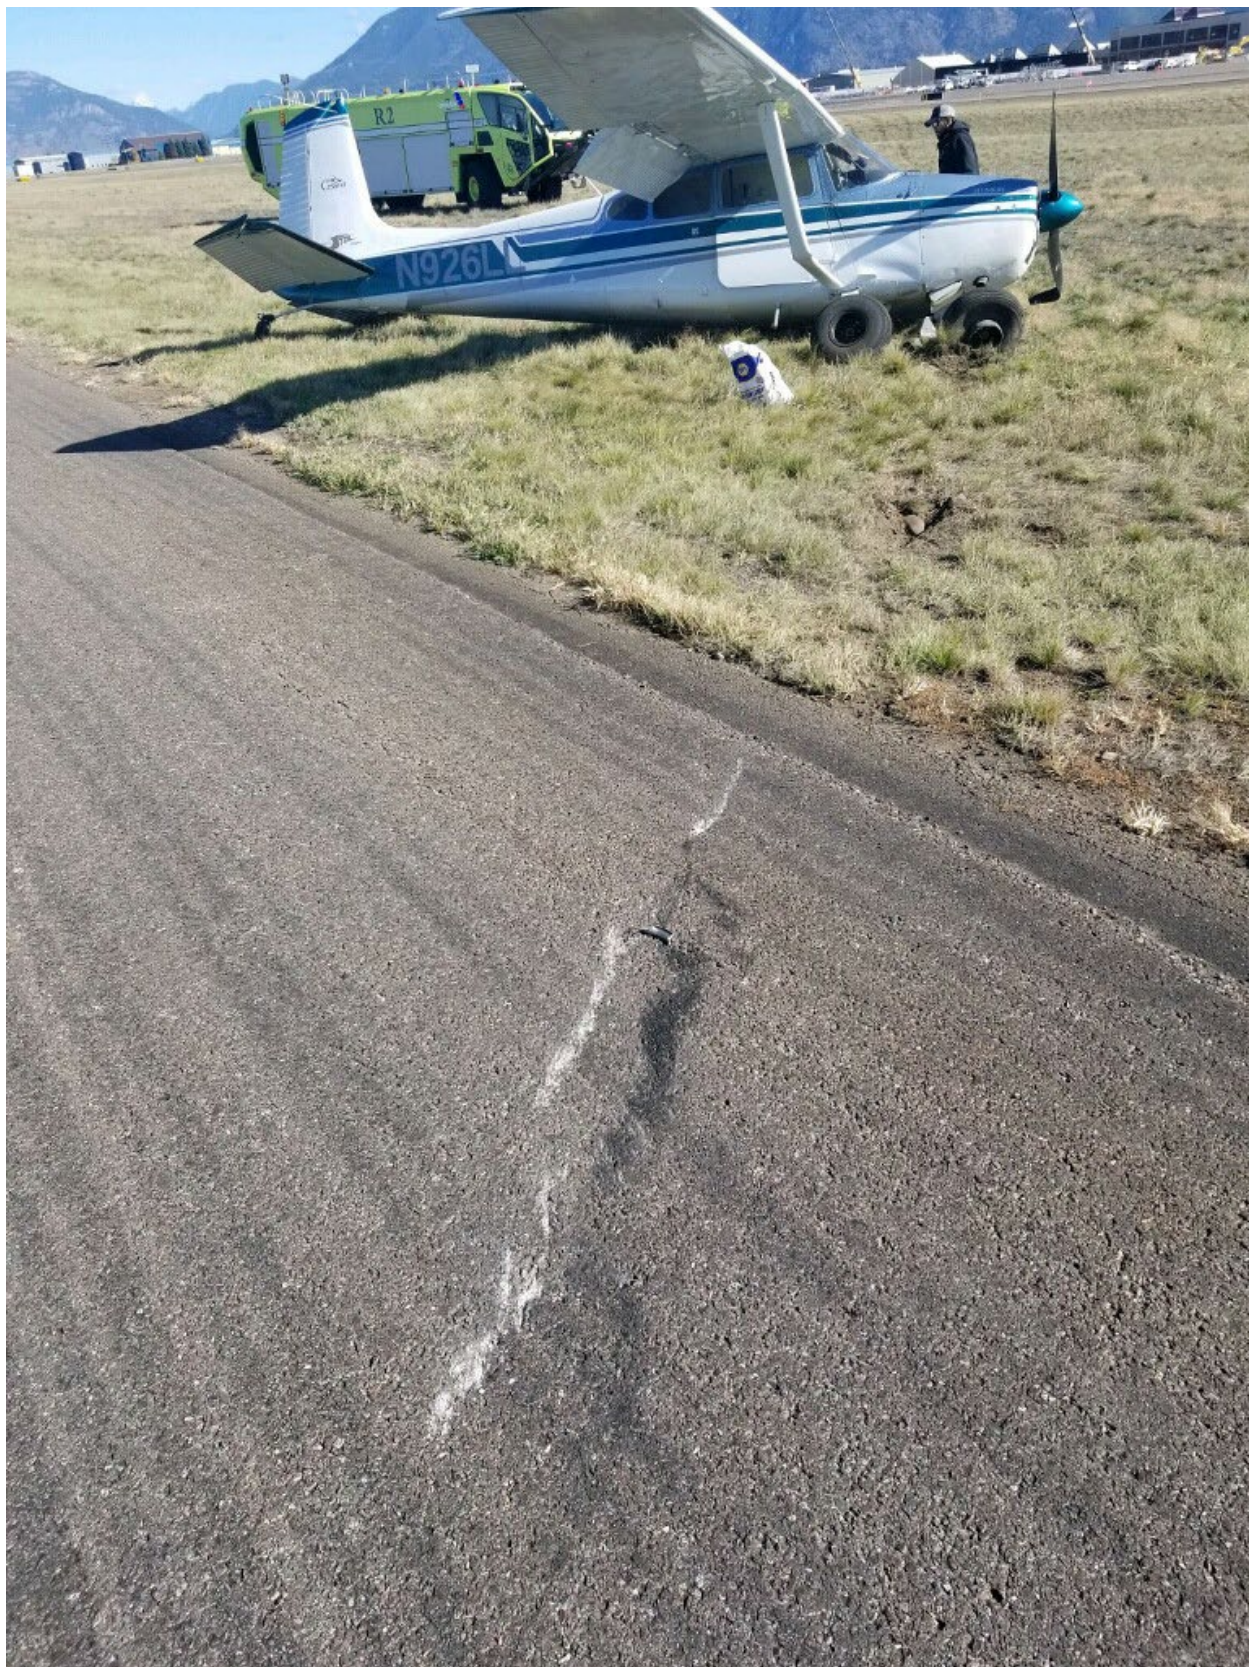
Fuselage. The fuselage sustained minor damage but did exhibit wrinkling of the sheet metal on the right side, just aft of the fire wall, and forward of the right main landing gear.

Right Wing. The right wing buckled downward, and the wing strut folded and exhibited a bend of about 80°. The right flap contacted the fuselage and sustained crumpling of the flap at the inboard area. The aileron was undamaged.

Figure 4. Right side view. Photo FAA.

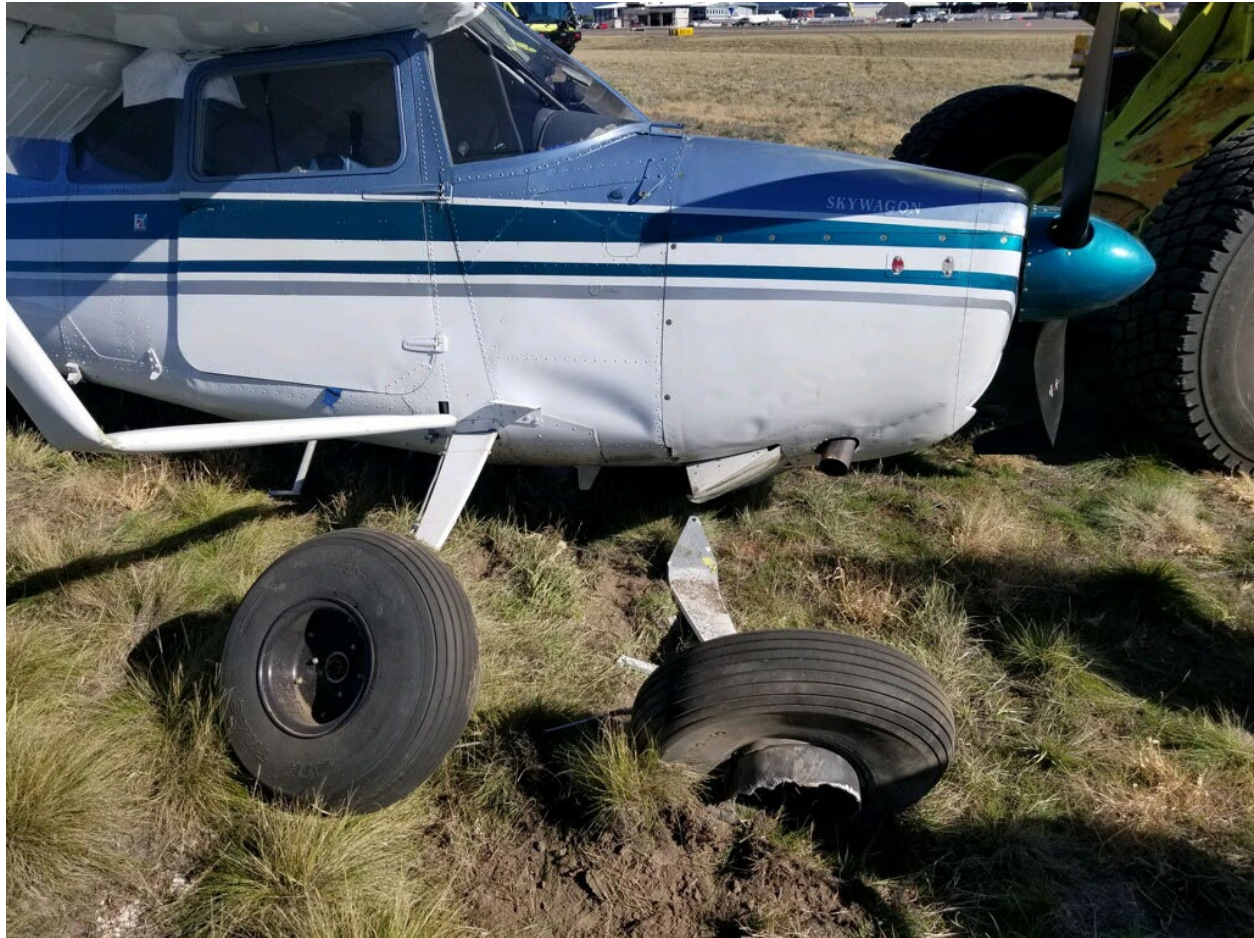
Figure 5. Landing gear. Photo FAA.

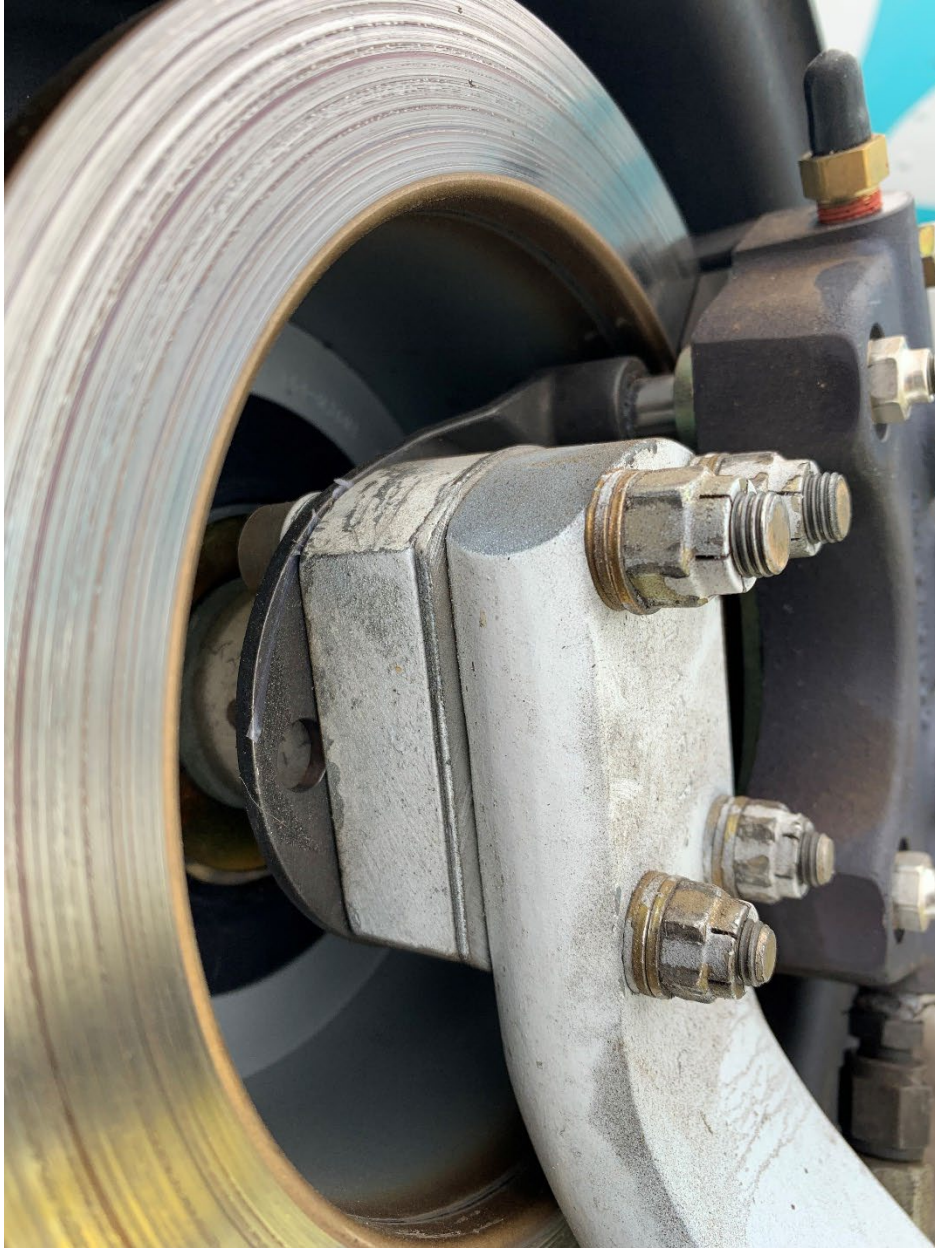
Main Landing Gear (MLG). The right-side main landing gear exhibited no damage. There was no wheel alignment shim between the axel and spring strut. The brake assembly remained attached, and the tire and spindle remained intact. The tire retained its seal. The left main landing gear separated from the fuselage. There was at least one wheel alignment shim between the axel and the spring strut. The tire lost its seal. The brake assembly remained attached.

Figure 6. Left main landing gear with shim. Photo FAA.

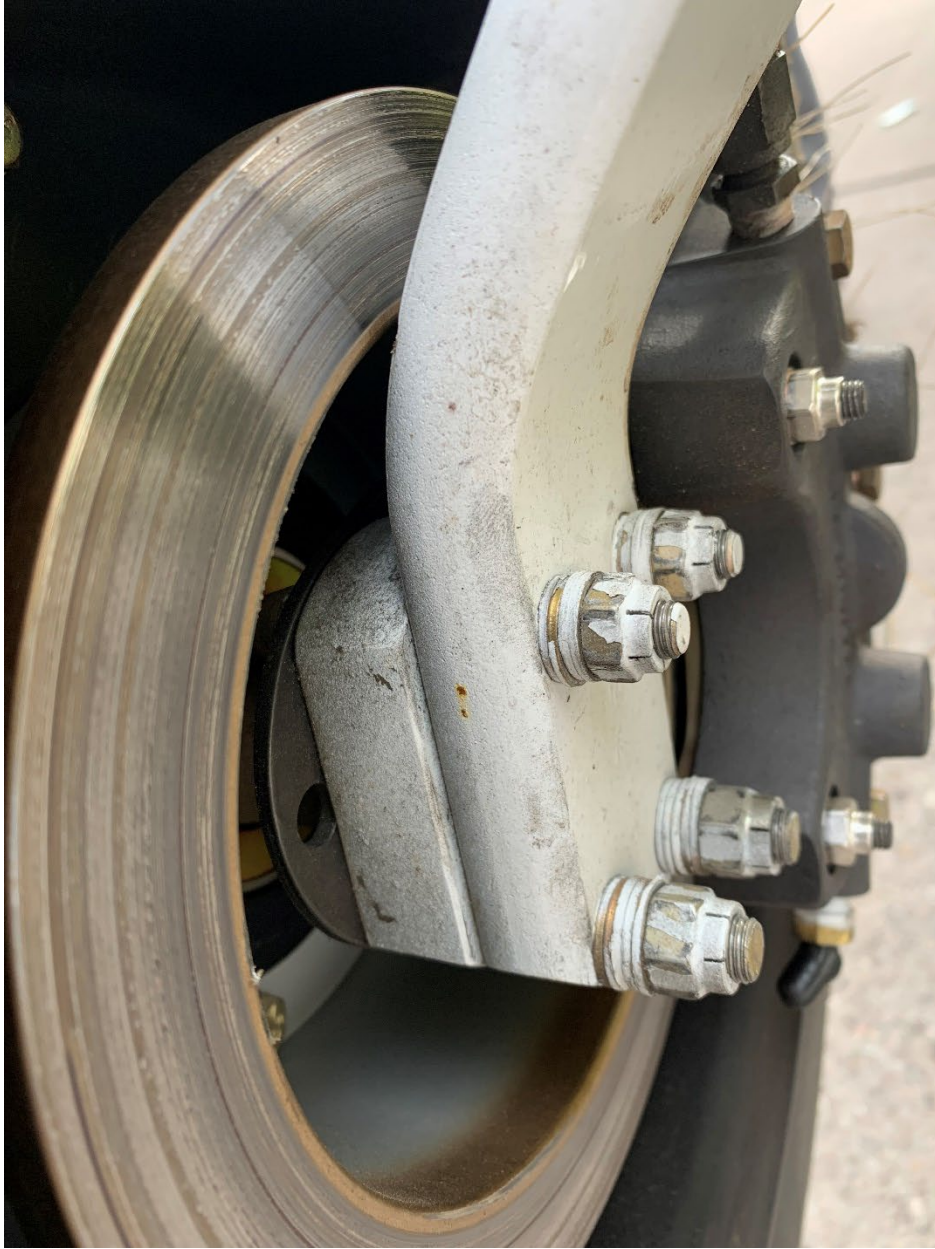
Figure 7. Right main landing gear without shim. Photo FAA.
