# National Transportation Safety Board

WPR22LA019

## **MATERIALS LABORATORY**

Specialist's Factual Report 22-066

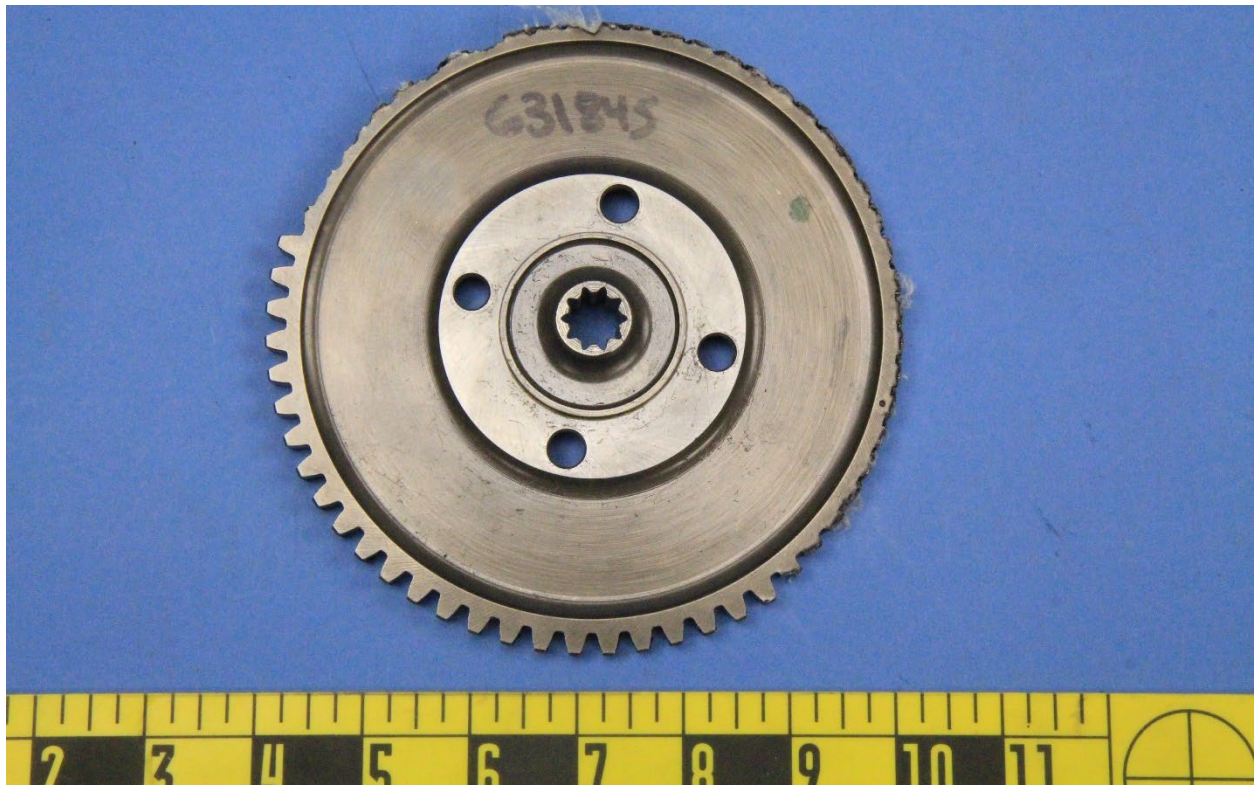
Figure 1 and Figure 2 show the camshaft gear remnant, as submitted. The markings written on the gear face stated "631845-F," with indelible ink markings stating, "631845." Thirty-six of the teeth had fractured and liberated from the gear. Twenty-four of the teeth were still intact and relatively undamaged, and one tooth was intact but deformed on the top land and forward face. Of these fractured gear teeth, only six still exhibited fracture features, as exemplified in the cluster shown in Figure 3. The remainder had been obliterated or destroyed, consistent with post-fracture damage to the gear. This damage was enough to completely smooth over most of the fracture sites.

**Figure 1.** View of the forward face of the camshaft gear, as received.

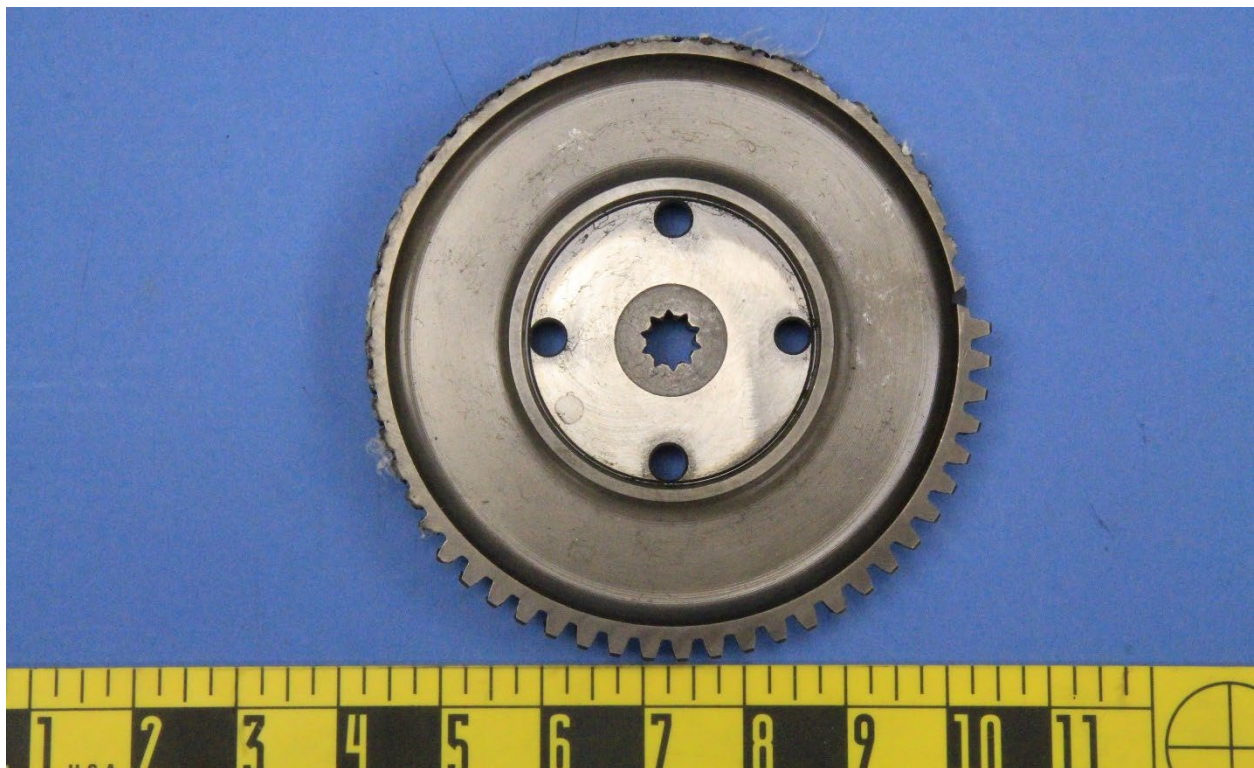
**Figure 2.** View of the aft face of the camshaft gear, as received.

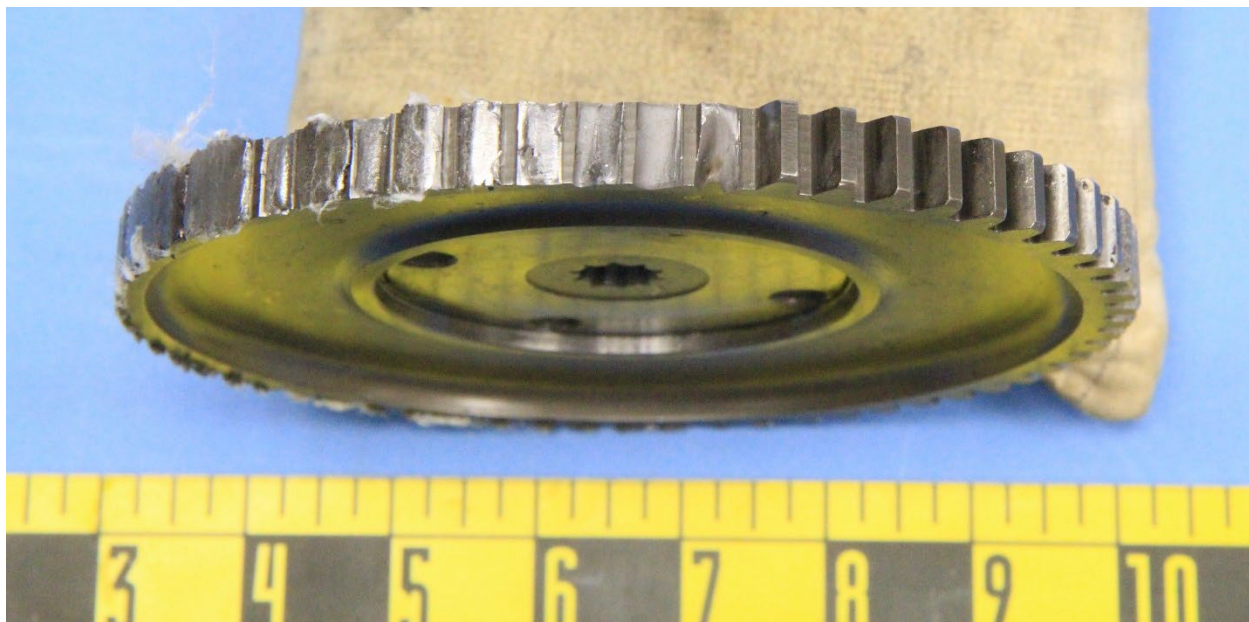
**Figure 3.** View of the fractured teeth on the camshaft gear.

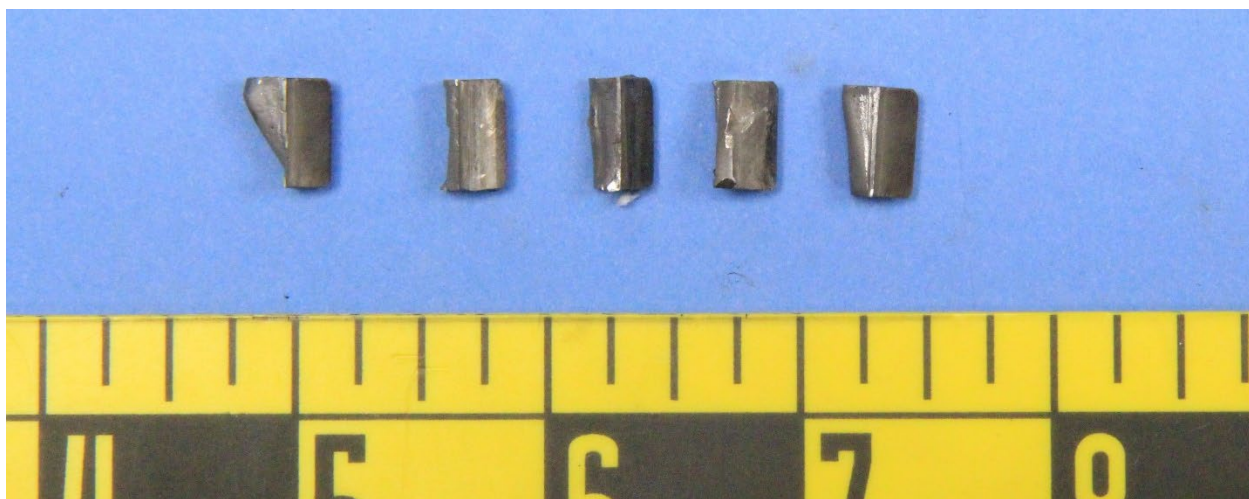
Five of the teeth that had liberated from the camshaft gear had been recovered and were received by the NTSB Materials Laboratory, as illustrated in Figure 4. The gear teeth were arbitrarily numbered 1 through 5, for the purposes of this report.

**Figure 4.** Five of the liberated camshaft gear teeth recovered from the engine, as received.

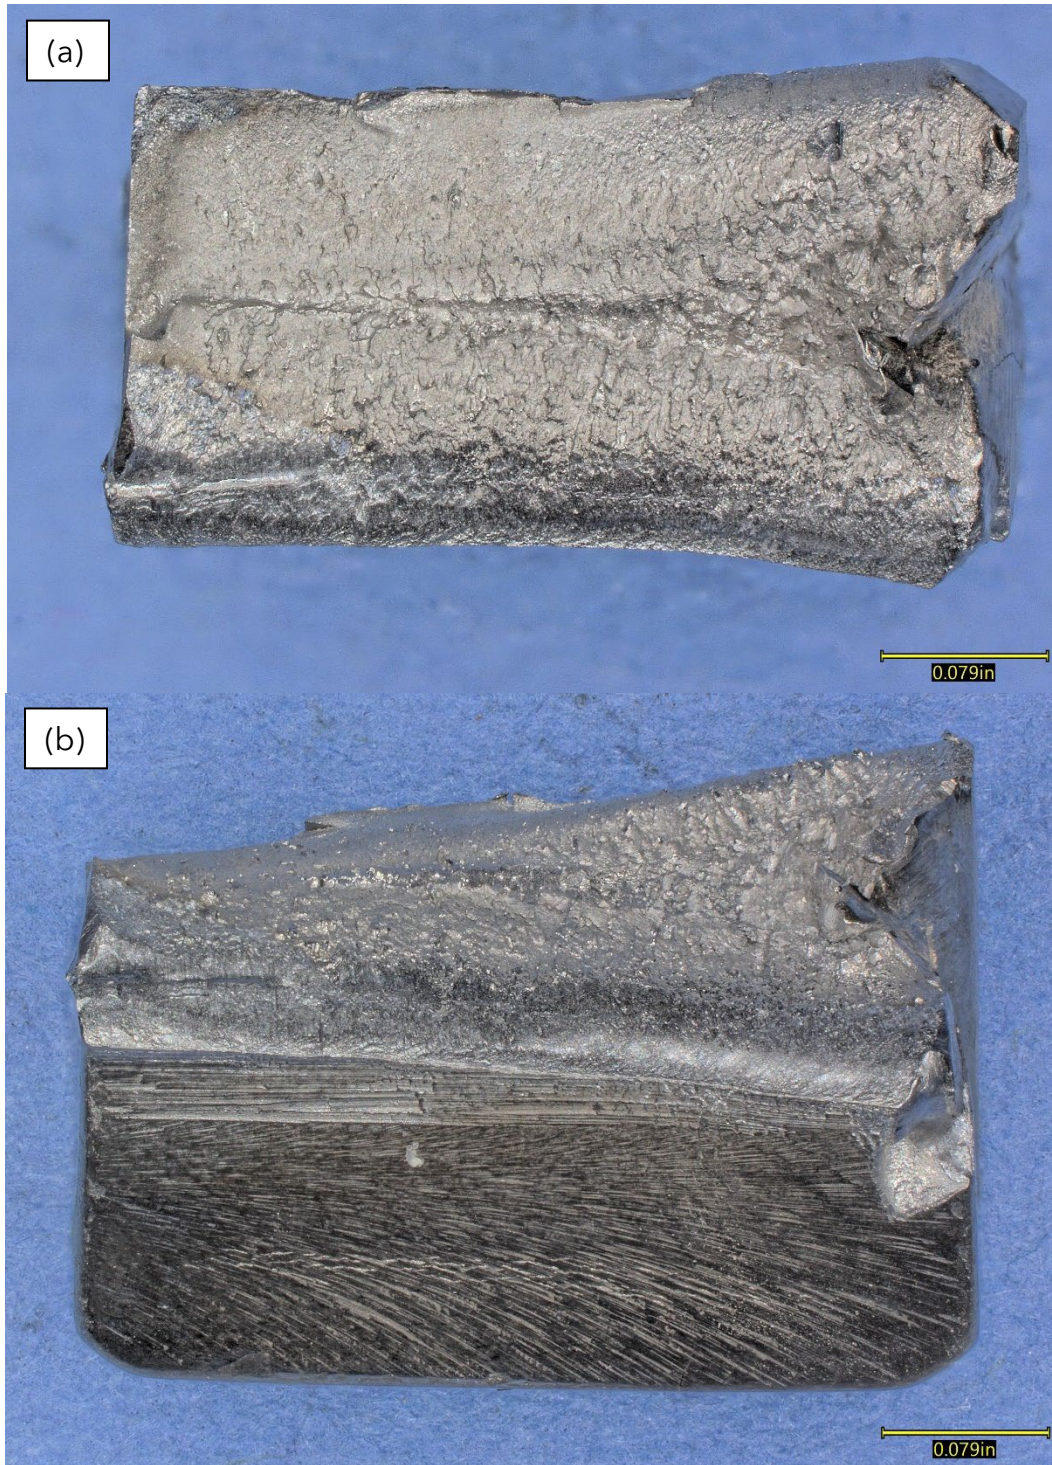
Figure 5 shows the fractured gear tooth #1, from the side and the fracture surface. The fracture surface exhibited a sloping, angled orientation, whose edges were located along the fillet radius below the flank. The fracture surface itself was mottled and reflective, consistent with post-fracture smearing. Examination of gear teeth #2 and #5 revealed similar features (the fracture surfaces of these teeth were not included in this report).

**Figure 5.** Views of the fractured gear tooth #1, viewed from (a) the fracture surface and (b) the side.

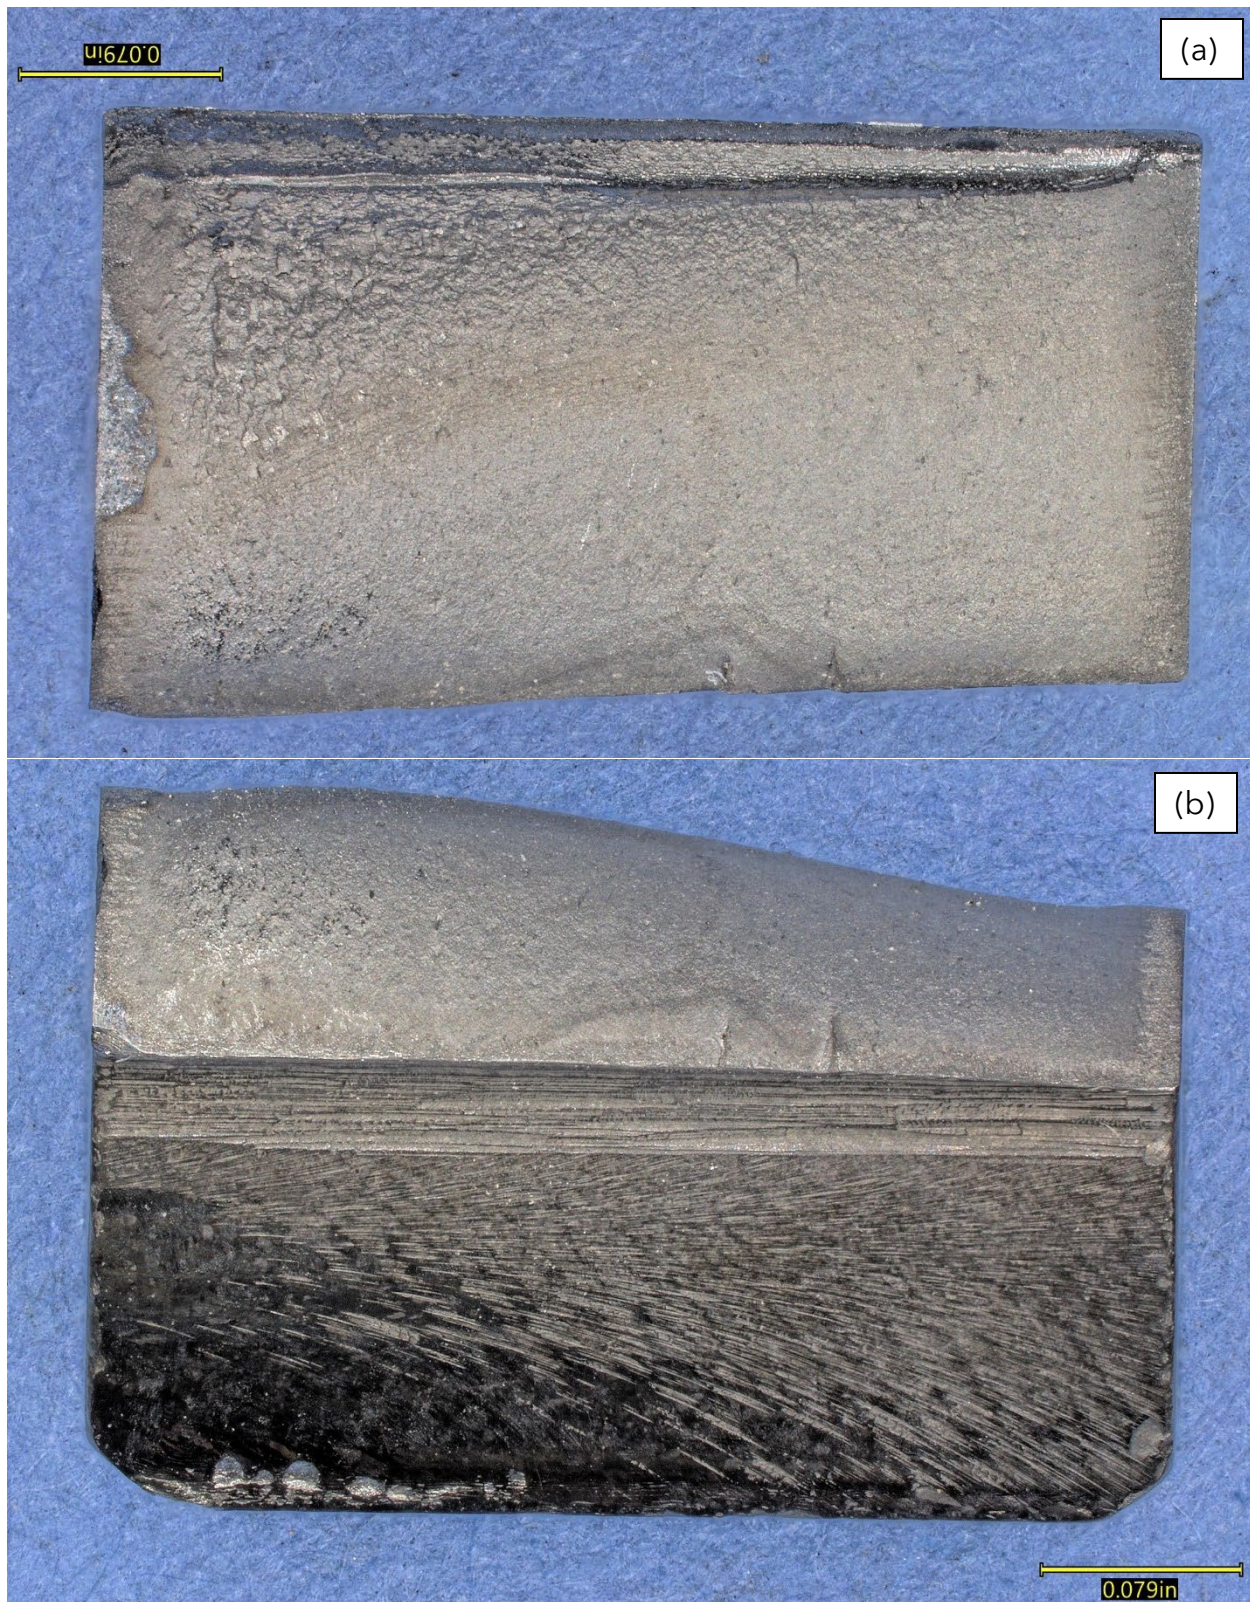
Figure 6 shows the fracture surface and side of the fracture surface edge of gear tooth #3. While also exhibiting an angled appearance, the fracture surface exhibited two areas with distinct features. The lower area in Figure 6a exhibited concentric marks consistent with crack arrest marks. The edge exhibited perpendicular features consistent with ratchet marks. These features were consistent with propagation of a pre-existing crack.

**Figure 6.** Views of the fractured gear tooth #3, from (a) the fracture surface and (b) the side of crack initiation. The figures are annotated to show the crack propagation direction and crack initiation site(s).

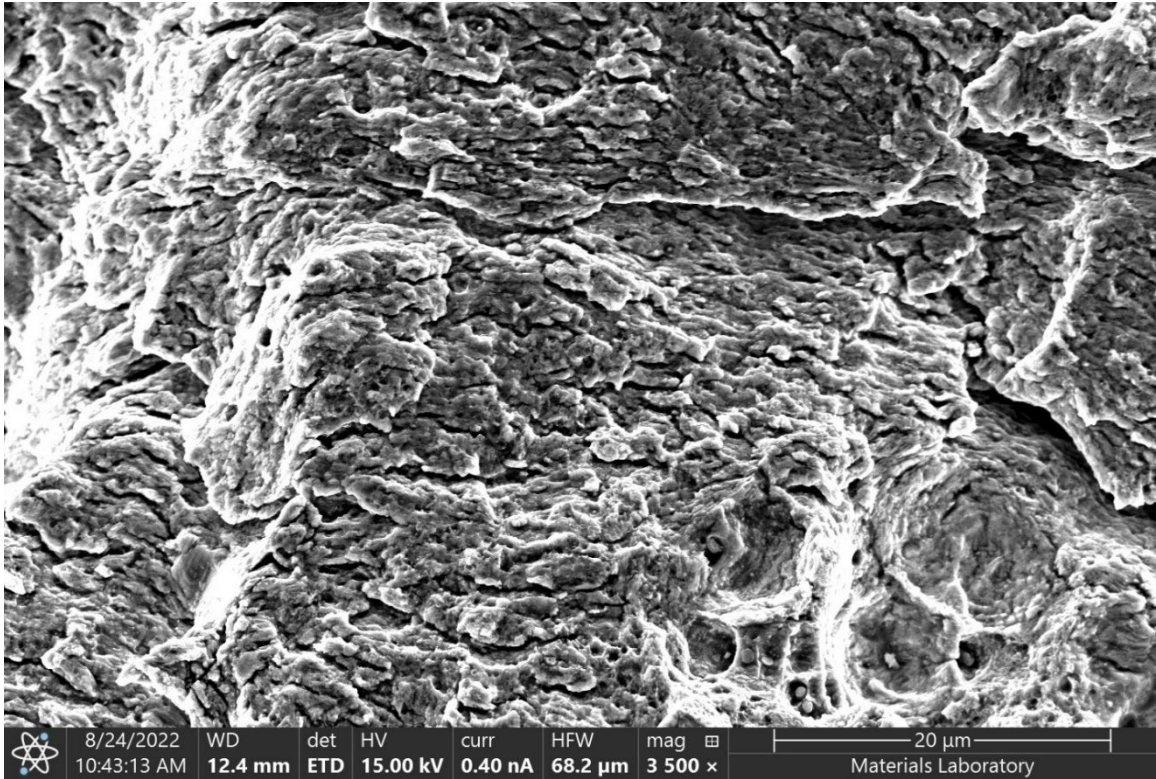
The #3 tooth was examined using a field-emission scanning electron microscope (SEM). Figure 7 shows a typical area of the fracture surface region with crack arrest marks—this area exhibited striations, consistent with fatigue crack propagation. Outside of this area on the fracture surface (or the upper area in Figure 6a), the fracture surface exhibited slanted dimpled rupture (Figure 8). These features were consistent with overstress fracture in shear. The fracture characteristics were consistent with this gear tooth having fractured from a fatigue crack that propagated about halfway through the tooth cross section before the remainder fractured in overstress.

**Figure 7.** Secondary electron (SE) micrograph of fatigue striations on the tooth 3 fracture surface.

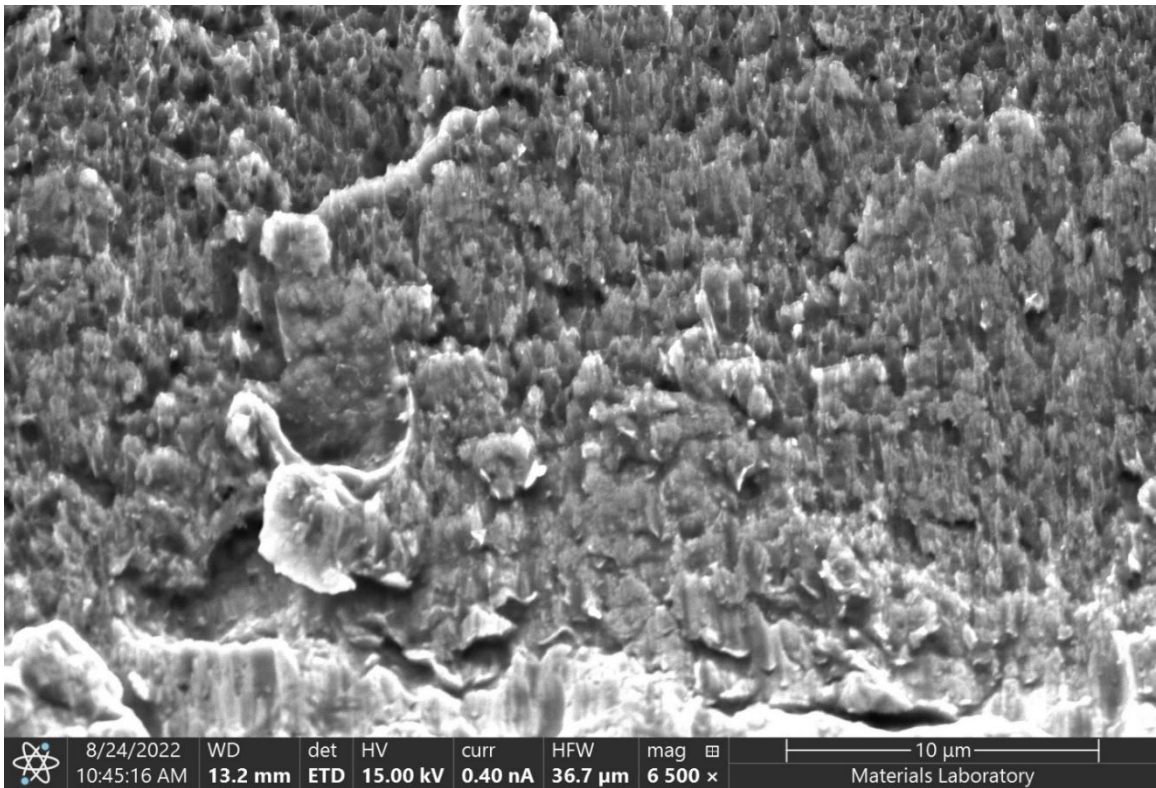
**Figure 8.** SE micrograph of dimpled rupture outside the fatigue crack on tooth 3.

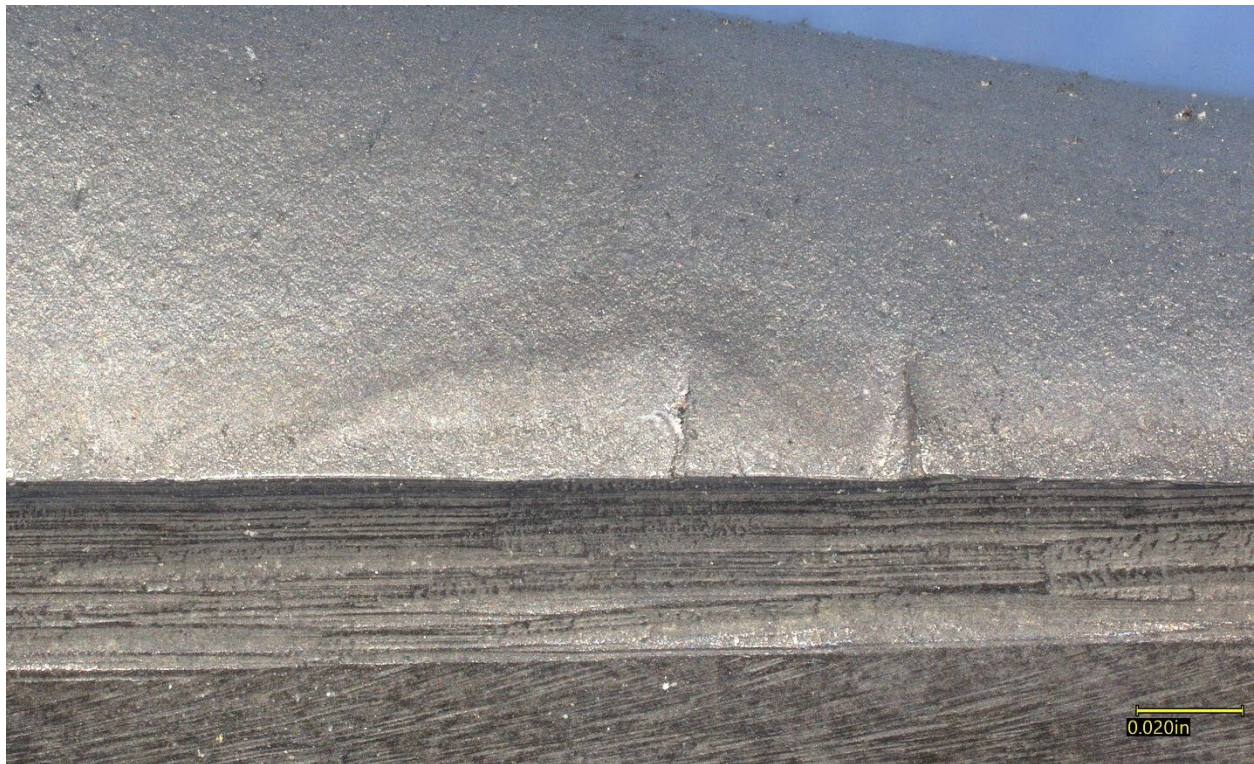
The initiation area of the fatigue crack is shown from the edge in Figure 9. As described previously, this area exhibited ratchet marks, consistent with multiple fatigue crack initiation sites. A planar view of one of these sites, located between two ratchet marks, is shown in Figure 10. Even after cleaning, many of the initiation sites retained post-fracture contamination, and several had been damaged by impacts and smearing. Figure 11 shows one undamaged initiation site. Located along the fillet radius of the tooth, the initiation site exhibited several concentric convex features, consistent with emanating or propagating from the surface site. A surface region 20 to 30  $\mu\text{m}$  ( $7.9$  to  $11.8 \times 10^{-4}$  inch) thick was present along the fracture surface edge. This area exhibited a flatter surface texture.

**Figure 9.** Closer view of the crack initiation sites and ratchet marks on the side of tooth #3.

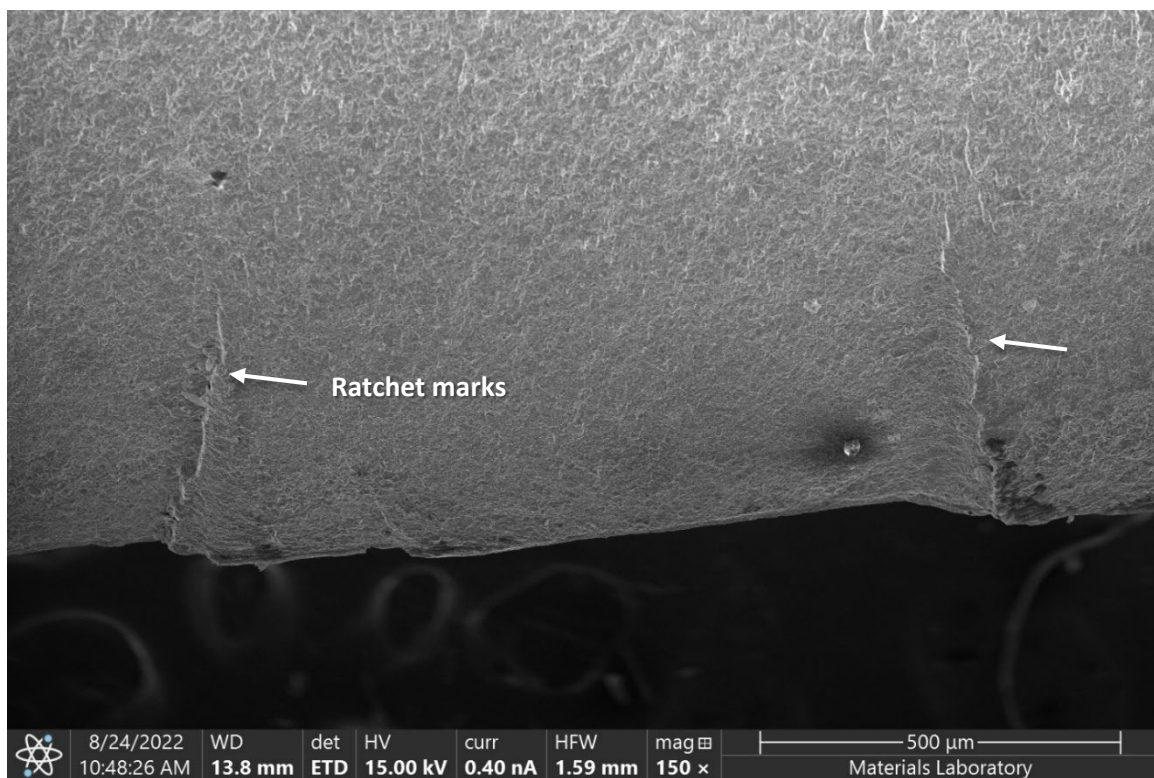
**Figure 10.** SE micrograph of several crack initiation sites of the fracture surface edge of tooth #3, highlighting the ratchet marks (yellow arrows).

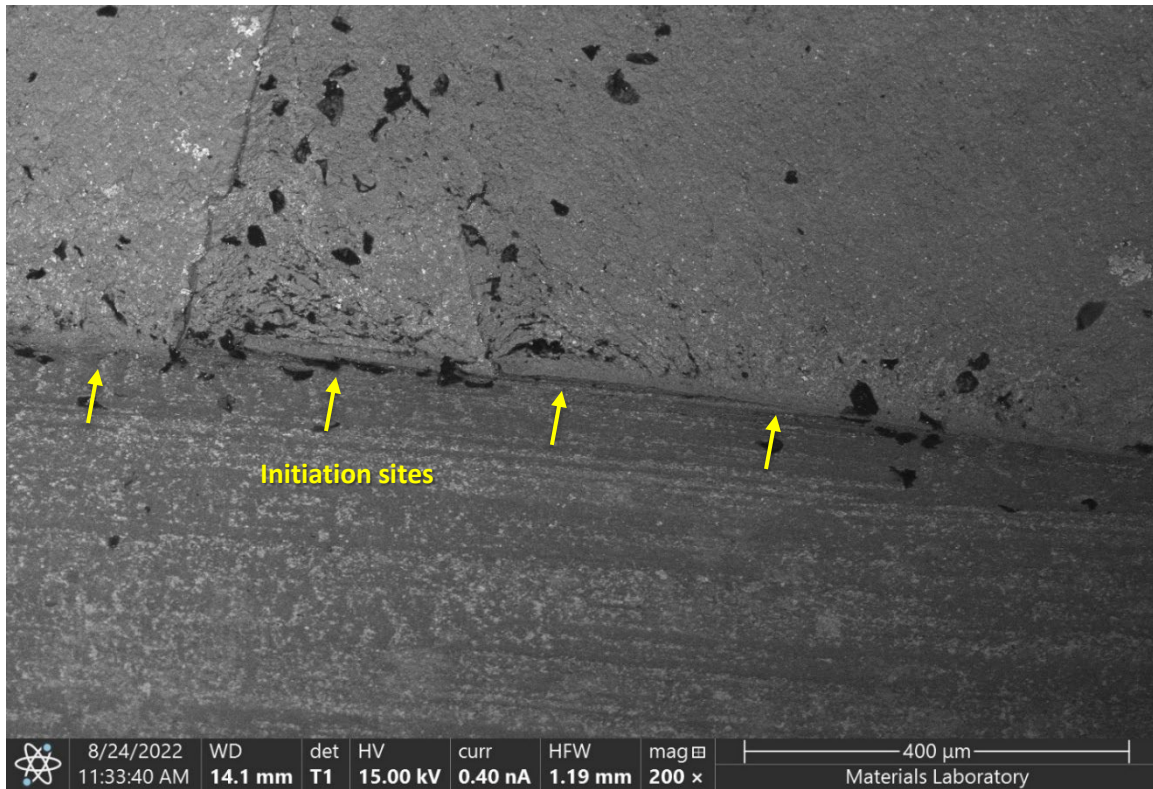
**Figure 11.** Backscattered electron (BE) micrograph of two of the crack initiation sites.

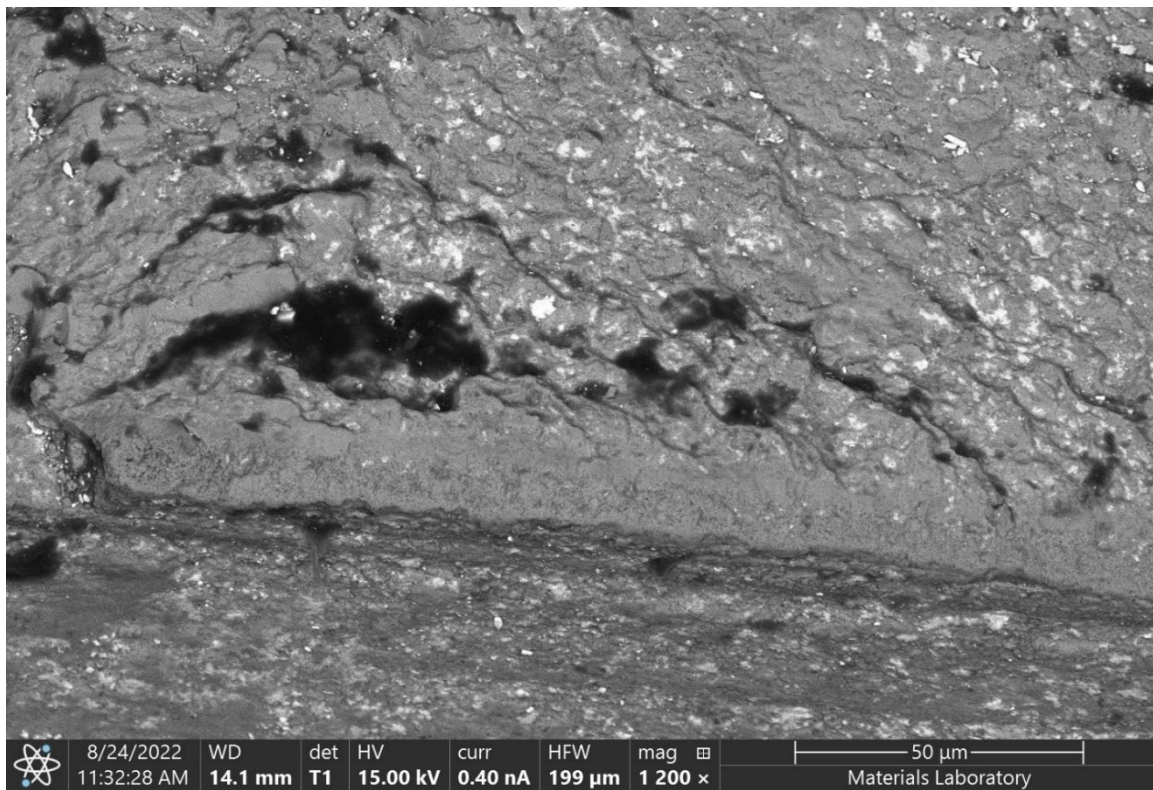
**Figure 12.** BE micrograph of the initiation site with the arrow in Figure 11.

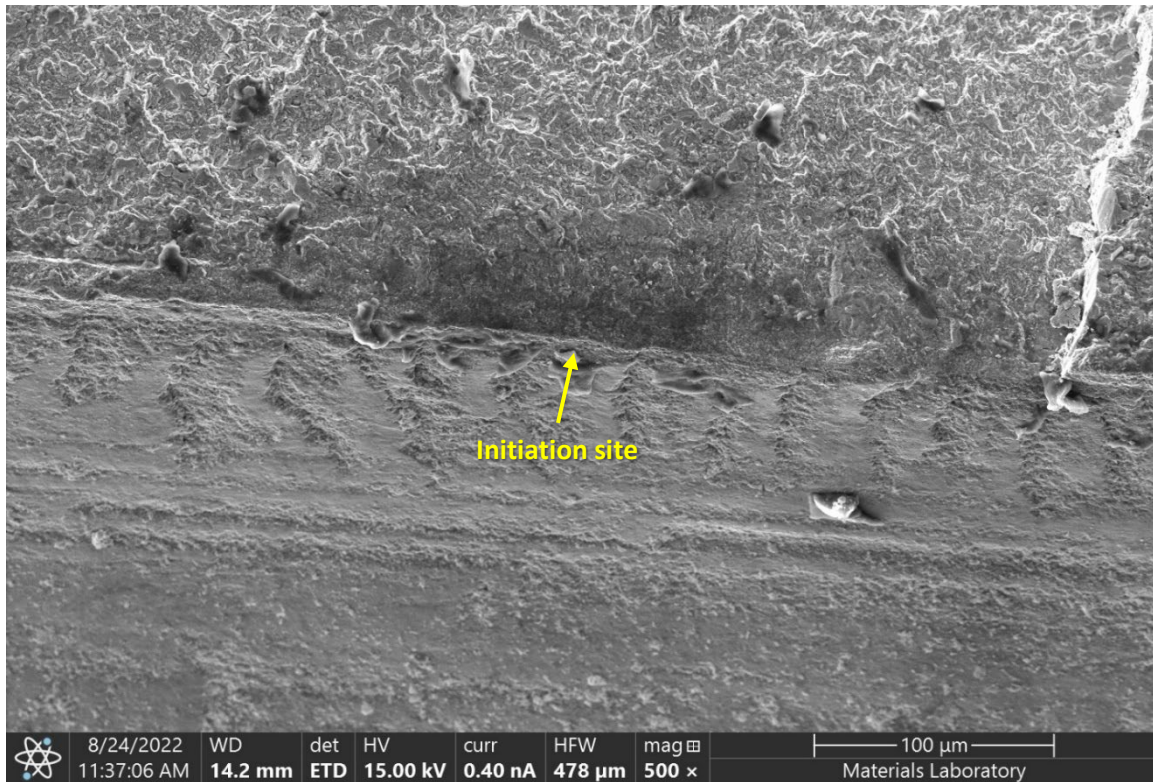
Another fatigue crack initiation site from this gear tooth, just left of a ratchet mark, is shown in Figure 13. Figure 14 shows a closer view of this site. Examination found a relatively flat edge, but there was some undulation along the surface, consistent with the surface wear marks along vertically oriented smearing lines (lower half of Figure 14). The radial lines on the fracture surface were consistent with crack propagation

**Figure 13.** SE micrograph of the crack initiation site to the left in Figure 11.

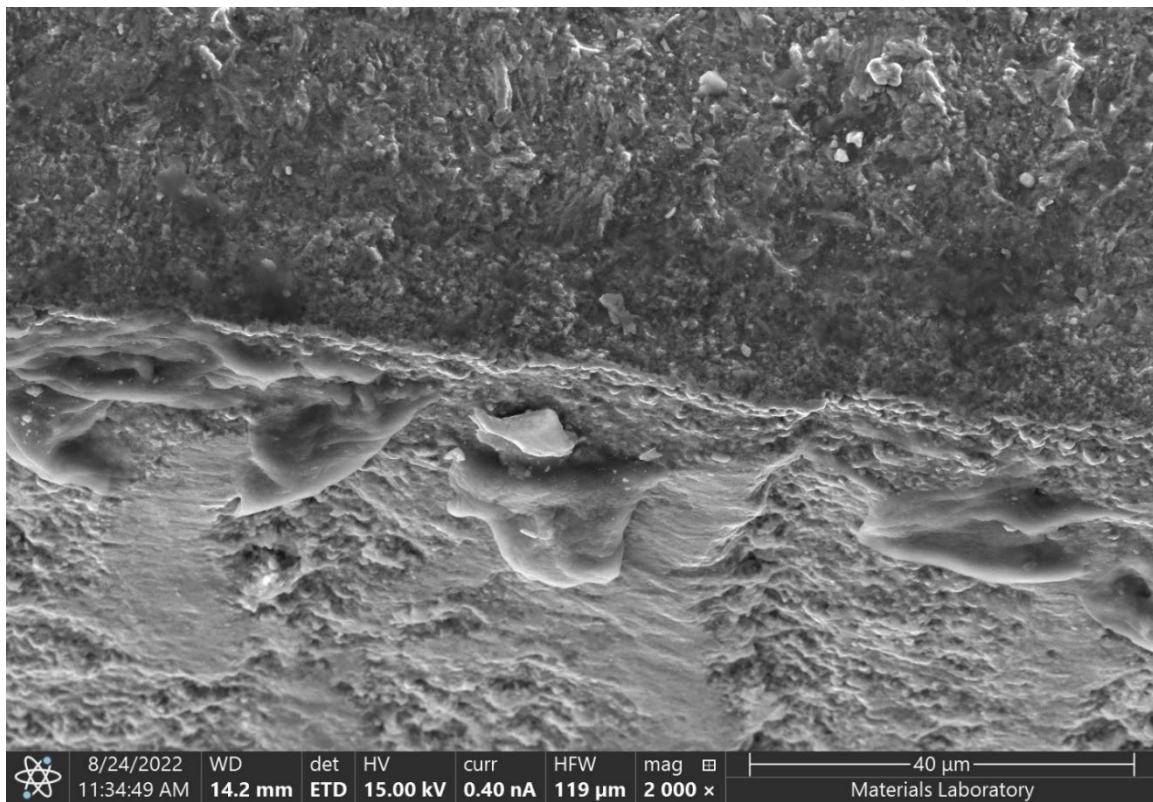
away from this region. There was also some surface material present on the fillet surface of the fracture tooth, consistent with contamination.

**Figure 14.** SE micrograph highlighting the crack initiation site in Figure 13.

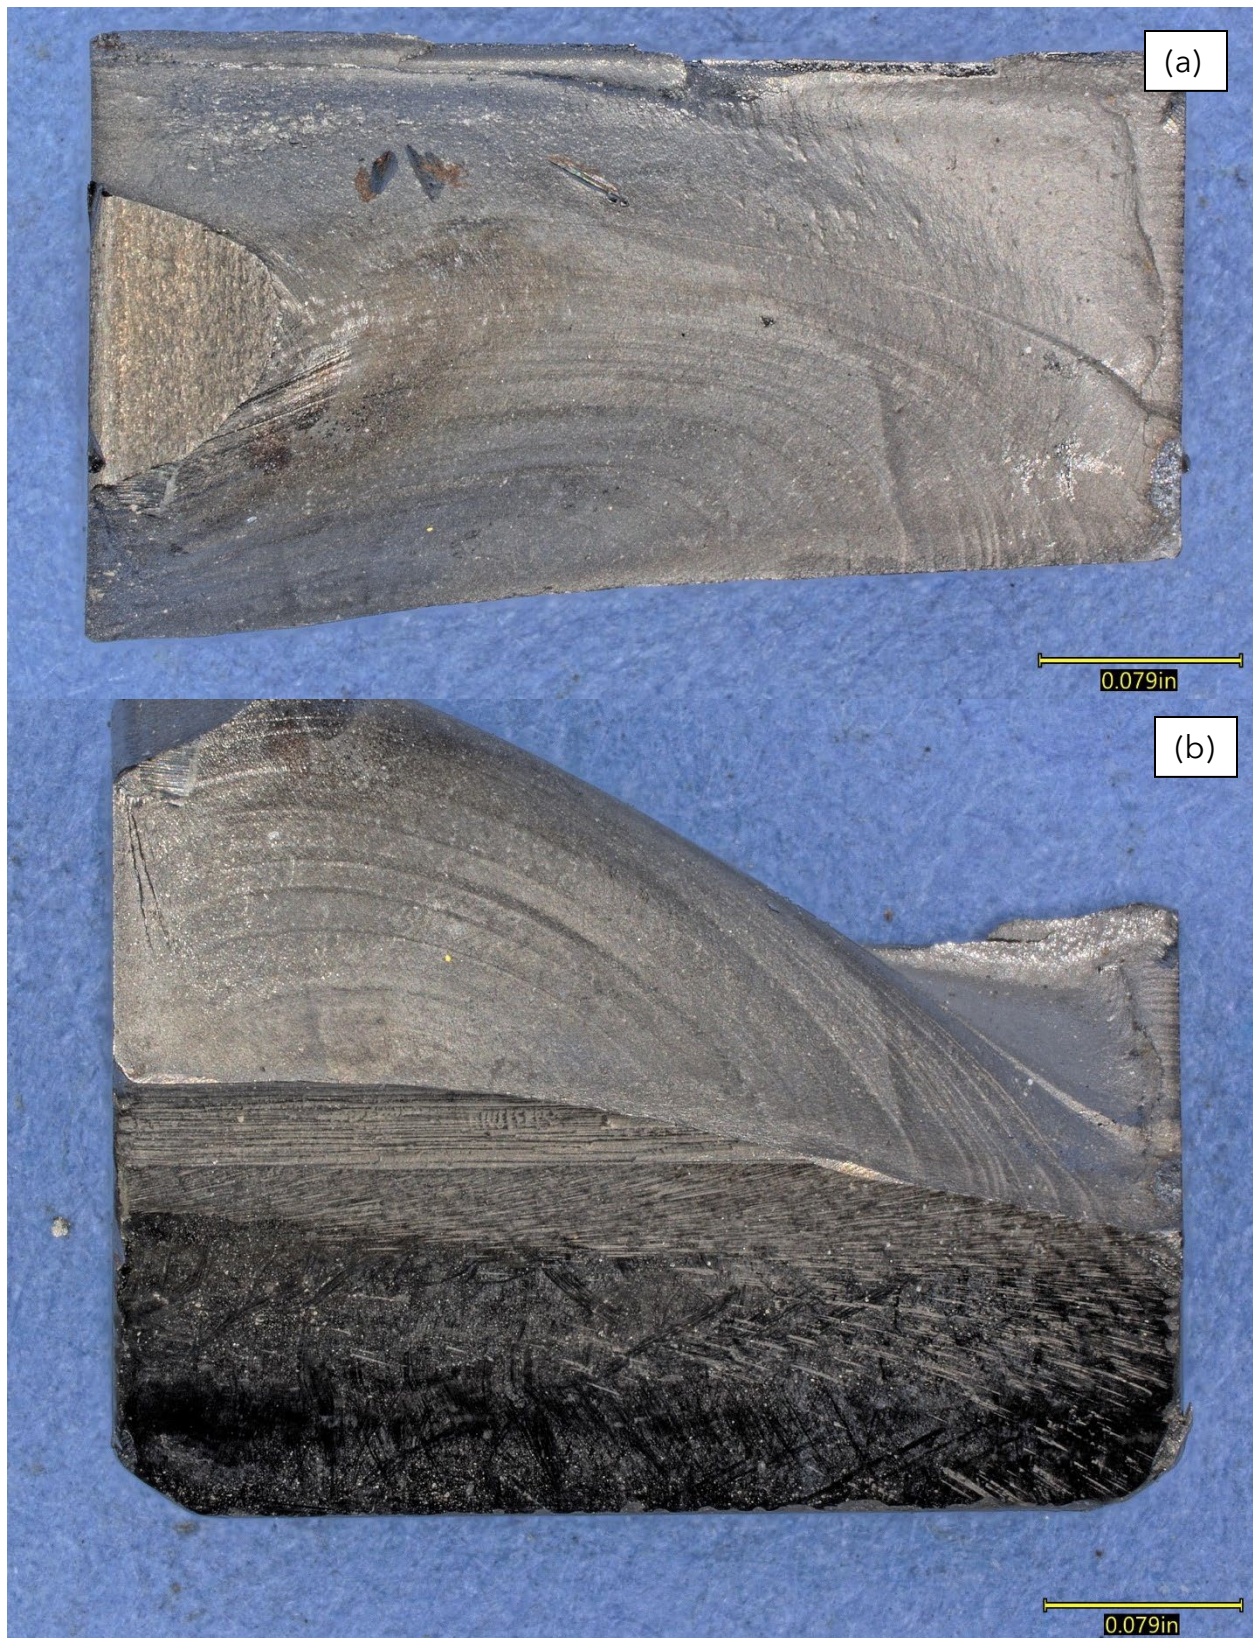
Gear tooth #4 also exhibited comparable features to gear tooth #3. As illustrated in Figure 15, gear tooth #4 exhibited concentric crack arrest marks over much of the fracture surface. Examination using a SEM found striations in this region, consistent with fatigue crack propagation. Outside this area (upper portion of Figure 15a), dimpled rupture was observed. Like the #3 fractured tooth, the #4 tooth exhibited a fatigue crack that propagated through over half the cross section, followed by the remaining material fracturing from overstress.

**Figure 15.** Views of the fractured gear tooth #4, viewed from (a) the fracture surface and (b) the side.

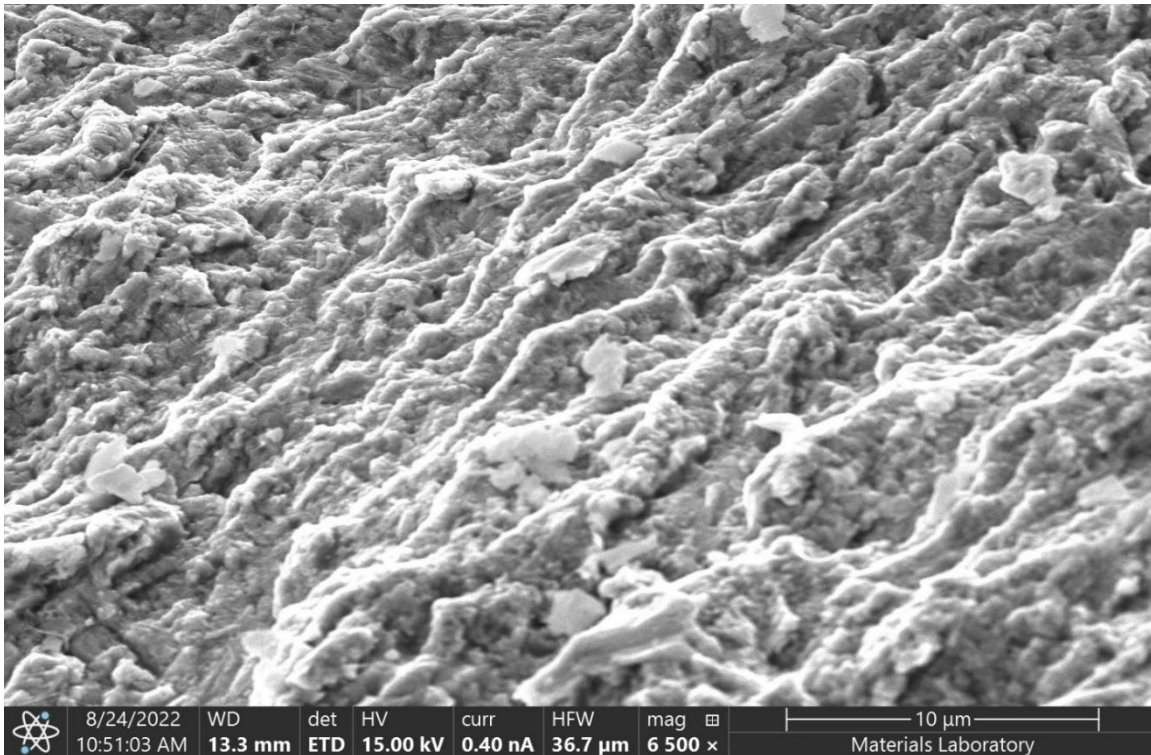
**Figure 16.** SE micrograph of a typical view of fatigue striations on the tooth #4 fracture surface.

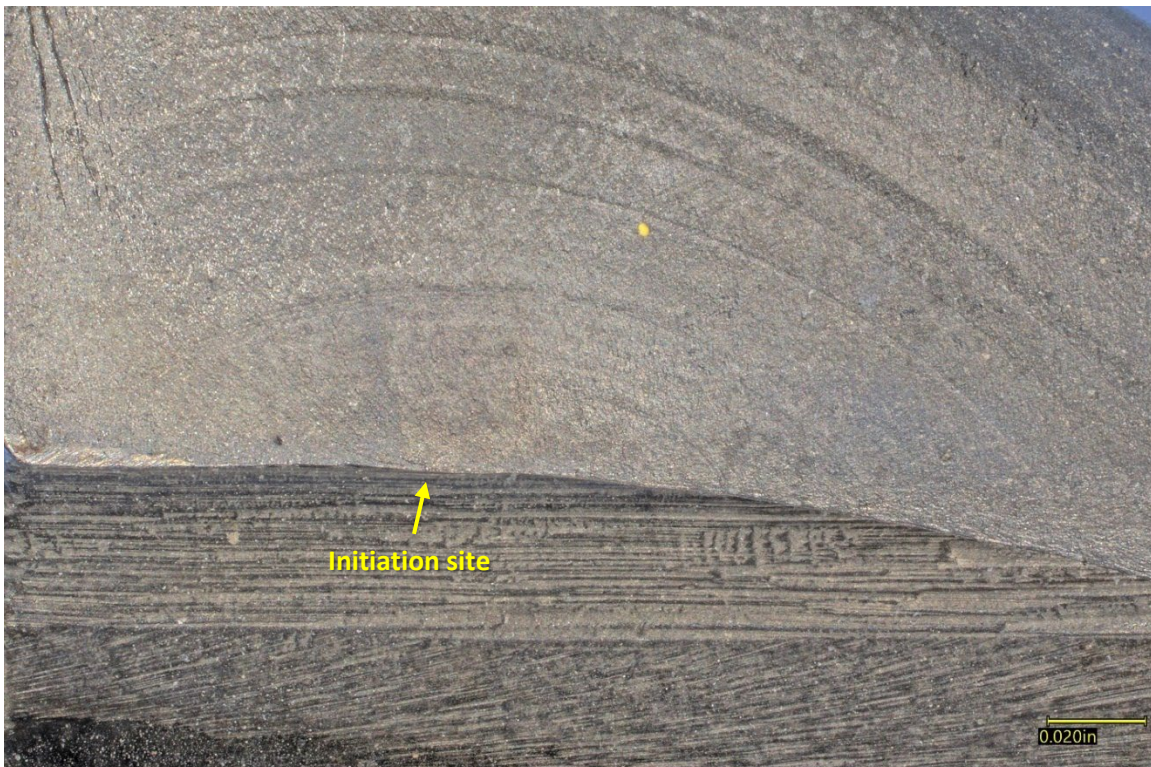
The initiation area, shown visually in Figure 17, was collocated at a fillet radius between the bottom land and the flank. Unlike tooth #3, there appeared to be only one initiation site for the fatigue crack of gear tooth #4. This was exemplified by the absence of ratchet marks (see Figure 18). As shown along and below the edge of the fracture surface in Figure 18, the crack initiation site was collocated with a gouge or machine mark.

**Figure 17.** View of the crack initiation site and propagating crack arrest marks on tooth 4.

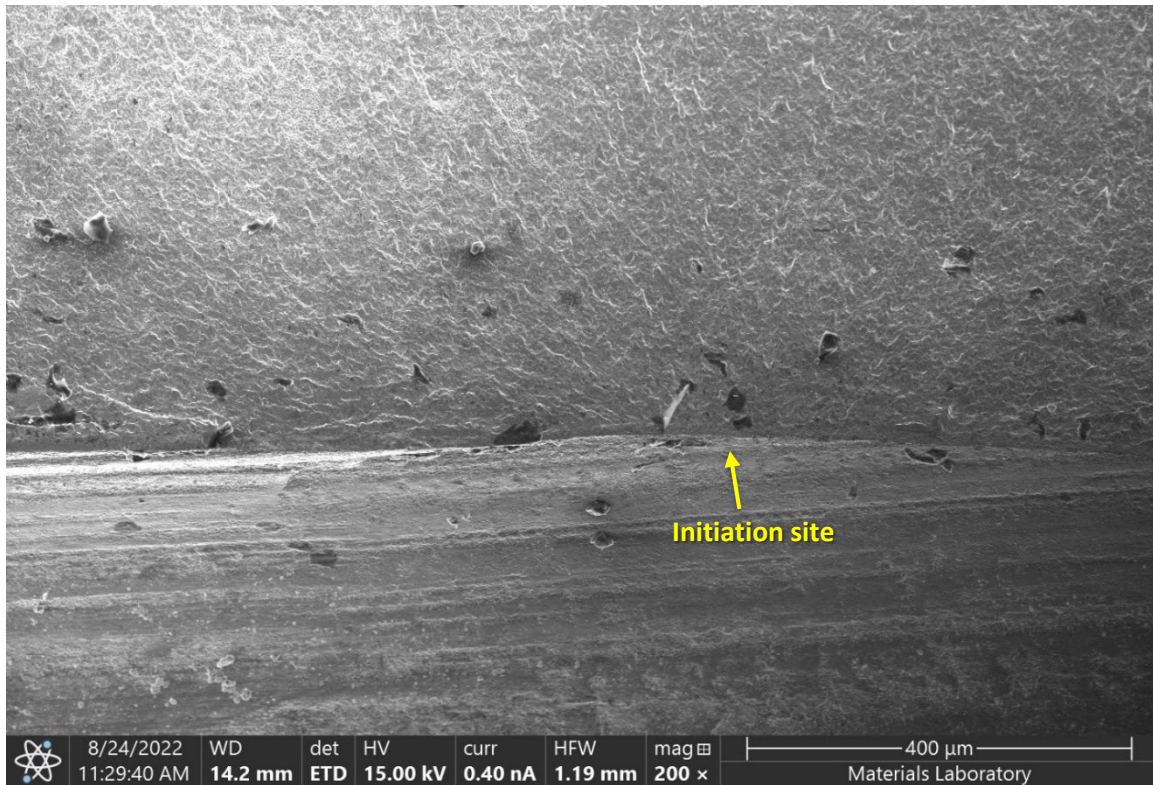
**Figure 18.** SE micrograph of the crack initiation site on tooth 4.

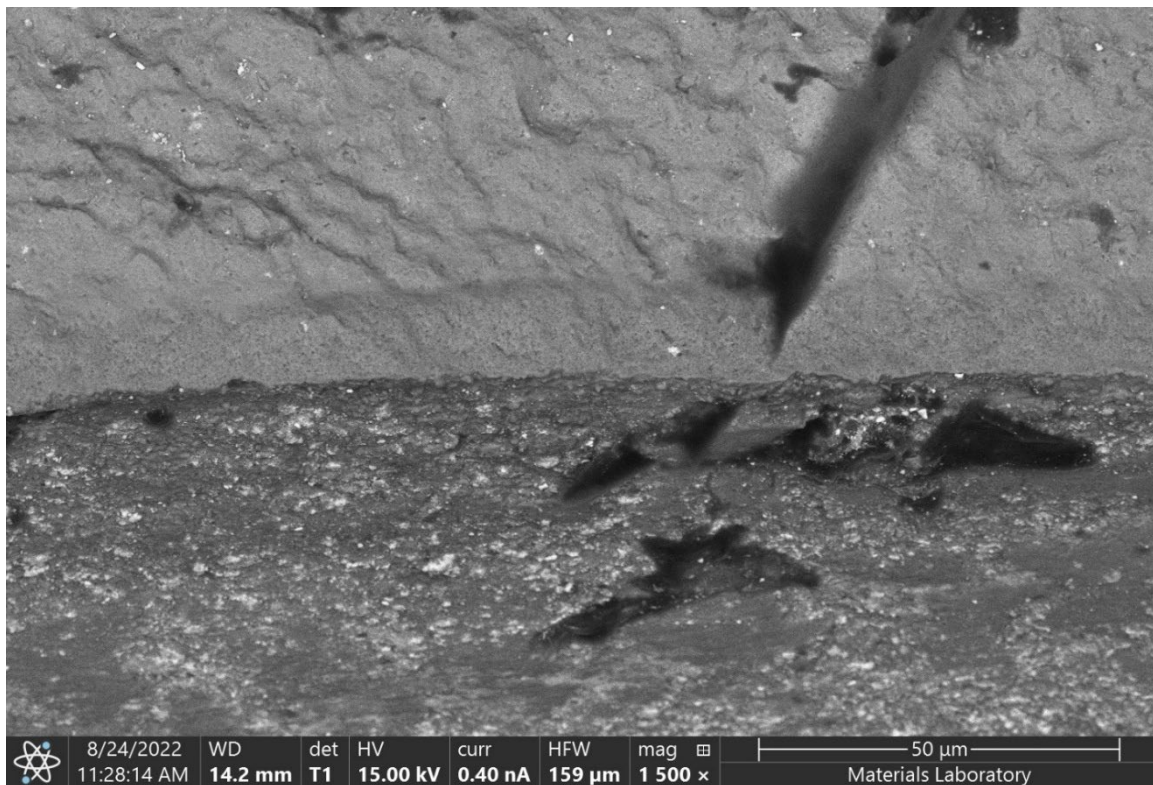
Figure 19 shows a closer view of the fatigue crack initiation site. This location showed the river patterns emanating outward away from the surface, consistent with the crack propagation direction into the thread material. There was also a surface area parallel to the fracture edge, which exhibited a flatter morphology than the radiating surface features further inward. The thickness of this layer was consistent with that of gear tooth #3 (shown in Figure 12 and Figure 14).

**Figure 19.** BE micrograph highlighting a closer view of the initiation site in Figure 18.
