# National Transportation Safety Board

WPR22LA019

## **MATERIALS LABORATORY**

Specialist's Factual Report 22-066

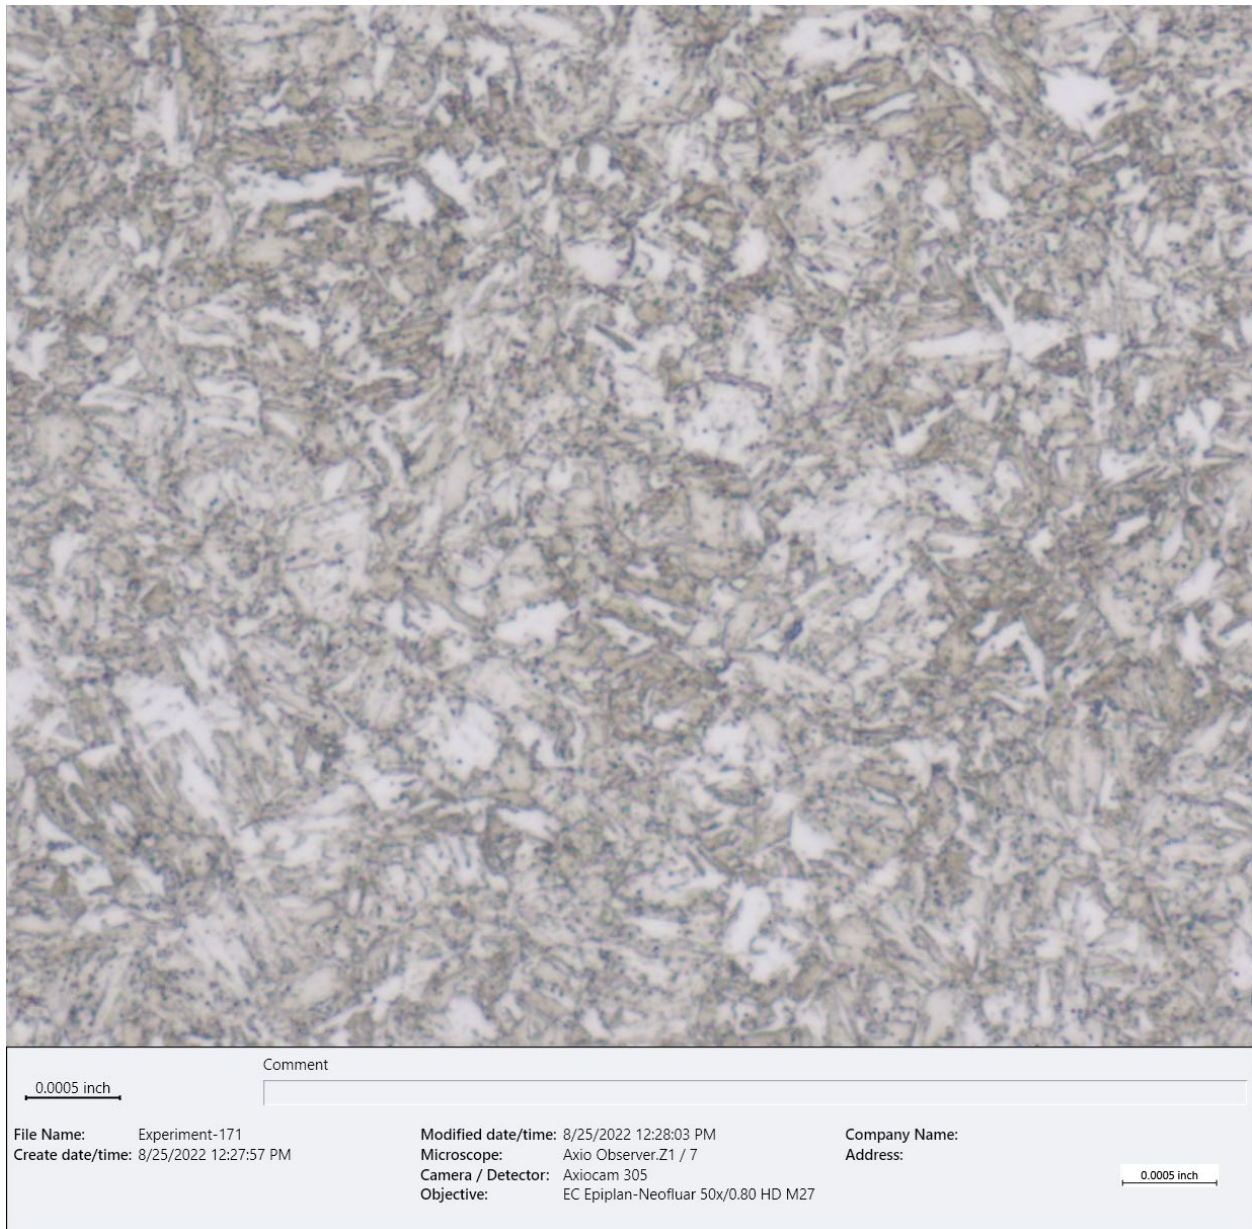
The fractured tooth #1 was mounted, polished, and etched with a 2% Nital solution to examine the camshaft gear teeth microstructure.<sup>1</sup> The grain flow of the material conformed to the shape of the threads, consistent with the forging manufacture of the camshaft gear. Figure 20 shows a typical area of the gear tooth microstructure, towards the central core location. The microstructure exhibited a morphology consistent with tempered martensite, exhibiting acicular lighter ferrite phases and cementite-containing darker constituents. This microstructure was typical for alloy steels having been quenched and tempered after normalizing or annealing.

**Figure 20.** Bright-field (BF) optical micrograph of a typical area of the gear tooth microstructure, showing ferrite and tempered martensite constituents (~1000X, etched 2% Nital).

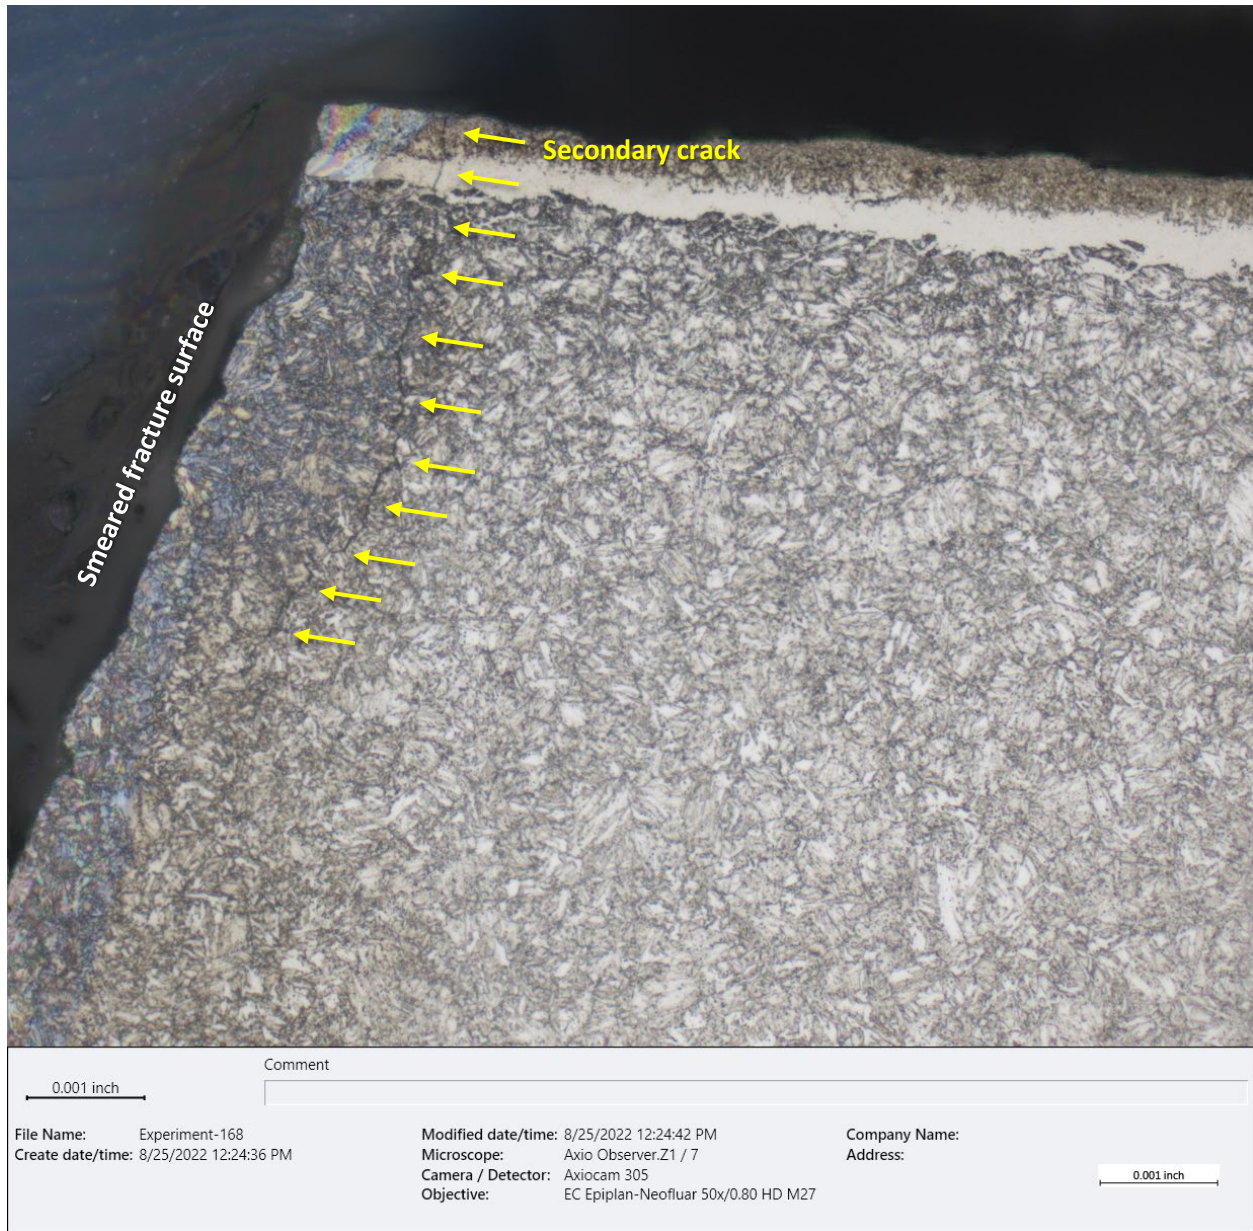
The edge of the cross-sectioned tooth #1 near the fracture surface is illustrated in Figure 21. The fracture surface itself had been smeared to the extent that the fracture features were obliterated, and as such, the surface exhibited rounding along the microstructural features. However, approximately 0.001 inches above the fracture surface, (to the right in the figure) a parallel secondary crack was observed. This crack extended approximately 0.006 inches into the tooth.

**Figure 21.** BF optical micrograph of an area adjacent to the tooth fatigue fracture surface, showing a parallel secondary crack (arrows) (~500X, etched 2% Nital).

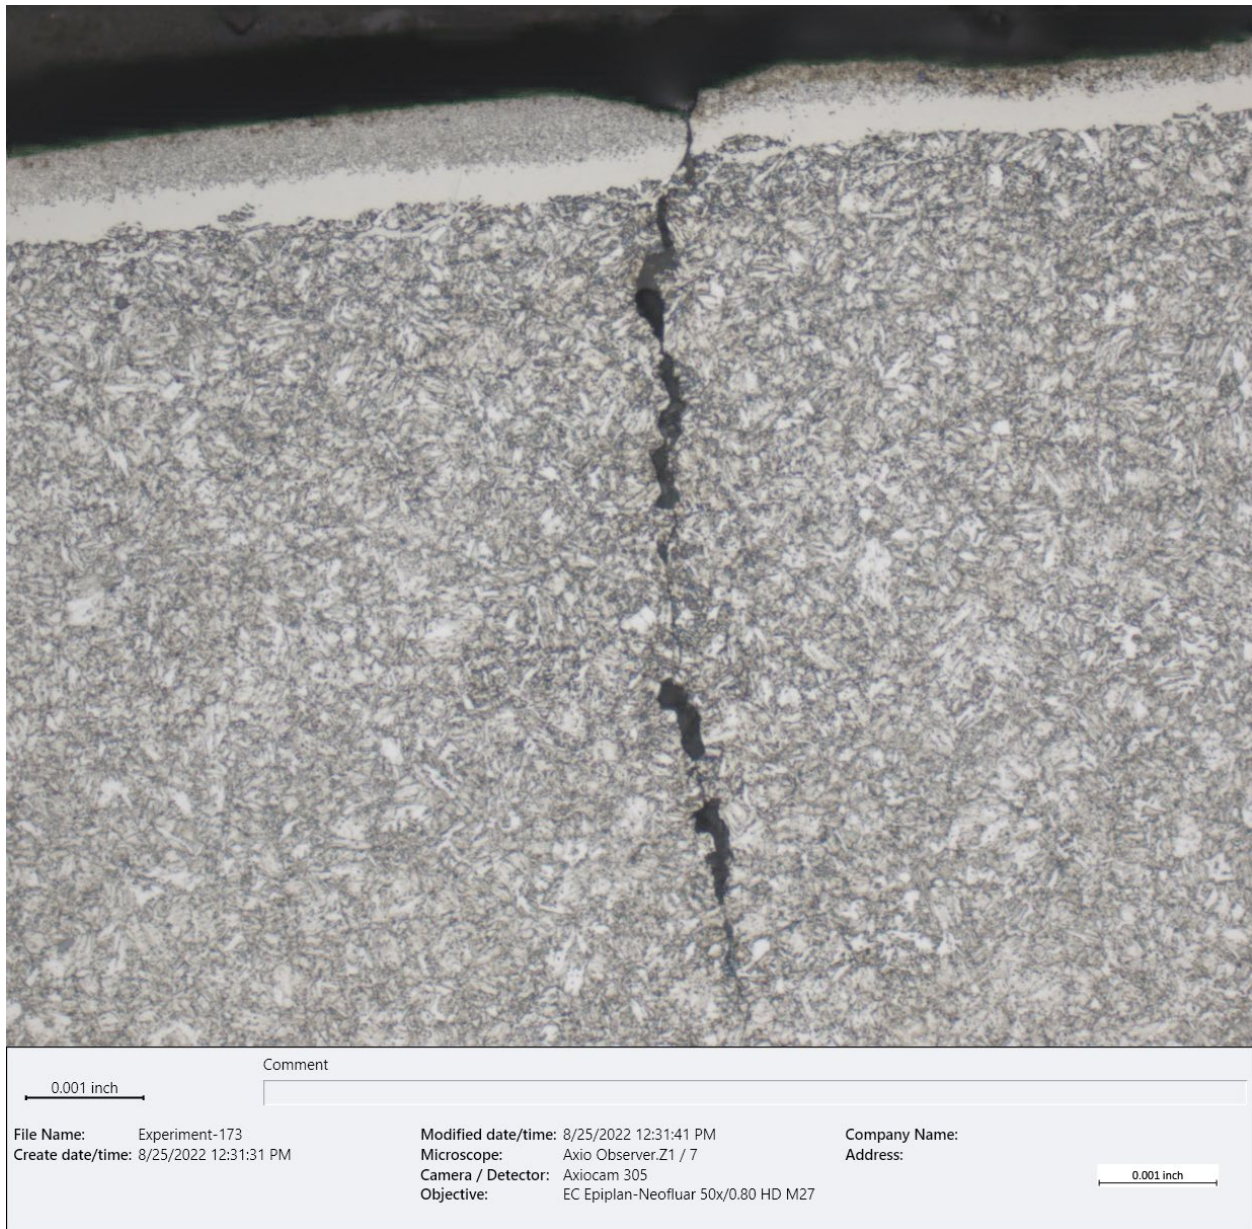
A similar crack was found on the opposite side of the tooth away from the fracture surface. As shown in Figure 22, this crack was approximately 0.007 inches long, and it had initiated at the surface. In both cases, the cracks were oriented perpendicular to the surface, consistent with transgranular propagation.

**Figure 22.** BF optical micrograph of a surface crack on the opposite side of the tooth shown in Figure 21, located away from the fracture surface, located through a surface nitride layer (~500X, etched 2% Nital).
