## **NATIONAL TRANSPORTATION SAFETY BOARD**

# **ENGINE EXAMINATION SUMMARY REPORT**

**WPR22LA019**

Location: Fall River, Oregon  
Date: October 14, 2021  
Aircraft: N511ZZ  
NTSB IIC: Andrew Swick

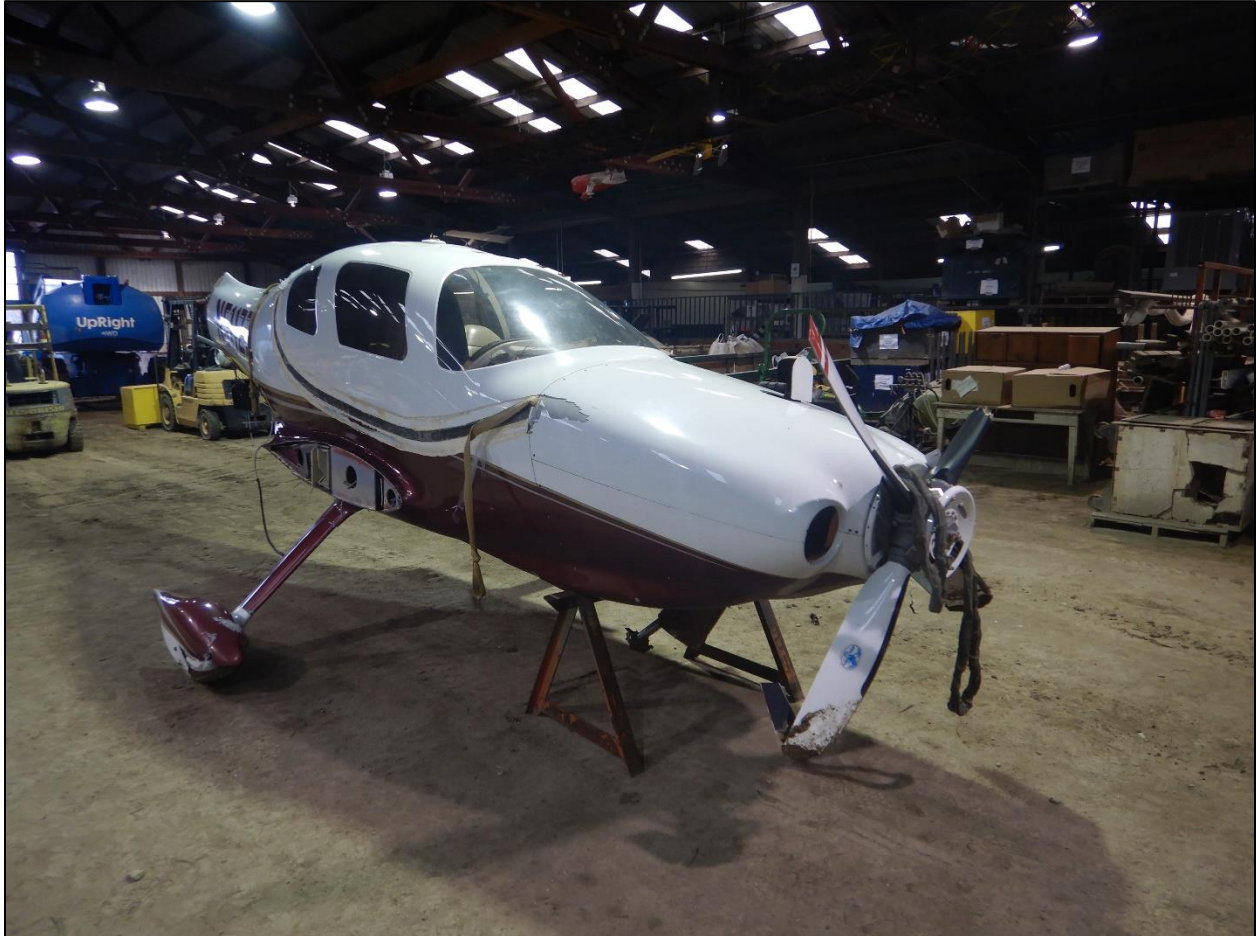
Figure 1-Main wreckage.

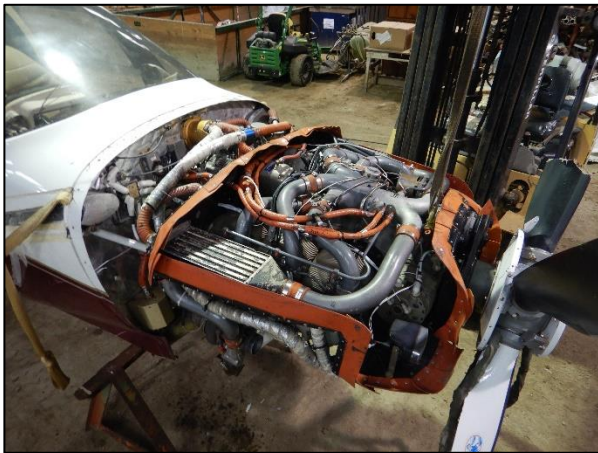
Figure 2-Upper right side of the engine.

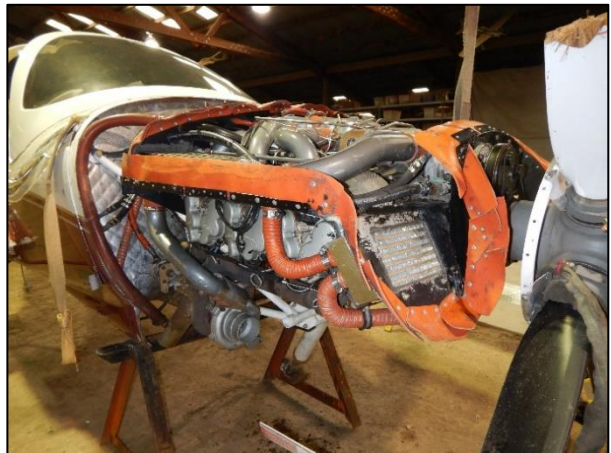
Figure 3-Forward left side of the engine.

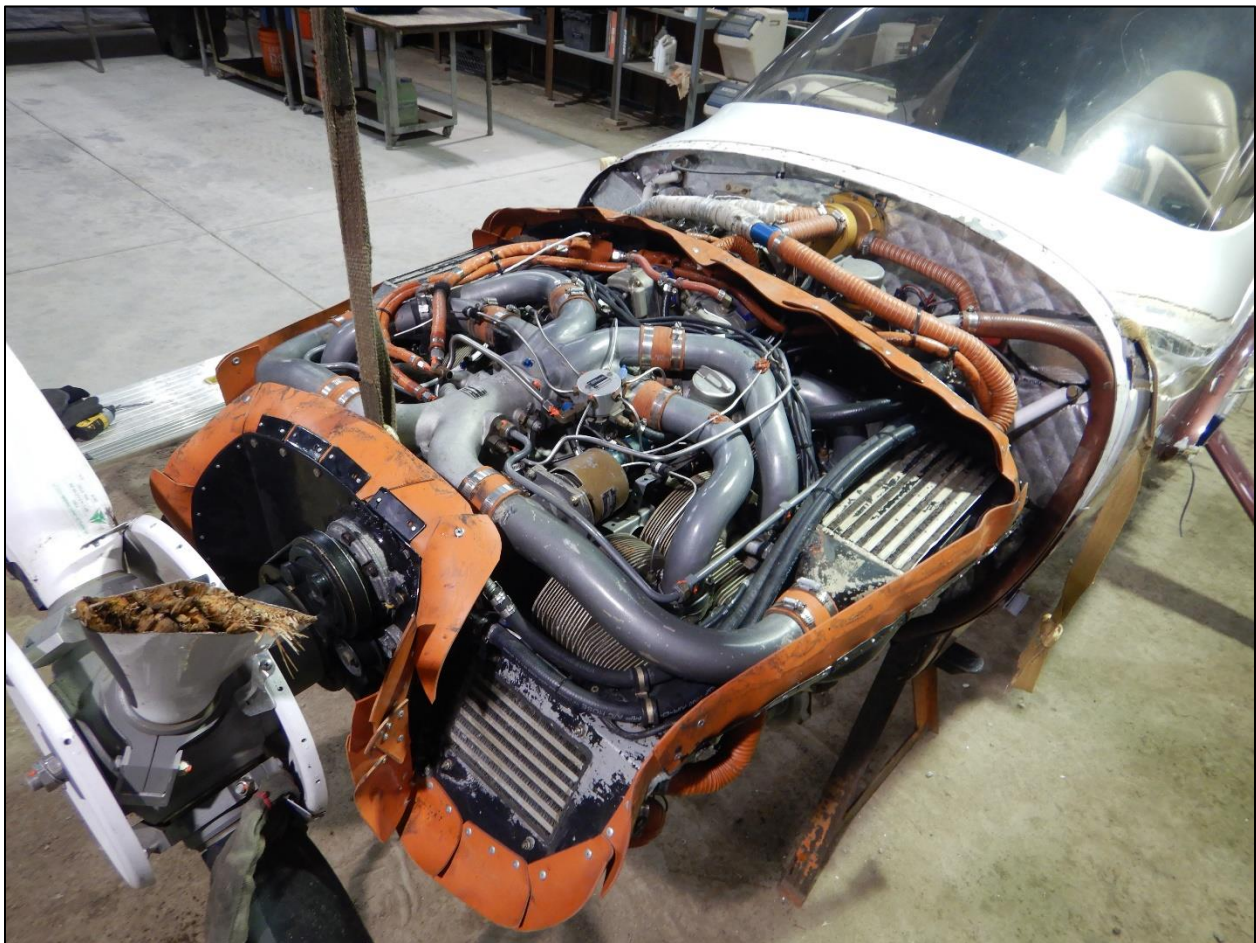
The upper and lower cowling was removed from the engine. The engine exterior was examined, and no damage was noted. About 7 quarts of oil was indicated from the oil dip stick.

Figure 4-Top left view of the engine.

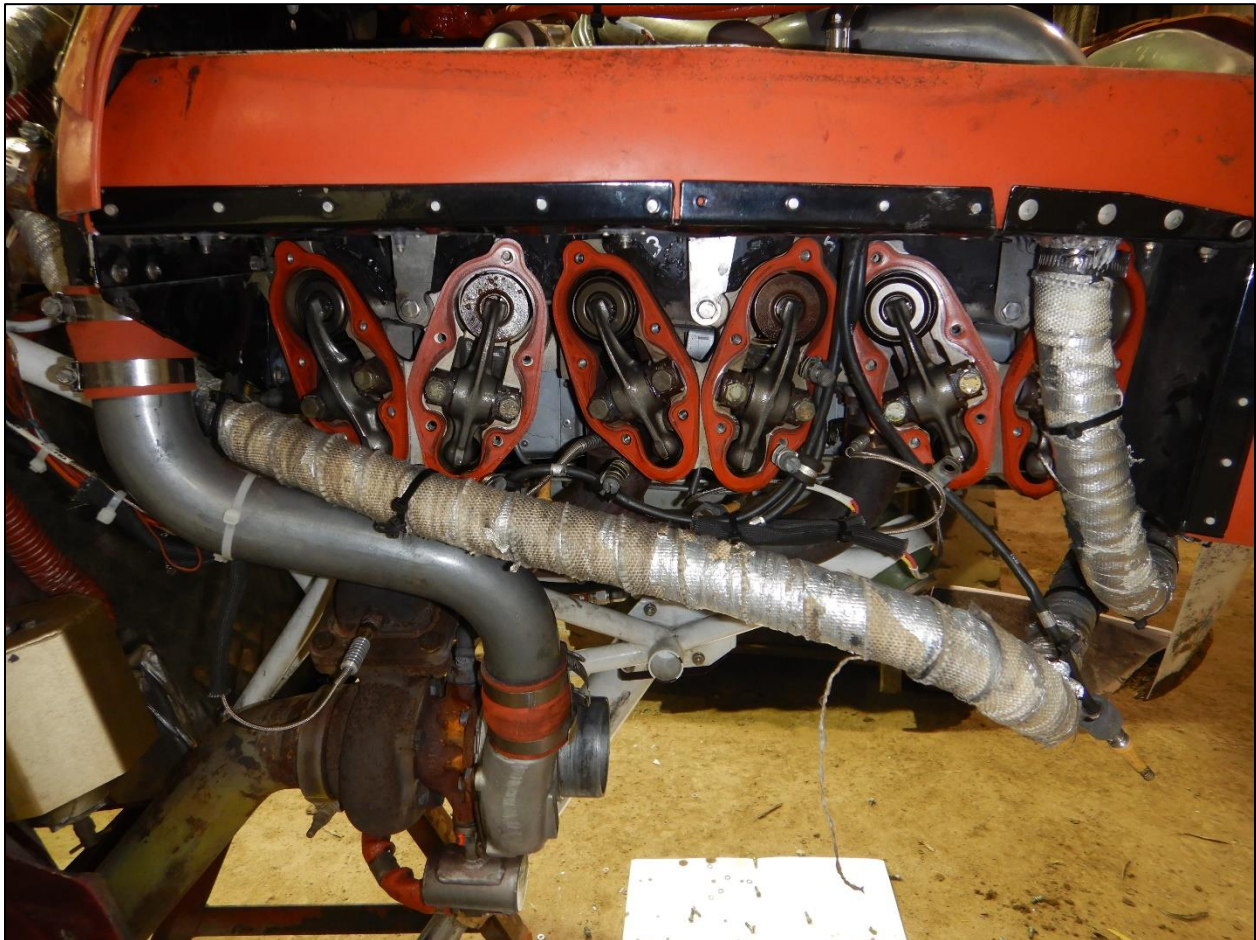
The lower spark plugs were removed from the engine. The cylinders combustion chambers were examined with the use of a lighted boroscope. Each cylinder revealed a normal amount of combustion deposits and the valve heads revealed normal operation. Each the six piston heads had impact marks from each valve. The crankshaft was rotated by hand from the propeller assembly, and cylinder thumb compression was obtained to only four cylinders. The cylinder rocker covers were removed from each cylinder and the cylinder overhead components were undamaged and covered in an oil residue. The crankshaft was again rotated, and no movement was noted from each of the cylinder overhead components.

Figure 5-Cylinder overhead components, right side (No. 1, 3 and 5.)

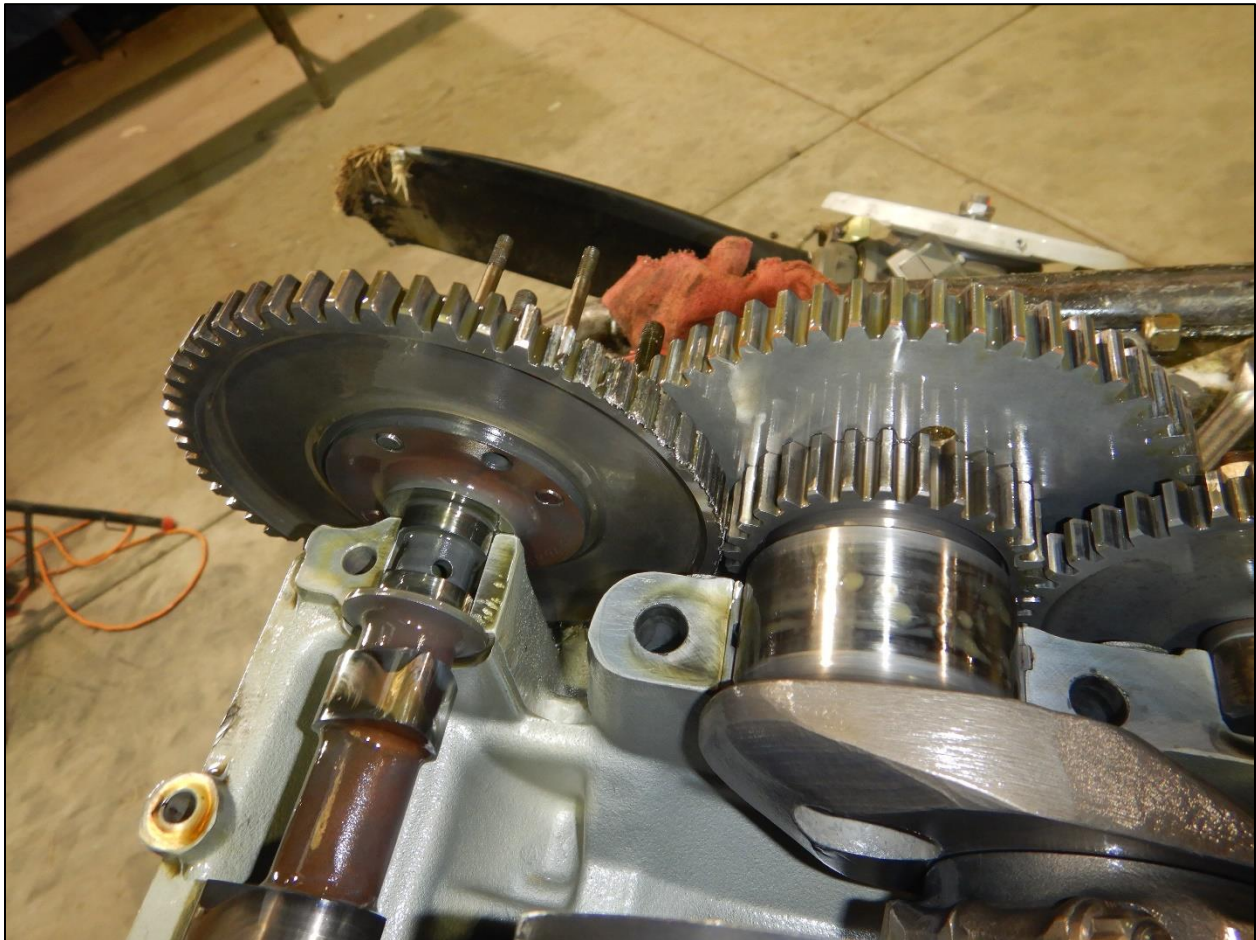
Examination of the engine was conducted at Plain Parts in Pleasant Grove, California on December 22, 2021. The examination revealed the separation of gear teeth from the camshaft drive gear. No other evidence of preaccident mechanical malfunctions or anomalies were noted that would have precluded normal operation.

Figure 6-Engine accessory section gears-camshaft drive gear teeth separation.

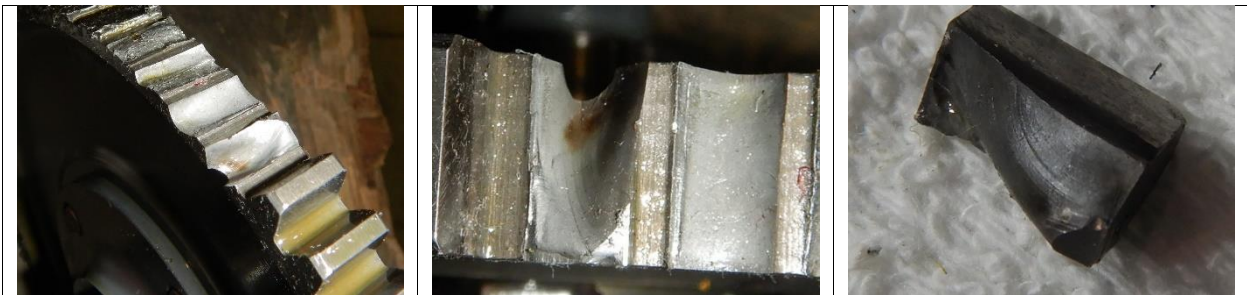
Figure 7-Camshaft drive gear-gear teeth separation.

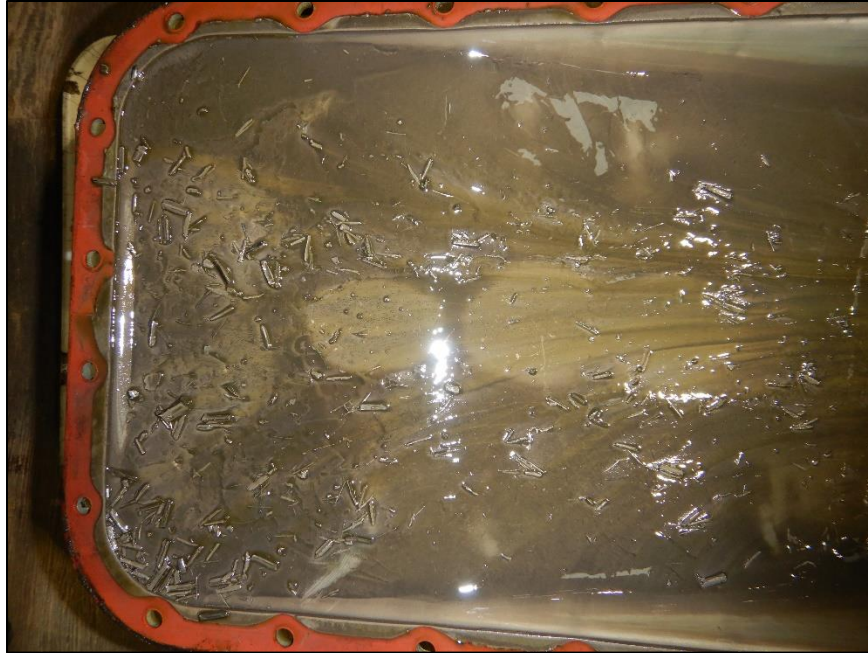
The engine was removed from the airframe and disassembled. The oil sump contained metal fragments. The crankcase halves were separated, and the crankcase mating surfaces were undamaged. Small metal fragments were found throughout the interior of the engine. The valve lifters installed in both crankcase halves were undamaged. The camshaft drive gear had missing gear teeth and material deformation. About 2/3rds of the camshaft drive gear teeth were damaged. The camshaft lobes had normal lifter contact wear signatures and several lobes had mechanical damage on their edges. The crankshaft was removed, and the main bearings were undamaged and showed normal operating wear signatures.

Figure 8-Oil sump and contents.

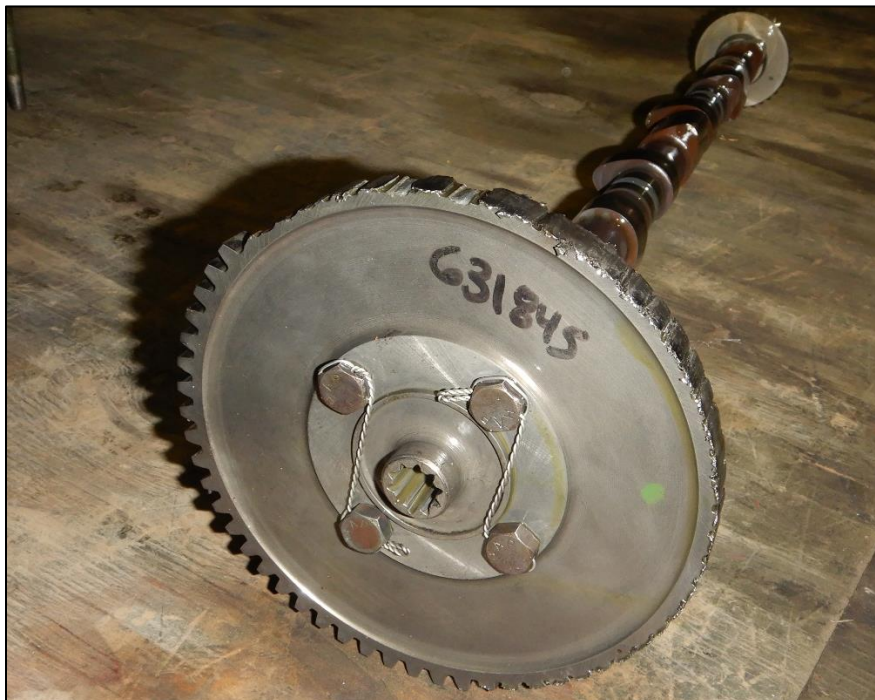
Figure 9-Camshaft assembly.
