# NATIONAL TRANSPORTATION SAFETY BOARD

## MATERIALS LABORATORY FACTUAL REPORT

Report No. 22-062

Place : Laveen Village, Arizona  
Date : November 15, 2021  
Vehicle : Sonex Waix B, N535D  
NTSB No. : WPR22LA035  
Investigator : Andrew Swick, AS-WPR

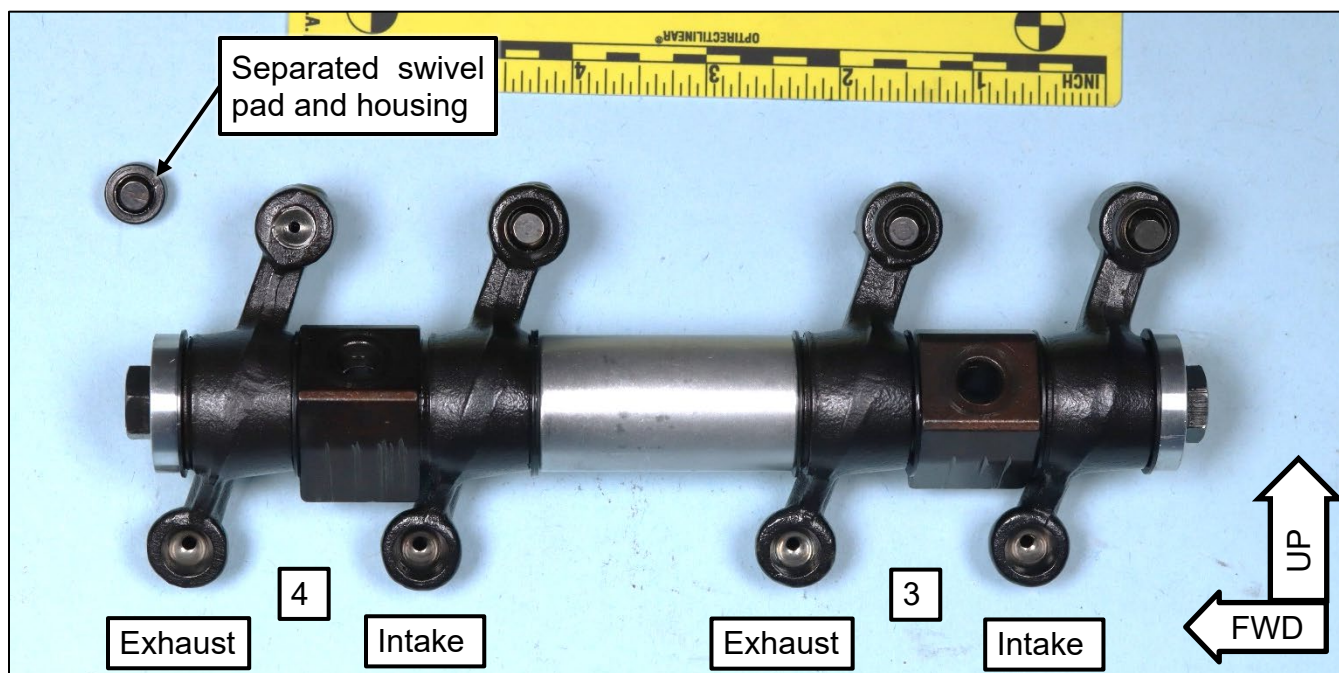
An overall view of the submitted rocker assembly for the number 3 and number 4 cylinders is shown in figure 1. The adjuster for the number 4 exhaust valve was fractured at the outboard side of the swivel pad housing, and the inboard end of the adjuster with the swivel pad and housing was recovered loose in the rocker cover during the post-accident engine examination. The other three adjusters were intact, and the swivel pads moved freely within the housings.

Figure 1. Overall view of the rocker assembly showing the inboard side of the rocker arms including the fractured number 4 exhaust valve adjuster.

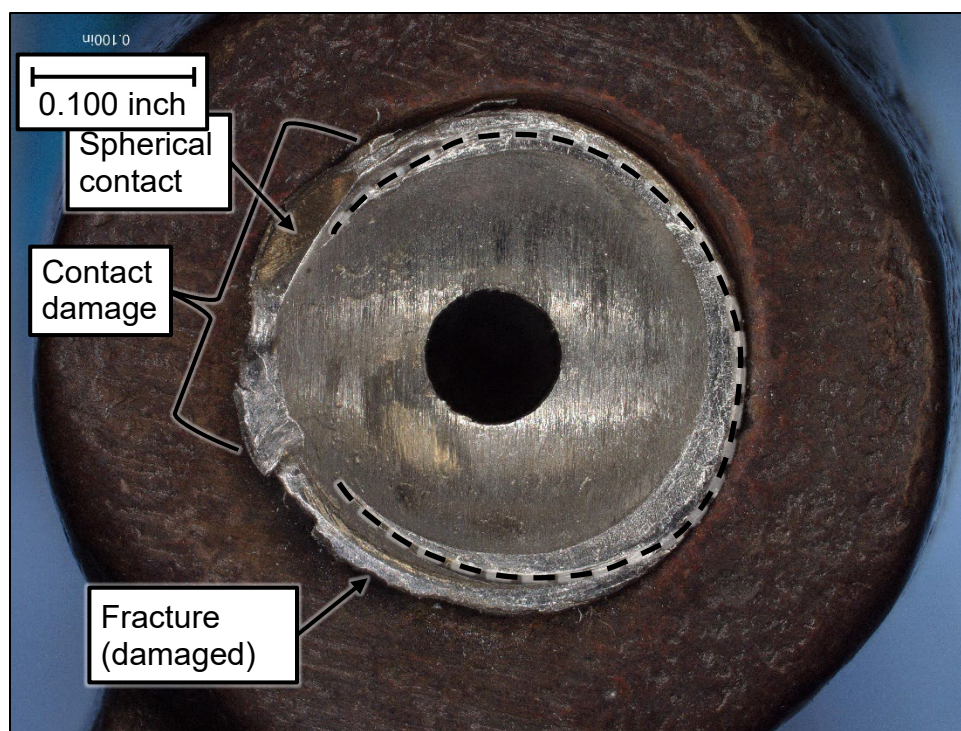
The threaded portion of the number 4 exhaust adjuster outboard of the fracture was retained within the rocker arm. A closer view of the outboard side of the fracture is shown in figure 2. The fracture surface was mostly rubbed and damaged by post-fracture recontact with the mating fracture surface and from contact with the valve tip after the swivel pad and housing had been displaced. A dashed line in figure 2 indicates a flat circular area that corresponded to contact with the exhaust valve tip. The center of the valve tip contact area was positioned slightly aft of the adjuster centerline. According to the AeroVee 2.1 Assembly and Installation Manual, the center of the swivel pad is offset from the valve tip center to facilitate proper valve rotation.

A bracket in figure 2 indicates an area of contact damage on the forward side of the fracture. Within the damaged area shown in figure 2, a smooth spherical impression was observed consistent with contact with the outboard side of the separated and displaced swivel pad. Corresponding contact damage was observed on the mating side of the fracture shown in figure 3. Overall, the corresponding contact damage was consistent with the separated swivel pad and housing being displaced forward following fracture from the threaded portion of the adjuster.

Figure 2. Outboard (rocker arm) side of the valve adjuster fracture. A dashed line indicates an area corresponding to contact with the valve tip, and a bracket indicates contact damage corresponding to contact with the displaced mating side of the fractured adjuster.

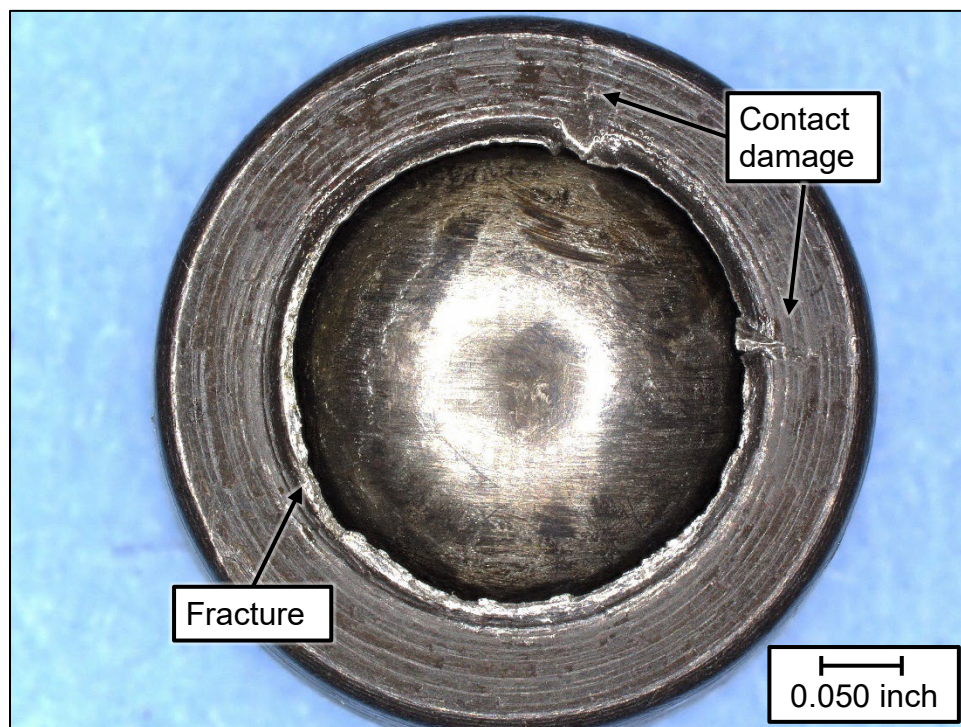
Fracture features on the outboard side of the fracture were mostly obliterated by post-fracture damage. The fracture surface on the opposite side of the fracture as shown in figure 3 appeared to be less damaged. The thickness of the fractured section varied around the circumference. The remaining ligament was thickest in the lower left quadrant (in the orientation as viewed in figure 3) and was thinnest in the damaged area shown at the upper right quadrant.

Figure 3. Inboard (valve) side of the valve adjuster fracture.

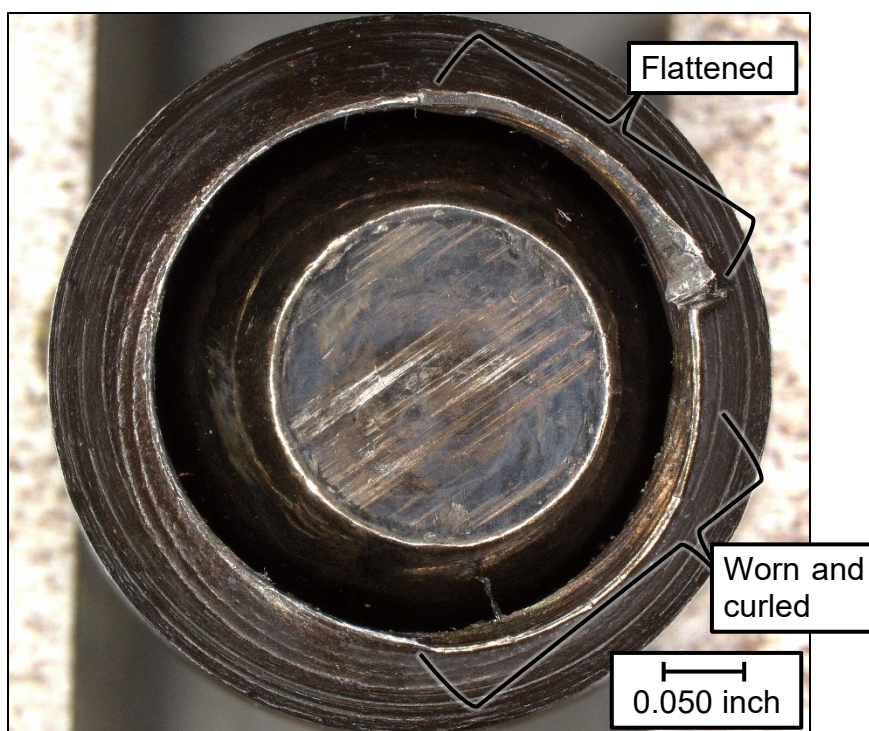
The inboard (valve) side of the separated portion of the adjuster is shown in figure 4. The flat valve contact face on the swivel pad had linear scratches that appeared to be machining marks, similar to those observed on the intact swivel pads as well. A faint circular pattern consistent with rotating valve contact was observed, but not as prominent as the patterns observed on the other three pads. Overall, the pad surface had a frosted appearance, and spalling damage was observed near the edges.

A side view of the separated pad and housing is shown in figure 5. The swivel pad was recessed within the housing, and the flat side was approximately flush with the inboard edge of the housing. One side of the housing inboard edge was worn and curled outward as indicated in figure 4, damage that was consistent with contact with the edge of the valve tip with the pad recessed within the housing. The inboard edge of the pad housing also showed a flattened area as indicated in figure 4, likely associated with contact with the valve tip after the swivel pad and housing displaced forward after fracture. The flattened area indicated in figure 4 was within the same quadrant as the contact damage on the outboard side (as indicated in figure 3).

Figure 4. Valve side of the swivel pad showing valve tip contact damage at the edge of the pad housing.

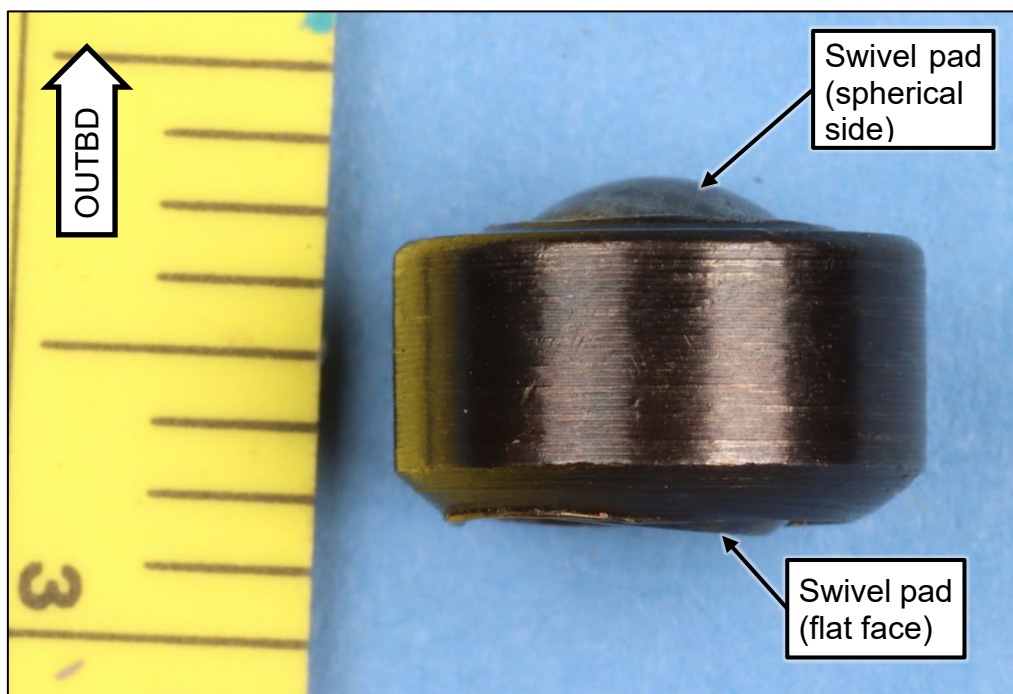
Figure 5. Side view of the swivel pad housing showing the pad recessed within the housing.

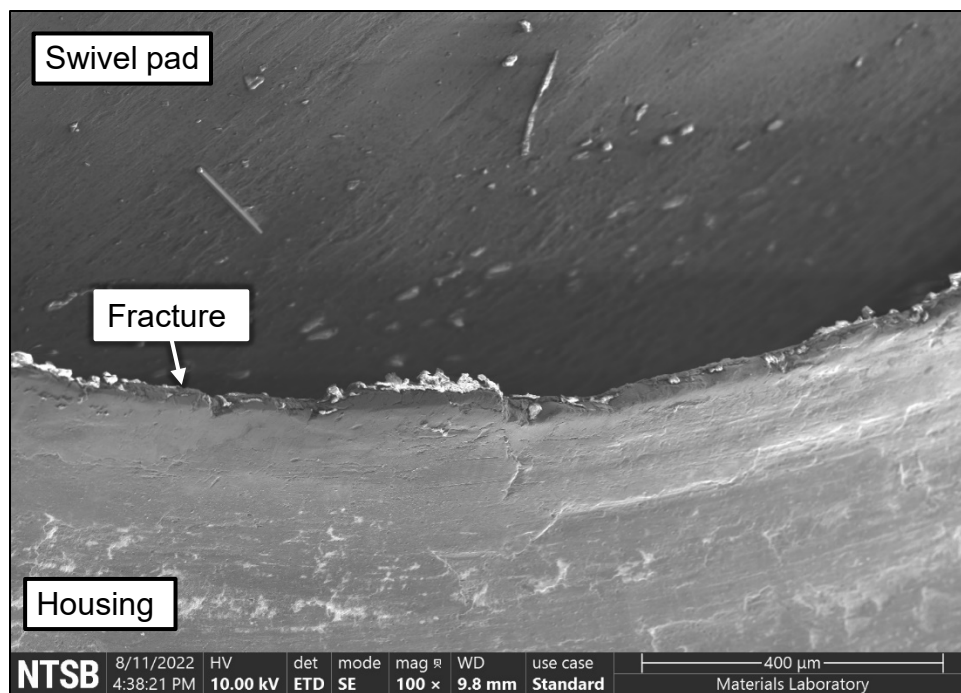
The inboard side of the adjuster fracture surface was further examined using a scanning electron microscope (SEM). To clean the swivel pad and housing for SEM examination, the assembly was cleaned with an ultrasonic cleaner while immersed in acetone. The cleaned fracture was examined around the circumference. The fracture features were obscured with rubbing damage and oxidation, and no determination of fracture mechanism was made from the examination. An SEM image of a relatively thin portion of the fracture is shown in figure 4, where the thickness of the housing measured approximately 0.0012 inch thick.

Figure 6. SEM image of the adjuster fracture where the thickness of the housing was relatively thin.

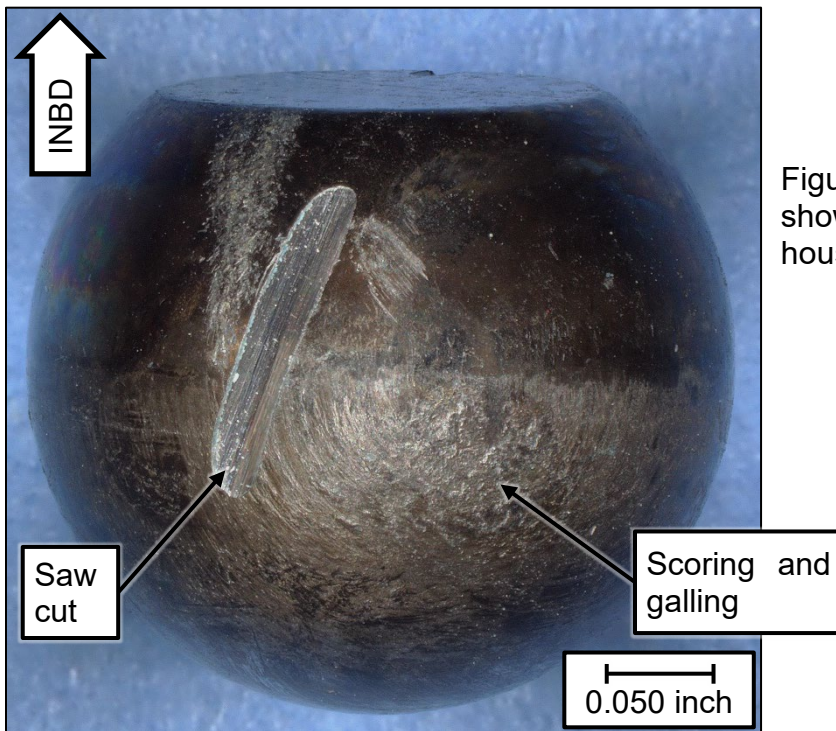
Next, the swivel pad was separated from the housing by using a water-cooled abrasive saw to section through the housing on two sides. A view of the swivel pad after sectioning is shown in figure 7. The spherical outboard half of the swivel pad had a rough surface consistent with scoring and galling damage. The damage pattern had circular

patterns on two sides with linear features in between consistent with rotating contact within the housing.

Figure 7. Swivel pad after sectioning showing scoring and galling on the housing contact faces.

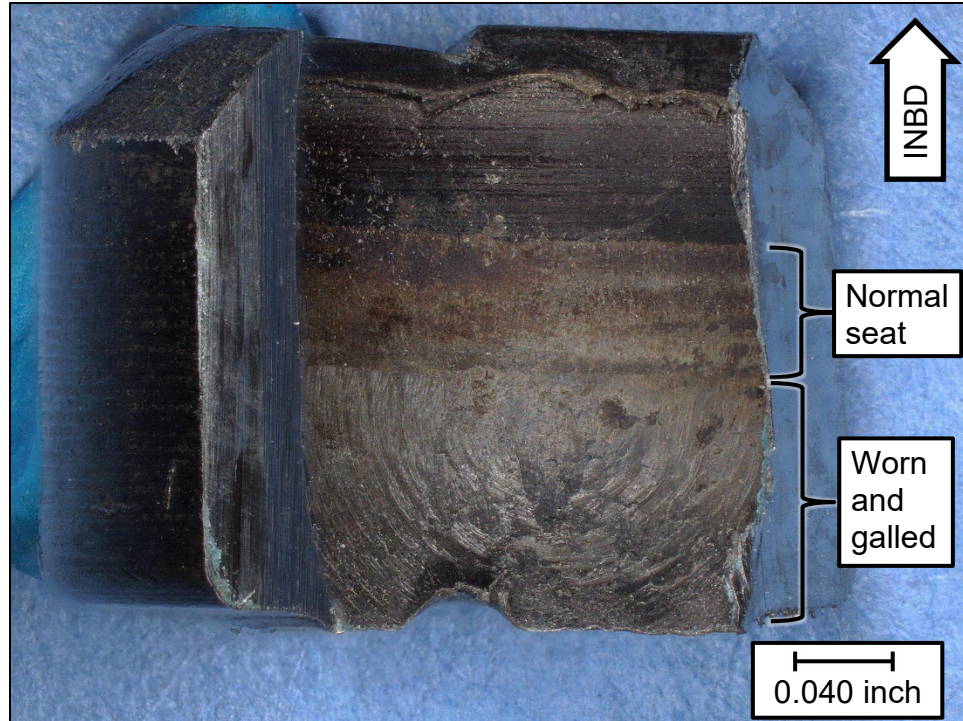
On the interior surfaces of the swivel pad housing, the outboard portion had scoring and galling that mirrored the damage patterns observed on the swivel pad with a circular pattern on two sides and linear scratches between. The scoring and galling damage was concentrated at the outboard side of the housing as shown in figure 8, and material on the outboard side of the housing had worn away, producing space for the swivel pad to be recessed within the housing. The normal seat surface for the swivel pad was inboard of the worn area as shown in figure 8 and was darkened from time in service with the swivel pad recessed in the worn housing.

Figure 8. Sectioned half of the swivel pad housing showing galling and wear on the interior surface.

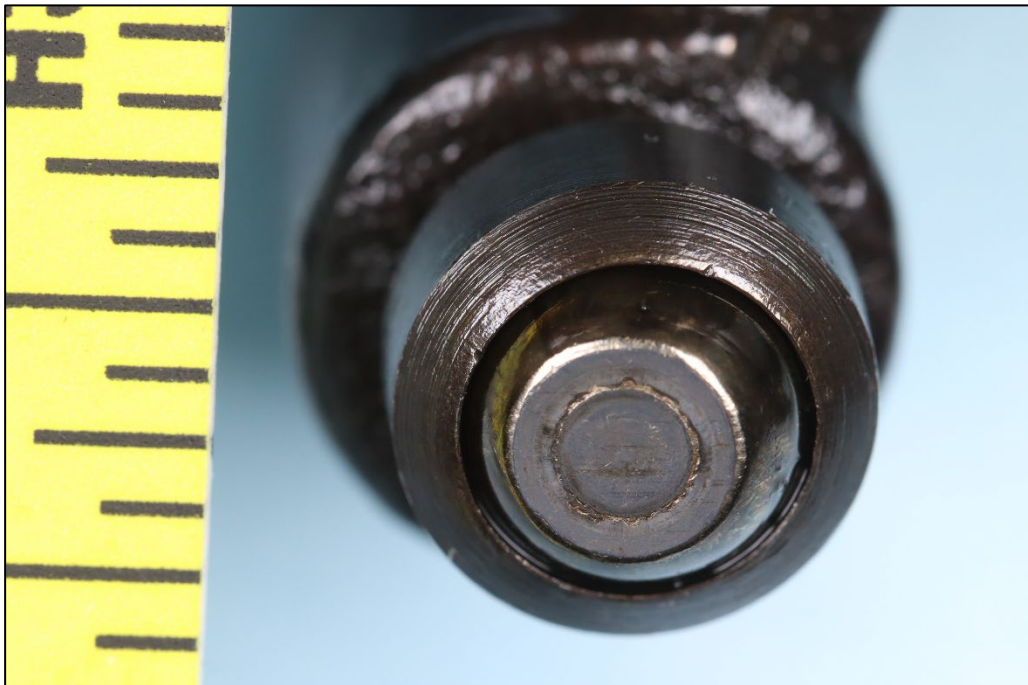
The three intact adjusters had swivel pads that appeared to be positioned normally in the housing and did not appear to be recessed. The swivel pads for the two intake valves had nominal contact patterns on the valve contact faces. However, the number 3 exhaust swivel pad contact face was spalled in a circle around the center of the pad as shown in figure 9. The swivel pads were rotated within the housing to look for any evidence of damage or wear. The swivel pads for the two intake valve adjusters had smooth oiled surfaces with no evidence of degradation. However, the number 3 exhaust swivel pad had areas of pitting damage on the spherical portion of the surface such as the area shown in figure 10. The optical image in figure 10 was obtained using a Keyence VHX-7000 in depth mode with enhanced shadow imaging.

Figure 9. Number 3 exhaust valve adjuster showing spalling damage on the swivel pad face.

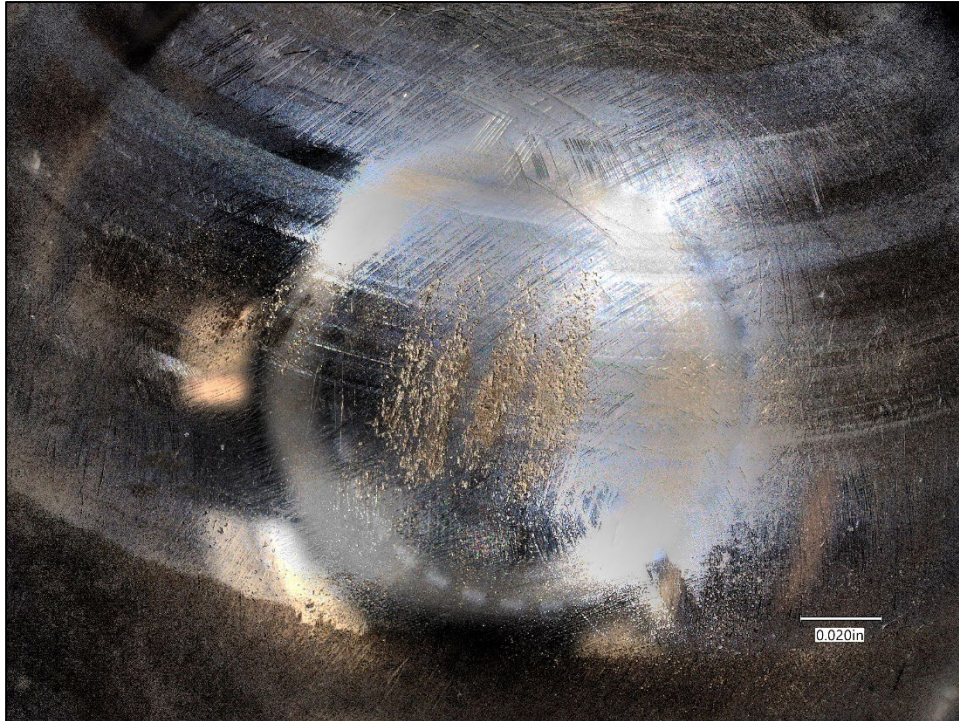
Figure 10. Optical image obtained using a Keyence VHX-7000 in depth mode with enhanced shadow imaging showing pitting on the spherical surface of the number 3 exhaust swivel pad.

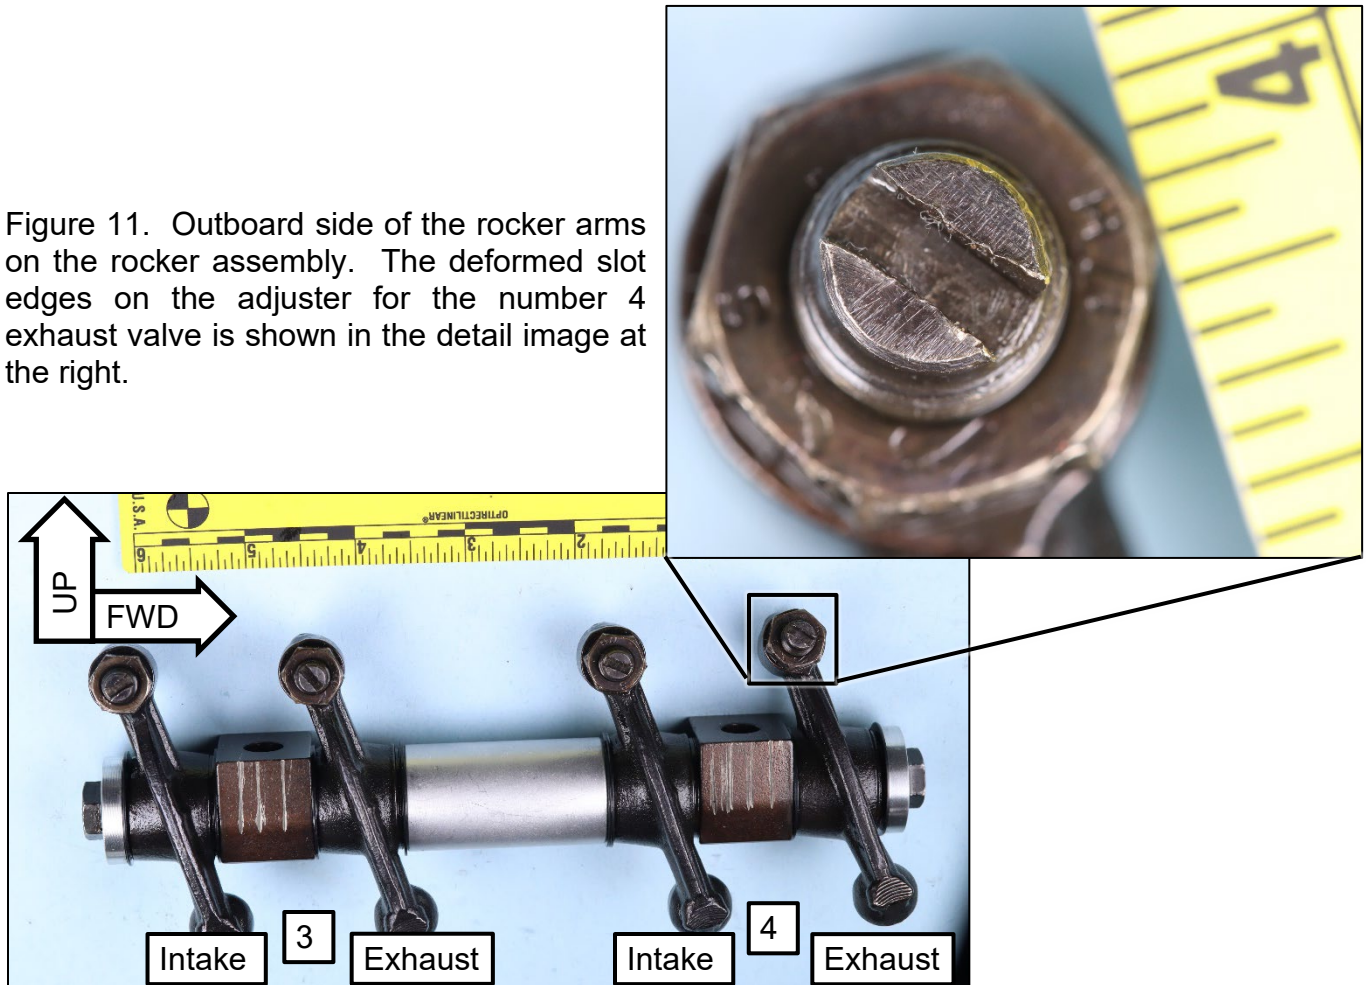
The outboard ends of the adjusters are shown in figure 11. The screwdriver slots at the outboard ends were deformed on each of the adjusters, including the number 4 exhaust valve adjuster shown at higher magnification in the detail image in figure 11. The distance from the outboard face of the locking nut to the outboard end of the adjuster was measured on each rocker arm. The distances measured 0.227 inch, 0.191 inch, 0.217 inch, and 0.247 inch for the number 3 intake, number 3 exhaust, number 4 intake, and number 4 exhaust adjusters, respectively.

Figure 11. Outboard side of the rocker arms on the rocker assembly. The deformed slot edges on the adjuster for the number 4 exhaust valve is shown in the detail image at the right.
