## **NATIONAL TRANSPORTATION SAFETY BOARD**

# **AIRFRAME AND ENGINE EXAMINATION SUMMARY**

**WPR20LA035**

| Aircraft: | N535D; Sonex |

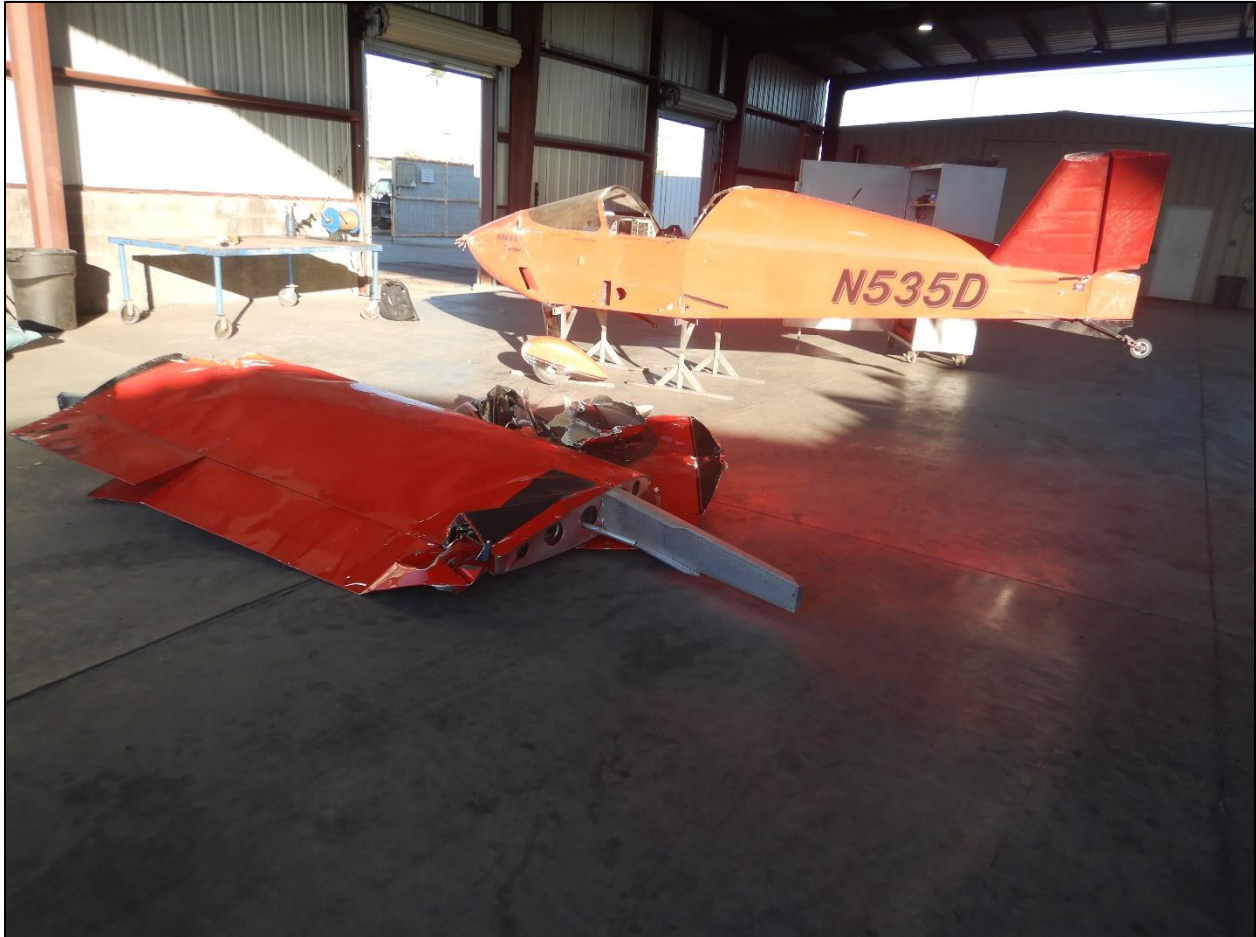
**Figure 1-Main wreckage layout.**

The wings were disassembled and removed from the airframe during the wreckage recovery from the accident site. The wings had impact damage at the tips and buckling throughout their surface. The canopy structure was crushed, and the canopy glass had separated. The flight control tubes to the wings were cut during the recovery. The empennage and the tail flight controls (Y-tail), were undamaged and moved freely by hand. Flight control continuity was established.

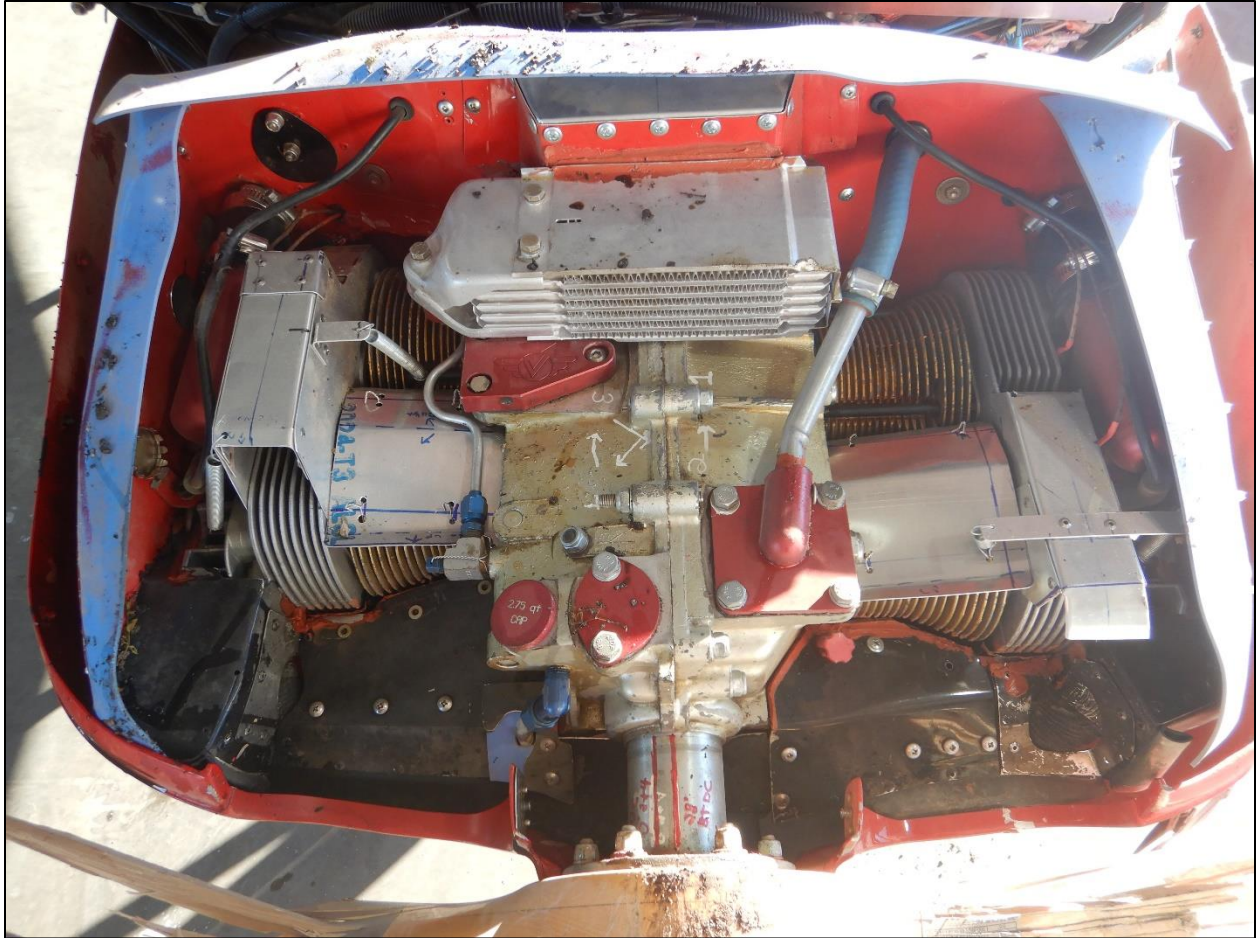
**Figure 2-Engine assembly.**

The upper and lower engine cowlings were removed from the engine. The upper and lower cowlings had oil and dirt debris on their right-hand inside surfaces. The engine exterior was examined and no anomalies were noted. Oil was leaking from the right set of cylinders, (Cylinder No. 3 and 4) from the rocker cover mating surface area.

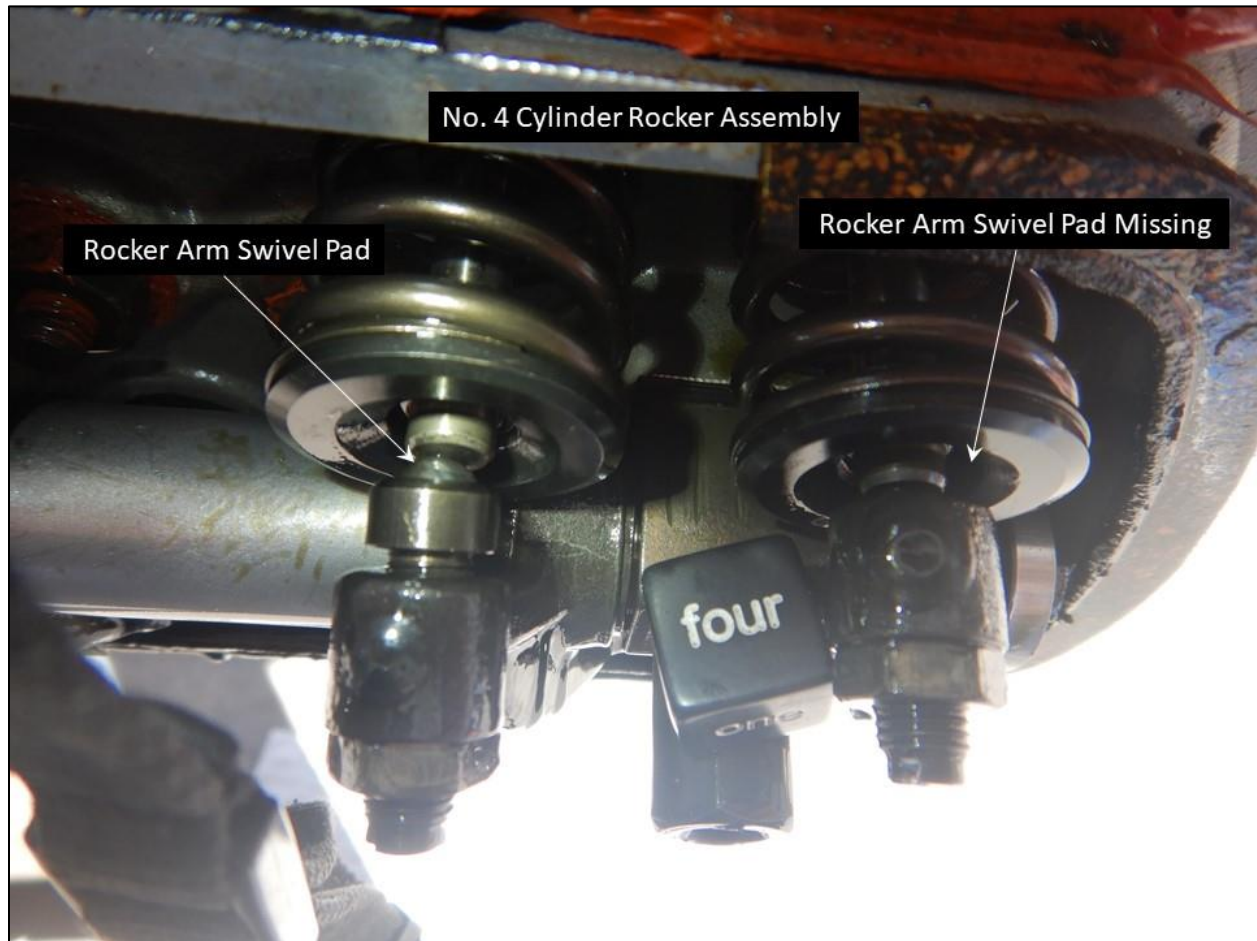
**Figure 3-No. 4 cylinder rocker assembly.**

Examination of the airframe revealed no evidence of preexisting malfunctions or failures that would have precluded normal operation. The engine was examined, and the No. 4 exhaust valve rocker swivel pad and swivel housing separated from its adjustment screw and rocker. The No. 4 exhaust push rod was not secured in the rocker socket end. The No. 4 exhaust valve would not actuate during the crankshaft rotation.

The rocker covers were removed and the right rocker cover gasket separated into two sections. The valve rocker assemblies, on both sets of cylinders were covered in a residue of oil and were secure.

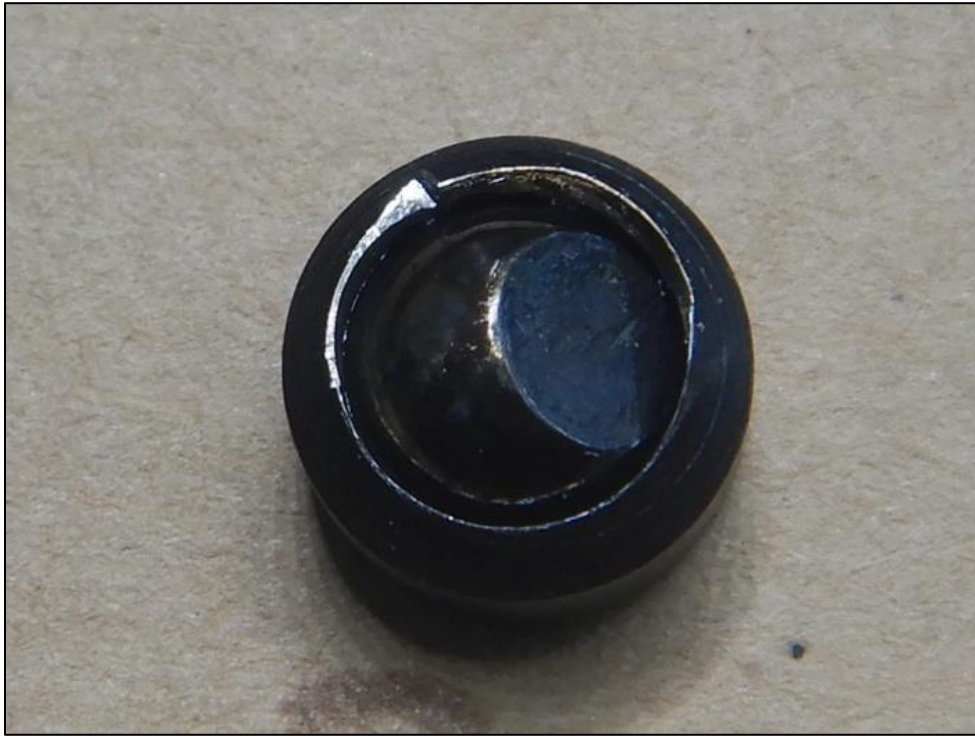
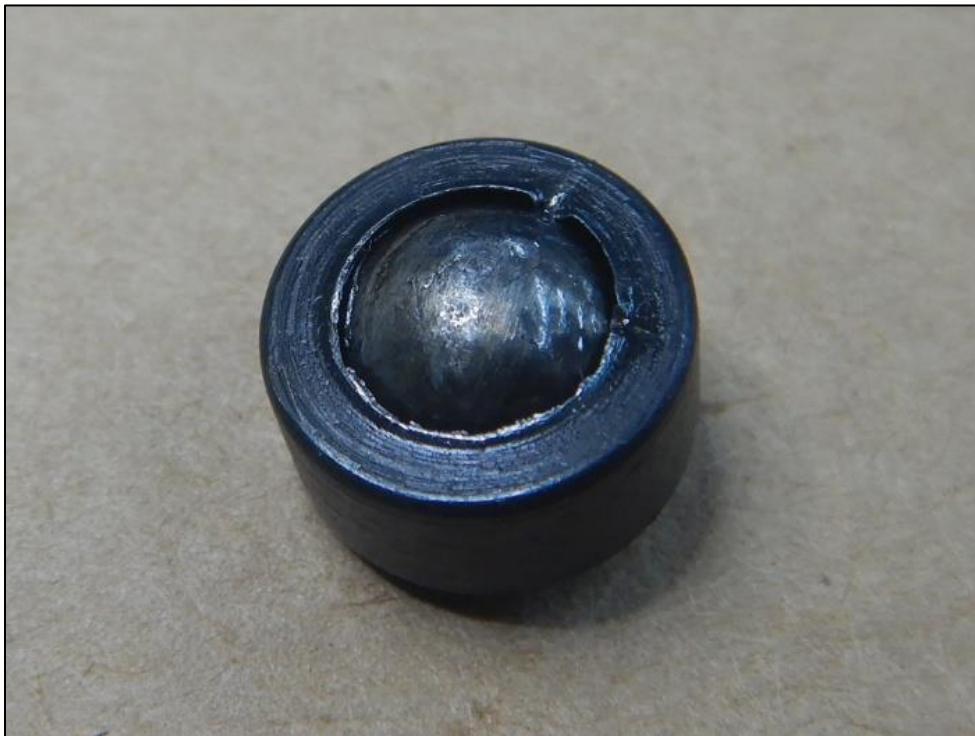
**Figure 4-Rocker valve swivel pad and housing (valve side view).**

**Figure 5-Rocker valve swivel pad and housing (separated section view)**

The No. 4 cylinder exhaust valve rocker arm swivel housing and swivel pad separated from its screw body. The screw body was remained secured to the rocker arm (see figure 6). The swivel pad and swivel housing was found loose in the rocker cover. The swivel pad remained loose in the swivel housing and impact damage was visible on the swivel housing. Impact damage on the swivel housing, on the separation surface side, had two impact marks consistent with impact from the circular swivel housing screw side. The No. 4 rocker arm's oil galley's were free of obstruction.
