**NATIONAL TRANSPORTATION SAFETY BOARD  
Office of Research and Engineering  
Vehicle Recorder Division  
Washington, D.C. 20594**

**SPECIALIST'S FACTUAL REPORT OF INVESTIGATION**

**WPR22LA039**

## **Cockpit Voice Recorder**

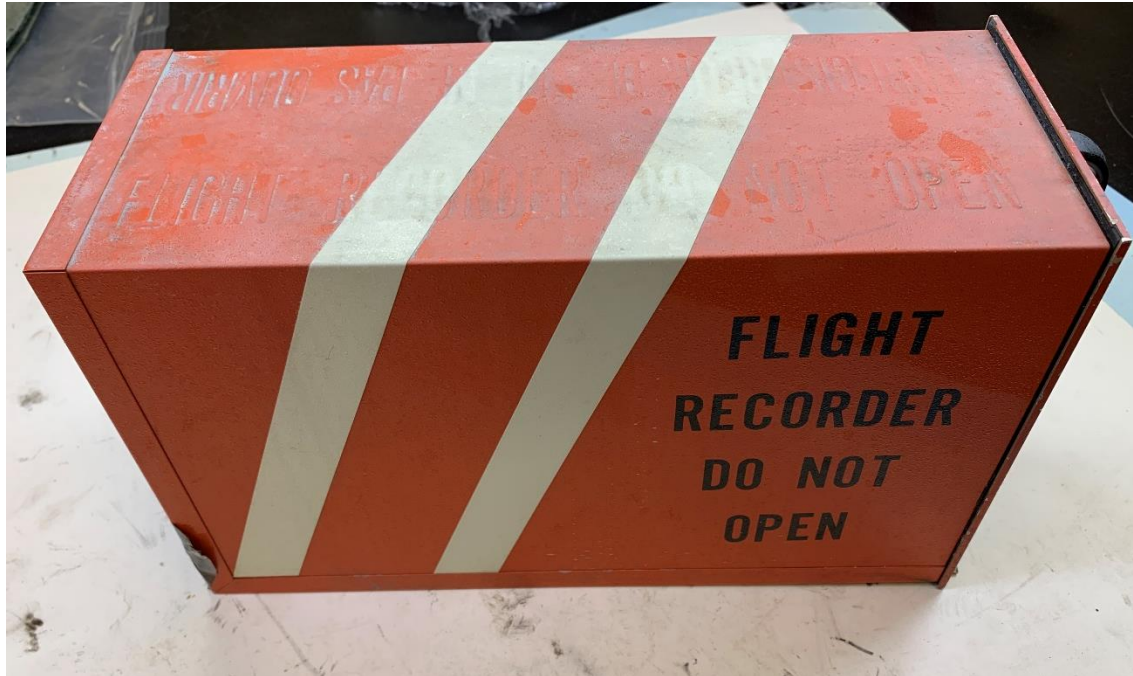
Upon arrival at the laboratory, an examination was conducted, and the unit was disassembled to retrieve the enclosed magnetic tape recording medium. External examination did not reveal any readily apparent damage, as seen in figure 1.

**Figure 1.** External of the CVR, as received.

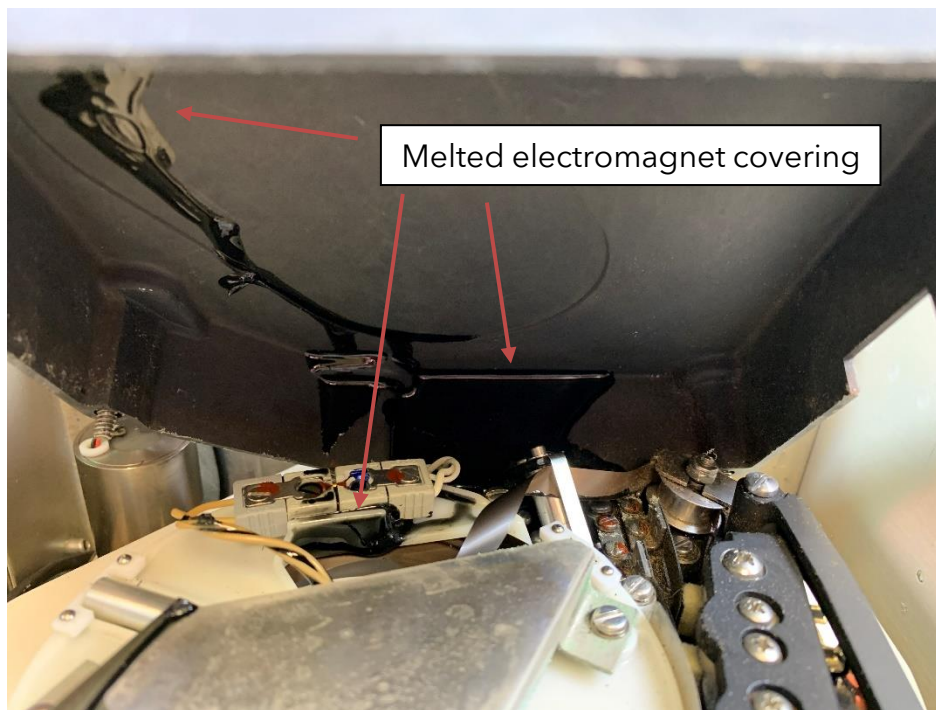
Upon extracting and opening the crash survivable memory unit (CSMU), it was noted that the bulk erase electromagnet's casing had melted, which then coated portions of the magnetic tape and the recording mechanism, as seen in figure 2.

**Figure 2.** Inside of the crash case, showing the melted electromagnet covering.

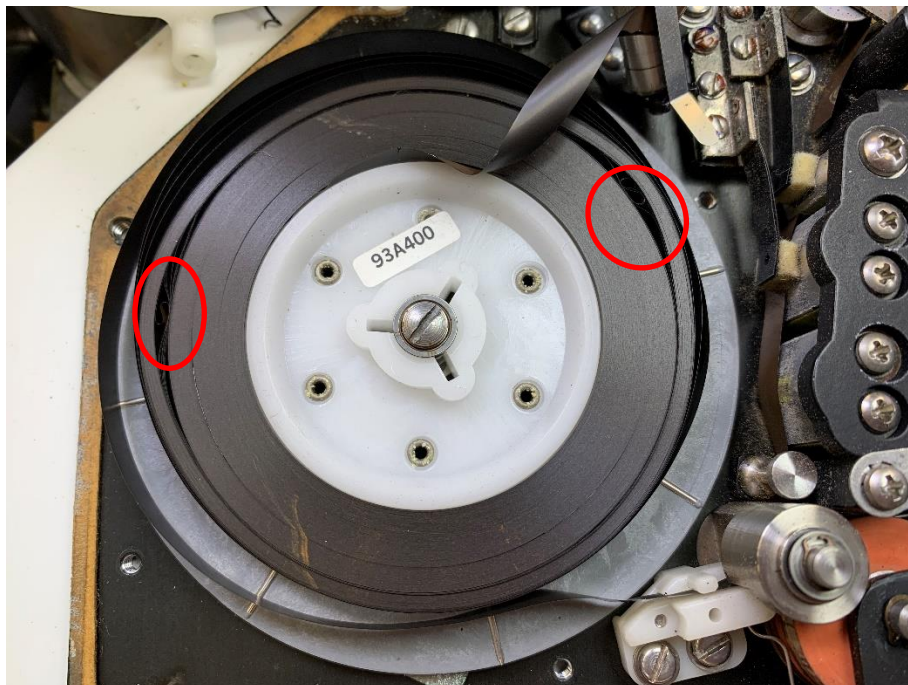
The tape itself was noted to have several folds in its main winding, as highlighted in red circles in figure 3.

**Figure 3.** The magnetic tape spool, showing instances of tape folding.

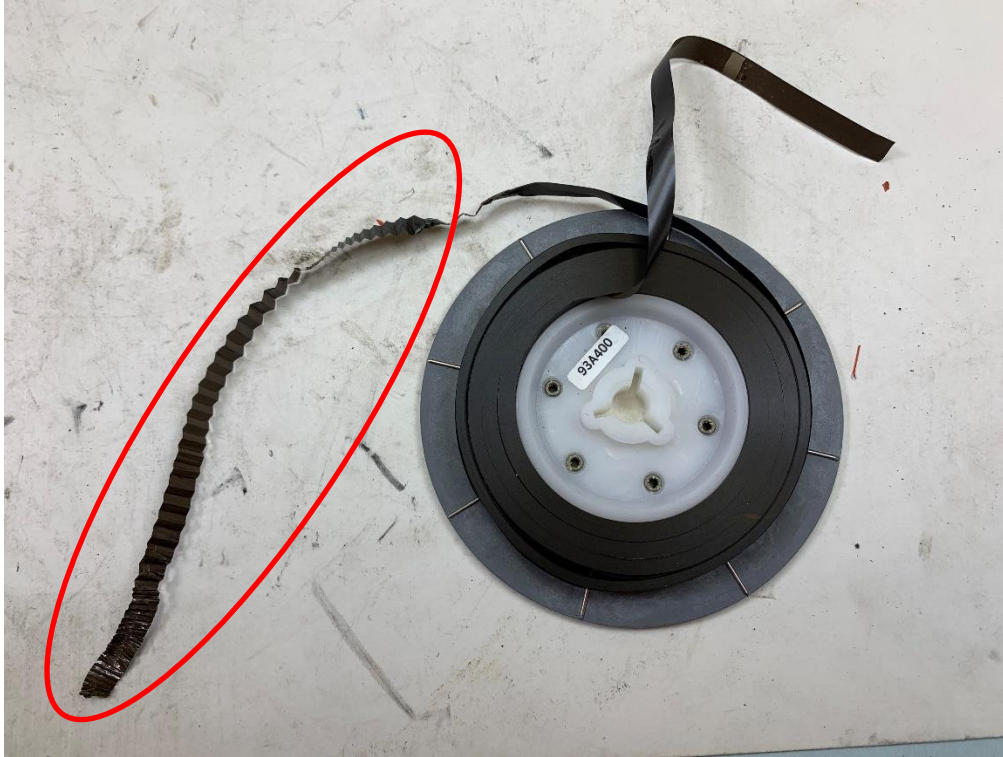
The magnetic tape was then recovered from the CSMU. Examination of the extricated tape revealed that it had been bunched in the recording heads in an accordion shape, as seen on the left of figure 4.

**Figure 4.** The magnetic tape, liberated from the recording mechanism, showing operational damage.

The tape was treated using laboratory techniques, including removing small portions of the tape that had been covered in the melted electromagnet covering. The tape was then read out. Approximately 34 minutes of data were recovered, with the remaining small amount of data unrecoverable due to tape damage.
