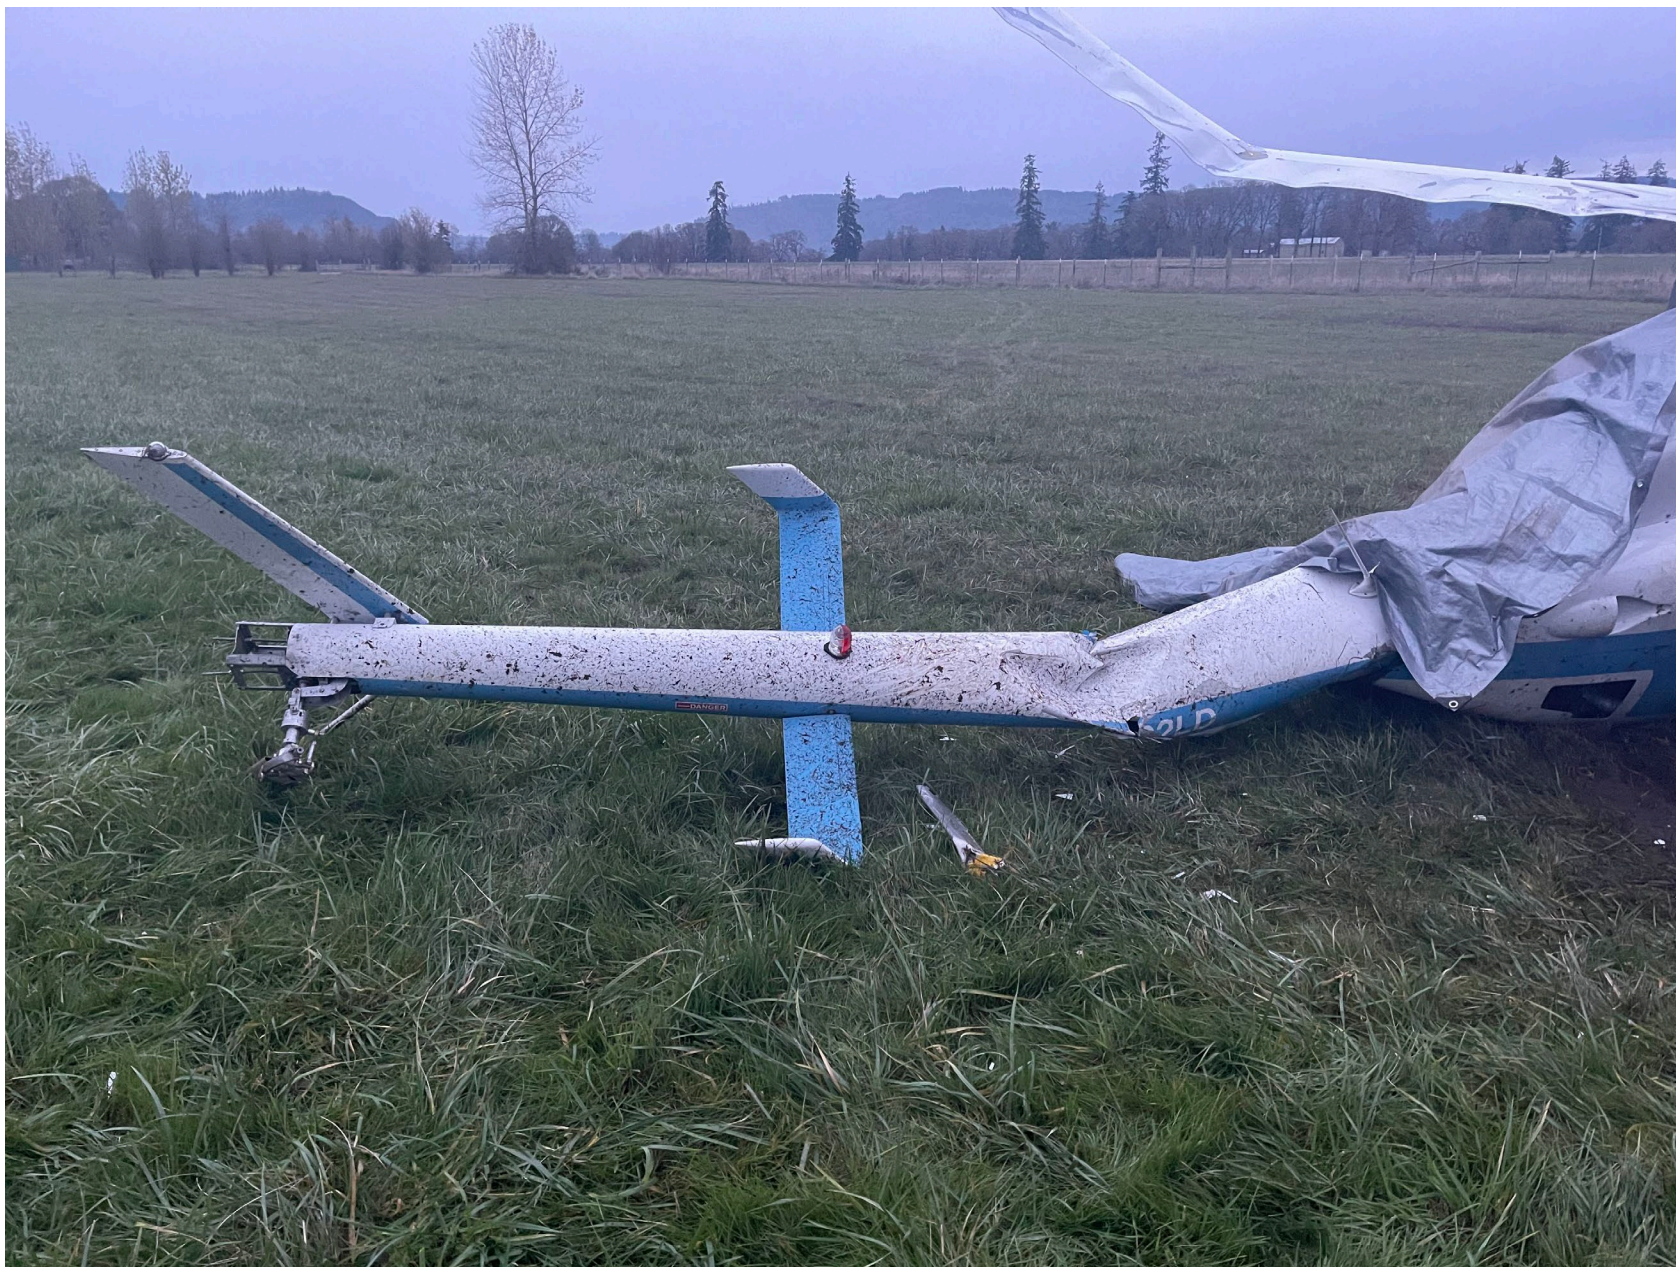
**Photo 1 – Right-rear view of N102LD, showing substantial damage to the tailboom. Photo courtesy of the pilot.**

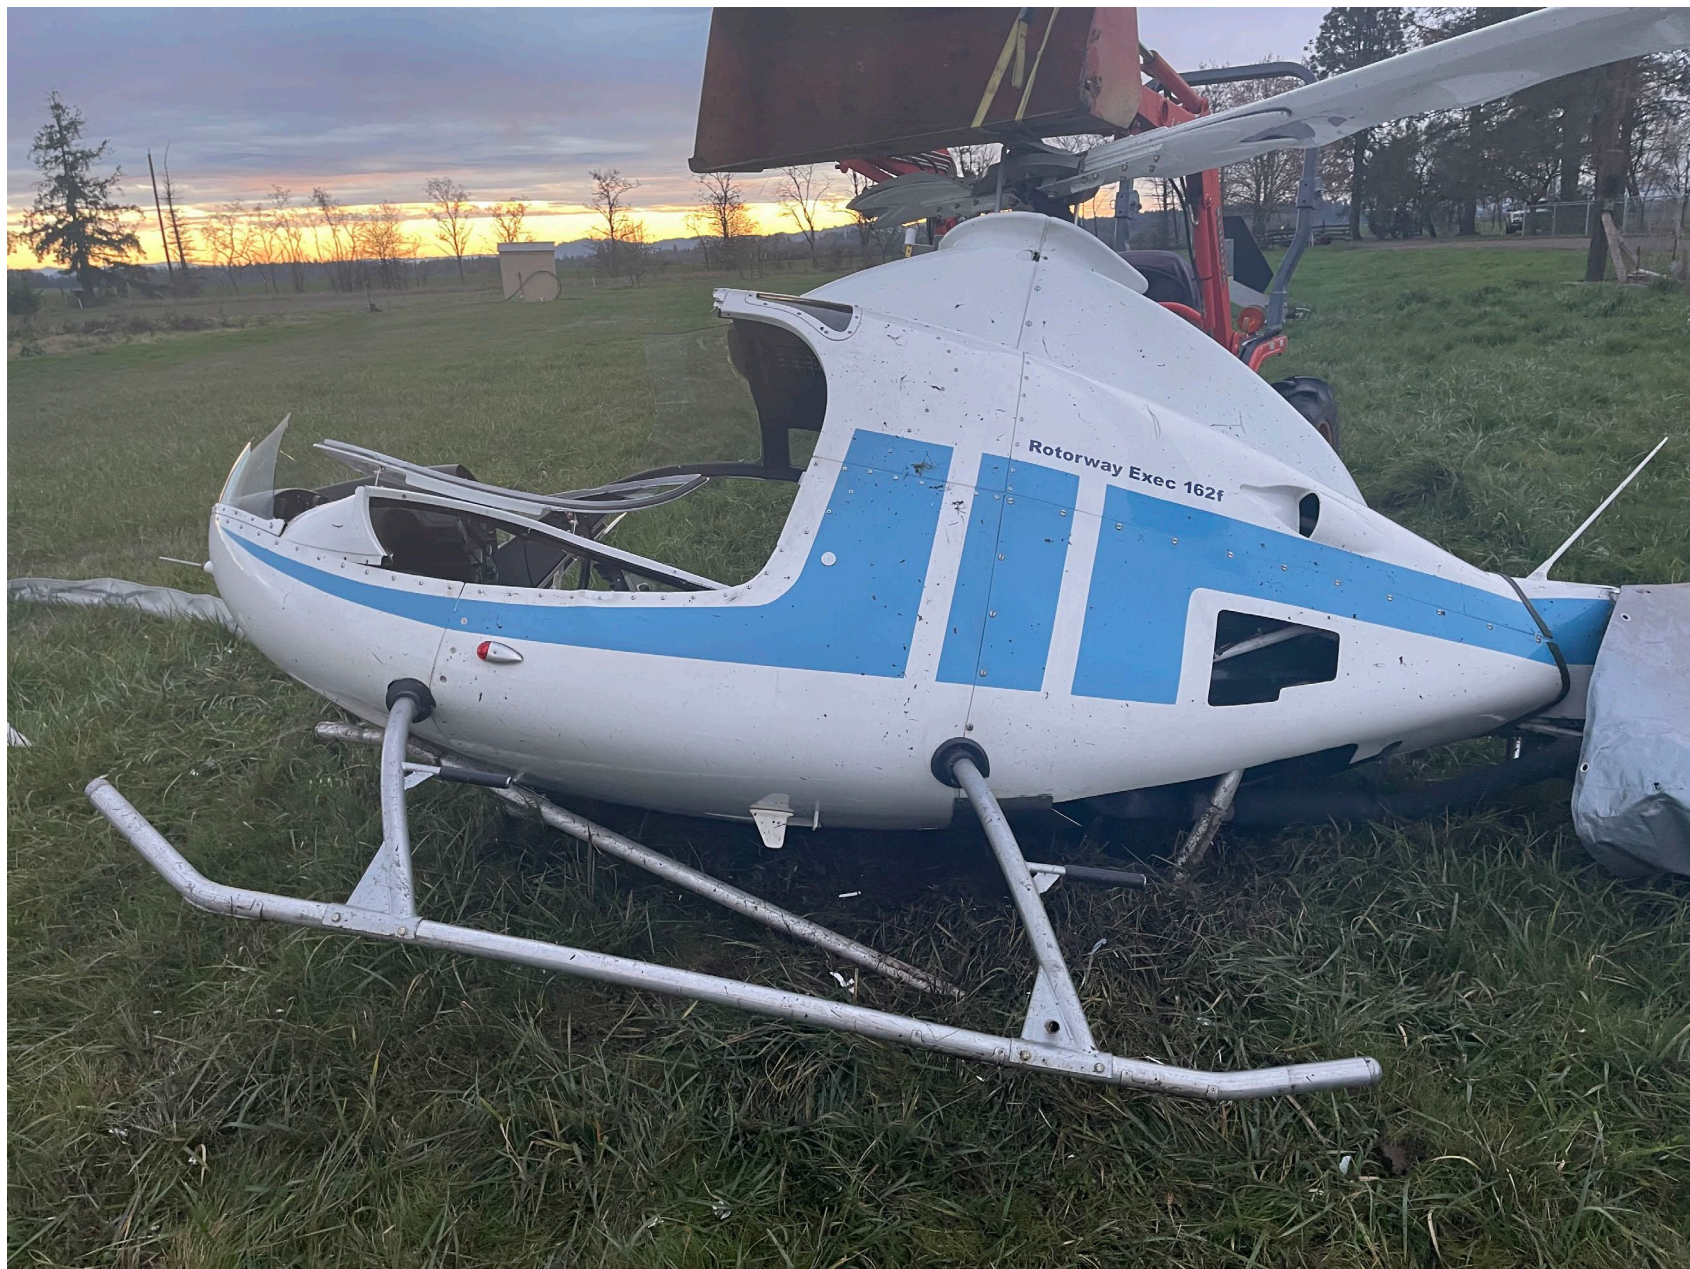
**Photo 2 – Left-side view of N102LD, showing substantial damage to the fuselage. Photo courtesy of the pilot.**

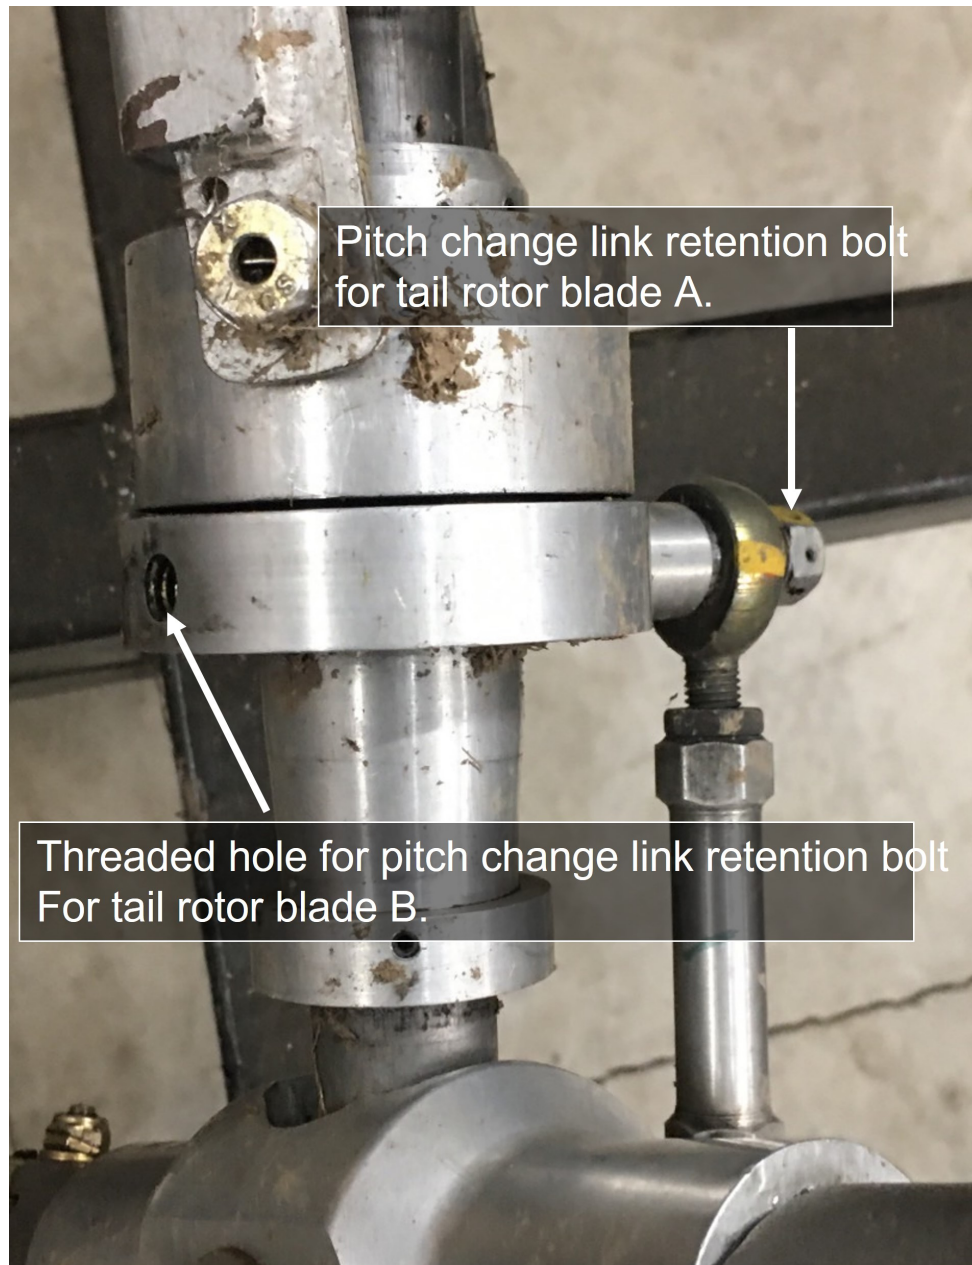
**Photo 3 – Photo showing the attachment hole for the missing pitch change link retention bolt. Photo courtesy of the pilot.**
