## **NATIONAL TRANSPORTATION SAFETY BOARD**

### **AIRFRAME / ENGINE EXAMINATION SUMMARY**

**WPR22LA046**

| Aircraft: | Vans RV-10, N54CT |

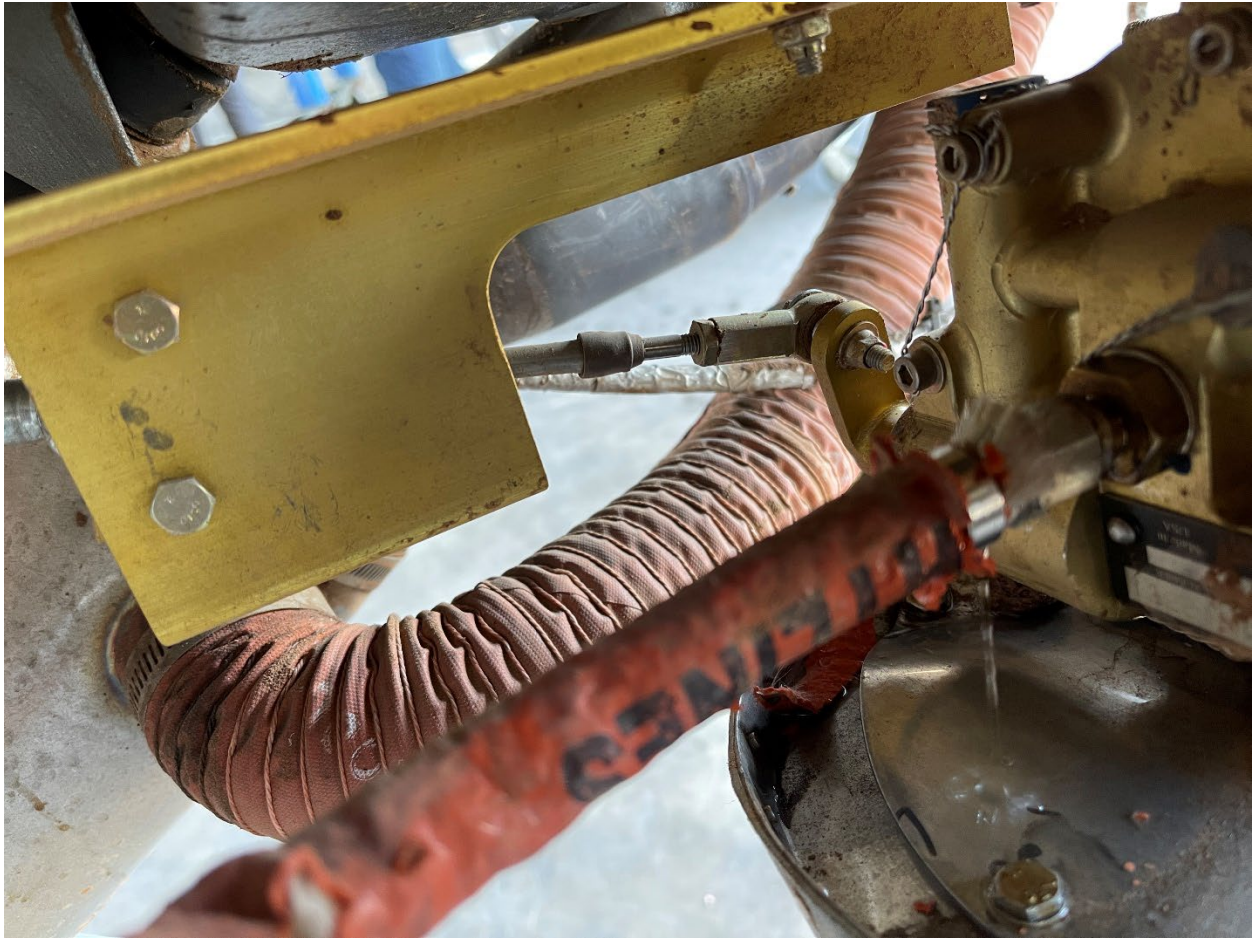
Examination of the recovered airplane revealed that the Lycoming IO-540-X engine remained attached to the airframe via the engine mount. All engine accessories remained attached to the engine. All fuel and oil lines appeared to be connected to their respective fittings, however, the fuel line from the fuel servo outlet port to the fuel flow transducer inlet port was loose at the fuel servo fitting. An external fuel source was attached to the left wing fuel inlet line, and the number 1 cylinder fuel injector line was removed from the fuel injector for testing purposes. When power was applied to the airframe and the airframe boost pump was turned on with the throttle and mixture levers in the full forward position, fuel was observed expelling from the loose fuel line fitting (at the fuel servo), and no fuel was observed flowing from the fuel injector line. Damage sustained to the firewall appeared to restrict fuel flow from left and right wing fuel inlet lines.

An external electric fuel boost pump was attached inline from an external fuel source to the fuel inlet line of the engine driven fuel pump, and the loose fuel fitting at the fuel servo was tightened about 3.5 turns. The fuel boost pump was turned on with the throttle and mixture levers full forward position. Fuel was observed expelling from the cylinder no. 1 fuel injector line. Then the fuel outlet line at the fuel servo was loosened about 3.5 turns, fuel began to leak from the fitting, with no fuel expelling from the no. 1 fuel injector line.

**Figure 1: View of the fuel servo outlet fuel line, with fuel leaking.**
