# NATIONAL TRANSPORTATION SAFETY BOARD

MATERIALS LABORATORY FACTUAL REPORT

Report No. 22-001

Place : Puyallup, Washington  
Date : November 22, 2021  
Vehicle : Cessna R182, N7592Y  
NTSB No. : WPR22LA047  
Investigator : Eric Gutierrez, ASI-WPR

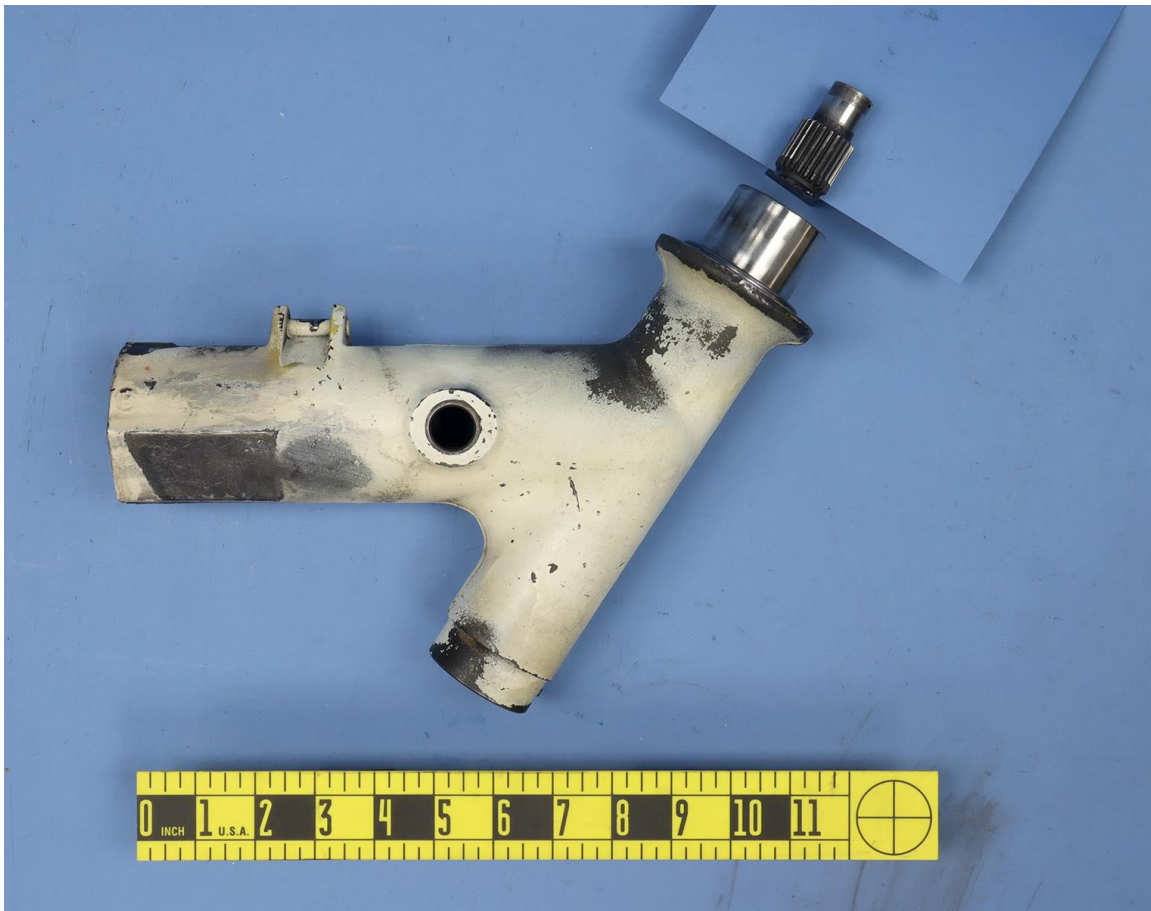
A left main landing gear pivot assembly, fractured in two pieces as shown in figure 1, was submitted to the NTSB Materials Laboratory for examination. The pivot had fractured near the forward inboard location where a splined shaft extended off the main body of the pivot. Both fracture faces are shown in figures 2a and 2b, for the body-side and splined-shaft-side, respectively. Most of the fracture exhibited circumferentially oriented shear marks and smearing in the clockwise direction, consistent with a shear overstress fracture in clockwise torsion.

**Figure 1:** Left main landing gear pivot assembly in two pieces, as received.

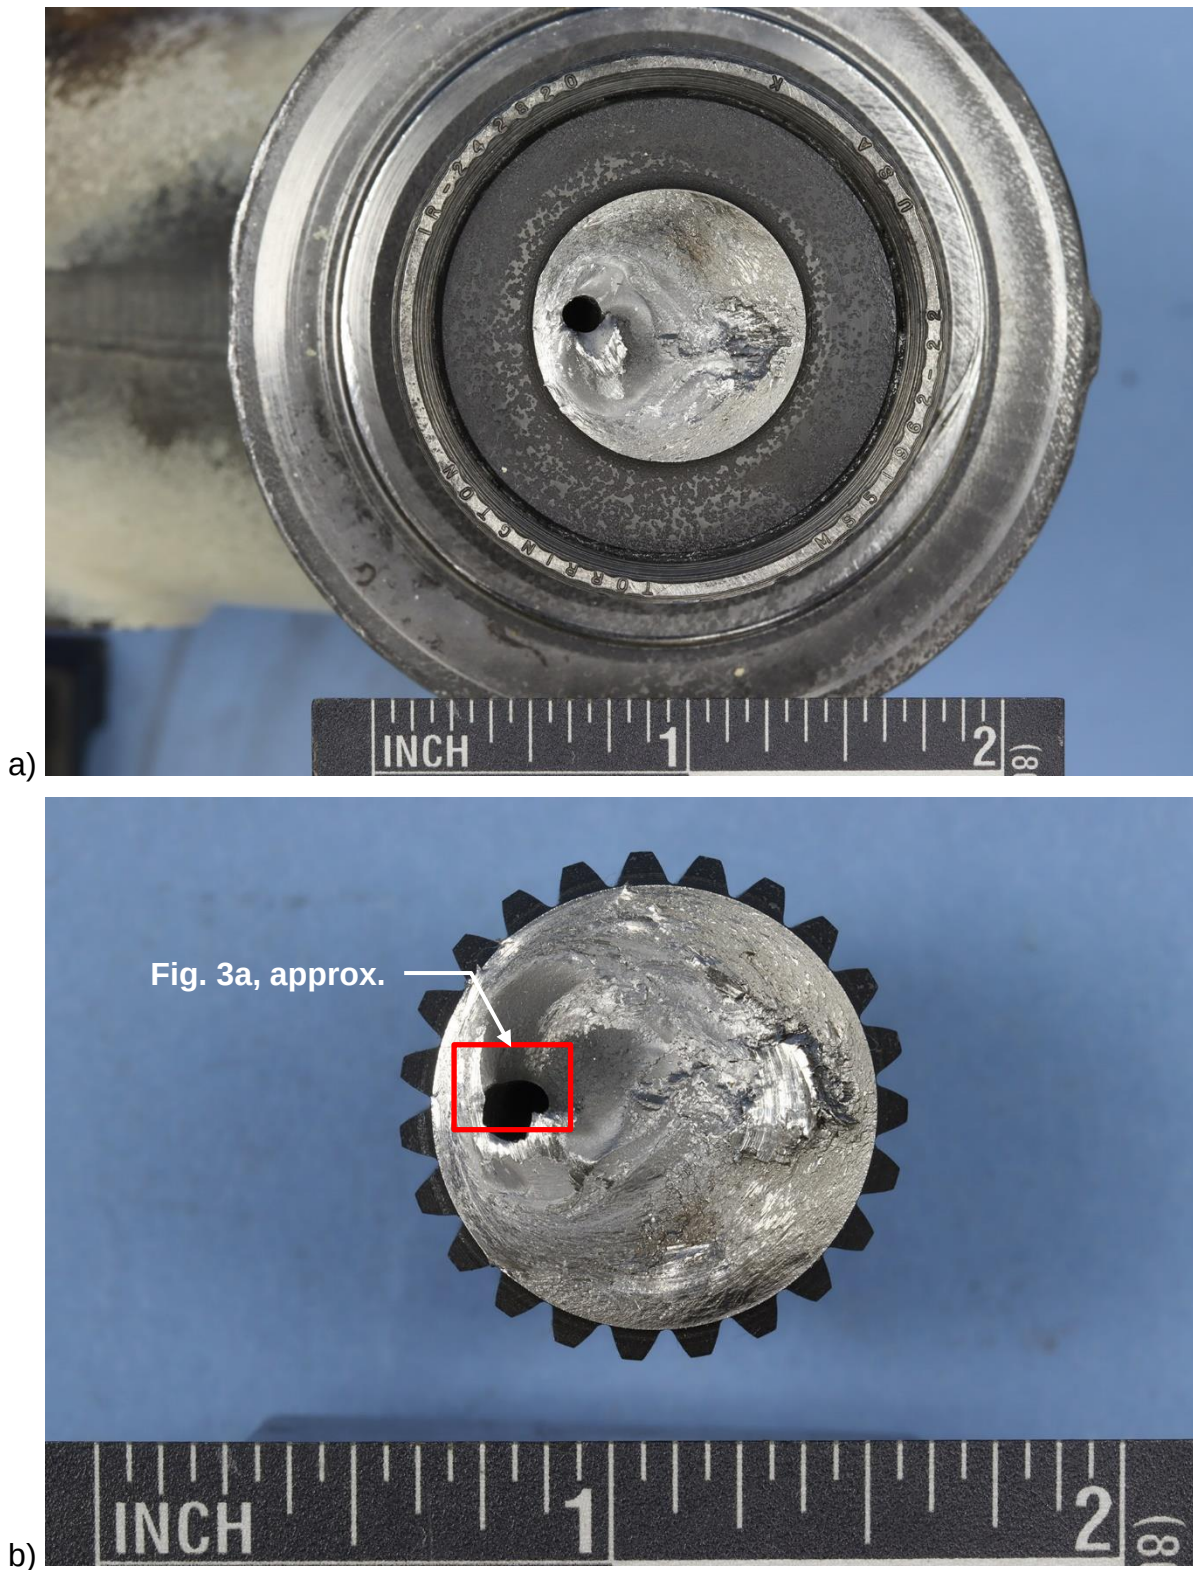
**Figure 2:** Images of the fracture surfaces: a) fracture face adjacent to main body of the pivot and b) fracture face adjacent to the splined shaft.

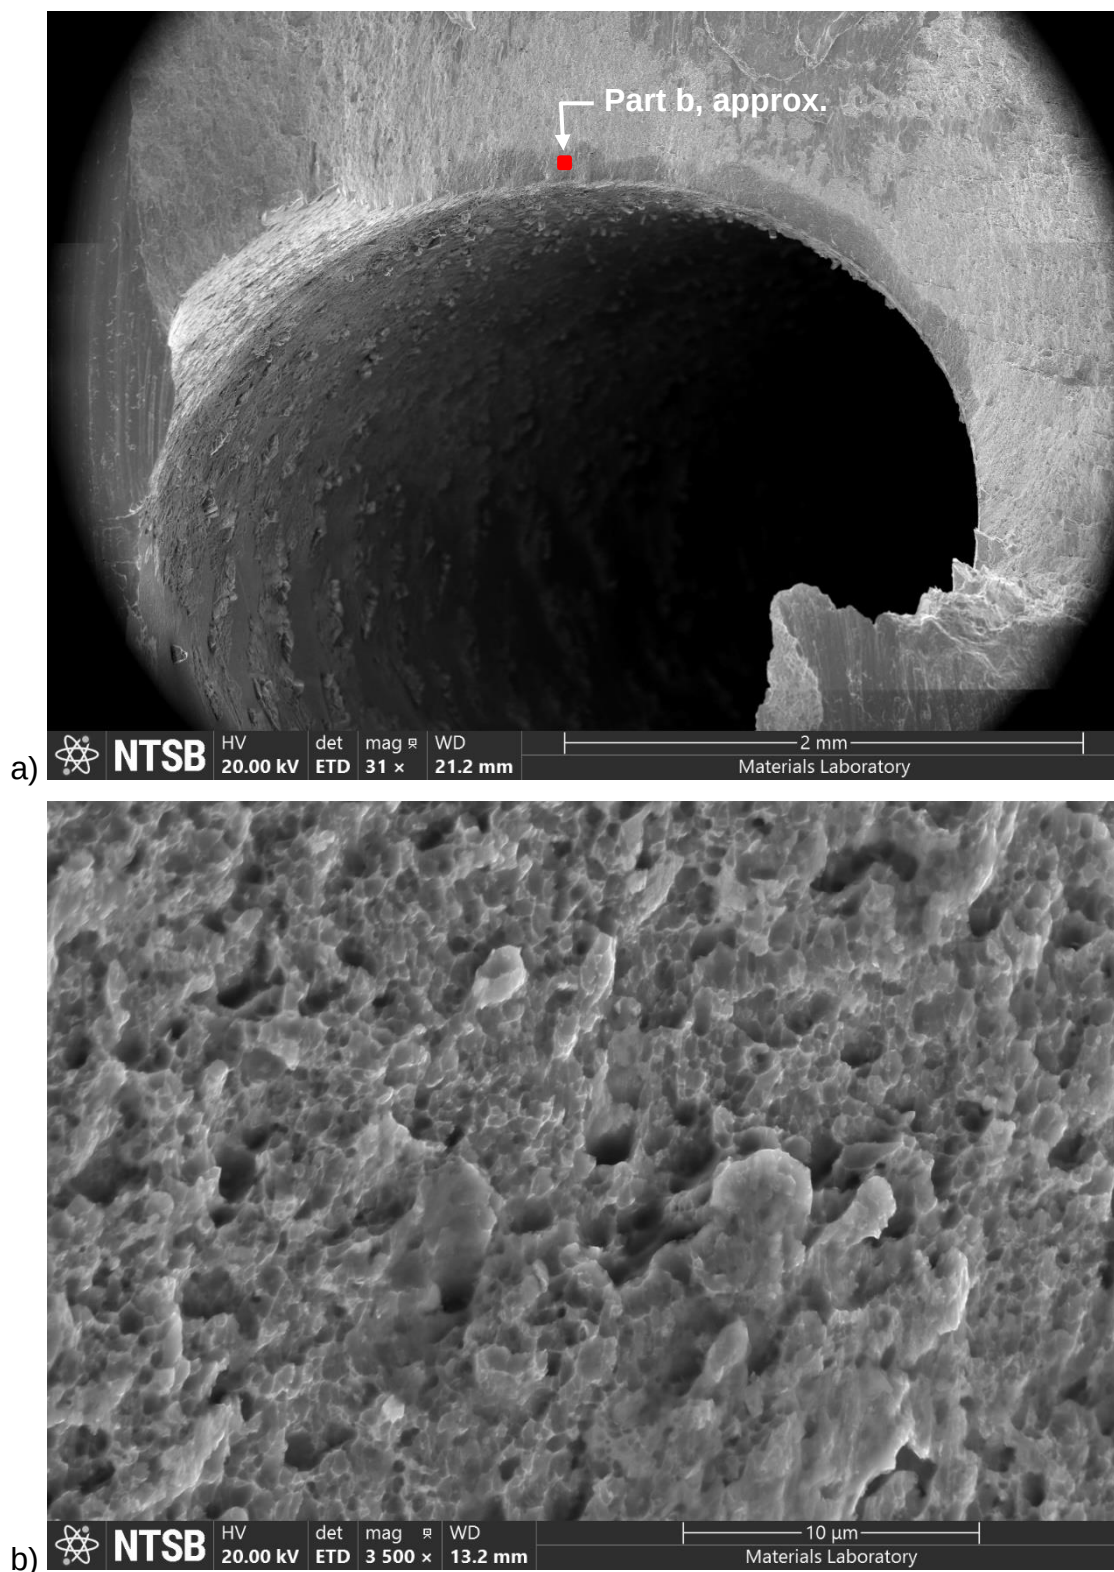
The splined shaft contained a machined hole that was internal to the shaft. Adjacent to this hole, there was a region where the fracture was inclined at 45° to the longitudinal axis and the fracture features were comparatively flat. The splined-shaft piece was submerged in an acetone-filled beaker and cleaned in a sonicating bath. The fracture adjacent to the internal hole was then examined in a scanning electron microscope (SEM), as shown in figures 3a and 3b. The examination revealed dimple featured. The observations were consistent with a tensile overstress fracture in clockwise torsion.

**Figure 3:** Scanning electron microscope images at the hole internal to the shaft: a) overview image at the edge of the hole with the 45° inclined fracture and b) high magnification image near the edge of the hole showing fine dimples, consistent with overstress.
