# National Transportation Safety Board

WPR22LA060

## **POST ACCIDENT EXAMINATION**

Location: Hillsboro, Oregon  
Date: December 19, 2021  
Time: 1545 Pacific Standard Time  
Airplane: N152BT, Cessna P210

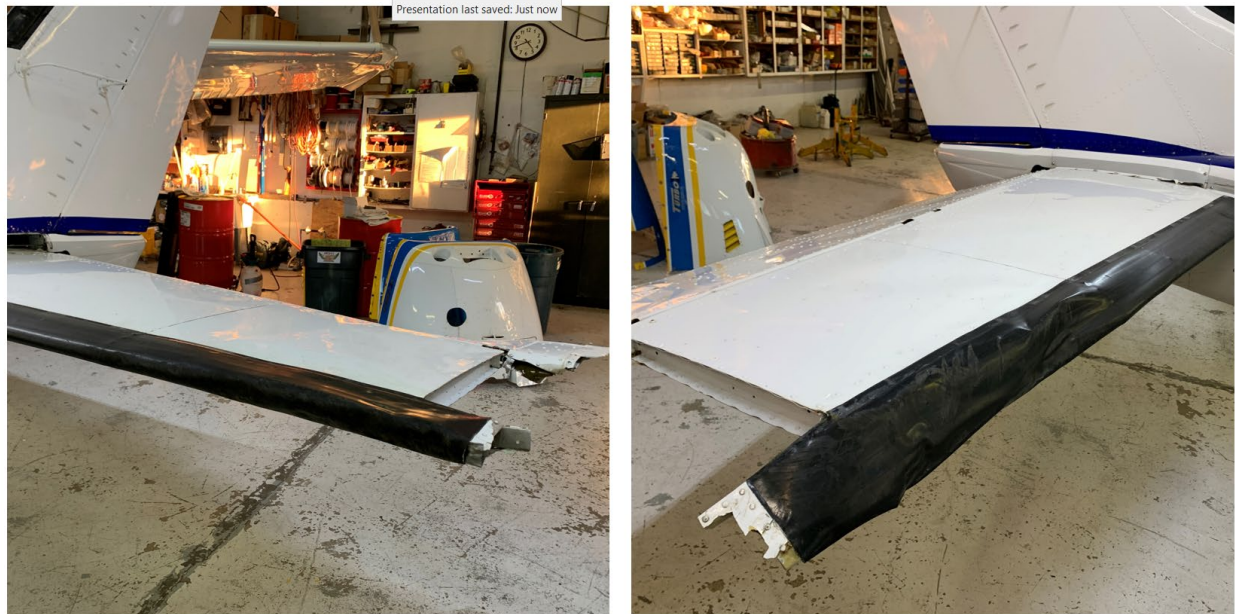
Examination of the airframe revealed that the left and right horizontal were substantially damaged. Flight control continuity was established throughout the airframe to all primary flight controls.

**Figure 1. View of damage to left and right horizontal stabilizer.**

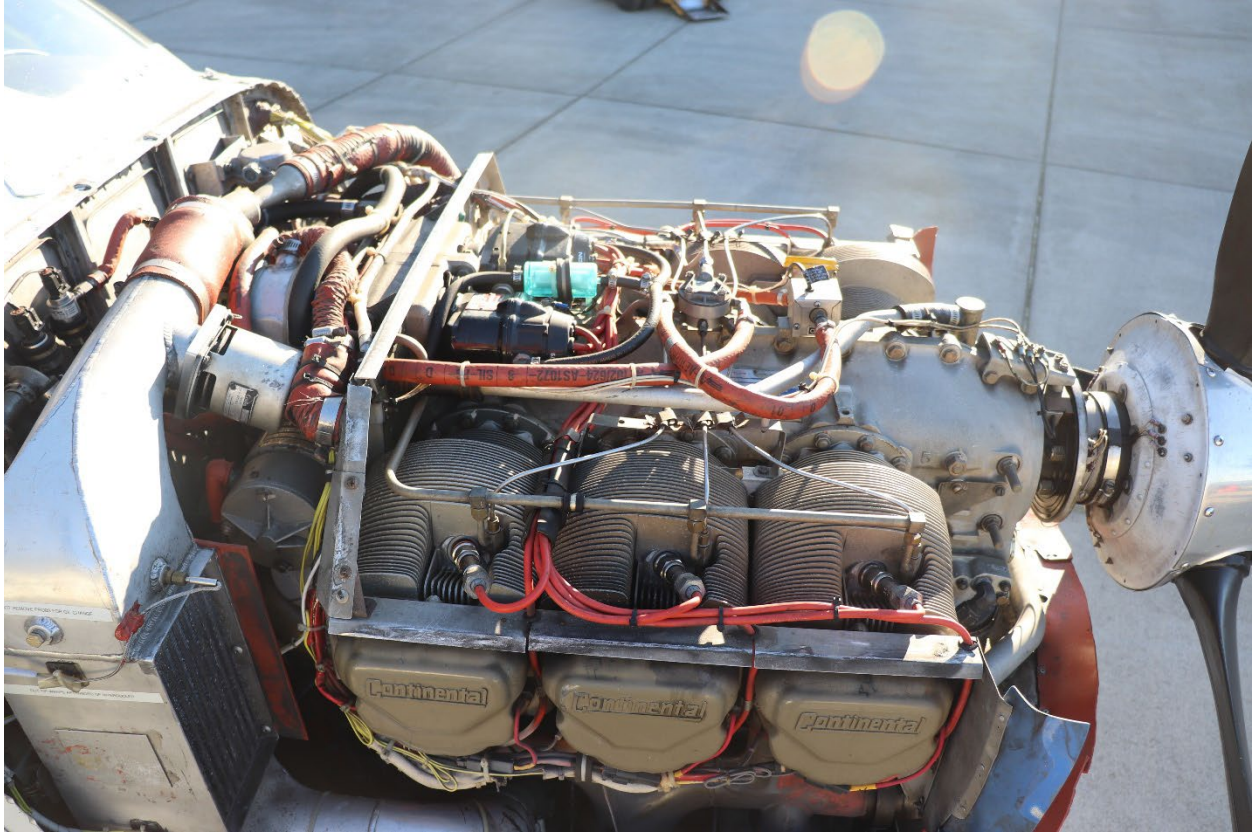
Examination of the recovered wreckage was conducted on January 26, 2022, at the facilities of Twin Oaks Maintenance LLC. The engine and propellers remained intact with no signs of visible impact damage. The engine stayed secure in the engine compartment throughout the examination.

**Figure 2. View of engine prior to engine run**

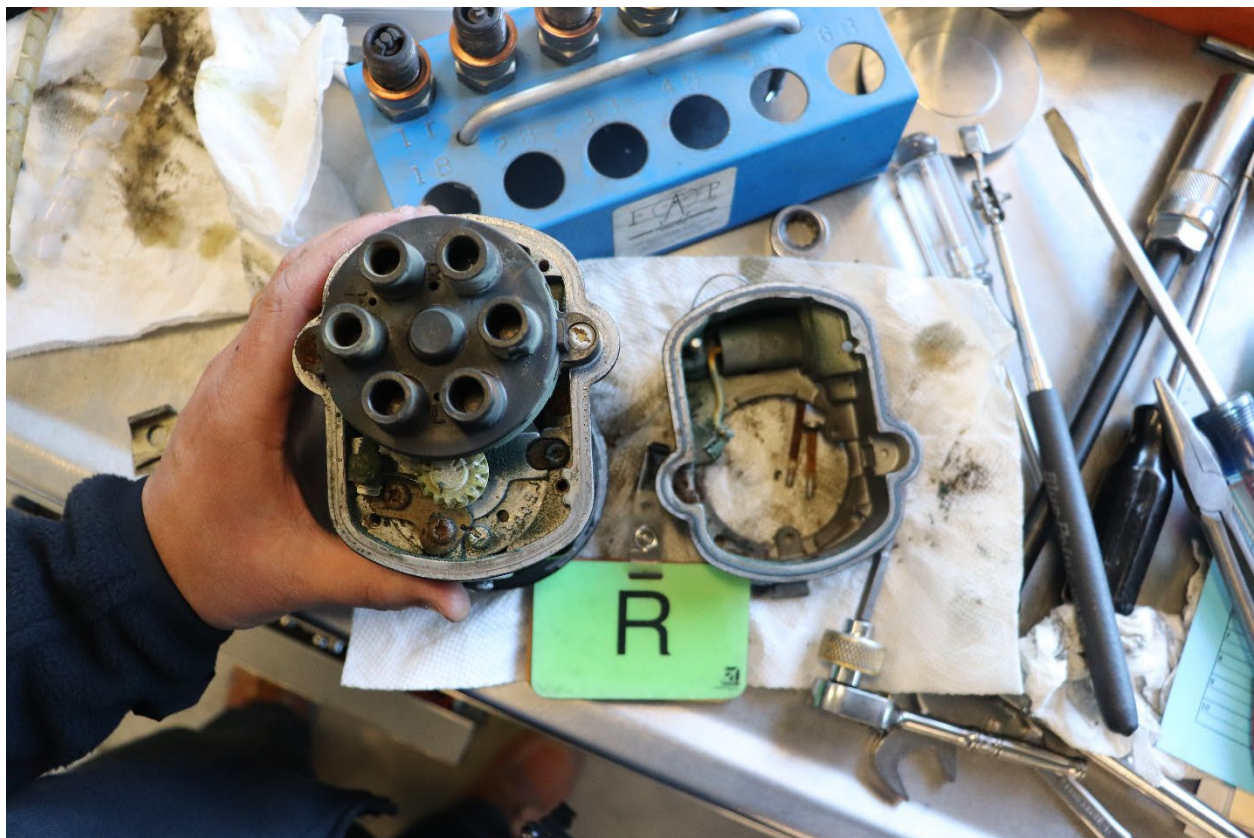
The airplane and engine were recovered and stored at Twin Oaks Aircraft Maintenance, LLC. A postaccident examination of the airplane took place on January 26, 2022. It did not reveal any preimpact mechanical anomalies or malfunctions that would have precluded normal operation. The engine revealed that the right hand magneto was inoperable due to corrosion.

Further examination of the right Slick magneto model no. 6320, SN: 0181738 revealed corrosion and a burning smell within the electrode.

**Figure 3. View of internal components of right magneto**

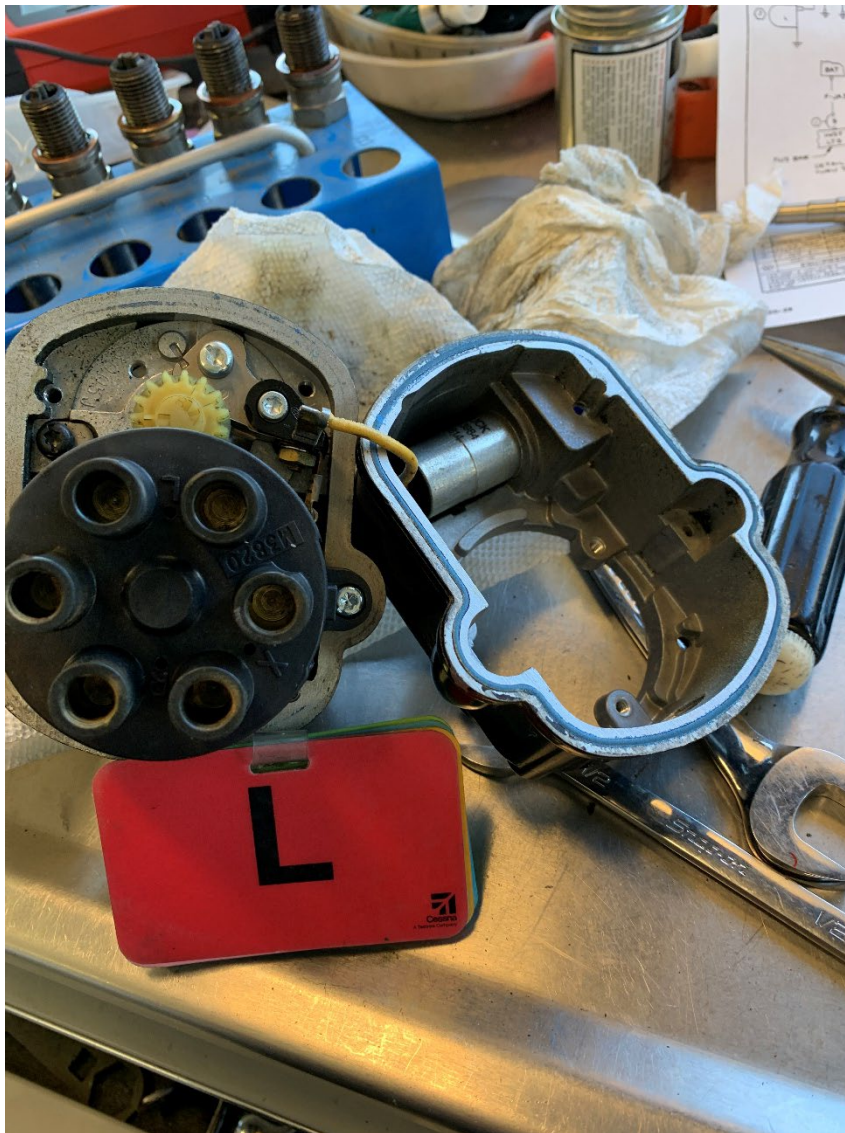
Further examination of the left Slick magneto model no. 6320, SN:8050835 revealed the internal components were unremarkable.

**Figure 4. View of internal components of left magneto**
