WPR22LA060

## INVESTIGATION PHOTOGRAPHS

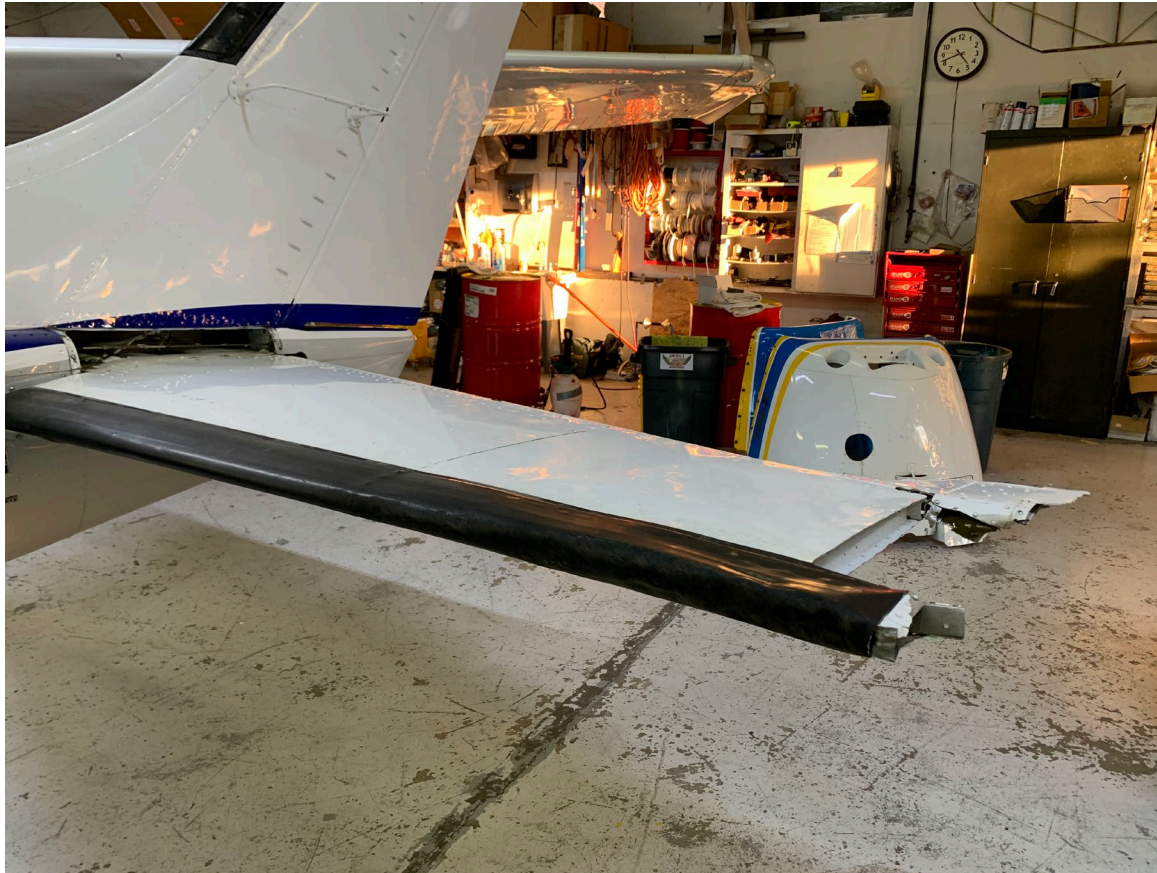
**Photograph 1 - View of damaged left horizontal stabilizer**

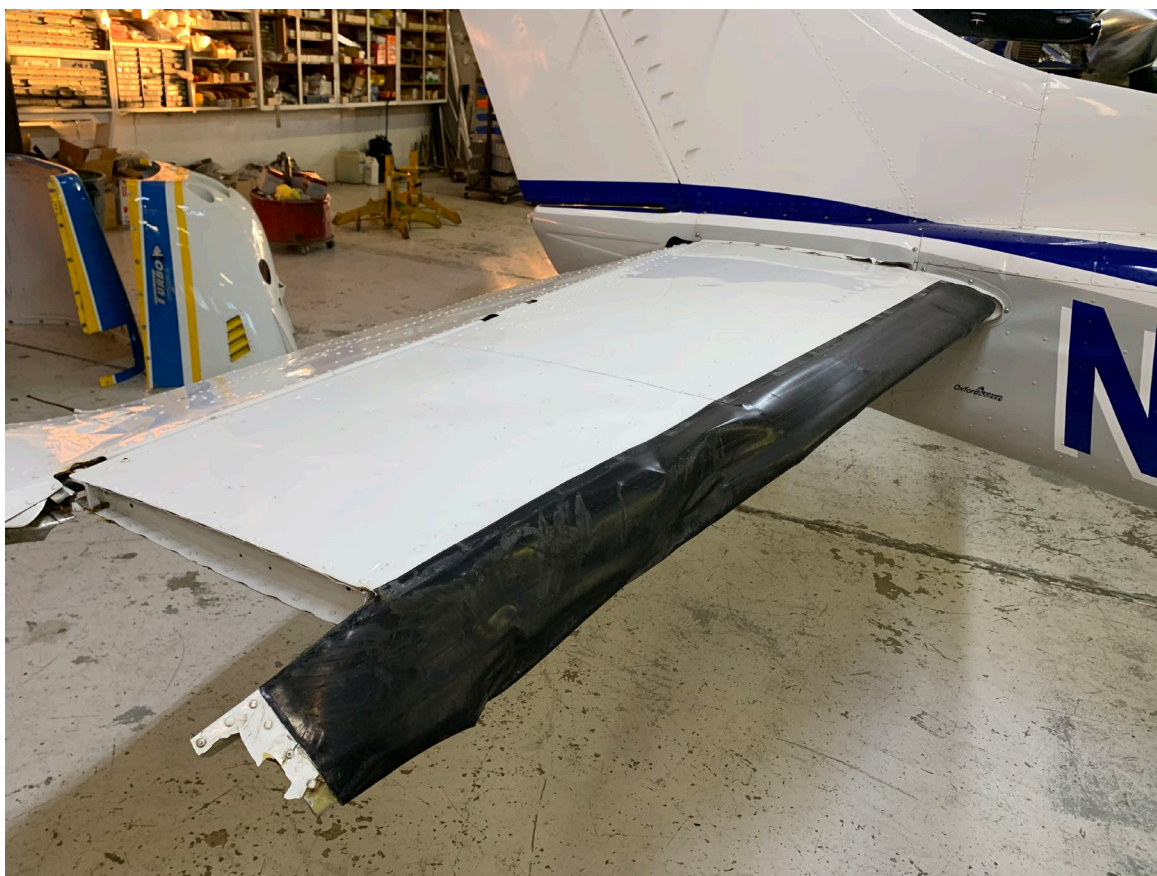
**Photograph 2 - View of damaged right horizontal stabilizer**

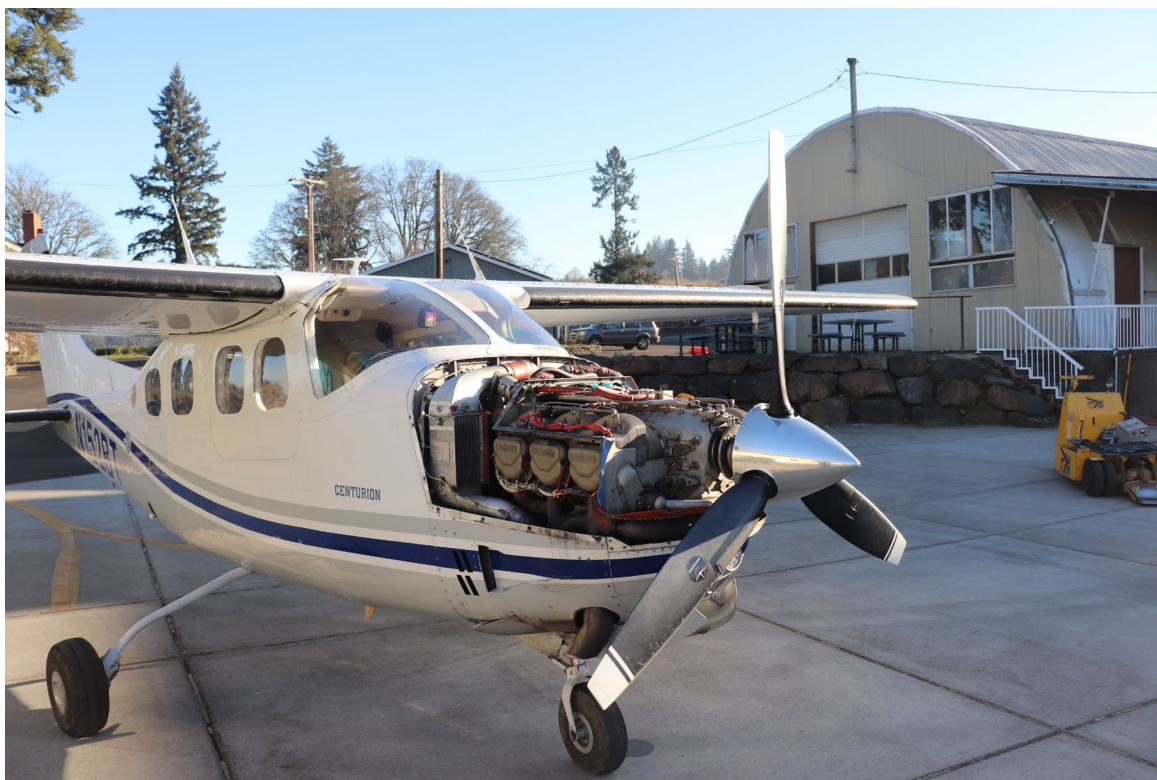
**Photograph 3 - View of airplane and engine prior to ground run**

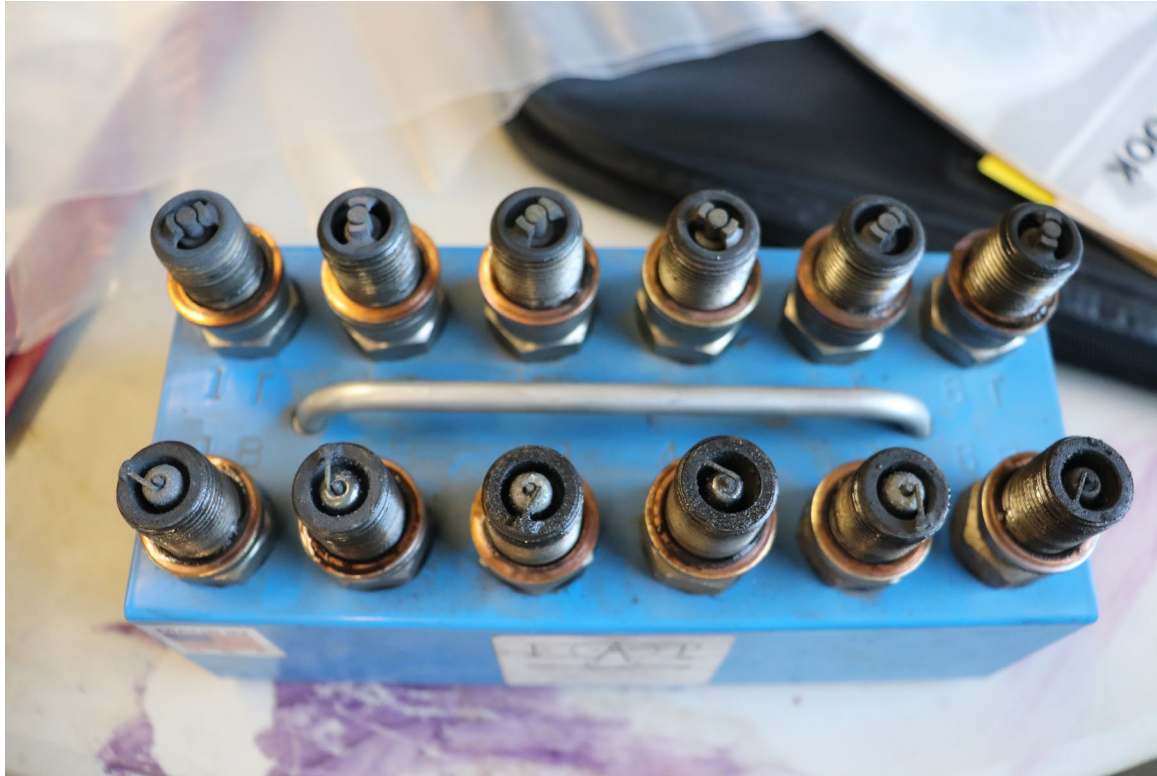
**Photograph 4 - View of removed top and bottom spark plugs**

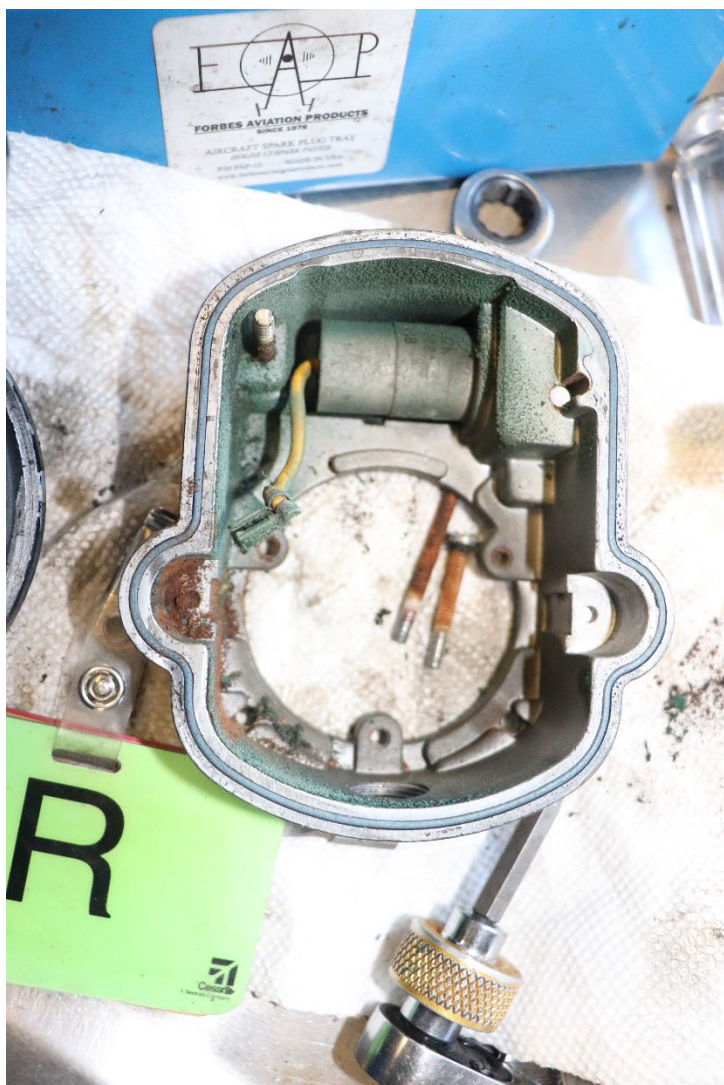
**Photograph 5 - View of internal components for right had magneto**
