## **NATIONAL TRANSPORTATION SAFETY BOARD**

# **AIRFRAME AND ENGINE EXAMINATION**

**WPR22LA061**

Aircraft: Rans RV-3 / N9YY

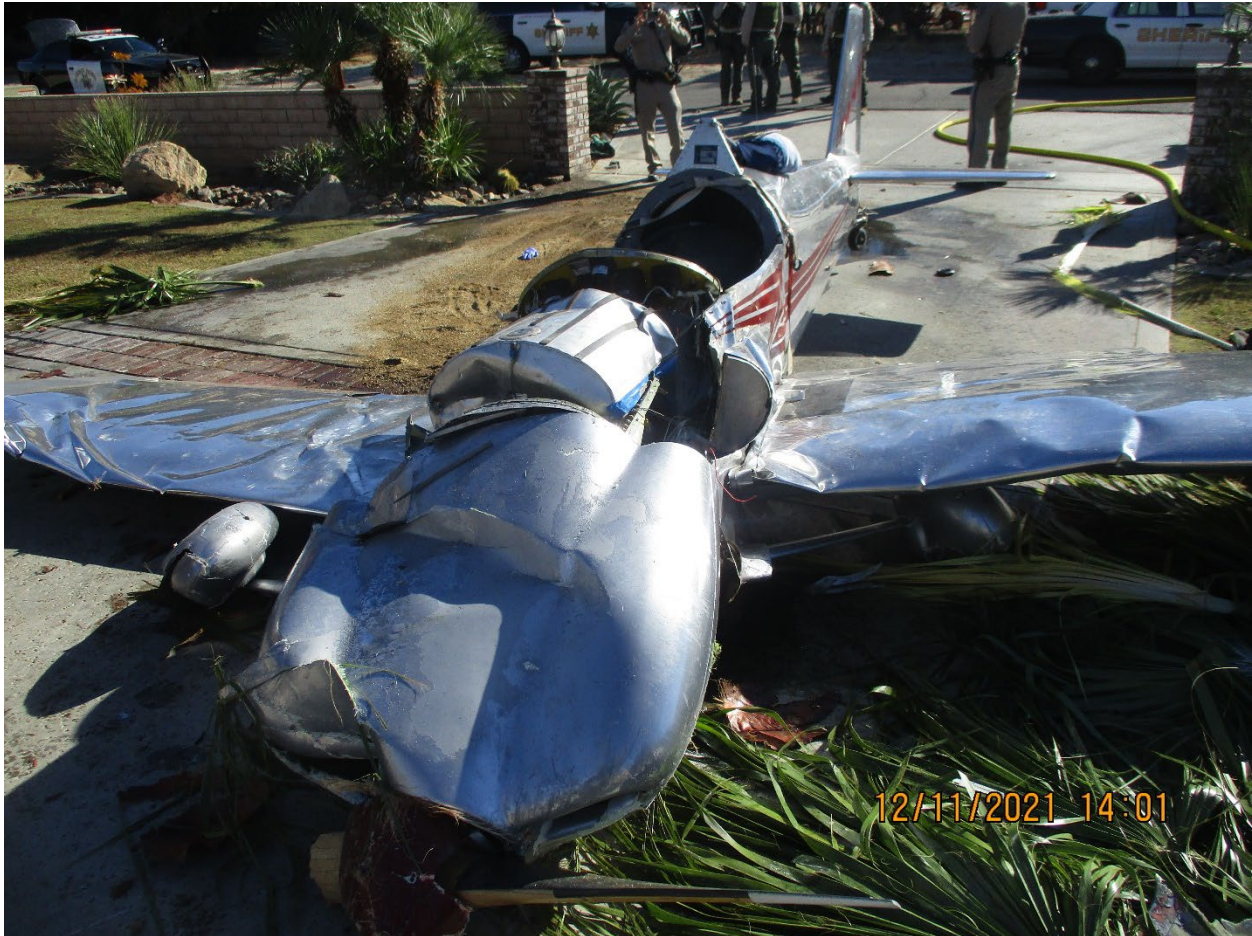
**Figure 1. N9YY at the accident site. The top of a palm tree is to the left of the airplane. Photo courtesy of the Riverside Sheriff's department.**

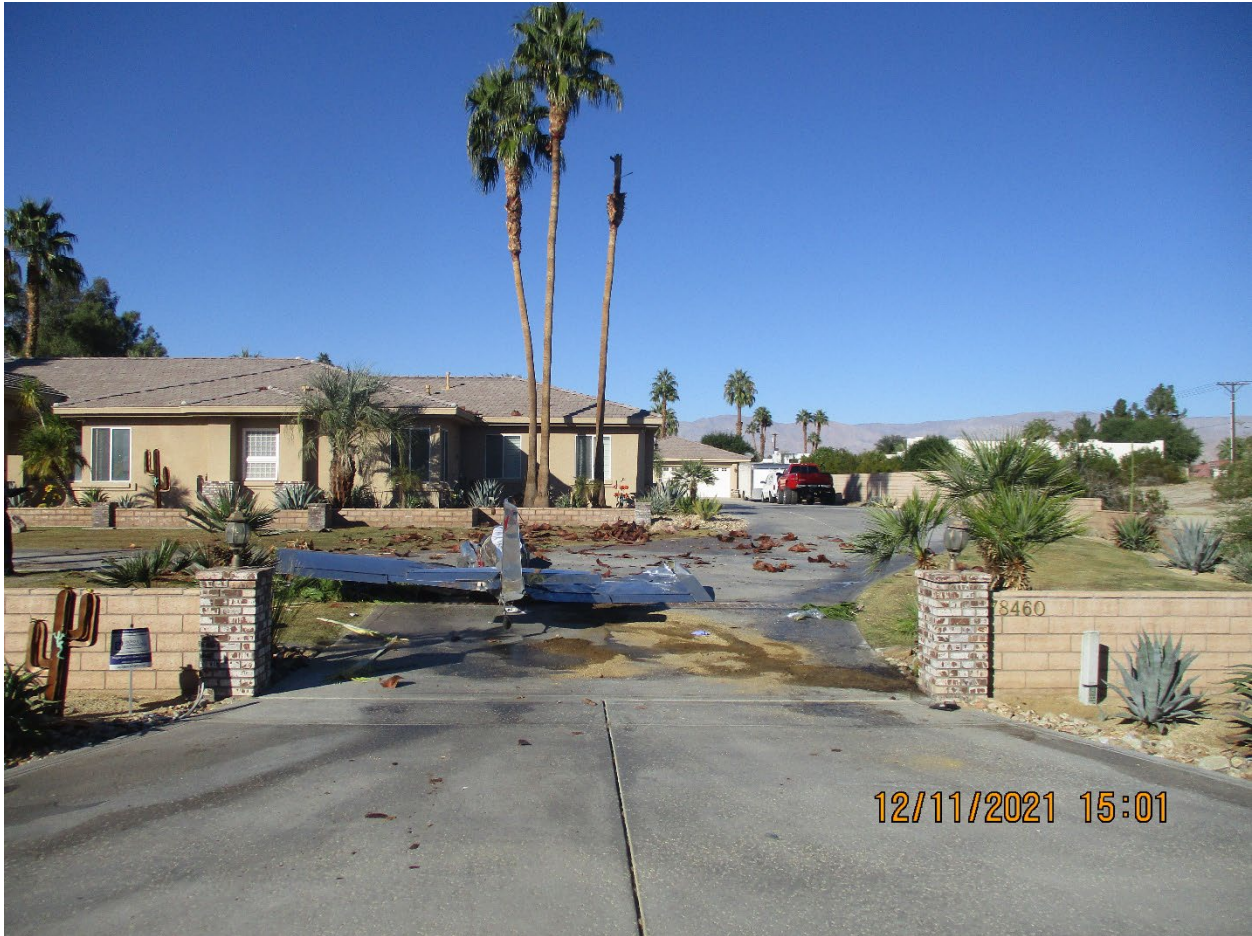
Figure 2. N9YY at accident site, showing sand spread out to absorb fuel, and a palm tree without a top, with palm tree debris around the accident site. Photo courtesy of the Riverside Sheriff's department.

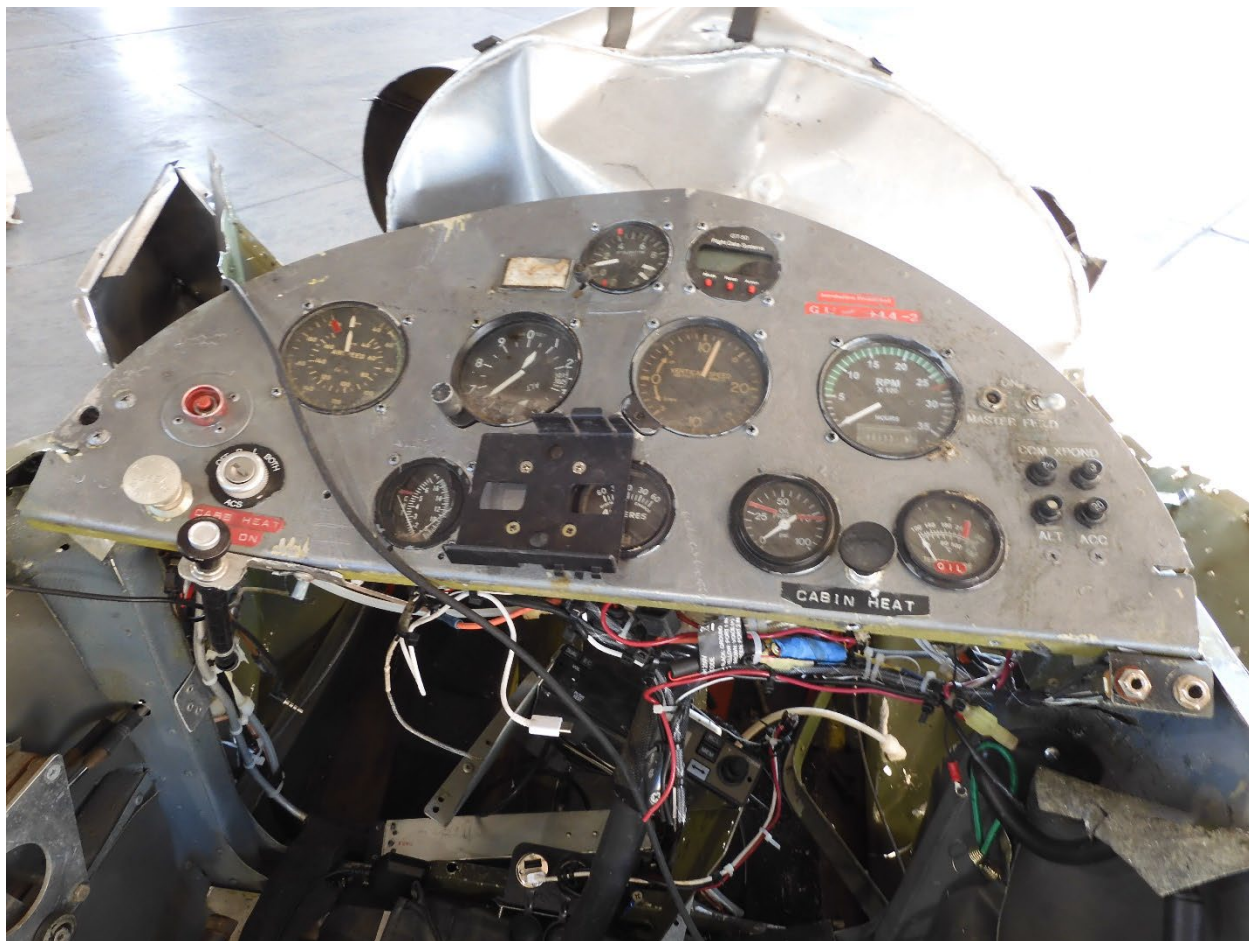
The instrument panel remained partially attached to the cockpit but had been pushed over so that the instruments were facing up. All instruments remained secured in their mounts.

Airspeed indicator: 0 knots  
Altimeter: 650 feet 30.18  
Vertical Speed Indicator: 1,200 feet per minute ascent  
Engine Tachometer: 0 RPM  
Tach hour meter: 173.73  
CHT: 0°F  
EGT: 0°F  
Ignition: OFF, key found in resting on the seat  
Carb Heat: Full in (off)  
Amperes: 0  
Oil Press: 0 PSI  
Oil temp: < 100°F  
Master Switch: Broken, Unknown  
Field: OFF  
COM C/B: IN  
XPOND C/B: IN  
ALT C/B: IN  
ACC C/B: IN  
Cabin Heat: IN  
Engine Primer: IN  
Acceleration: +1, +9, +11

Figure 13. Instrument panel.

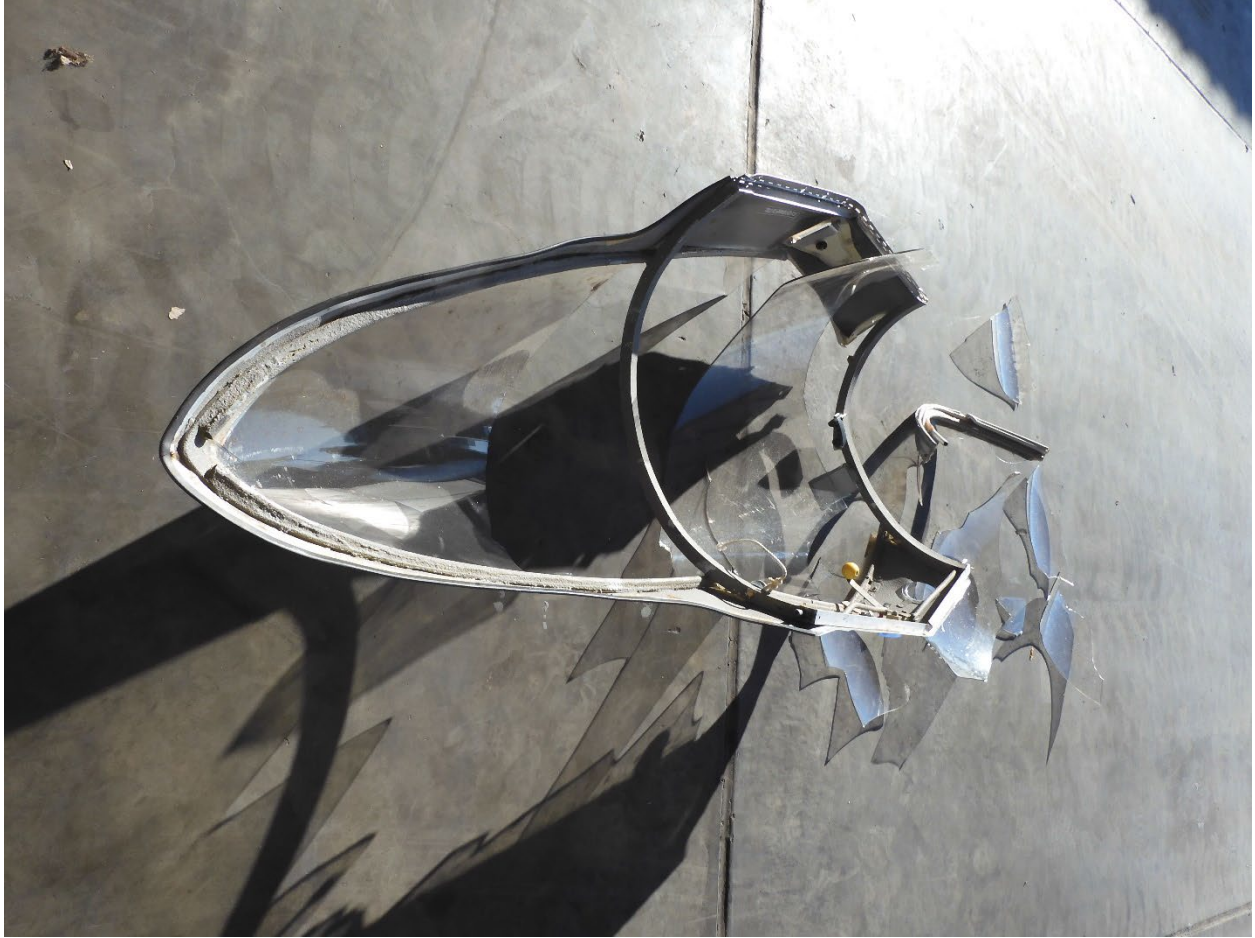
Figure 14. One-piece canopy.

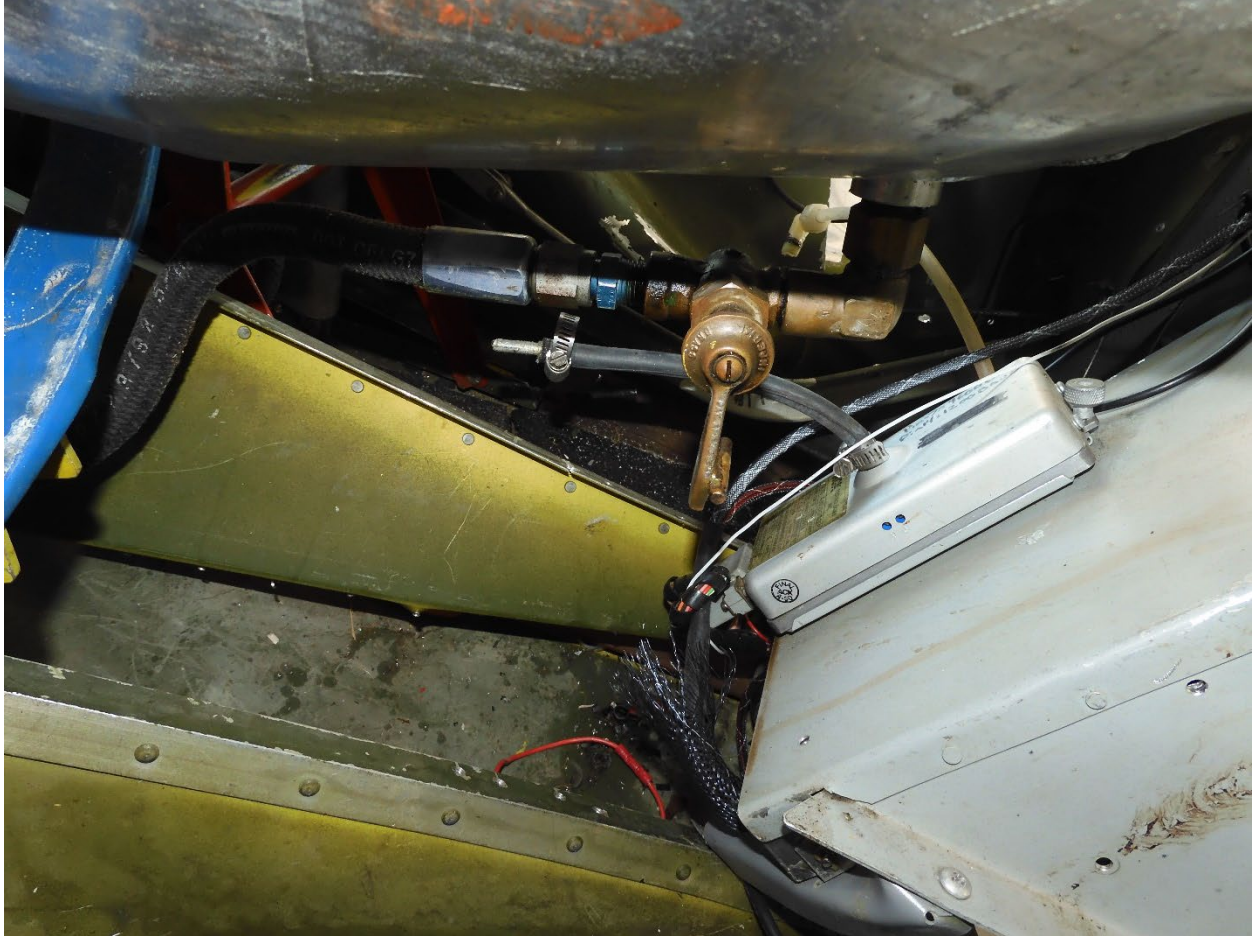
A fuel shutoff valve was found attached to the bottom of the fuel tank. The fuel shutoff valve handle was found perpendicular to the fuel line. Disassembly and examination of the valve revealed that the handle was manufactured to travel about 90° total. When pulled aft to the stop, towards the tail of the airplane, the passage was completely closed. When pushed fully forward to the stop, toward the nose of the airplane, the passage was completely open. When positioned halfway (90° to the fuel hose) the passage was about 50% open.

Figure 15. Fuel shutoff valve in intermediate position, as found.

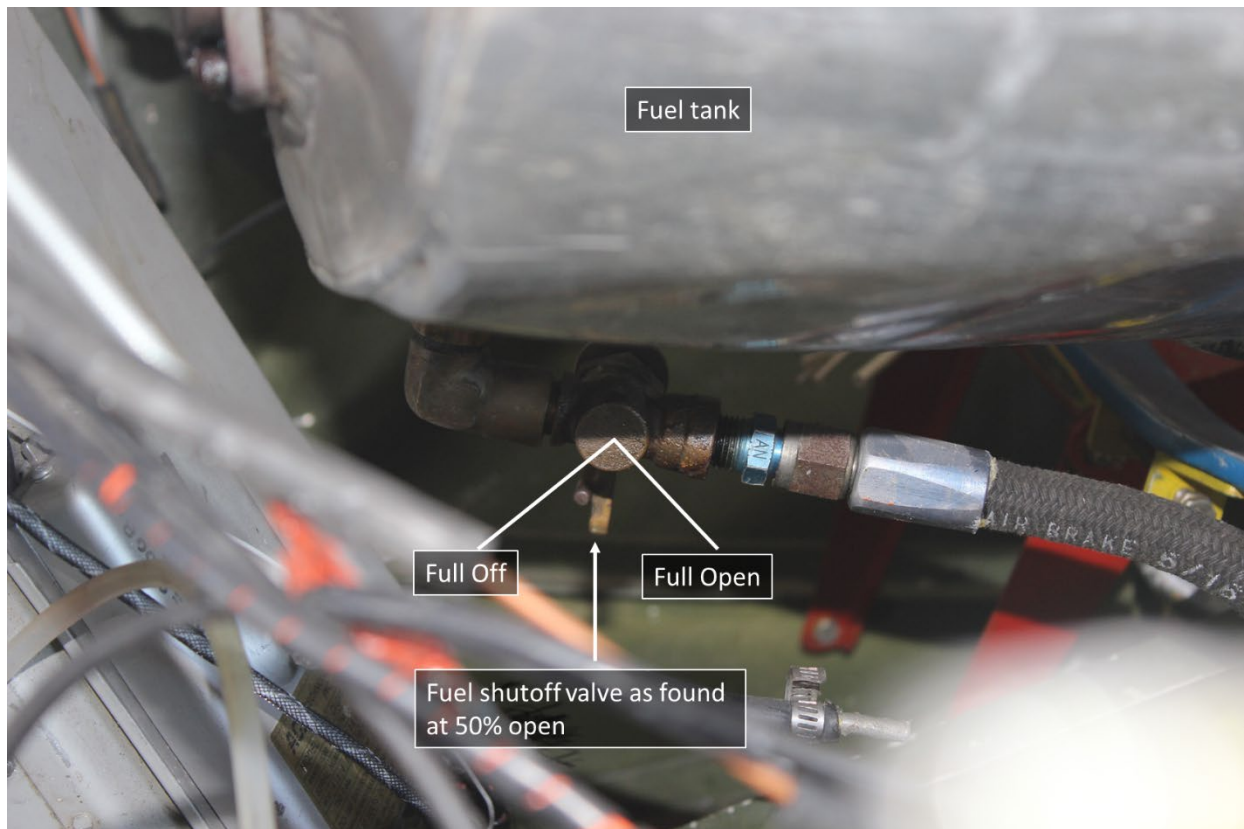
Figure 16. View of fuel shutoff valve handle travel.

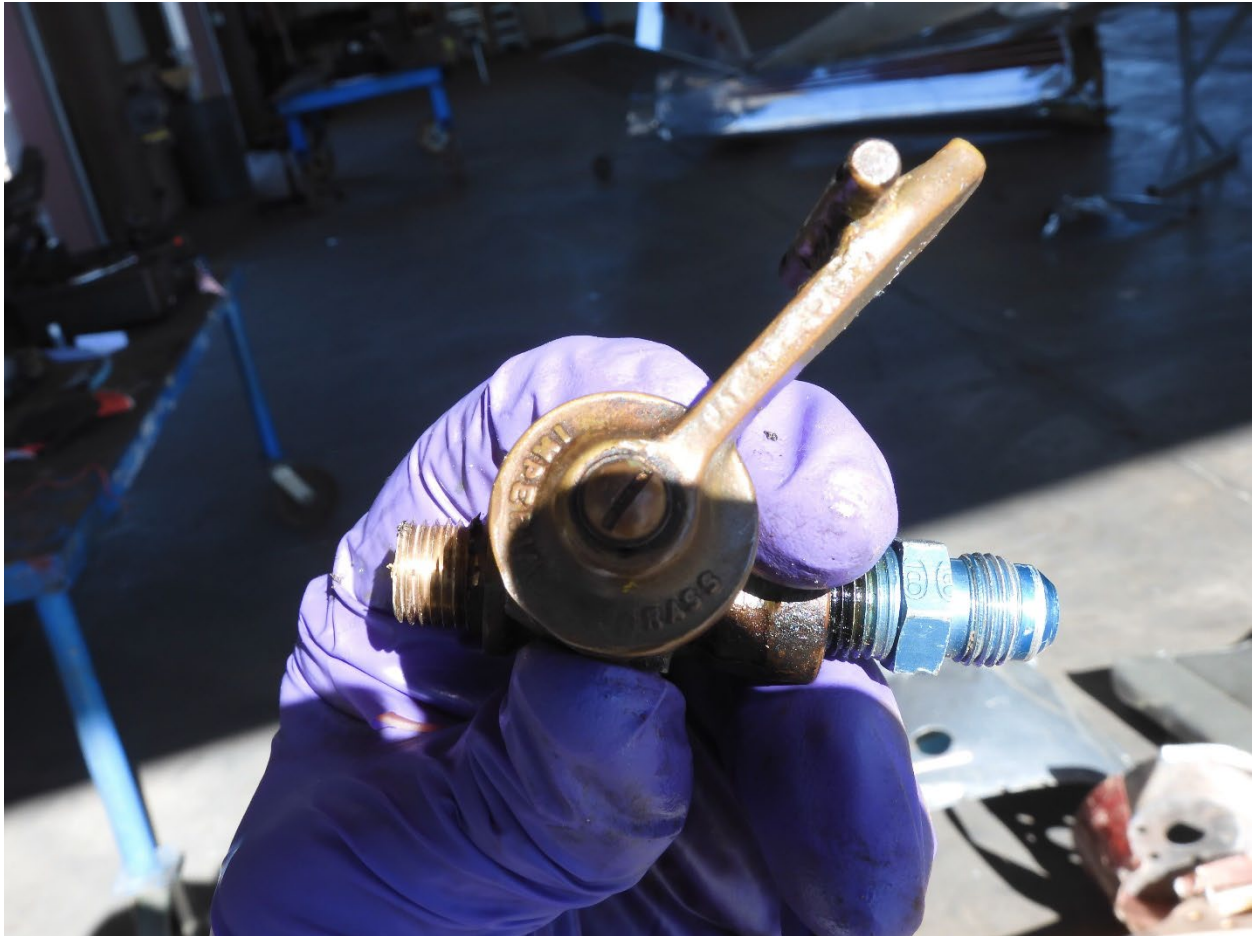
Figure 17. Fuel shutoff valve showing the valve handle position when the opening is at 100% open.

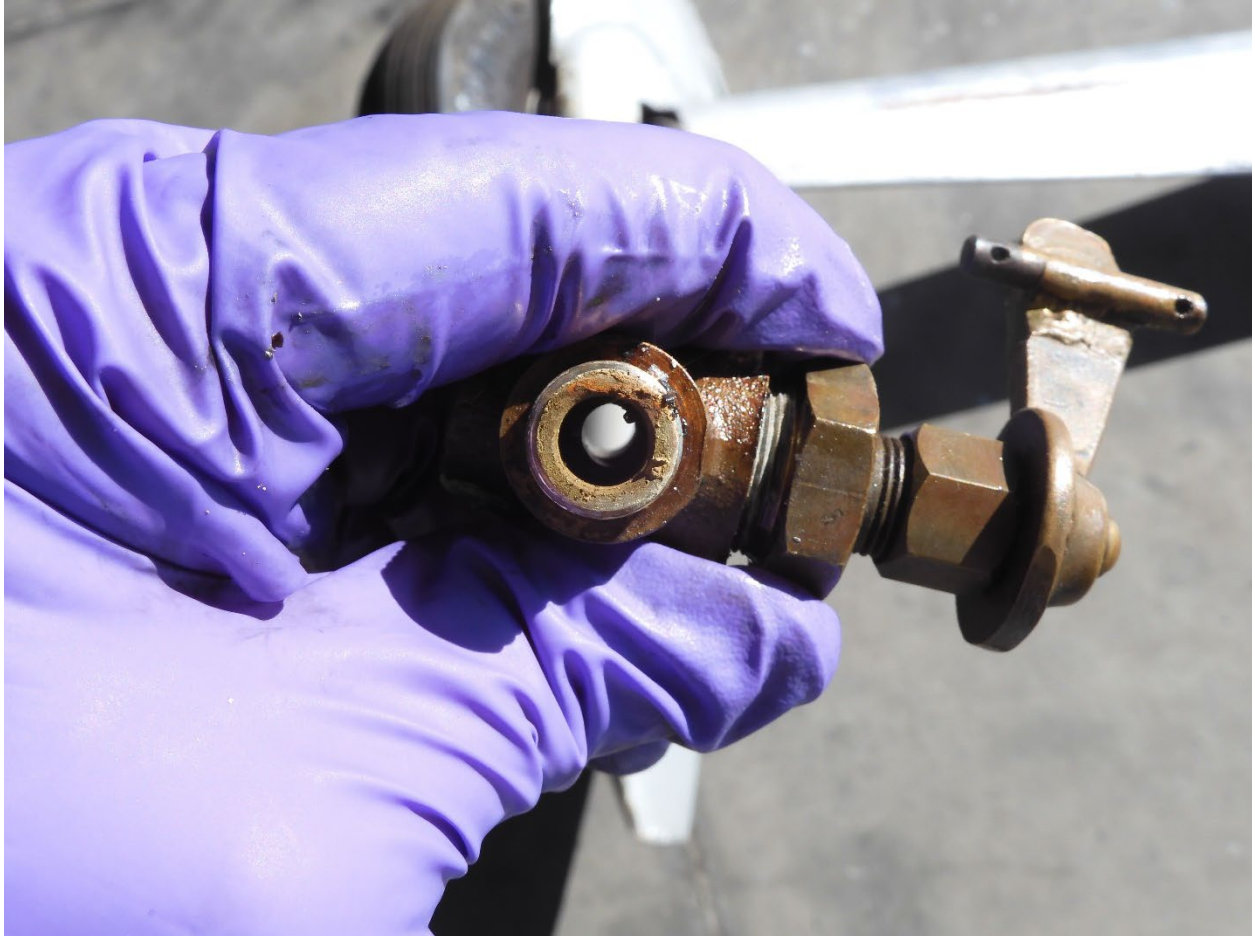
Figure 18. Fuel shut off valve showing the valve at 100% open and the fuel handle at 45° forward.

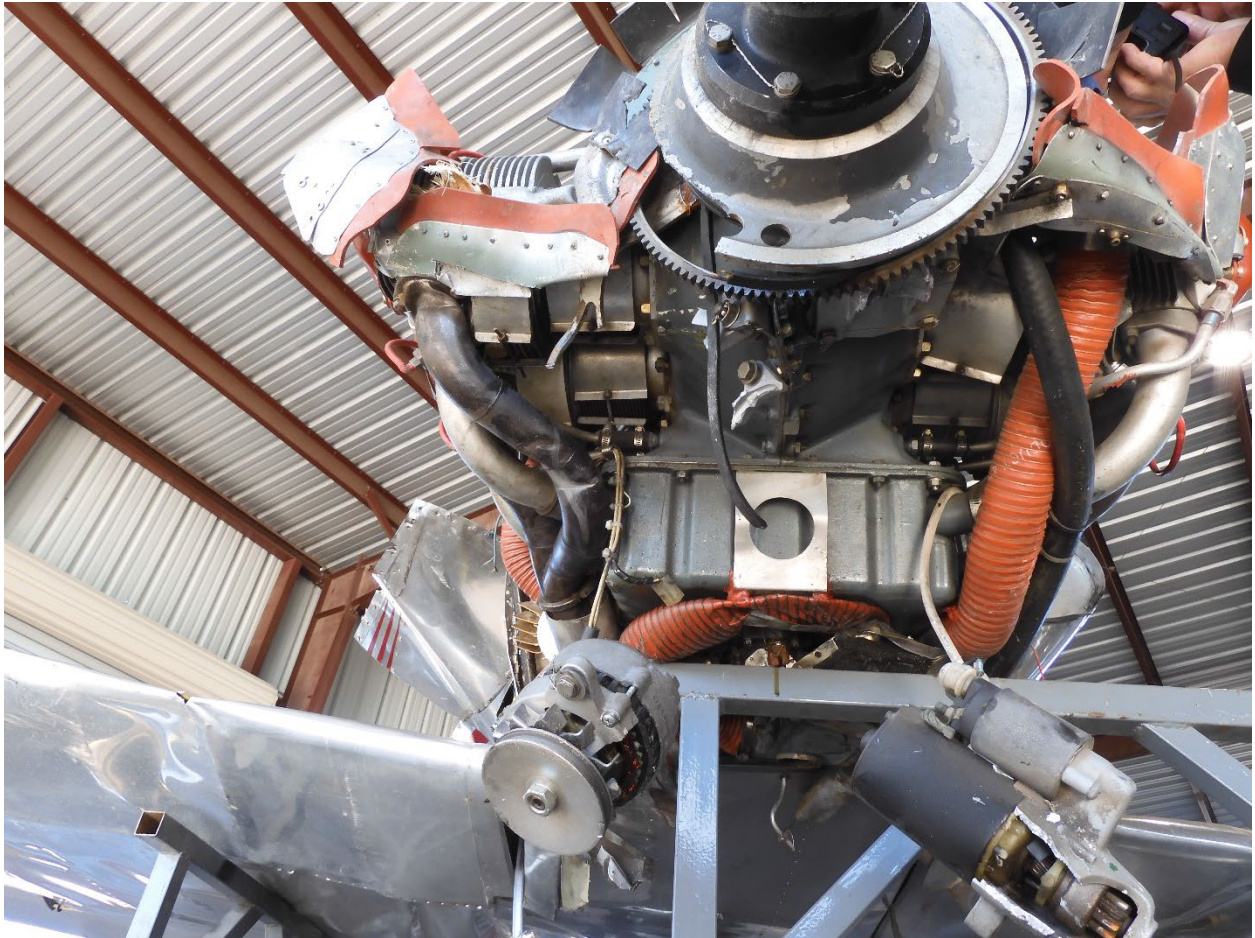
very loose. The starter ring gear had separated from the engine. The starter separated from the engine and did not exhibit any indication of the ring gear rotating when it contacted the starter.

Figure 22. Engine front view showing the displaced starter, alternator, and ring gear.

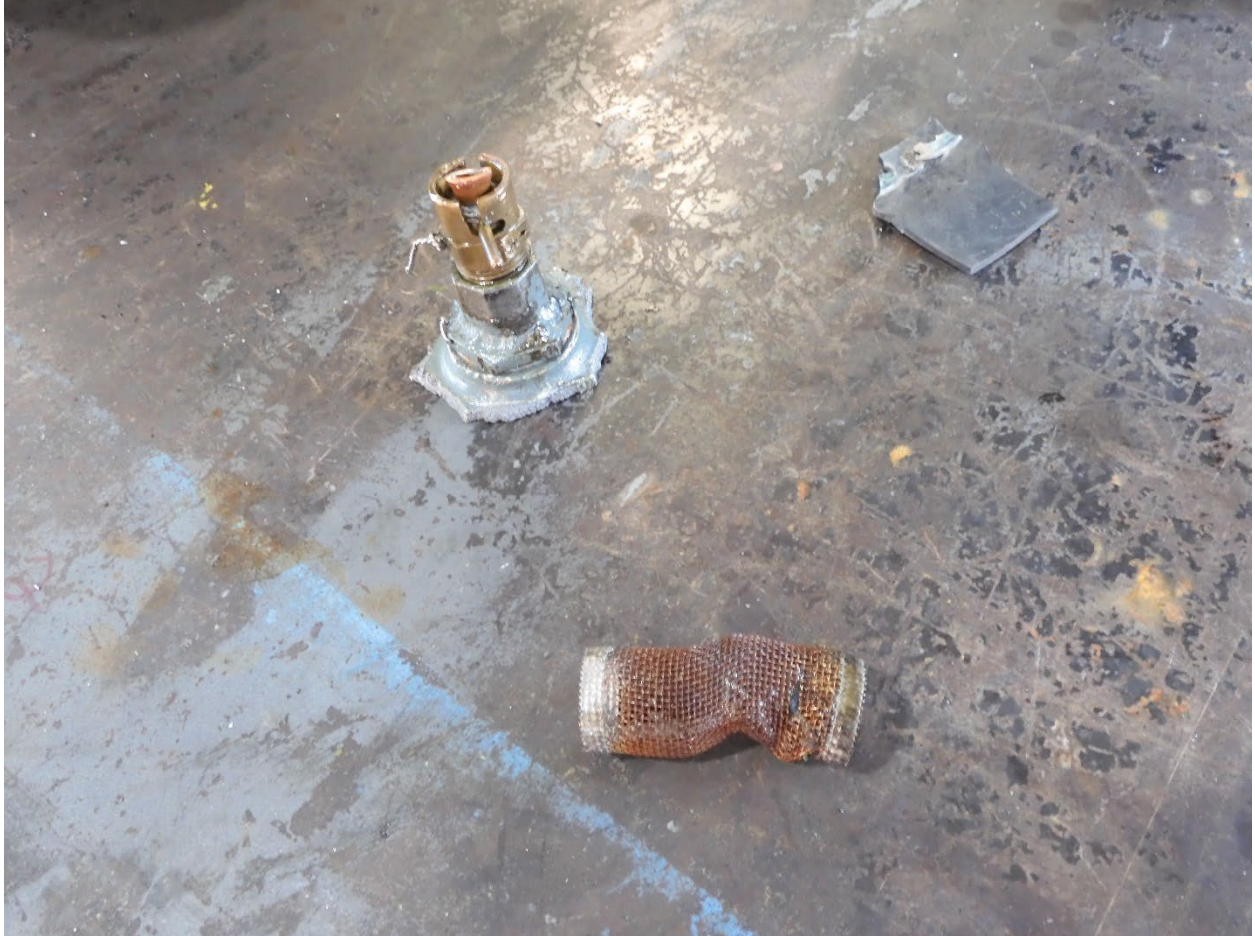
Valvetrain continuity and cam lobe integrity was established. Similar rocker arm movement was observed at all rocker arms for the intake and exhaust. The Exhaust tubes and intake tubes remained attached to the engine and exhibited minor crush damage upwards. The valve covers were removed and exhibited wet clean oil appearance for all the cylinder heads. The oil screen exhibited no blockage.

Figure 24. Engine oil screen.

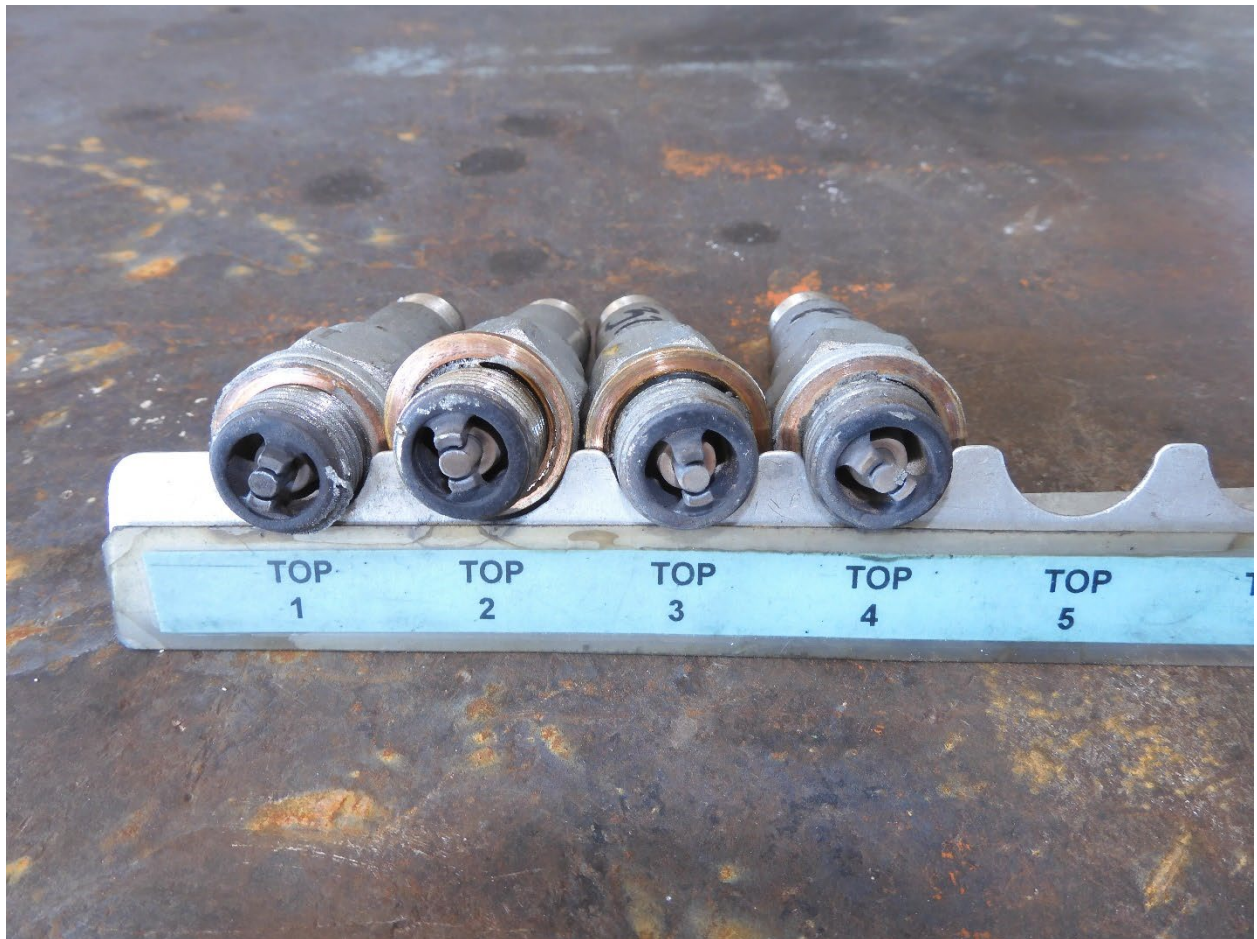
Engine. The engine was examined by the party member from Lycoming Engines and the IIC. The top spark plugs were removed and exhibited normal wear. The spark plug leads remained attached to all the spark plugs and exhibited breaks near the magneto, consistent with contact with the firewall. The two magnetos remained attached to their respective pads. The right magneto exhibited a minor defect with a quarter size hole from contact with an object. Spark was observed at all eight leads on the magnetos. E-gap was verified and found to be slightly retarded on both magnetos. The magneto to engine timing was recorded at 20° before top dead center (BTDC) of the number 1 cylinder. The engine data plate indicated 25° BTDC was the correct timing. The ignition switch was examined, and the ground wire was found to be attached but

Figure 25. Top spark plugs.

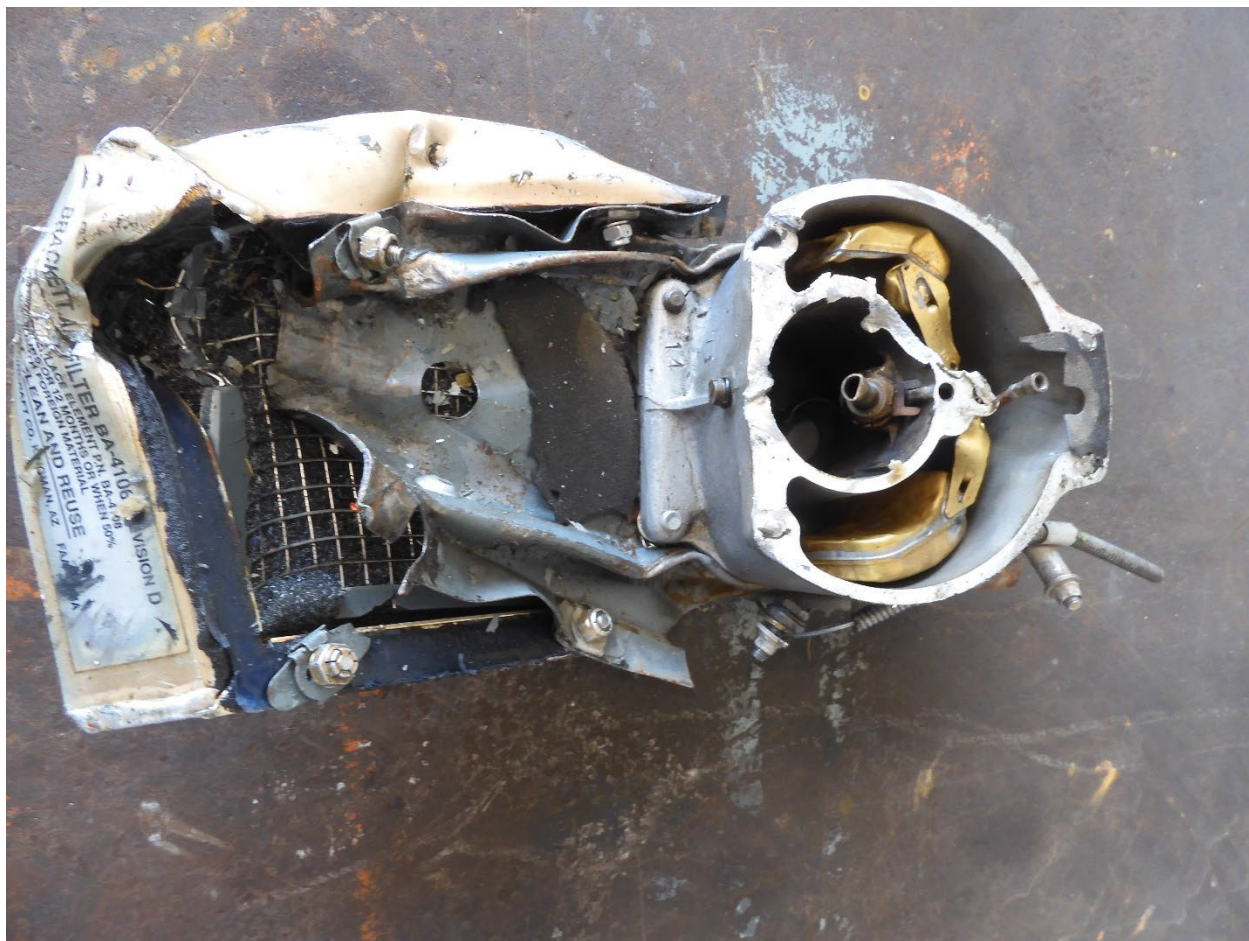
Thumb force compression was present in all cylinders and in the correct firing order. The carburetor was damaged, and the needle and the filter were not recovered. The brass floats were damaged, one exhibited inward crush damage consistent with fluid being present at the time of impact. The main jet was clear of obstruction, the throttle cable remained attached to the throttle arm, however the outer sheath had separated, allowing the inner control cable to flew when the throttle was advanced to full throttle. It is unknown if this outer sheath separation was a result of the displacement of the engine during impact. The fuel line from the fuel tank to the carburetor was clear but had separated from the carburetor. The intake plenum remained attached to the engine and exhibited minor damage. The gascolator was dry but contained a large amount of metallic rust at the bottom of the bowl. The filter screen was clear.

Figure 27. Carburetor bowl with floats.

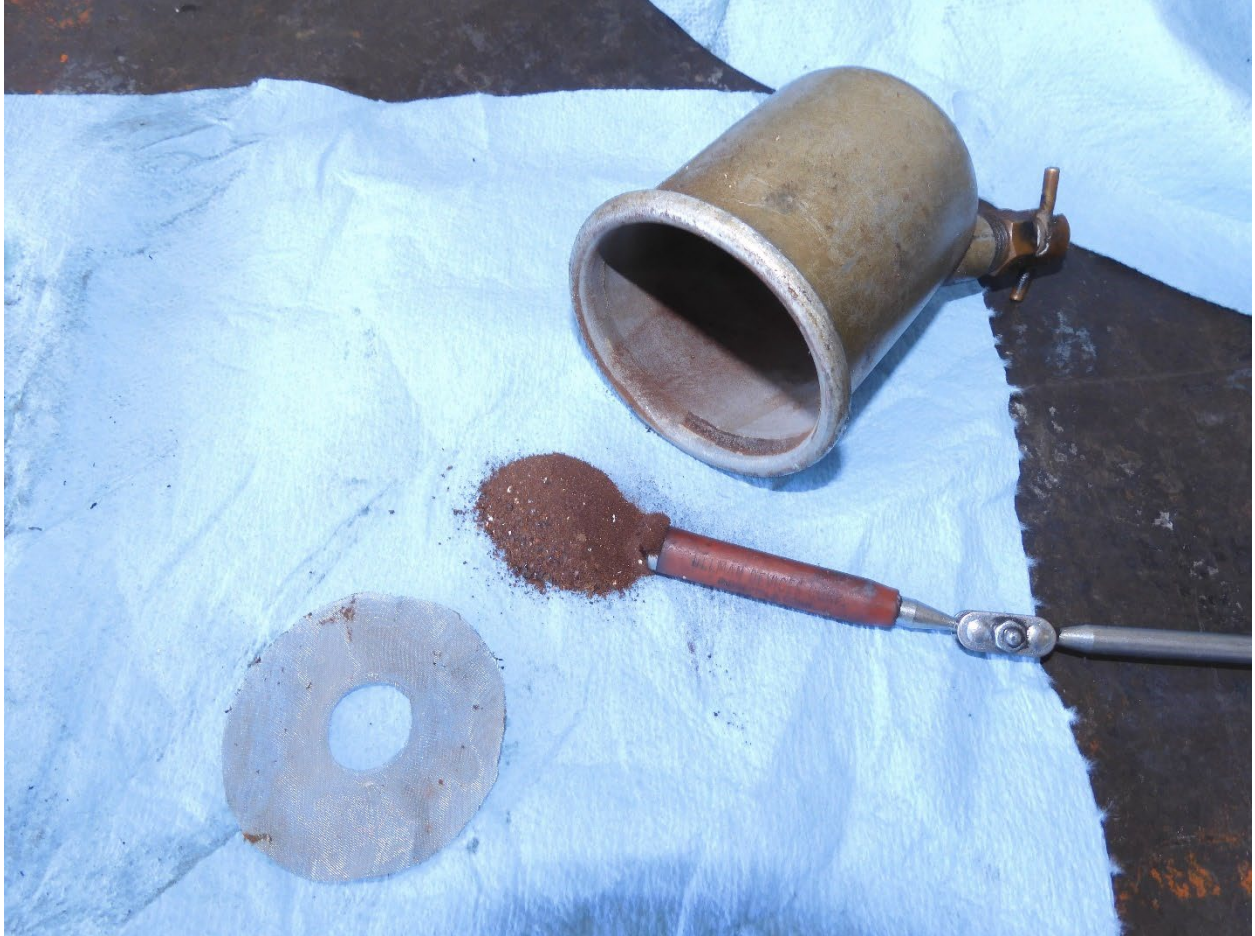
Figure 28. Gascolator bowl and screen, showing metallic rust debris found at the bottom of the bowl.

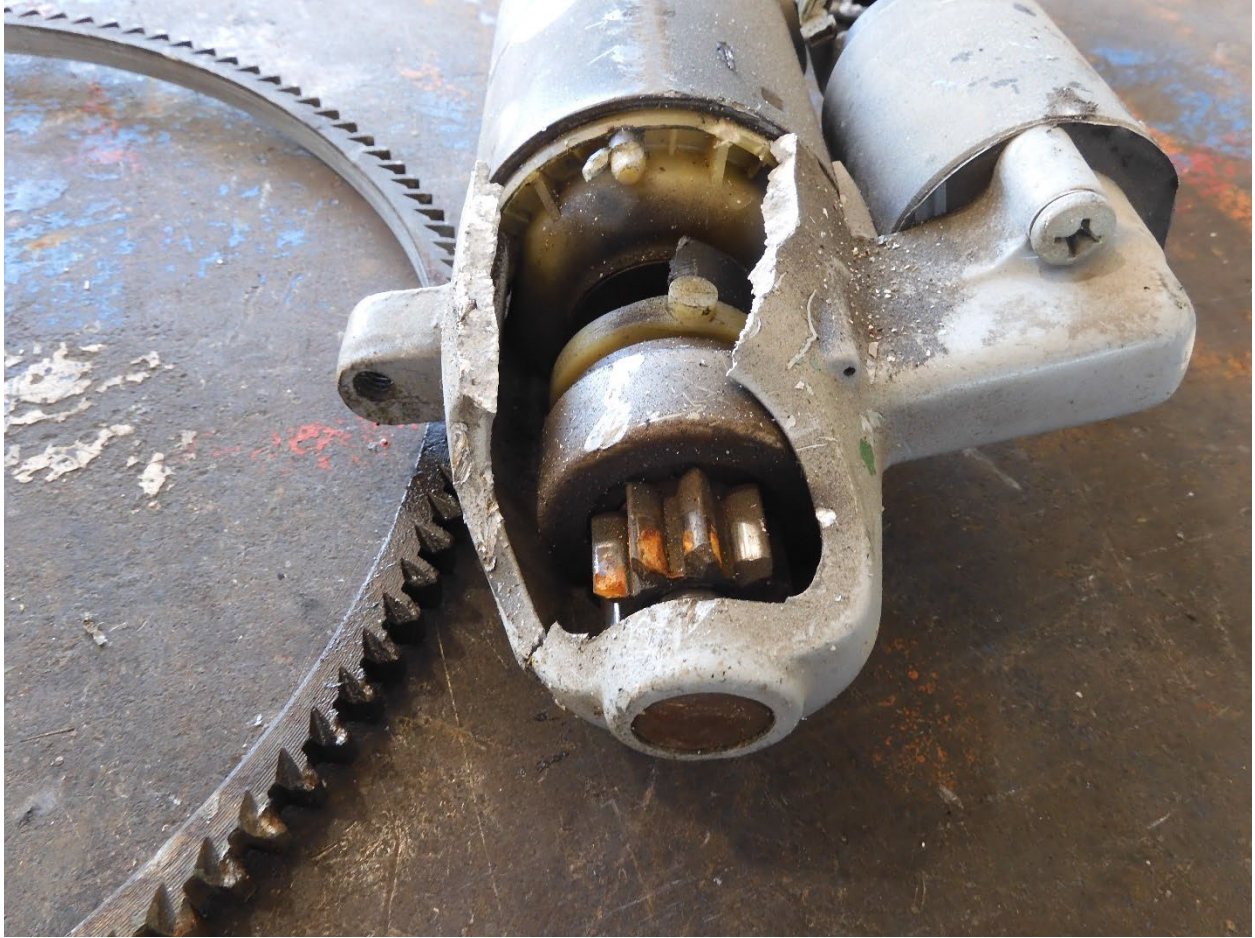
Figure 29. Starter and ring gear, showing no rotational damage to the starter from the ring gear.

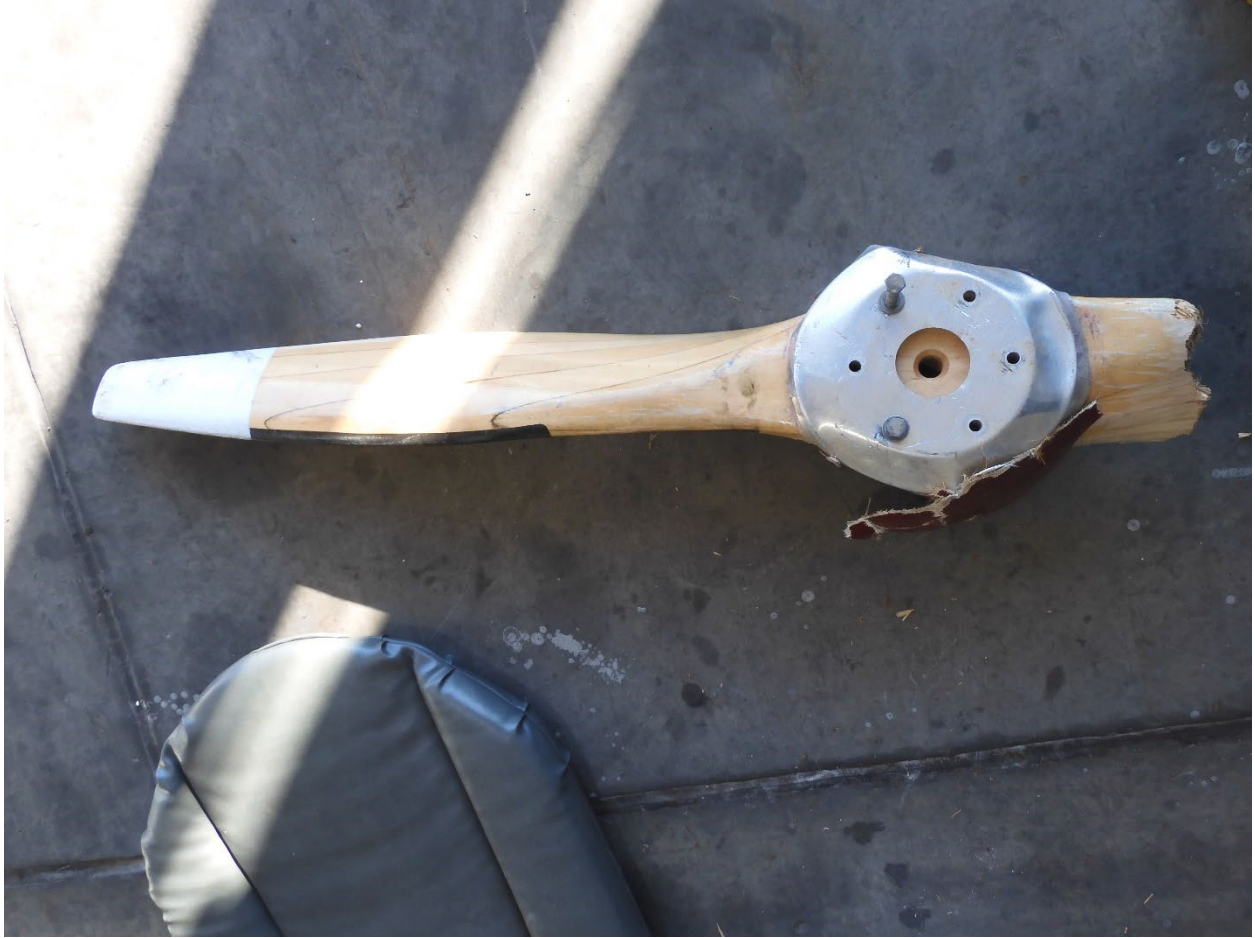
Propeller. The propeller was removed during recovery. The wooden propeller exhibited a fracture and separation of one blade. The blade was observed near the palm tree but not recovered. The fracture exhibited a front to back break. The opposite propeller blade exhibited very minor damage and did not appear to have struck an object. Minor removal dents were observed on the back side of the blade. The composite spinner was fractured into multiple pieces and mostly separated from its mount.

Figure 30. Wooden propeller and fragment of the spinner.

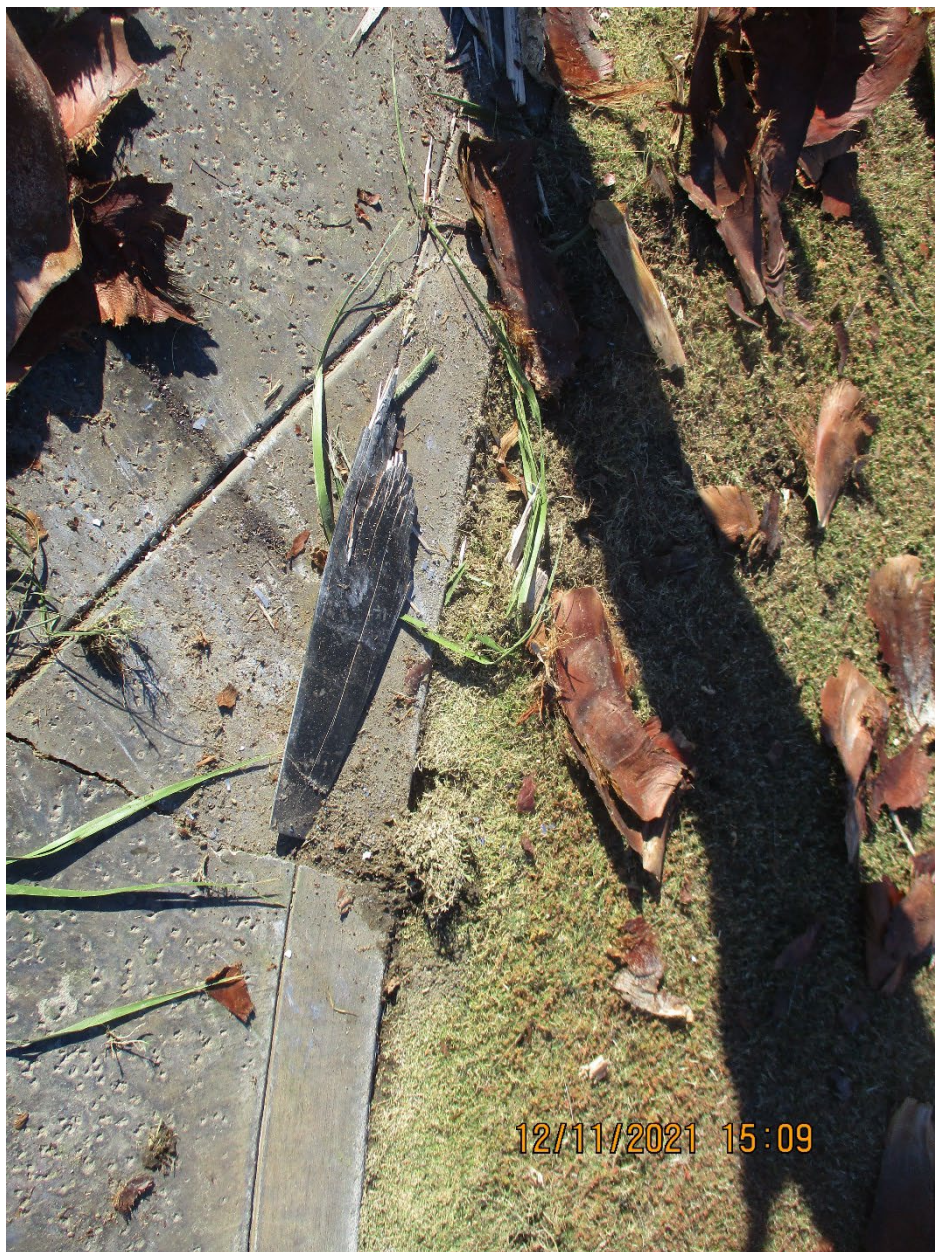
Figure 32. Back-side view of the separated propeller at the accident site, near the palm tree.
