## Record of Conversation

**NTSB Accident Number: WPR22LA061**  
**Aircraft Registration & Make/Model: N9YY / RV-3**  
**Accident Location: Bermuda Dunes, California**  
**Accident Date: December 11, 2021**

Survey of the accident site.

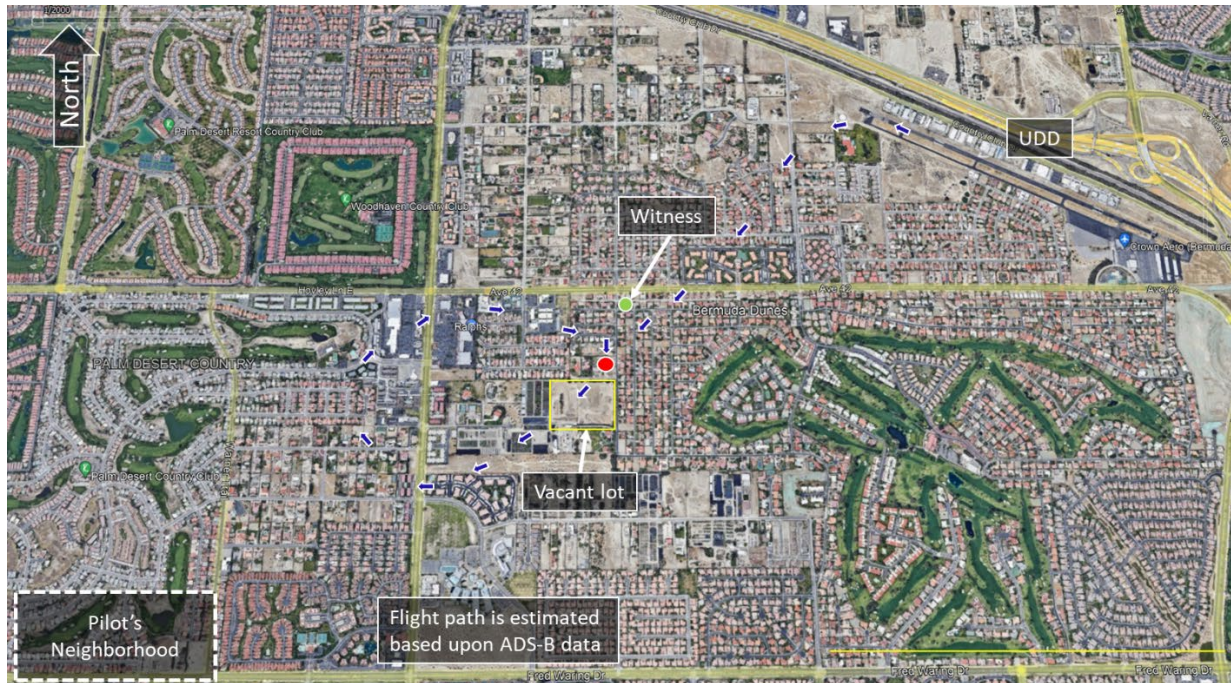
An overhead view of the flight path revealed the airplane made a descending right-hand turn over a populated neighborhood, about 1 mile northeast of his private dwelling at [REDACTED] Palm Desert, California 92211. A vacant lot of about 600 ft by 900 ft, was just south of the accident site and was in line with the airplane's path after the sharp right-hand turn was made.

Figure 1. Overhead view showing the estimated flight track, witness location and the two vacant lots.

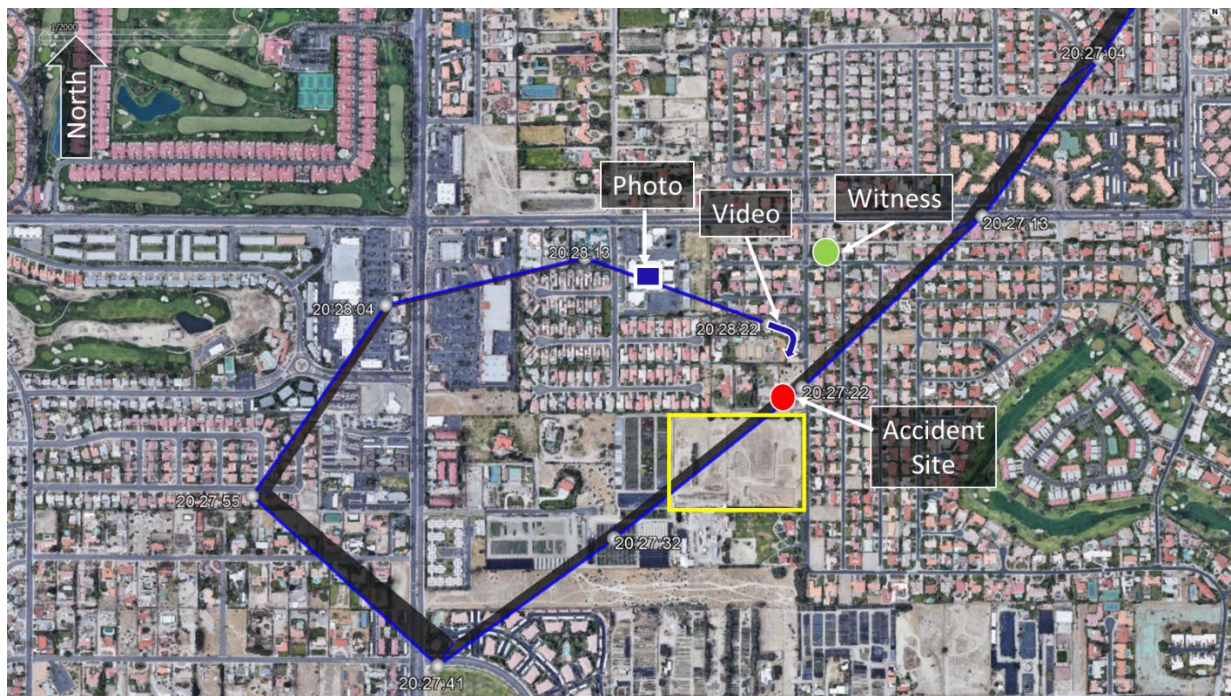
Figure 2. Close up overhead view showing the accident site, witness location, approximate location of where the photo and video were taken, and the vacant lot.

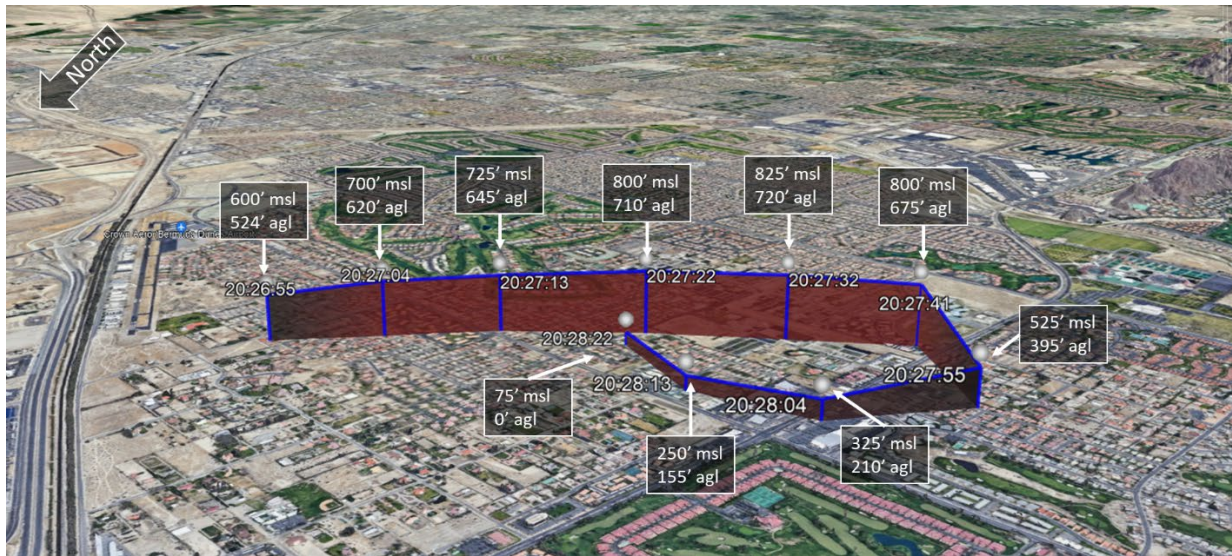
Figure 3. Profile view of the flight track, showing the airplane altitude in msl and agl.

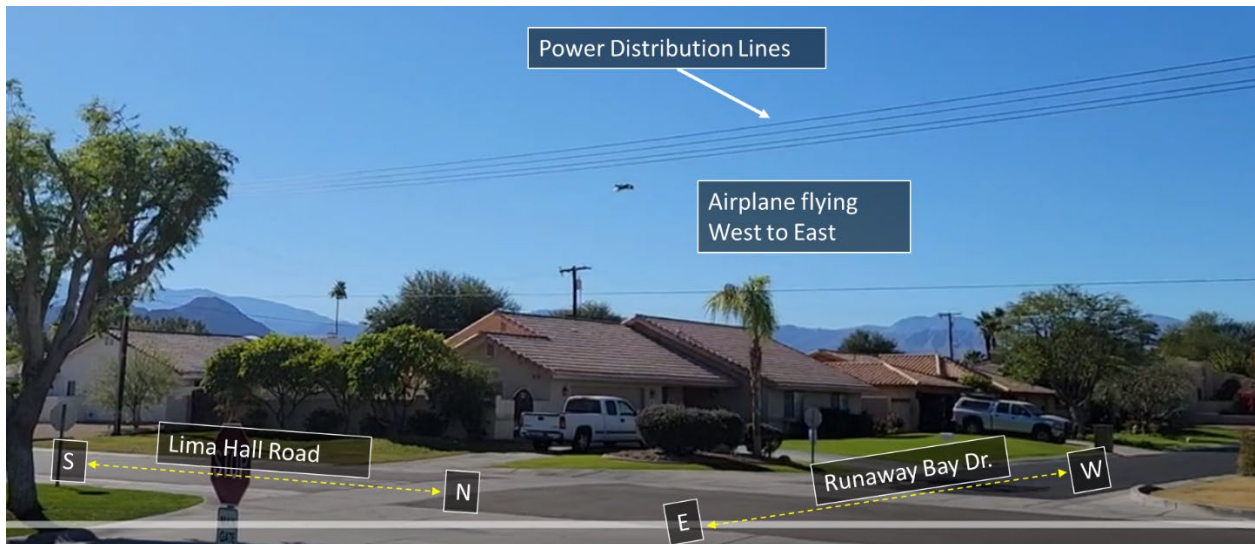
Figure 4. View of the airplane as it descended to the west. The power distribution lines on Lima Hall Road are shown.

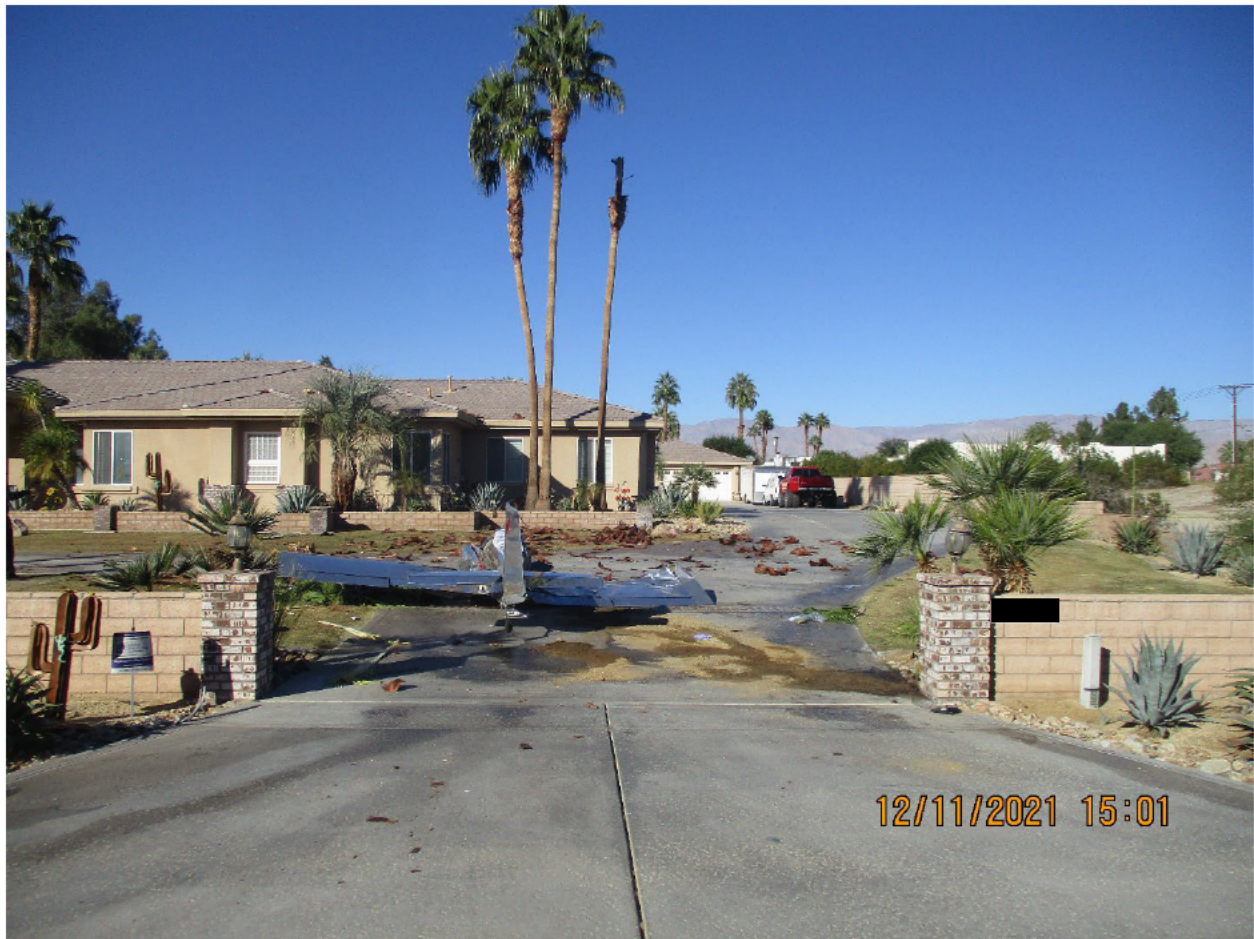
The accident site was located on the driveway of a private residence located at [REDACTED], Bermuda Dunes, California. The driveway was paved with concrete that sloped slightly toward the street. Three palm trees were situated near the residence adjacent to the driveway. The airplane came to rest upright in the driveway, on a magnetic heading of about 340°. Fluid was shown in photographs that drained from the airplane down the driveway. The fluid was later confirmed by a fire fighter to be fuel from the airplane.

Figure 5. Accident site location, showing a fluid draining from the airplane down the driveway.
