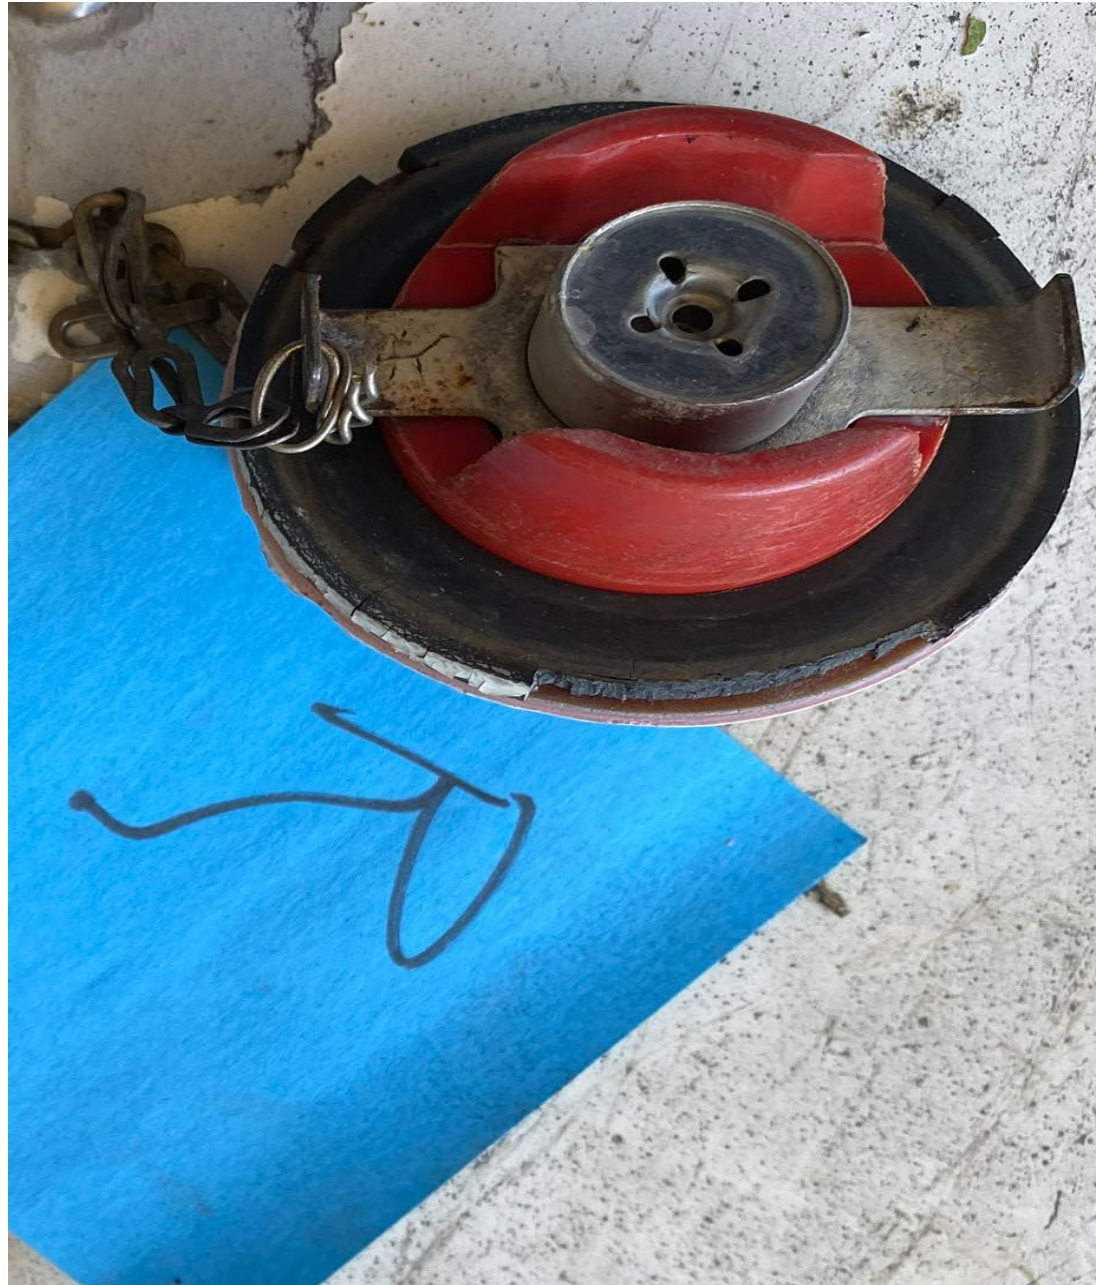
**Photo 1 – View of the right wing tank fuel cap containing rust, missing silicone vent, and the deteriorated rubber gasket missing outer sections (NTSB IIC)**

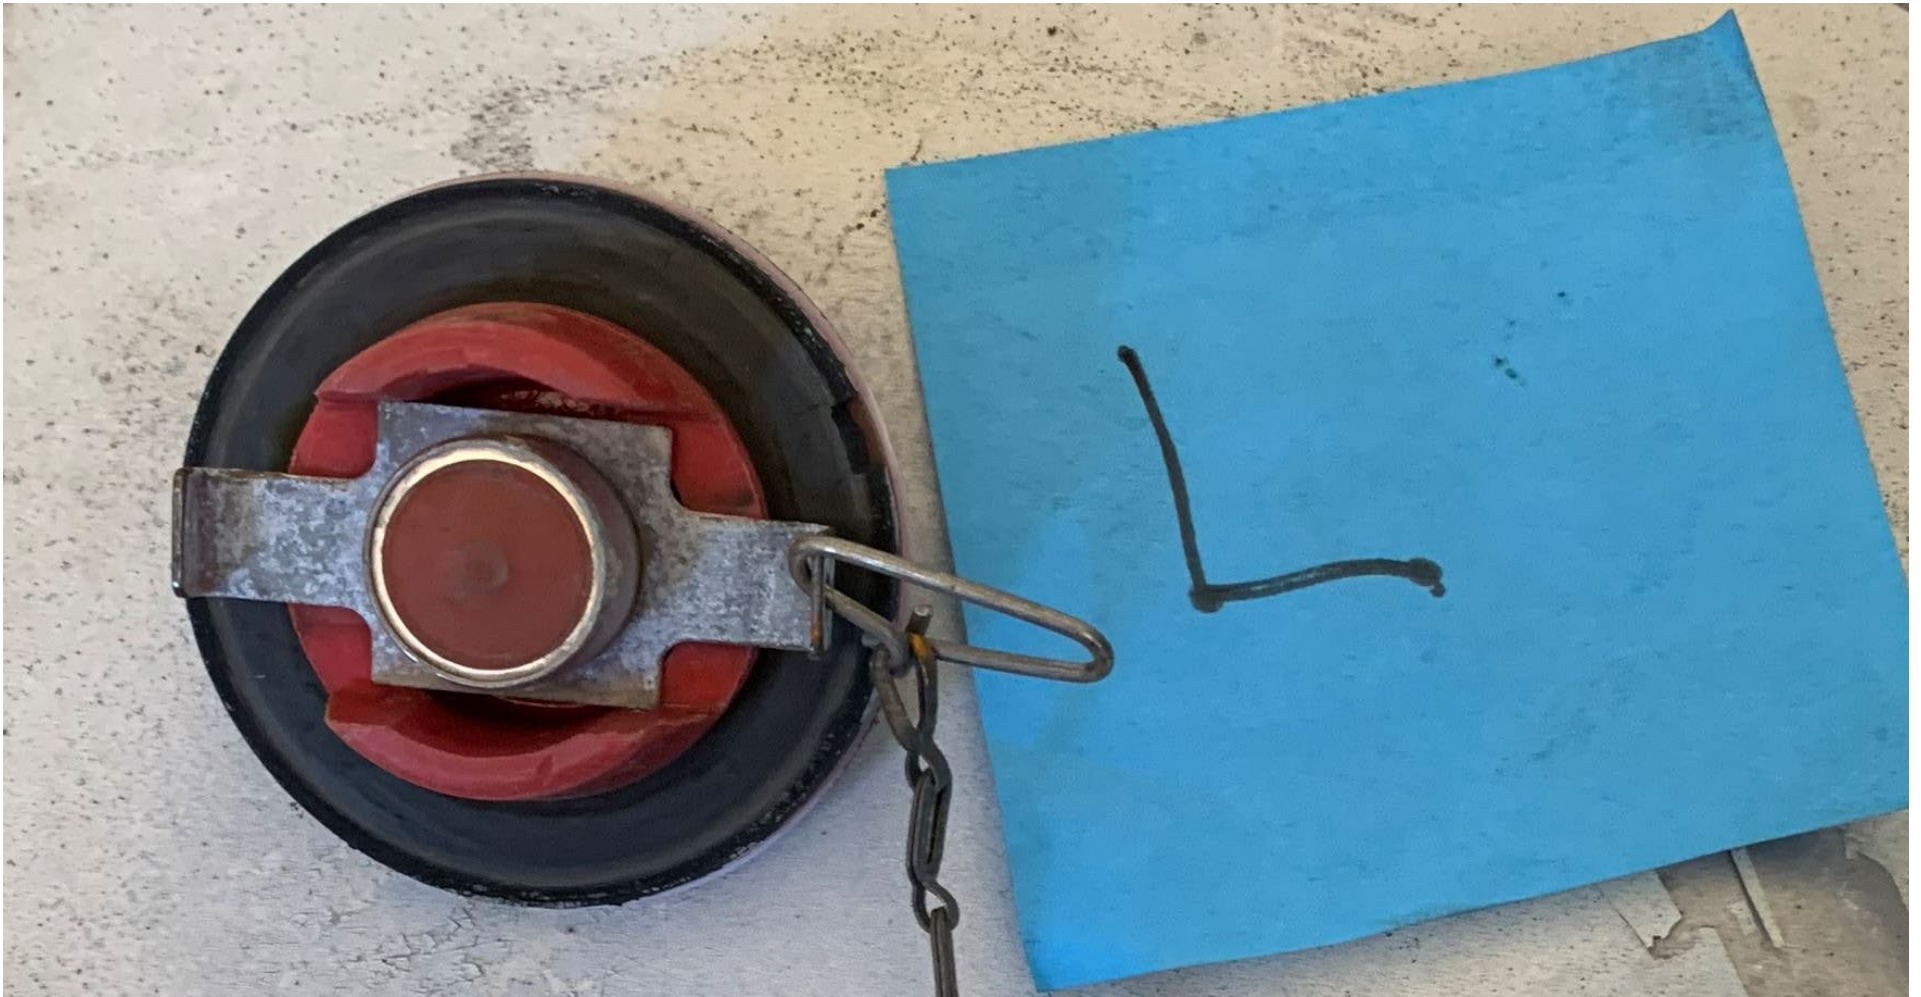
**Photo 2 - View of the left wing tank fuel cap and the deteriorated rubber gasket missing outer sections (NTSB IIC)**

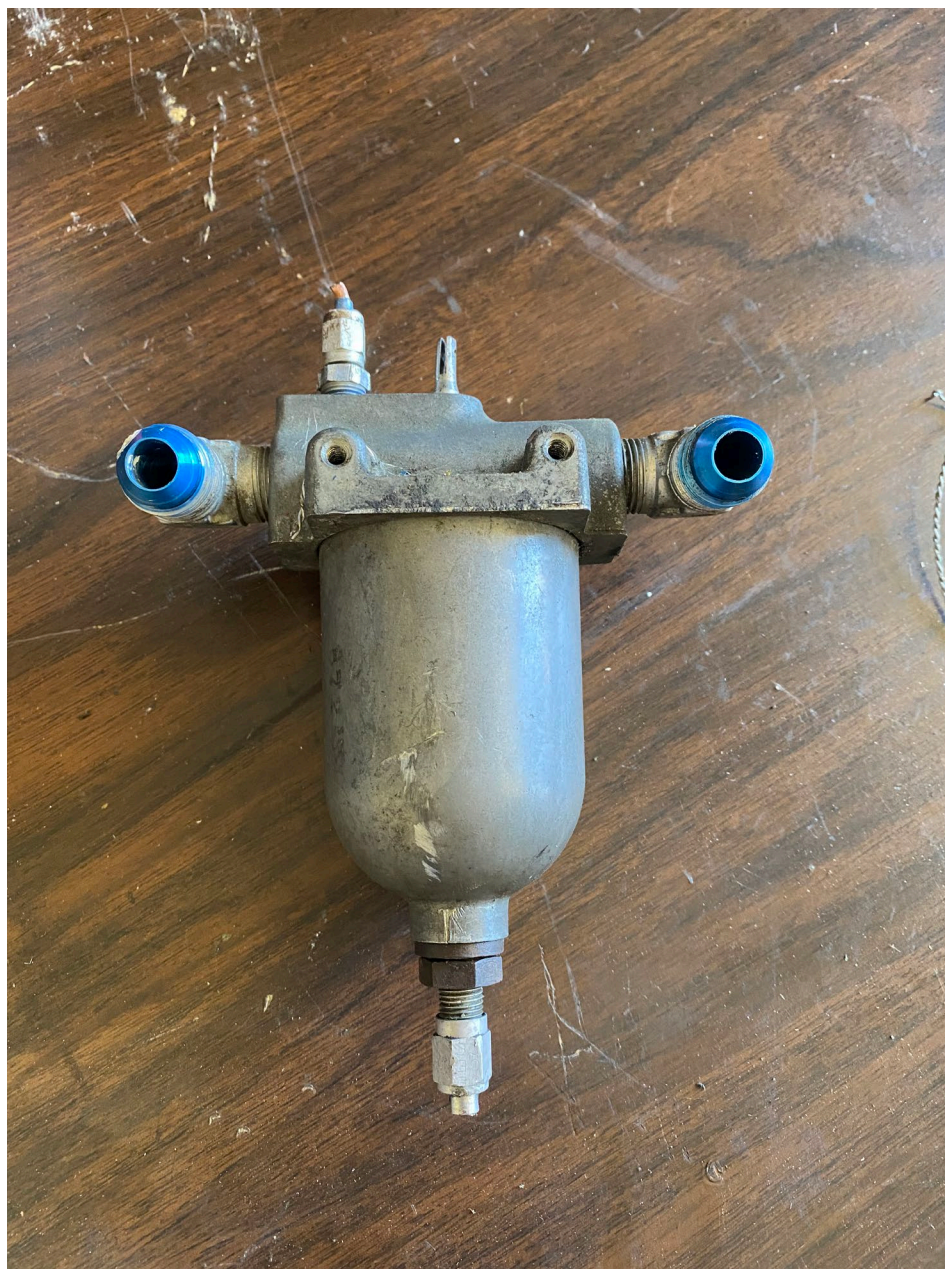
**Photo 3 – View of the gascolator before disassembly (NTSB IIC)**

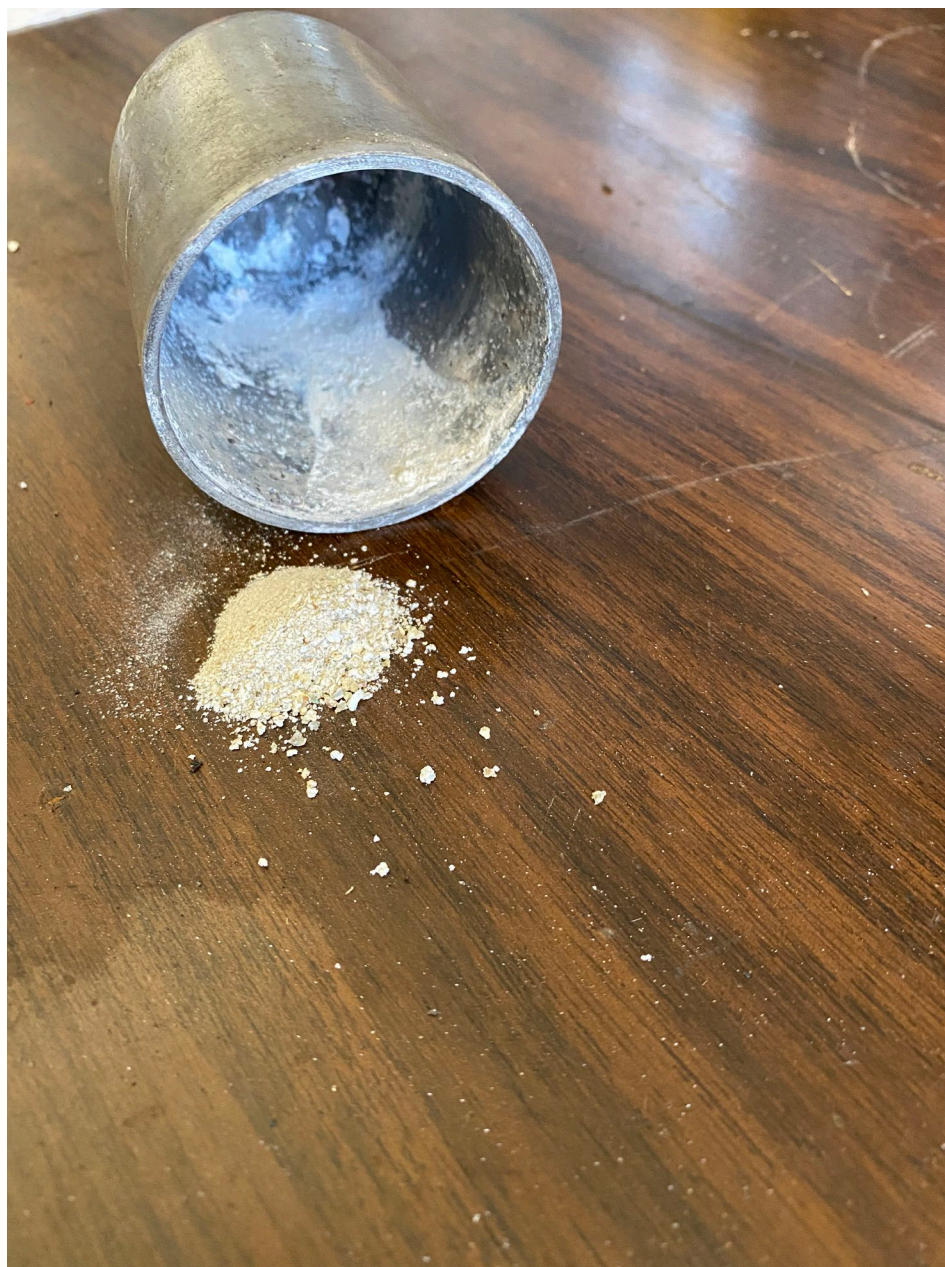
**Photo 4 – View of the gascolator fuel bowl internal pitting and the granulated, white powder, corrosion substance (NTSB IIC)**

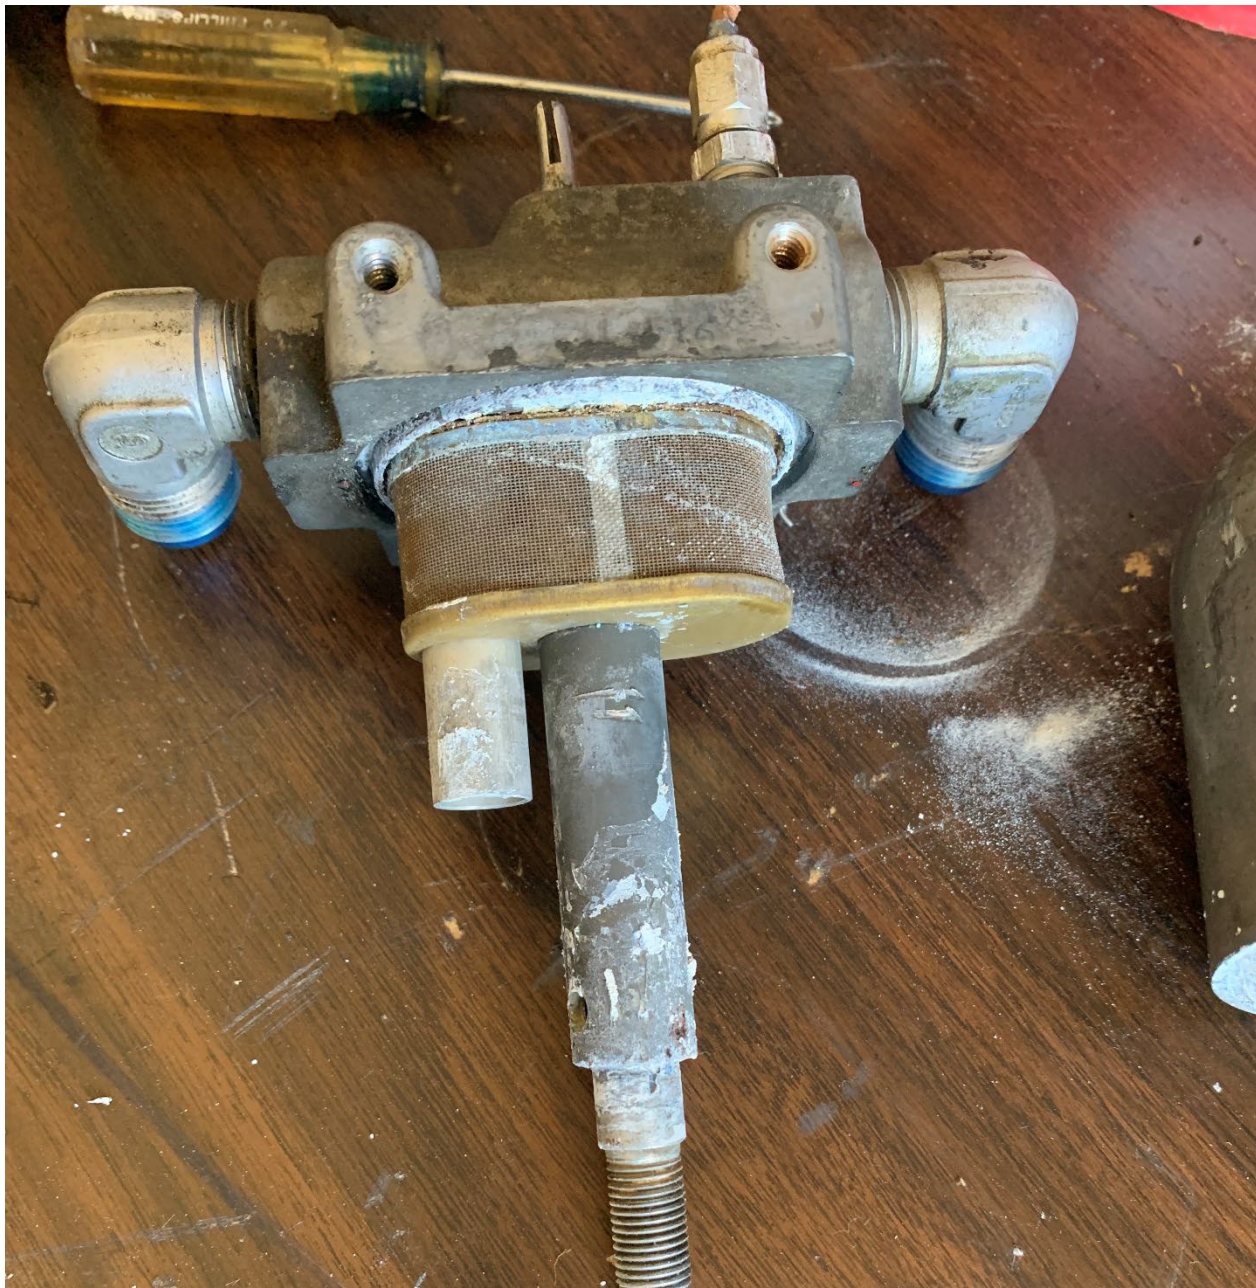
**Photo 5 – View of the gascolator standpipe, and fuel filter screen containing rust and corrosion substance with vivid fluid line corrosion (NTSB IIC)**

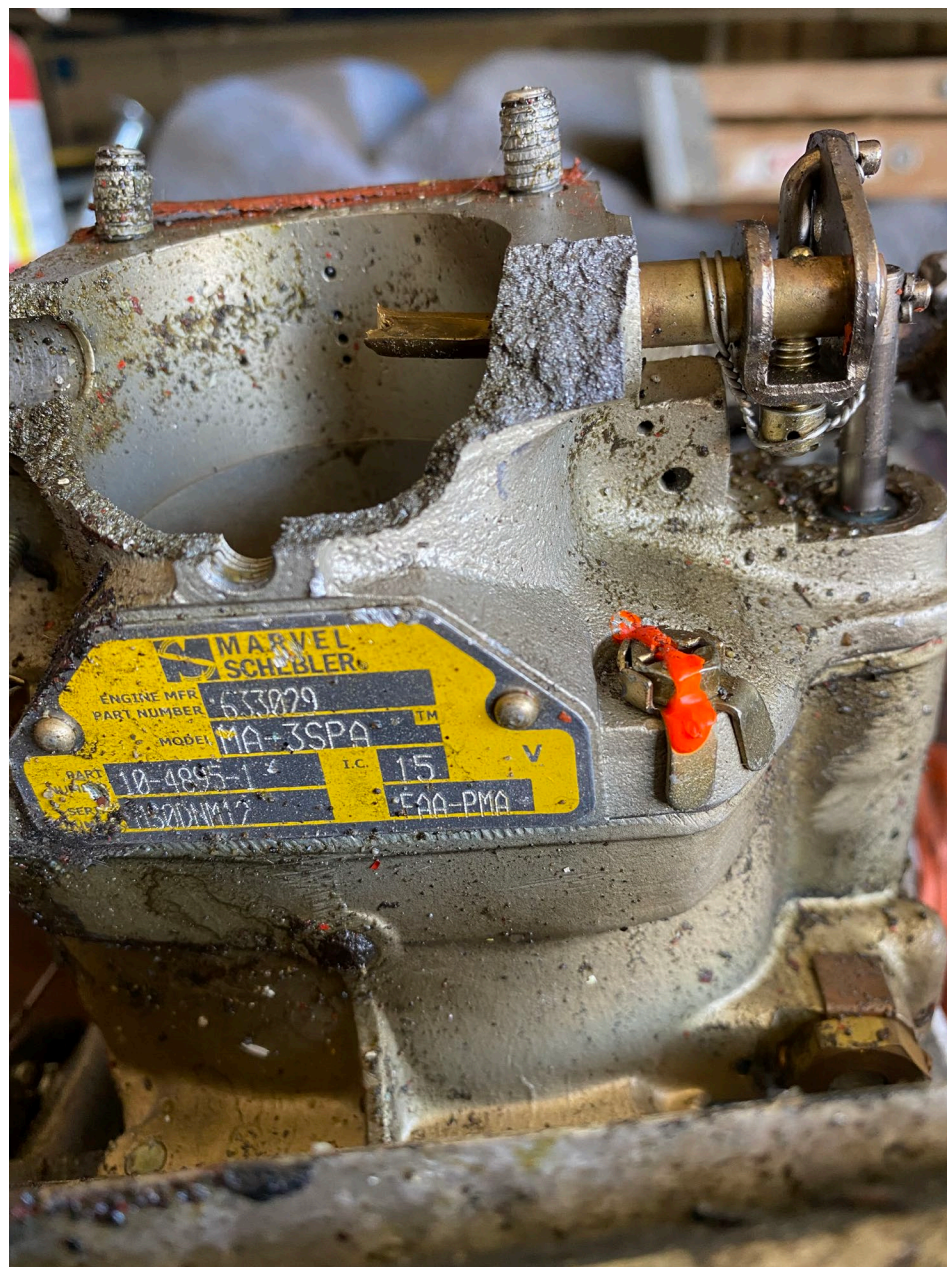
**Photo 6 – View of impact damaged carburetor before disassembly (NTSB IIC)**

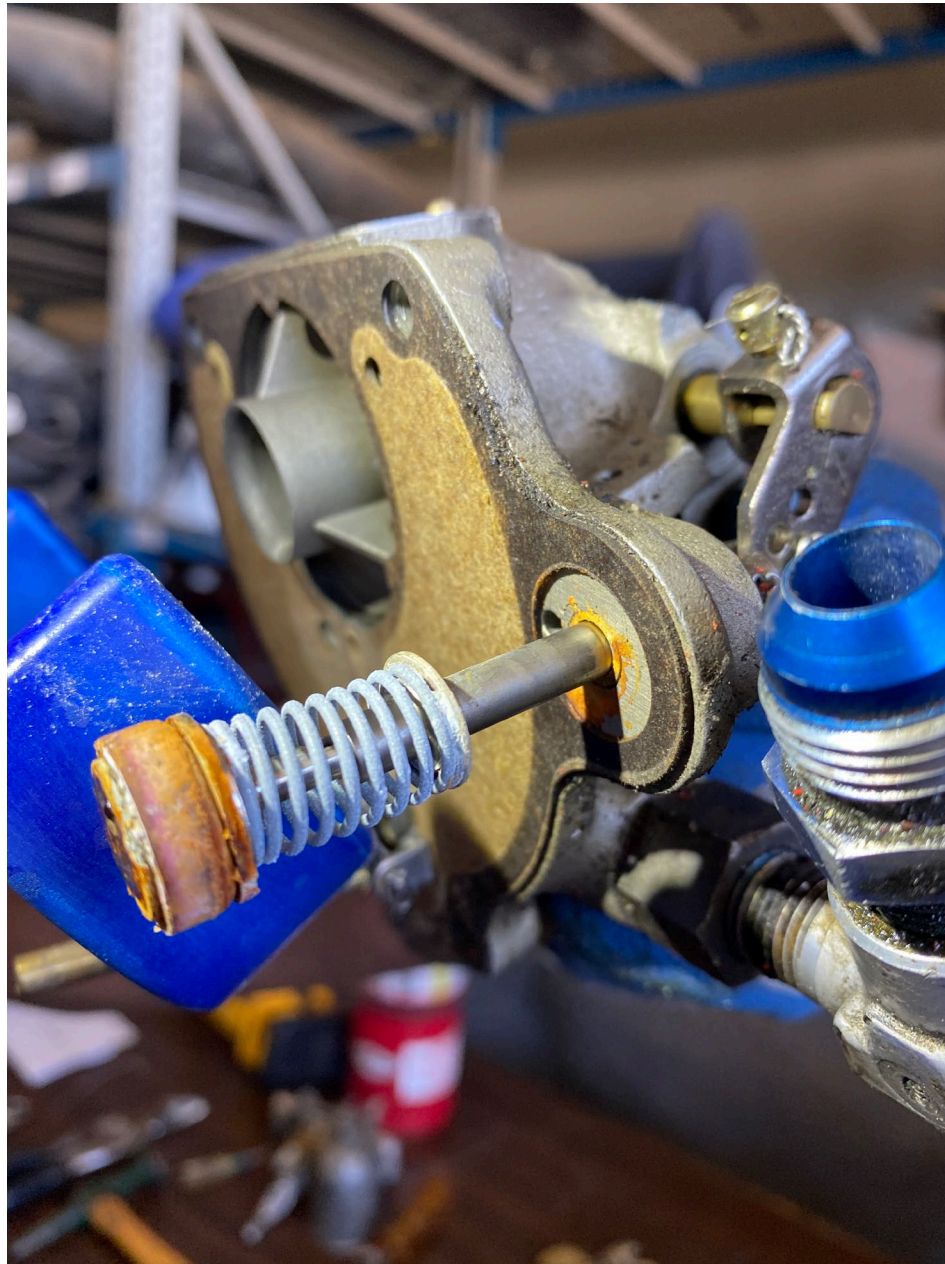
**Photo 7 – View of the accelerator pump containing rust and corrosion substance (NTSB IIC)**

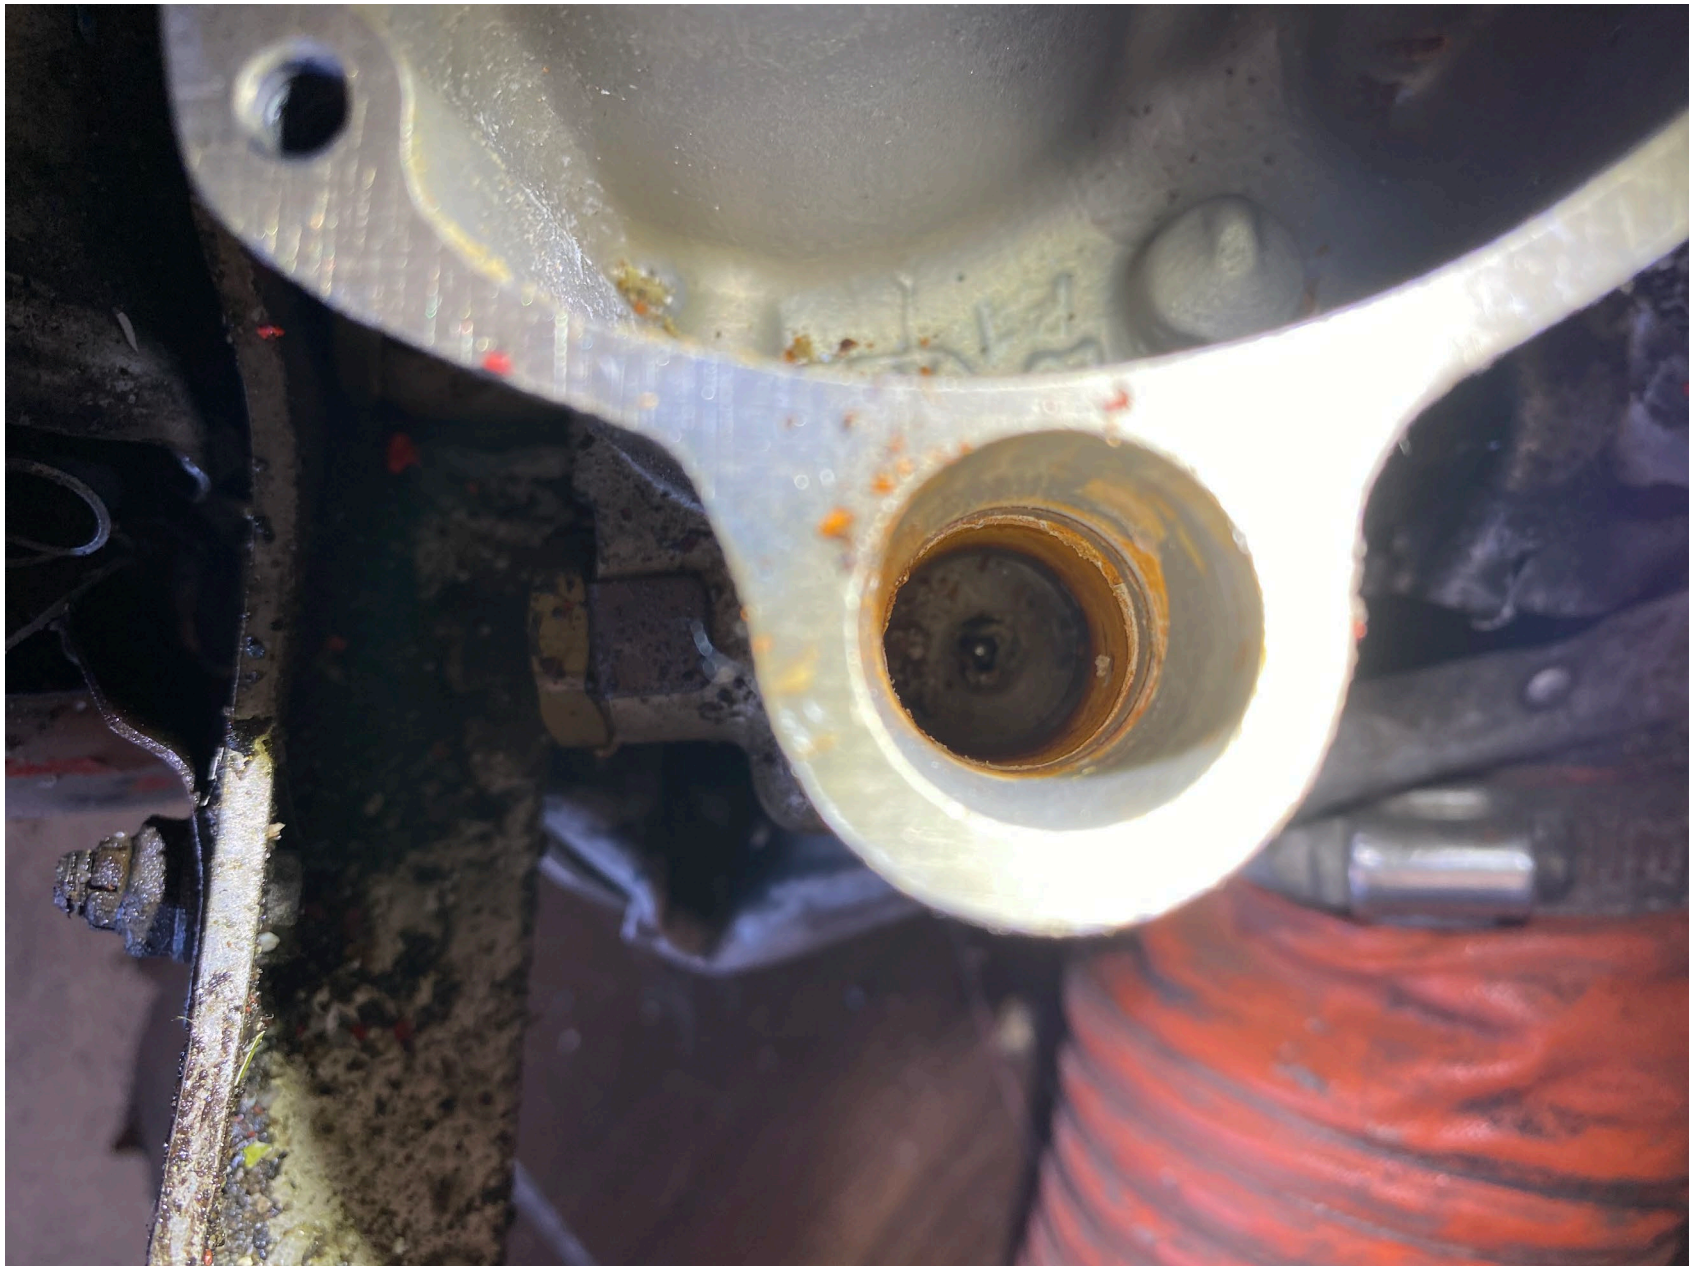
**Photo 8 – View of the accelerator pump housing containing rust and corrosion substance (NTSB IIC)**

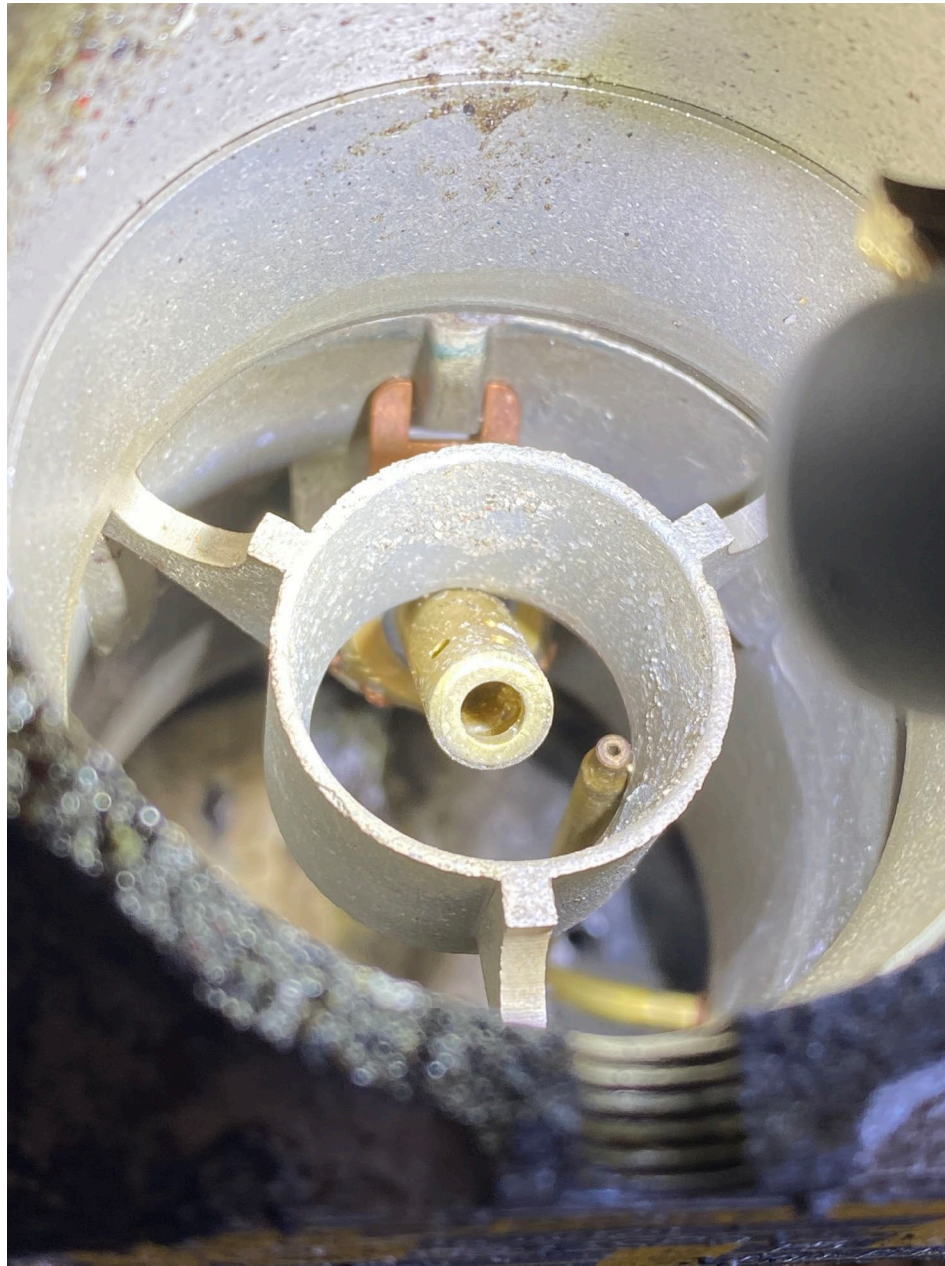
**Photo 9 – View of the carburetor fuel nozzle pitting and the accelerator pump discharge tube containing corrosion substance (NTSB IIC)**

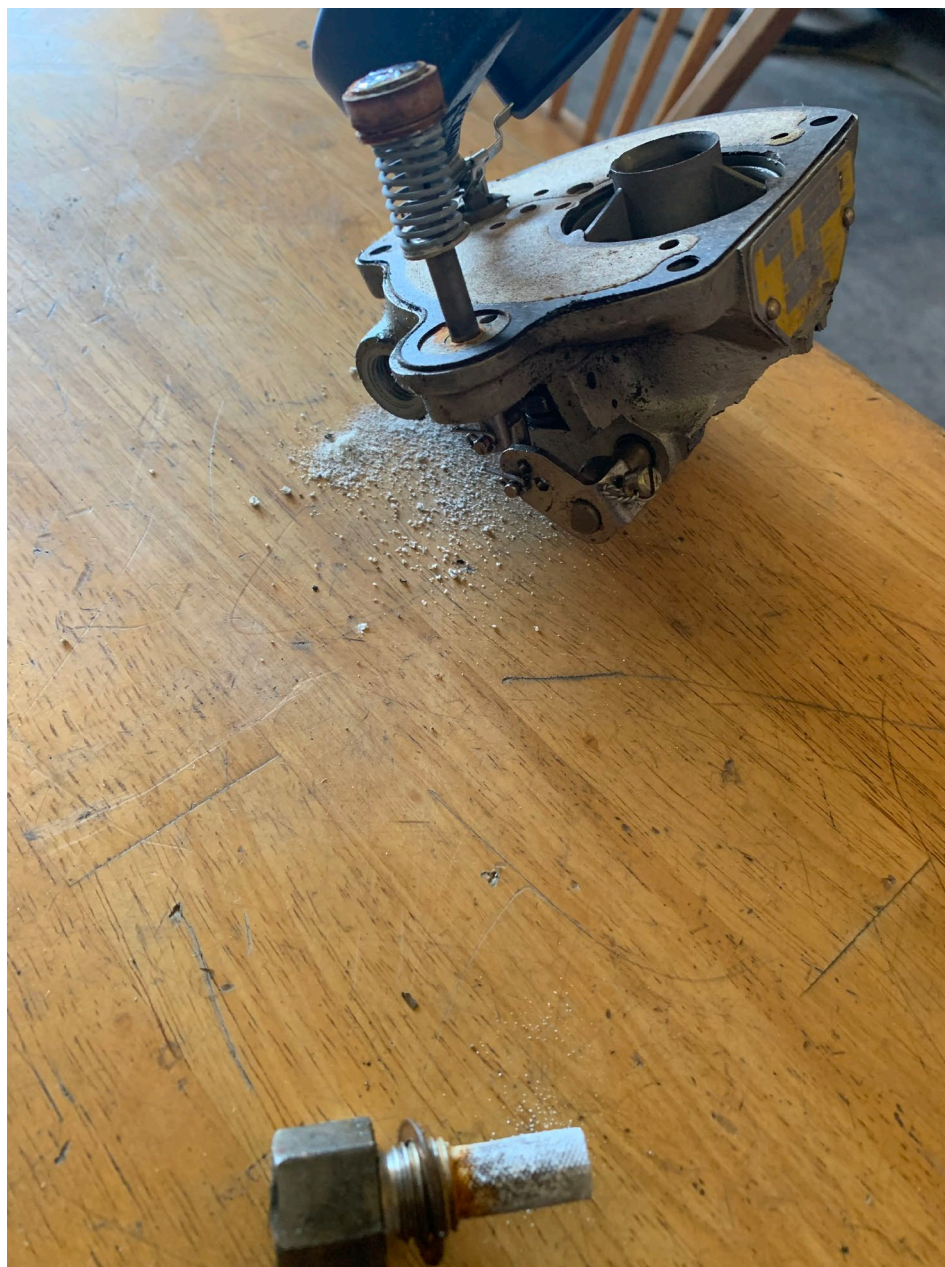
**Photo 10 – View of the rusted carburetor fuel inlet screen encapsulated with the corrosion substance and about ½ teaspoon of extracted corrosion substance from the fuel inlet screen and housing (NTSB IIC)**
