## **N8056L EXAMINATION**

WPR22LA076

#### **NATIONAL TRANSPORTATION SAFETY BOARD**

AIRCRAFT REGISTRATION/AIRCRAFT TYPE: **N8056L/Cessna 172H**  
ACCIDENT LOCATION: **Los Angeles, CA**

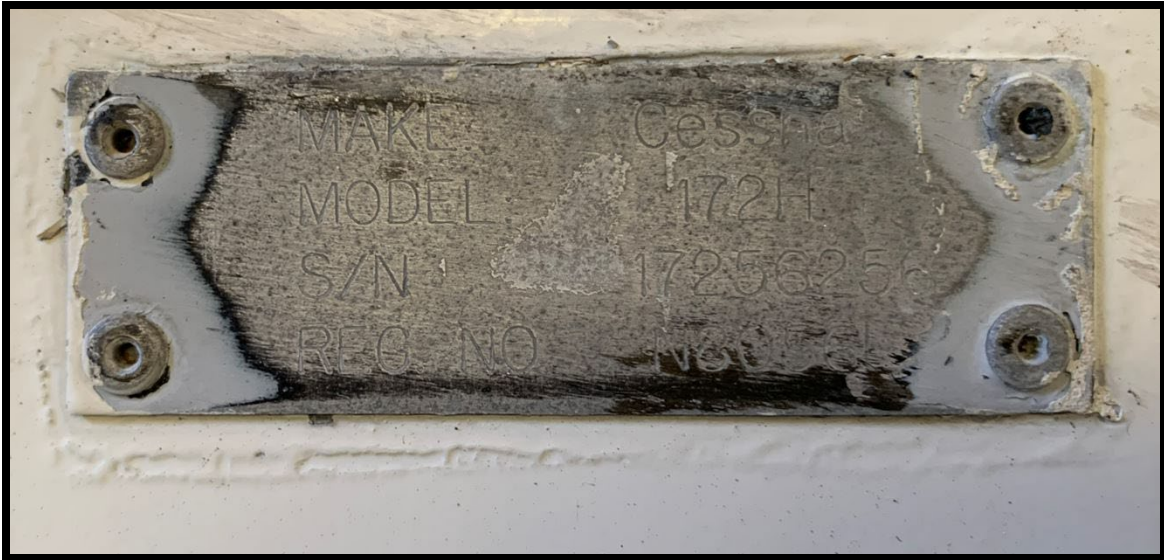
Figure 1: N8056L Airframe data plate

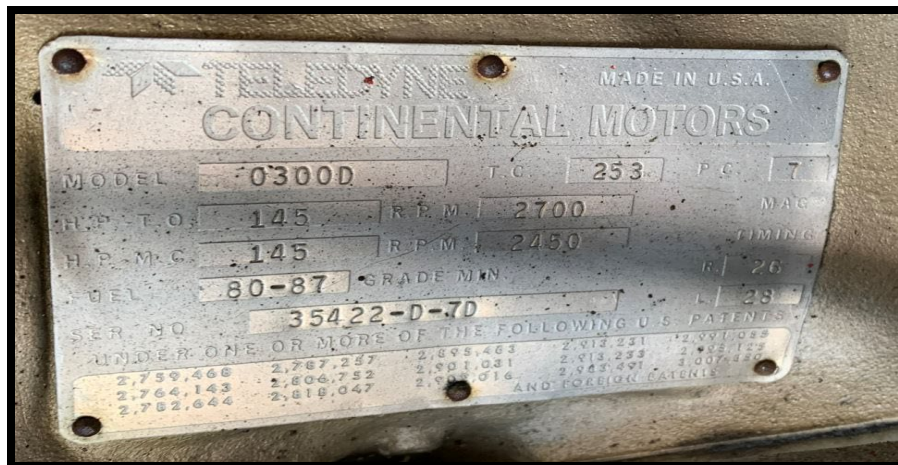
Figure 2: N8056L Engine data plate

- The engine was equipped with two Slick impulse coupled magnetos both were functional and produced sufficient spark in proper firing order. The magneto timing was found to be Left 28° and Right 30°. According to the engines data plate the left magneto is timed correctly, and the right magneto was found 4° advanced.
