**NATIONAL TRANSPORTATION SAFETY BOARD**  
Vehicle Recorder Division

## **Onboard Image Recorder**

### **Specialist's Factual Report By Kyle Garner**

| NTSB Number: | WPR22LA076 |

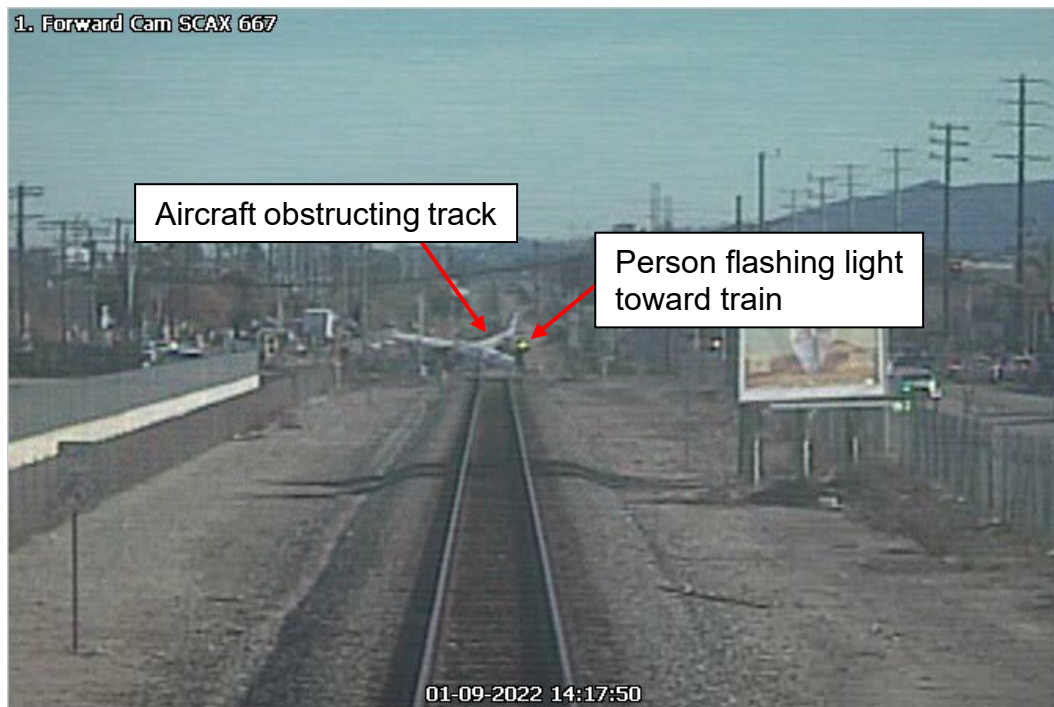
**Figure 3.** Forward-facing camera - 14:17:50.

At 14:17:50, a person on the west side of the upcoming grade crossing with the obstruction was visible flashing a light toward the train, as shown in Figure 3.

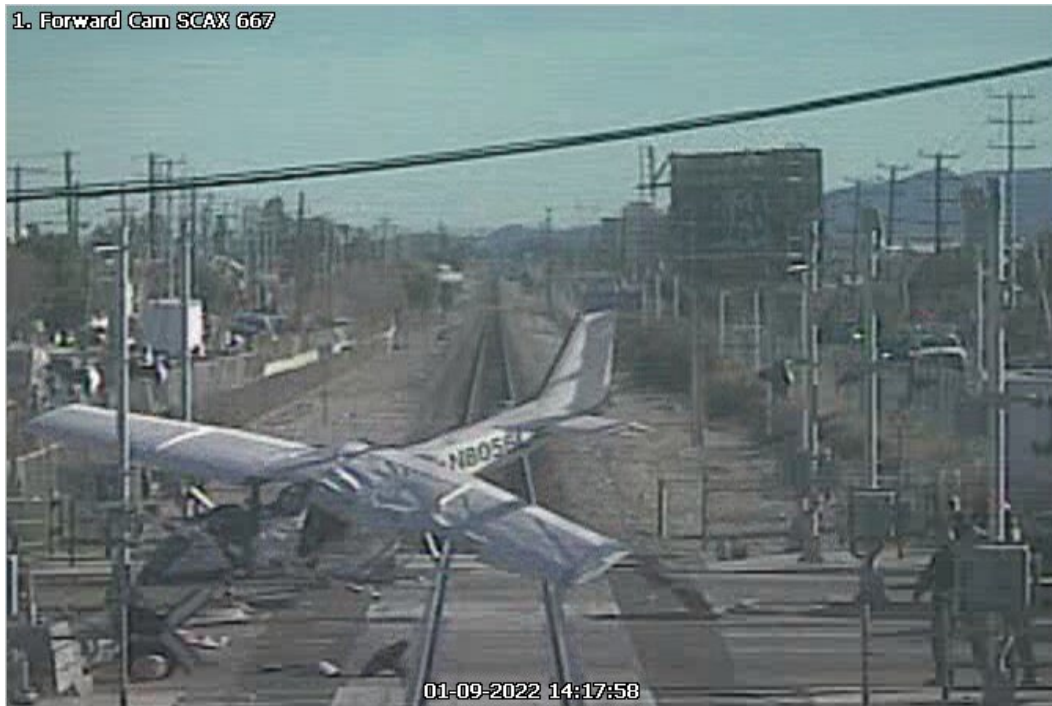
**Figure 4.** Forward-facing camera – prior to impact – 14:17:58.

A view of the aircraft prior to impact, at 14:17:58, on the forward-facing camera is shown in Figure 4.

At 14:18:01, the train impacted the aircraft.
