## **NATIONAL TRANSPORTATION SAFETY BOARD**

# **WRECKAGE EXAMINATION SUMMARY**

**WPR22LA081**

| Aircraft: | Piper PA-28, N5276W |

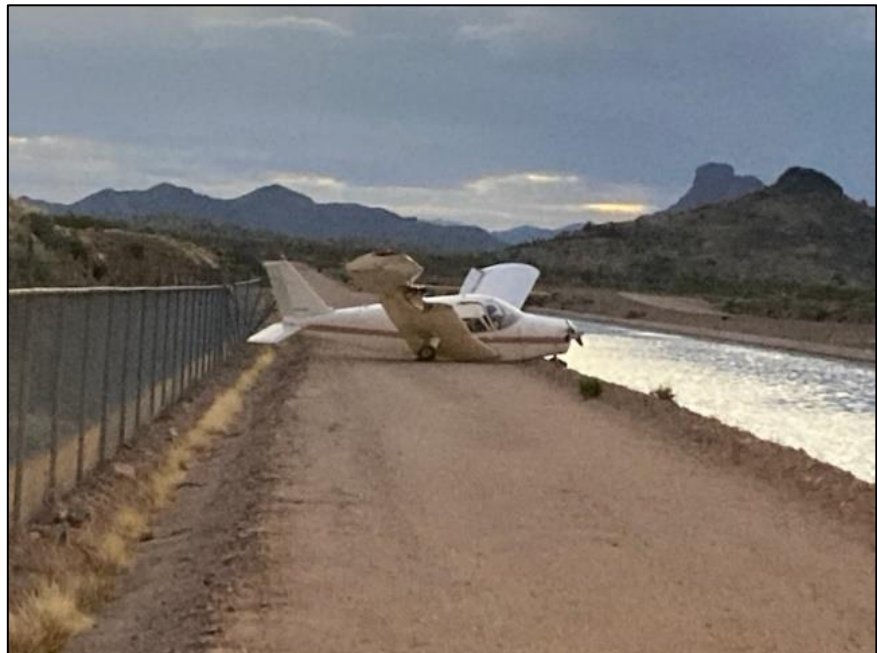
Figure 1-Accident site, forward right view of the wreckage.

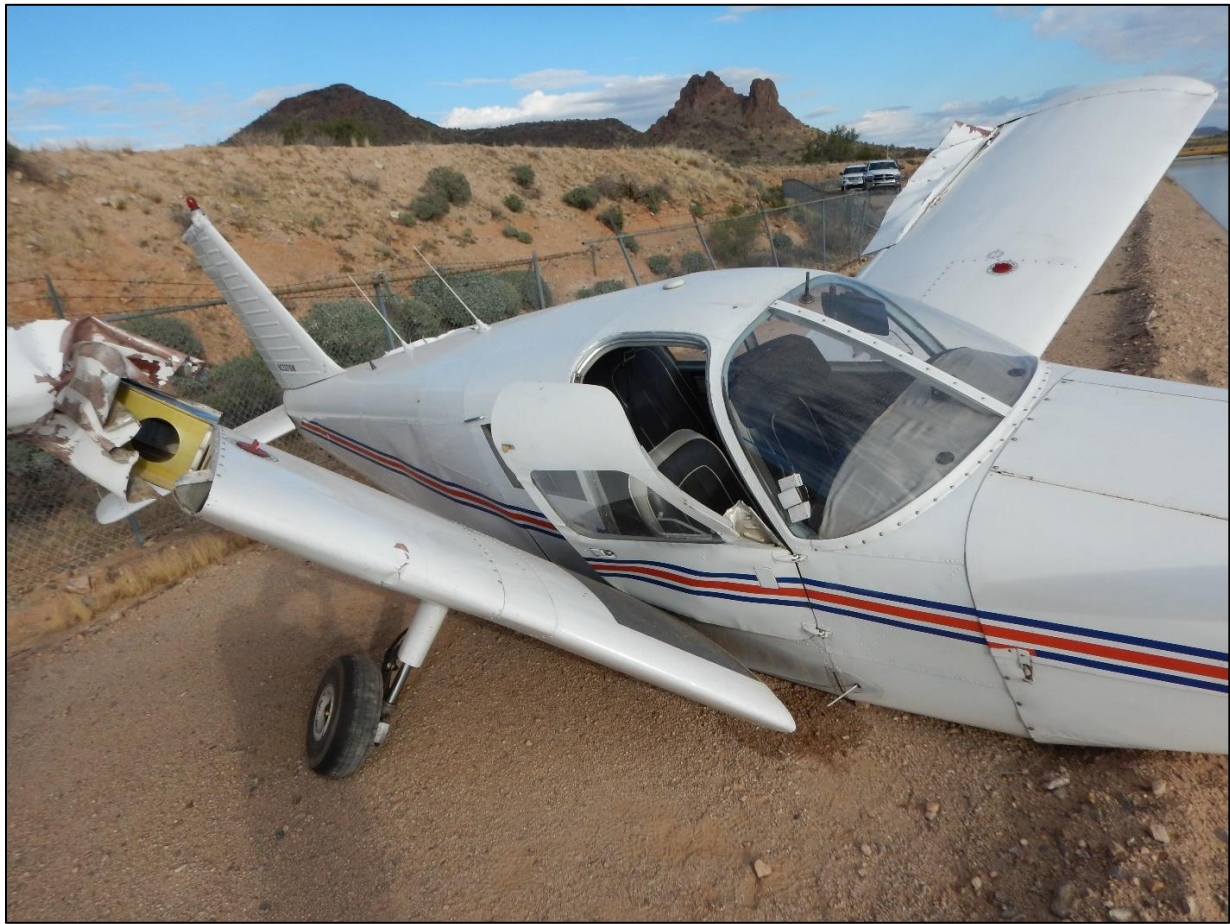
Figure 2-Accident site, view of the right wing and fuselage.

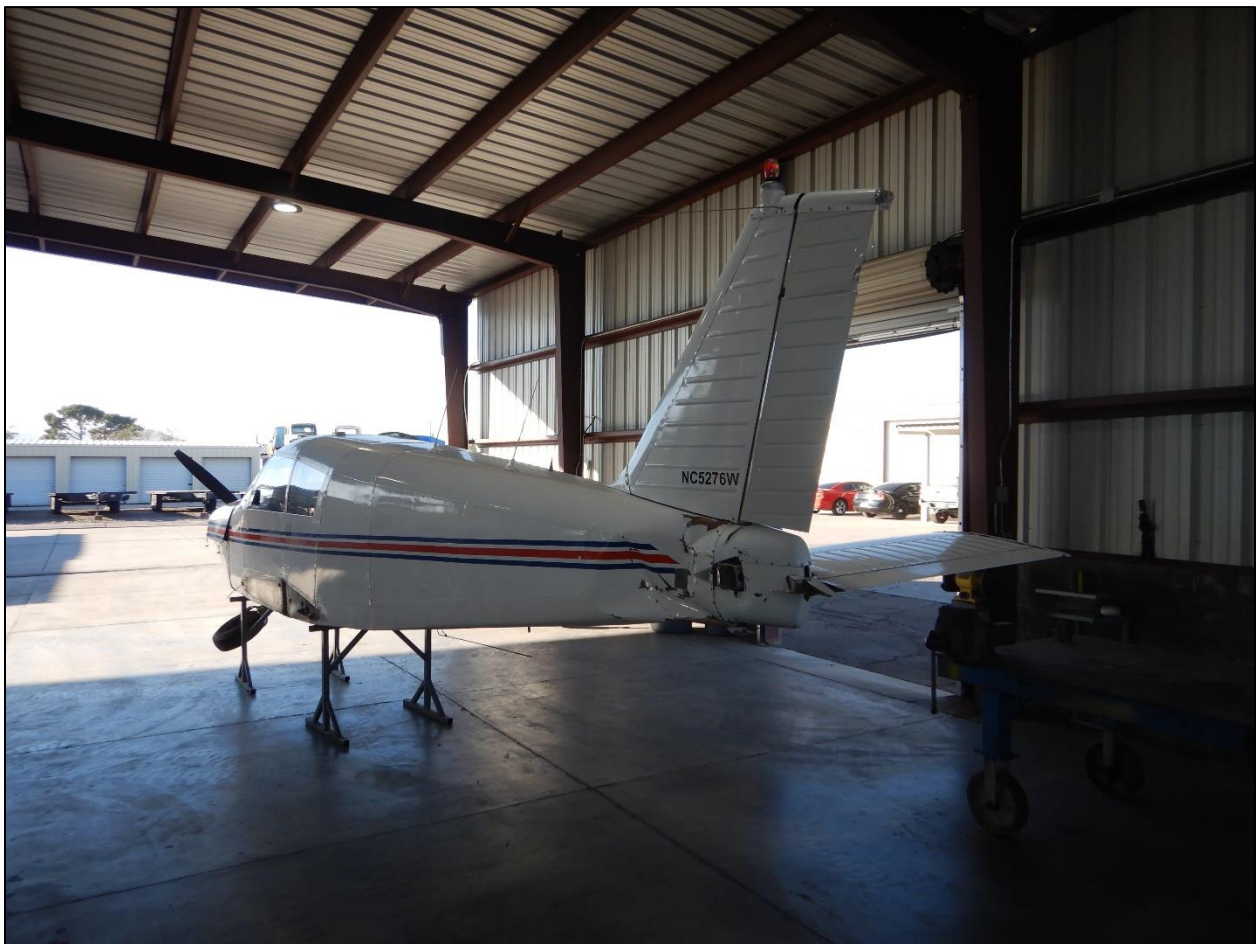
The left horizontal stabilizer and left elevator was crushed from the rear. A circular indentation was noted on the trailing edge of the elevator. The left side of the aft fuselage, adjacent to the tail cone was buckled inwards. The tail tie down loop was bent to the right. The rudder had a circular indentation and buckling on its trailing edge near the top.

Figure 3-Main wreckage, empennage.

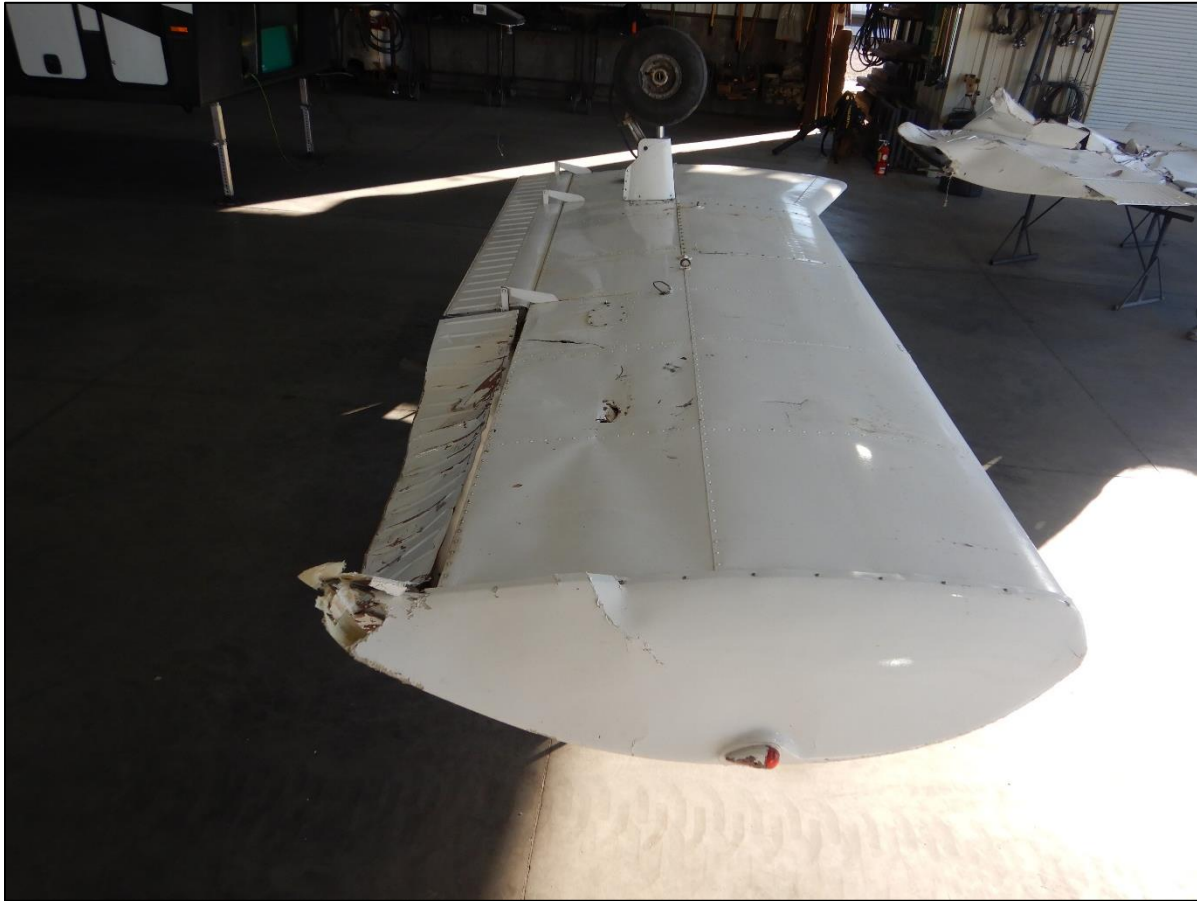
The left wing had impact damage at the tip fairing and buckling near the aileron. The left flap was undamaged and in the retracted position. The left aileron remained attached to the wing and had impact damage from the lower side. The left main landing gear remained attached to the wing and was undamaged. The wing tank was intact and not breached. The wing tank cap remained attached, and the seals were undamaged. Tank drains and vent were unremarkable.

Figure 4-Main wreckage, left wing.

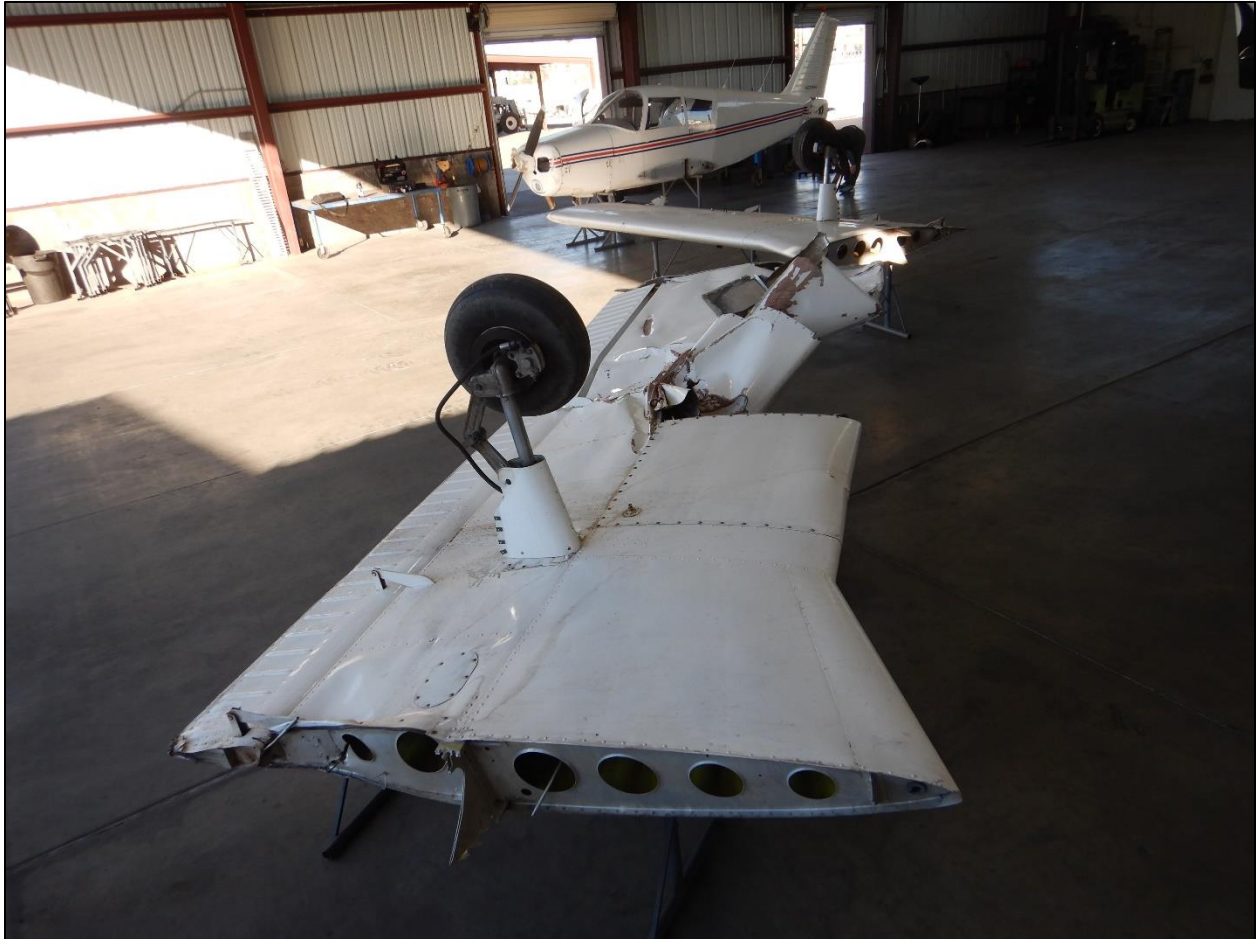
The right wing spar attach points separated from wing and remained attached to the airframe spar attach points. The right wing had a circular impact damage and accordion crushing outboard of the wing tank. The wing spar was bent aft about 6 inches. Buckling was noted near the inboard aileron attachment area. The aileron remained attached to the wing and was buckled on the inboard side. The right flap was found in the retracted position. The inboard trailing edge of the flap had crush damage. The right main landing gear remained attached to the wing and was undamaged. The aft wing root had impact damage. The wing tank was not breached. The wing tank cap remained attached, and the cap seals were undamaged. Tank drains and vent were unremarkable.

**Figure 5-Main wreckage, right wing.**

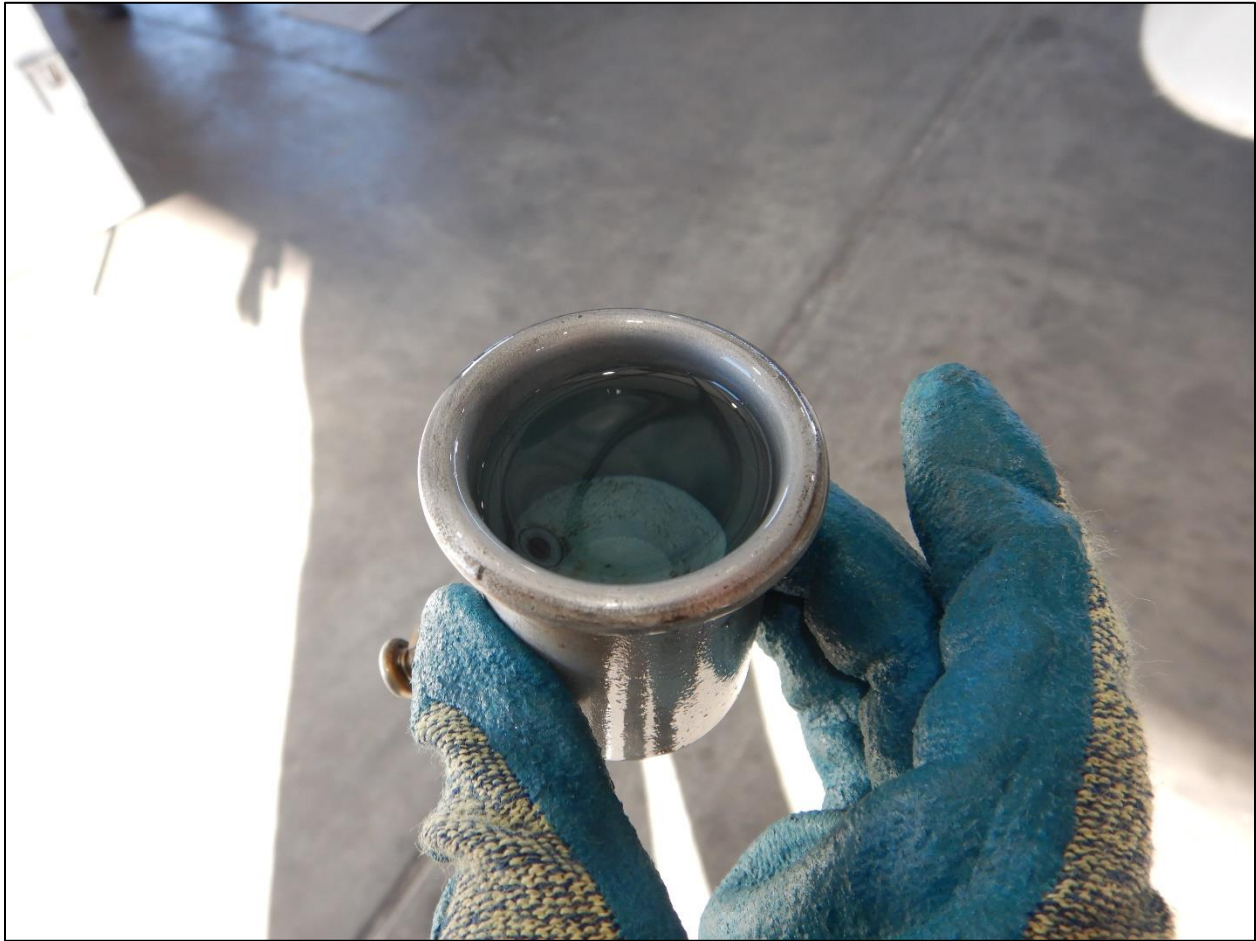
The fuel strainer was undamaged, and the bowl was removed. The inlet screen was clear and undamaged. The bowl was filled with a blue colored fuel and no water was detected in the bottom of the bowl. Electric boost pump was undamaged, and fuel was present in the pump and the lines. The inlet screen was clear and undamaged. Fuel selector was found in the “OFF” position and worked normally.

**Figure 6-Fuel strainer bowl.**

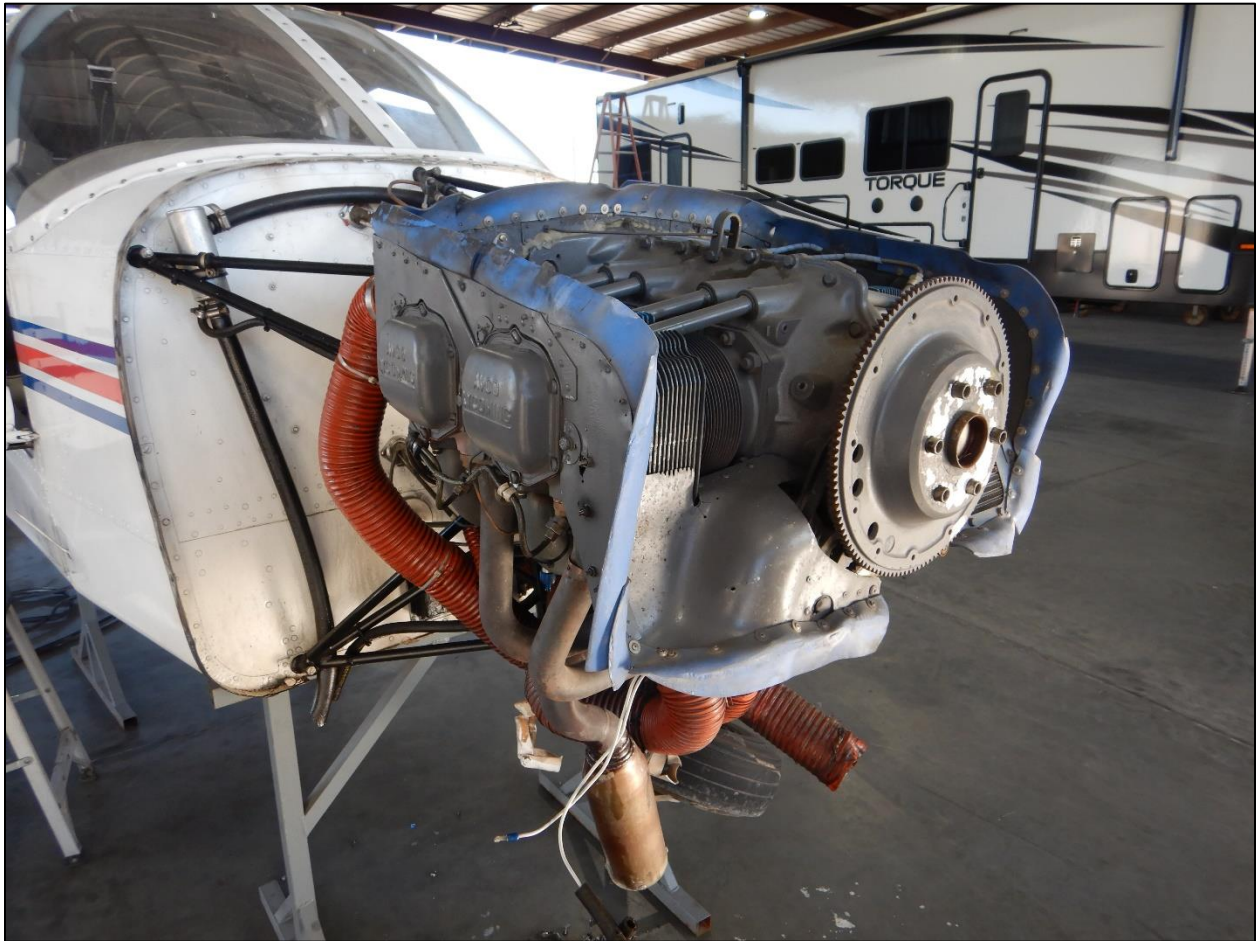
The upper and lower engine cowling was removed and undamaged. Residual oil was noted in the lower cowling and the lower side of the firewall. No oil was indicated on the dipstick. The lower and forward side of the engine crankcase had an oily residue. The starter cable was not attached to the starter. Hardware for this attachment was not found. The propeller was rotated by hand and could only rotate about 270-degrees before coming to an abrupt stop. The magneto impulse coupling engaged, and the vacuum drive coupler rotated during the propeller movement. The propeller and the starter ring gear was removed from the engine.

**Figure 7-Main wreckage, engine.**

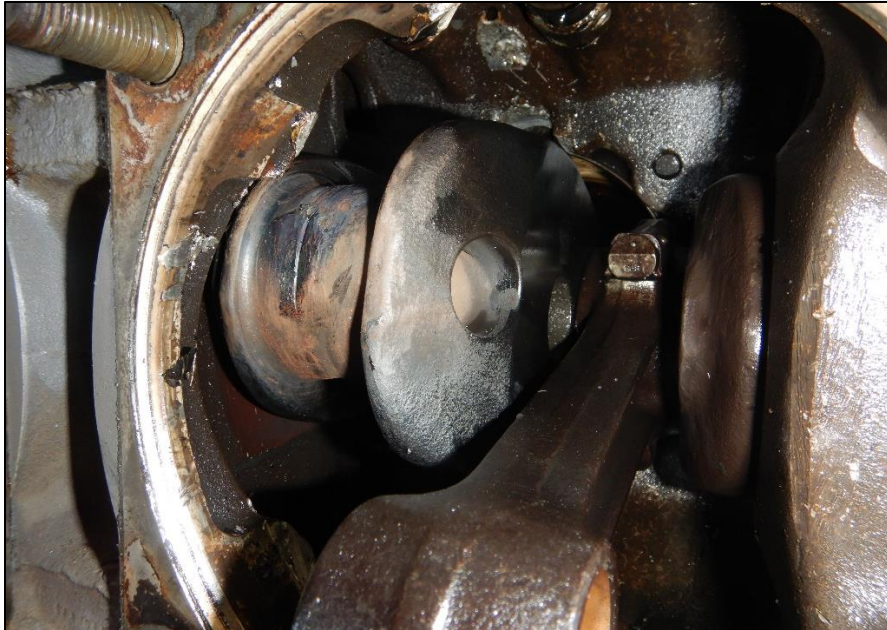
The No. 1 cylinder was removed from the engine. The internal crankcase surfaces, internal components were black in color. The No. 2 connecting rod separated from the crankshaft. The crankshaft No. 2 connecting rod journal and connecting rod bearing showed thermal distress and material deformation. Mechanical damage was noted at the No. 1 and 2 cylinder bay areas.

Figure 8-No. 1 and 2 crankshaft connecting rod journal, view from No. 1 cylinder bay.

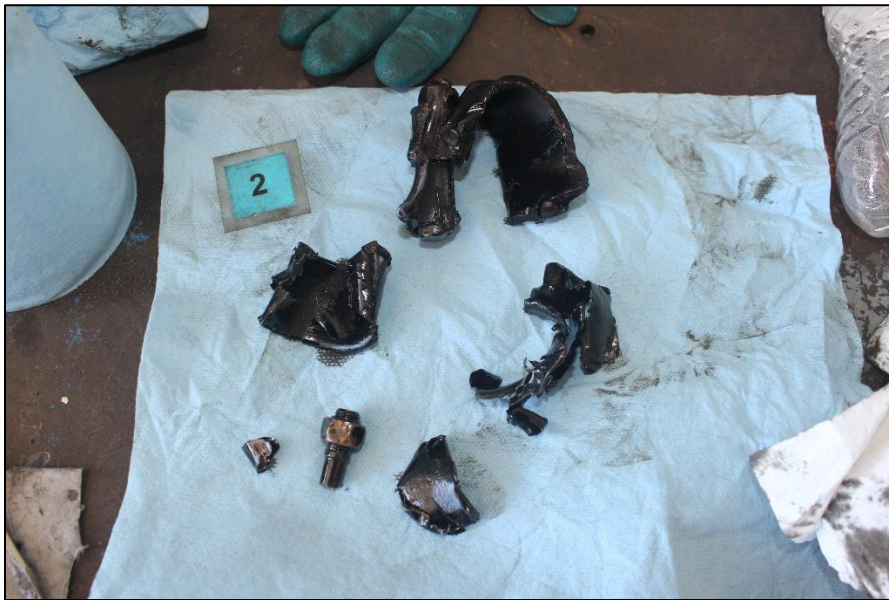
Figure 9-No. 2 connecting rod and bearing material.

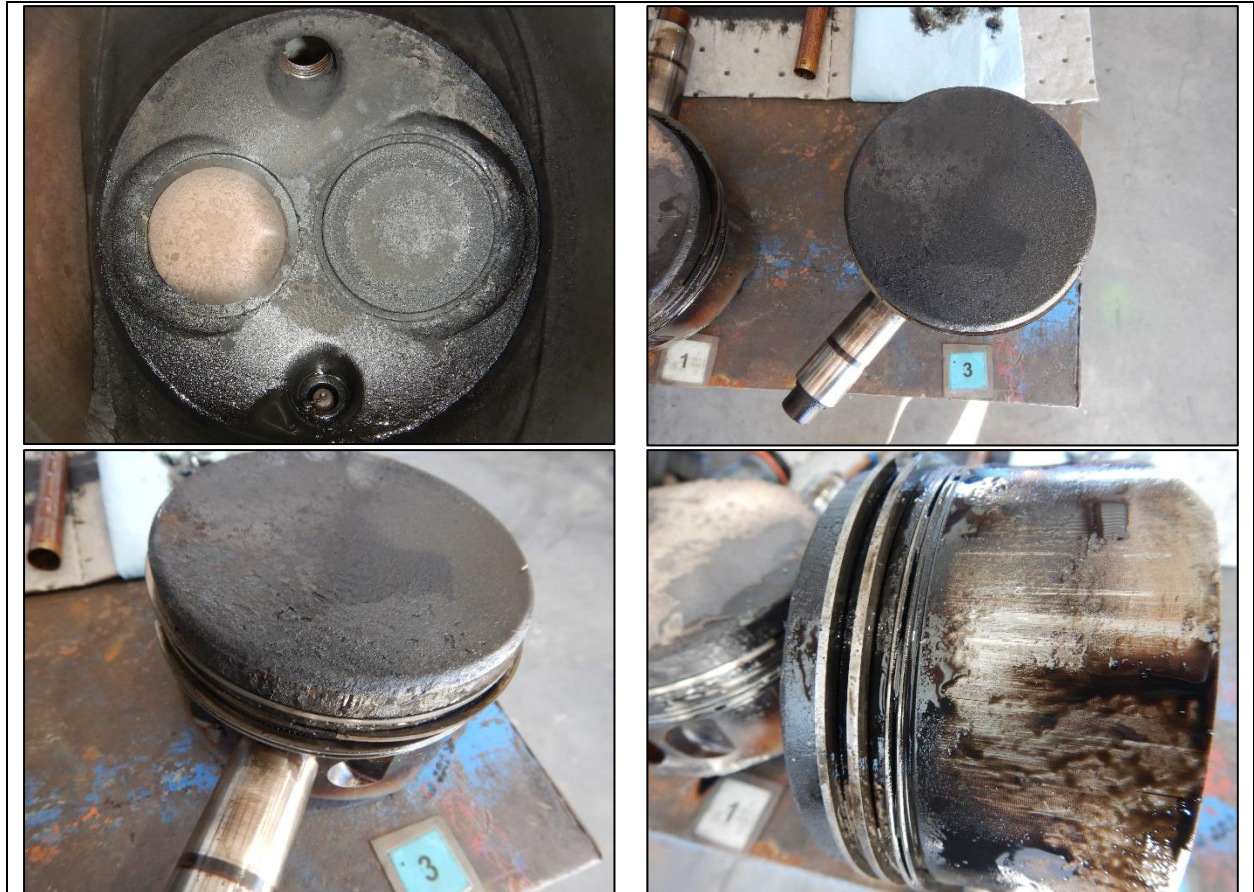
The No. 3 cylinder was removed from the engine. The No. 3 cylinder combustion chamber and the No. 3 exhaust stack had a sooty oily residue. The No. 3 piston head had heavy dark sooty deposits and the oil-control ring was stuck in its ring groove.

Figure 10-No. 3 Cylinder combustion chamber, piston head and rings.
