# NATIONAL TRANSPORTATION SAFETY BOARD

## Onboard Image Recorder

### Specialist's Factual Report

Location: Ravendale, CA  
Date: January 28, 2022  
Aircraft: Textron TTX T240, N420WT  
Operator: Private  
NTSB Number: WPR22LA090

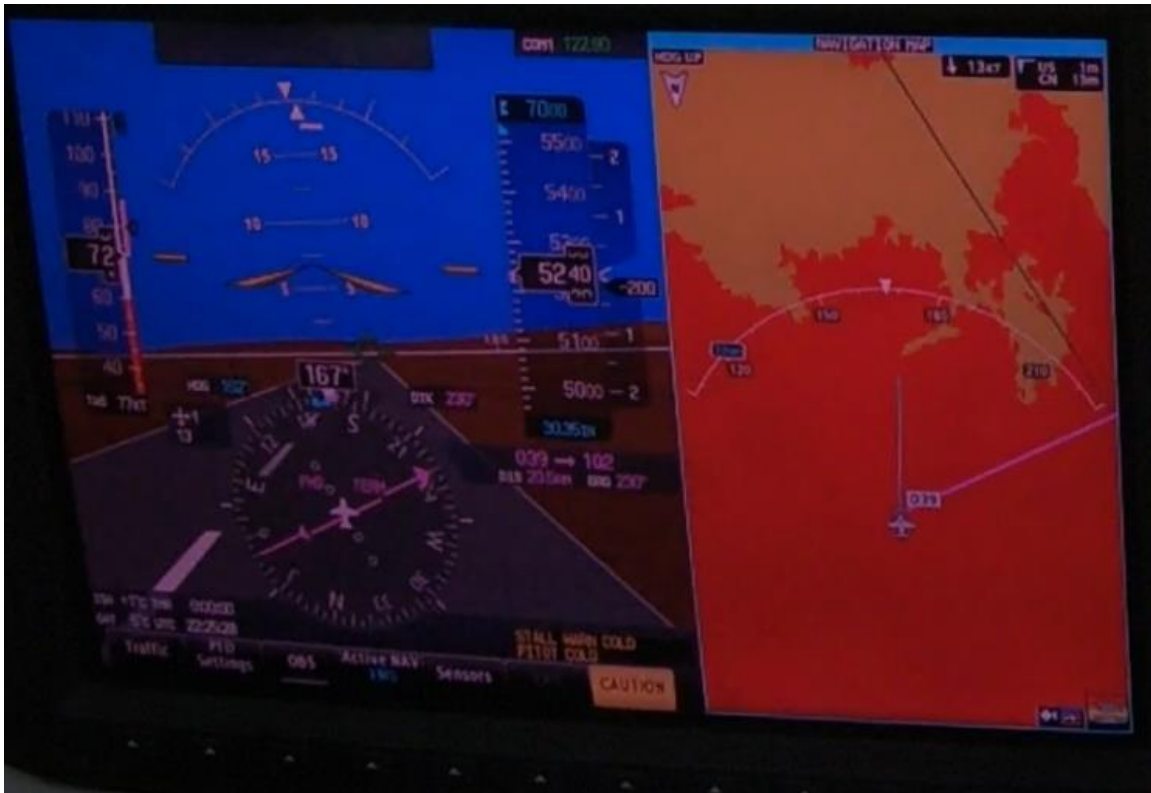
The aircraft pitched nose up, the LSP stated, “yeah pull it off come on.” As the LSP called for rotation, the PFD displayed a yellow caution message and a tone was audible. The PFD annunciated in yellow: *STALL WARN COLD PITOT COLD*. This occurred at 00:42 elapsed. The yellow caution remained for the rest of the recording until the camera’s view was changed at impact. Figure 1 is a screenshot of the PFD at this time.

**Figure 1.** The PFD at 00:42 elapsed which shows the yellow caution annunciation.

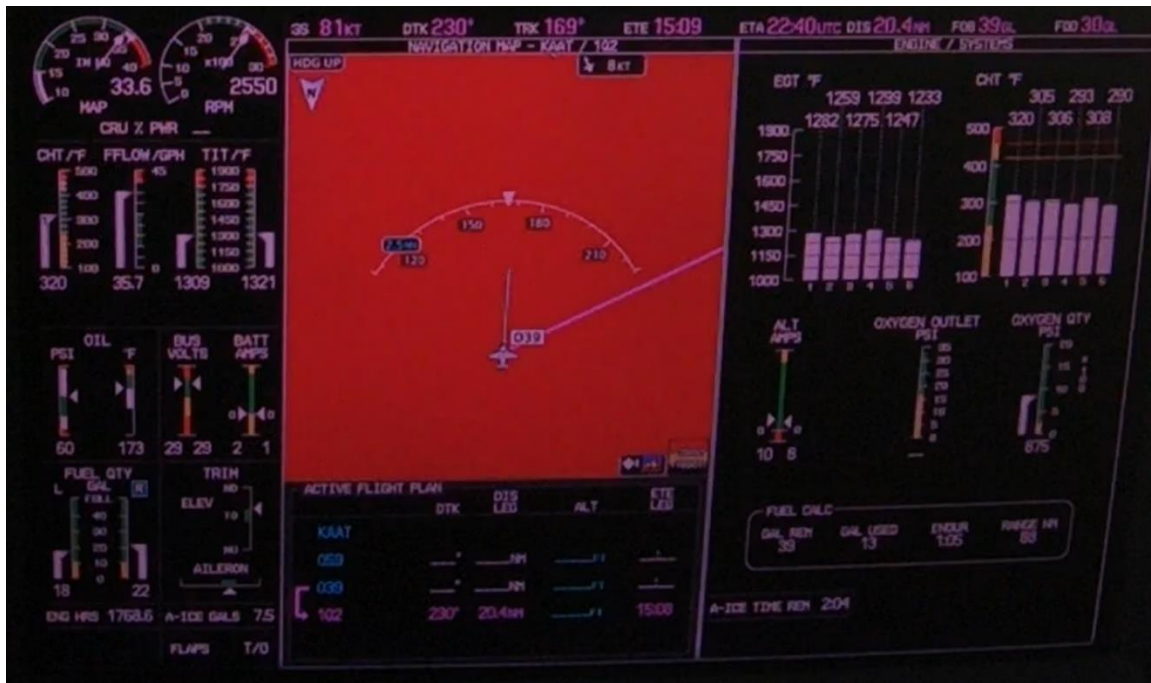
As the aircraft climbed, the RSP was on the right-side stick and his hand was guarding the throttle and prop controls. The PFD showed the pitch attitude as approximately 14 degrees nose up, at an airspeed of 85 indicated and an altitude of 5300 feet MSL. Figure 2 is a screenshot at this time (00:48 elapsed).

Figure 2. The MFD at 00:48.

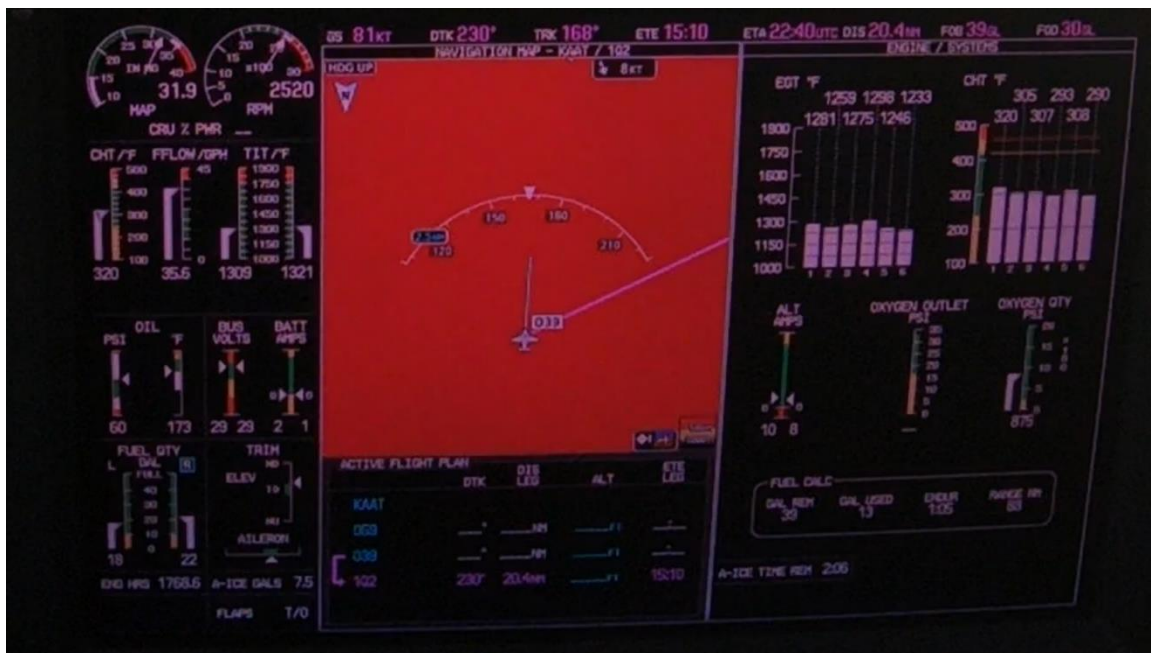
Within the next second, manifold pressure, RPM and EGTs for all cylinders began to rapidly decrease. Almost immediately the LSP's right hand appeared in the camera's field of view and pushed the right seater's left hand from guarding the throttle and prop controls. The RSP remained on the right side stick for the next few seconds as the left seater actively manipulated the controls (both the left side stick and throttle and prop control area). As the left seater non-verbally took the aircraft controls, his hands touched the throttle, prop and mixture control in a manner that confirmed maximum power, maximum prop rpm and maximum rich settings. The LSP stated, "really?" Within a few seconds the RSP was completely off of all controls<sup>1</sup>.

Figure 3 is a screenshot of the MFD at 00:48.5 which shows a decrease in manifold pressure, RPM and EGT values. At this time, airspeed was approximately 87 knots, and the aircraft's pitch attitude was approximately 12.5 degrees nose up.

Figure 3. The MFD at 00:48.5.

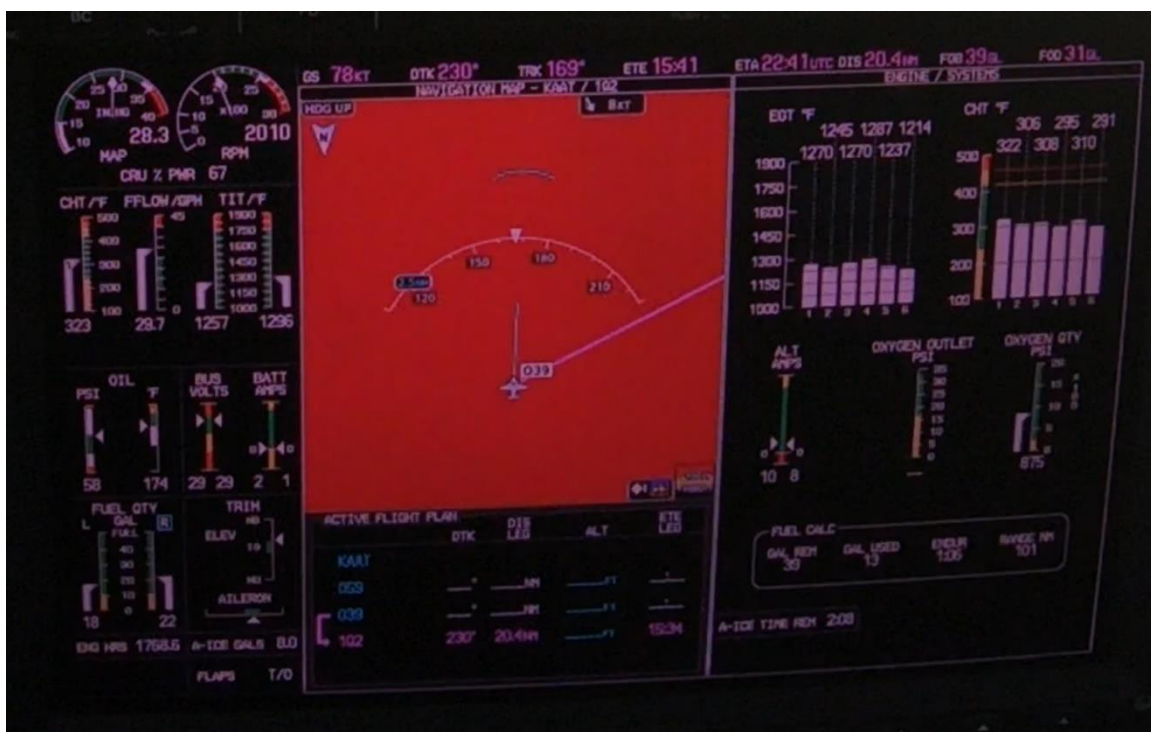
Figure 4 is the MFD approximately 0.5 seconds later. The engine page was displayed as shown in figure 3.

Figure 4. The MFD at 00:49. At this time the left seater had non-verbally took control of the aircraft.

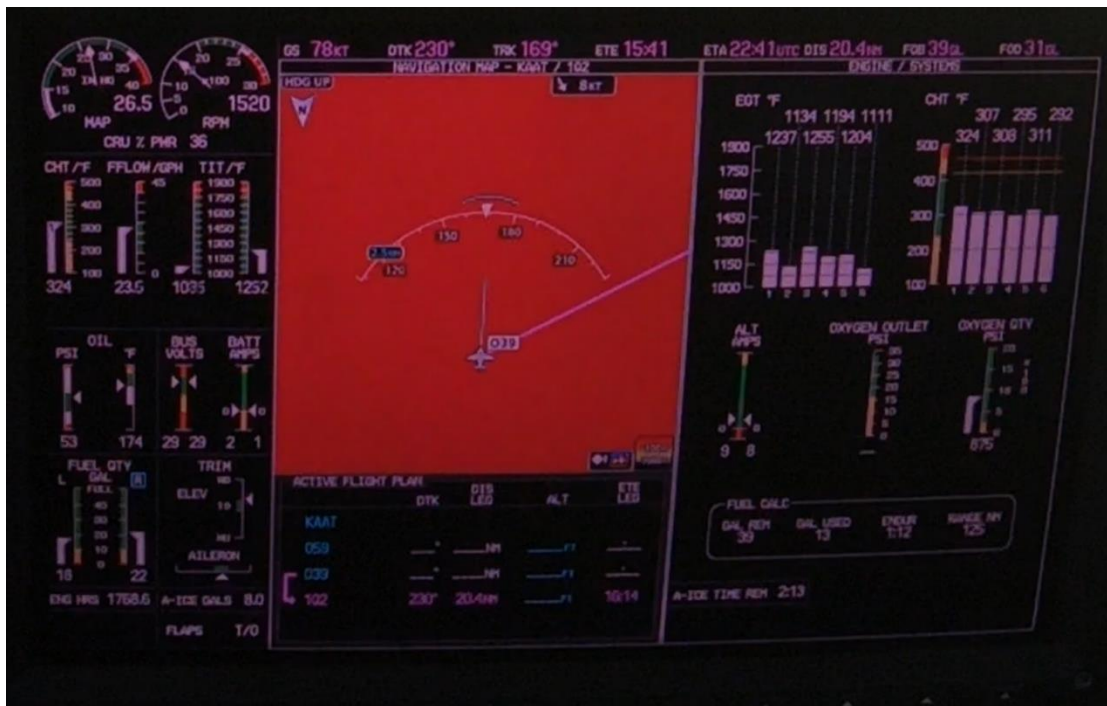
Figure 5. A screenshot at 00:50.

Figure 5 is a screenshot of the MFD at 00:50, approximately 1 second after figure 4. The engine page was displayed as shown in figure 5 at 00:50.

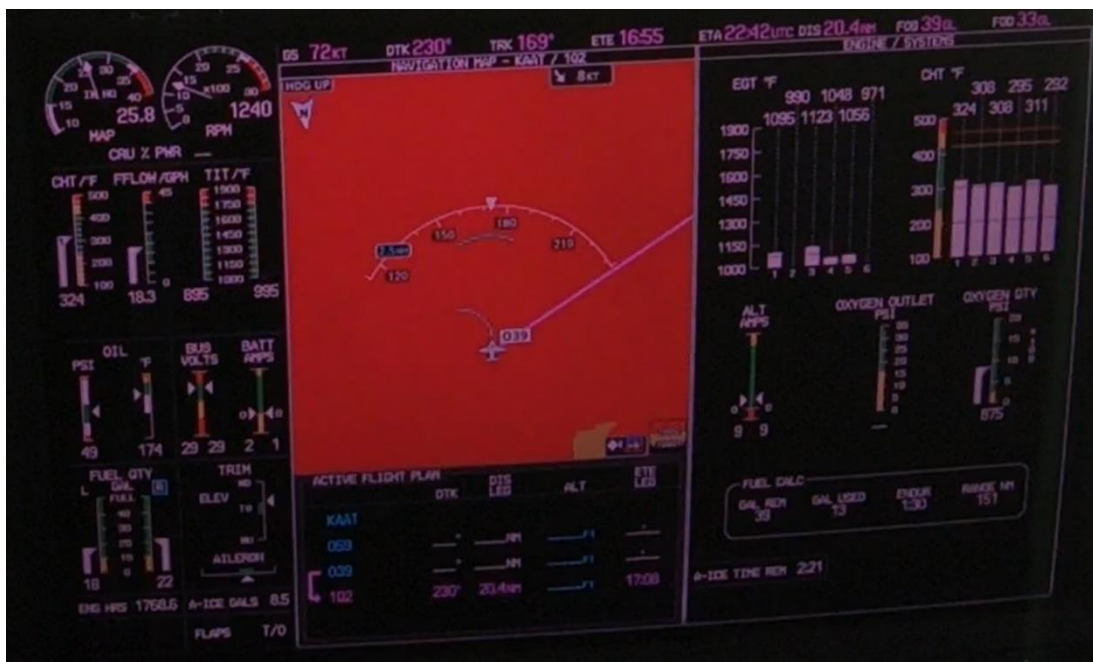
Figure 6. A screenshot at 00:52.

Figure 6 is a screenshot of the MFD at 00:52. The engine page was displayed as shown in figure 5 at 00:50.

In the seven seconds after the loss of RPM, manifold pressure and EGT indications, the aircraft continued to climb in a pitch up attitude. At 00:53, the LSP
