## **NATIONAL TRANSPORTATION SAFETY BOARD**

# **AIRFRAME AND ENGINE EXAMINATION SUMMARY**

**WPR22LA090**

| Aircraft: | N420WT |

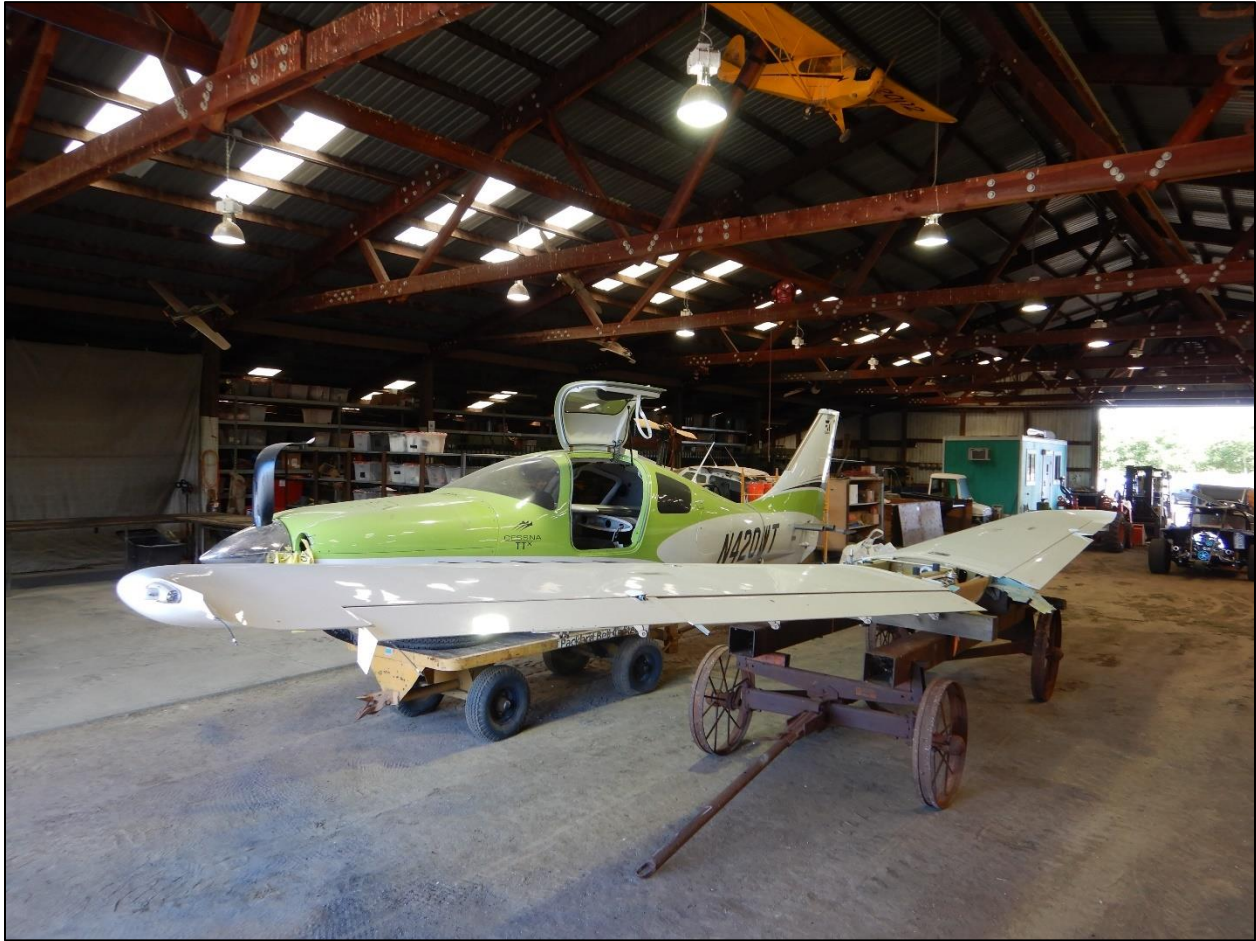
Figure 1-Main wreckage.

The left wing had leading edge impact damage. Aileron control continuity was attained from control rods near the center wing area where the ailerons control tubes had been disconnected during the recovery process. Flaps were positioned between 10 and 15 degrees down. The flap handle on the instrument panel was positioned to the takeoff position. Flight control continuity was established from the cabin area to the aileron wing connection, rudder and elevator linkage in the tail cone area. The nose and main landing gear had impact damage.

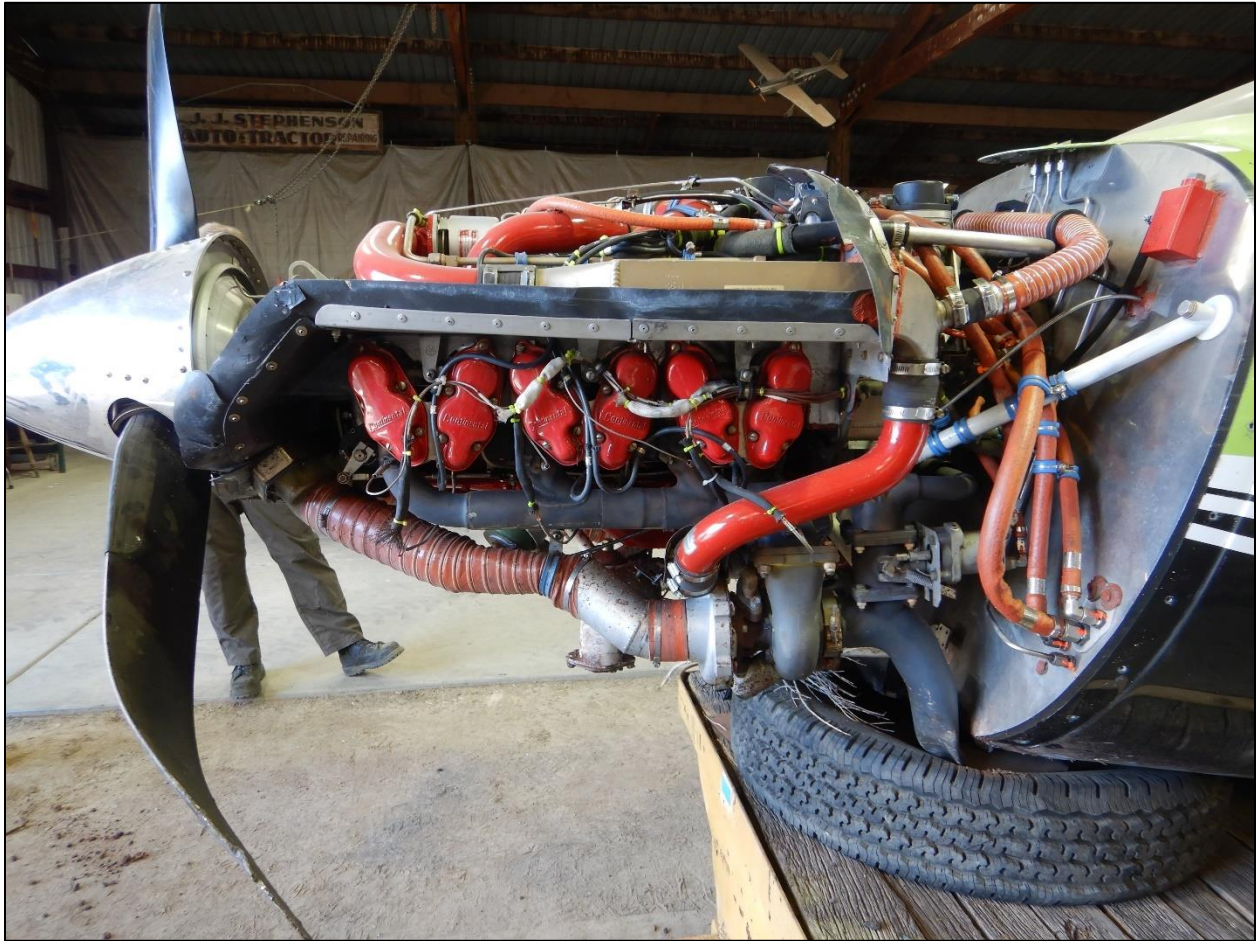
Figure 2-Engine and propeller assembly.

The engine remained attached to the airframe. The engine mounts and carriage assembly were undamaged. The cabin engine control continuity was established. The propeller assembly remained attached to the engine and had impact damage to the hub and its blades. The blades had multidirectional scoring on their cambered sides and were bent rearward. The lower engine cowling had impact damage on the right side and rear center section. The upper cowling was undamaged. The cowling was removed from the engine and impact damage was noted to the induction tubes connecting the air intake box and turbocharger compressor inlets.

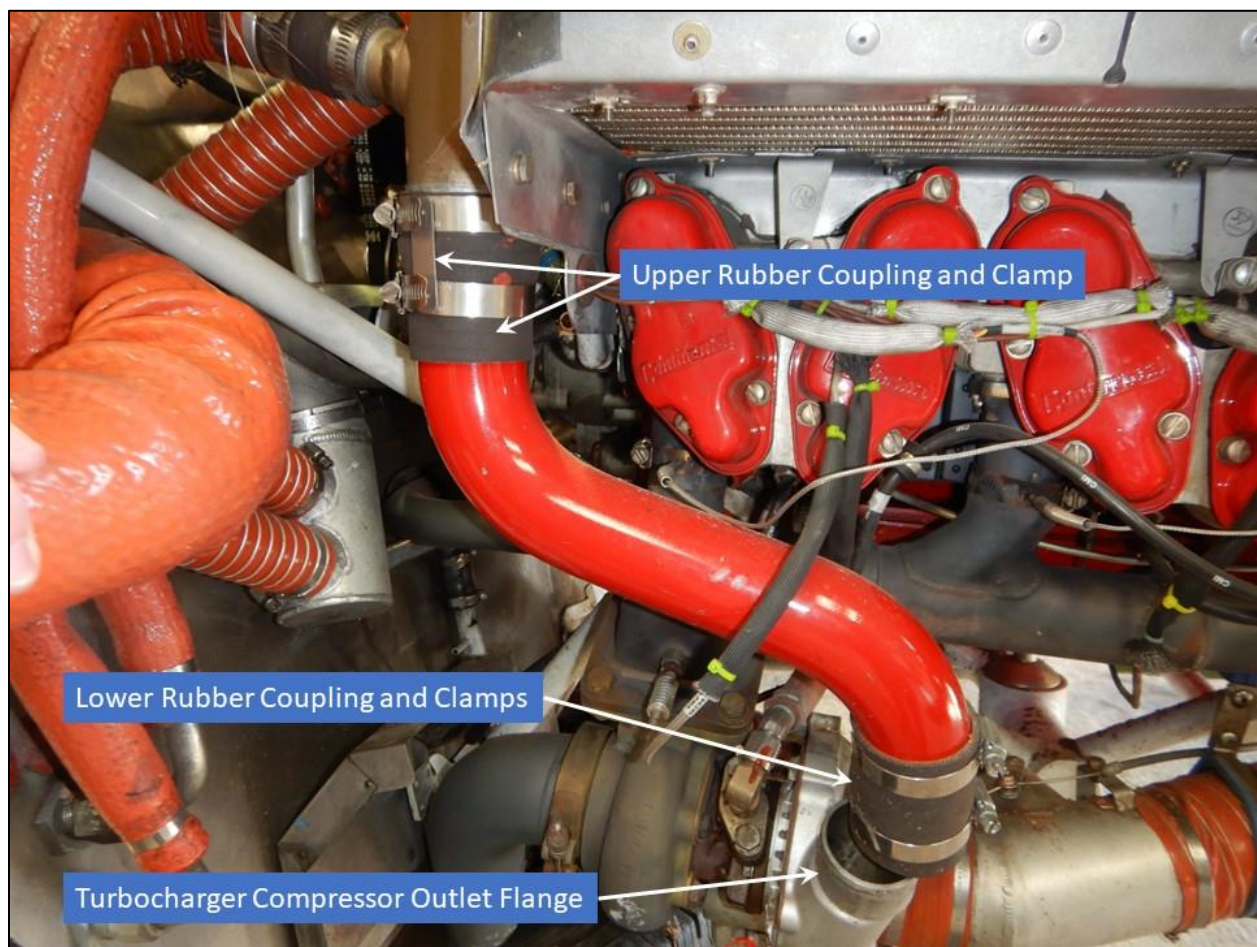
Figure 2-Right side induction tube and rubber couplings.

The right induction tube connecting the turbocharger compressor outlet to the intercooler inlet, separated from the turbocharger compressor outlet flange. The induction tube lower rubber coupling and band clamps remained attached. The tail end of the band clamps separated near the adjustment screw. Both clamps did not have a stamped part number but instead showed dimensions of the clamp's limitations (1-13/16 and 2-3/4). The clamps were tight to the coupling. Two inches of the induction tube was installed into the 3-inch-long rubber coupling leaving only 1 inch remaining to be installed on the turbocharger compressor outlet flange.

The upper rubber coupling had a band clamp assembly attached and was positioned flush to the top side of the rubber coupling. The band clamp assembly was not marked with a part number but with the clamp's limitations and manufacturer's name (1-13/16, 2-3/4 and Aero Seal Breeze). The spacing between the band clamps was 13/16 of an inch and appeared to be a non-manufactured part. According to the Continental Motors the required clamps are a band clamp assembly with the part number of 629163-7. The spacing between these clamps are 1-3/8 inch.

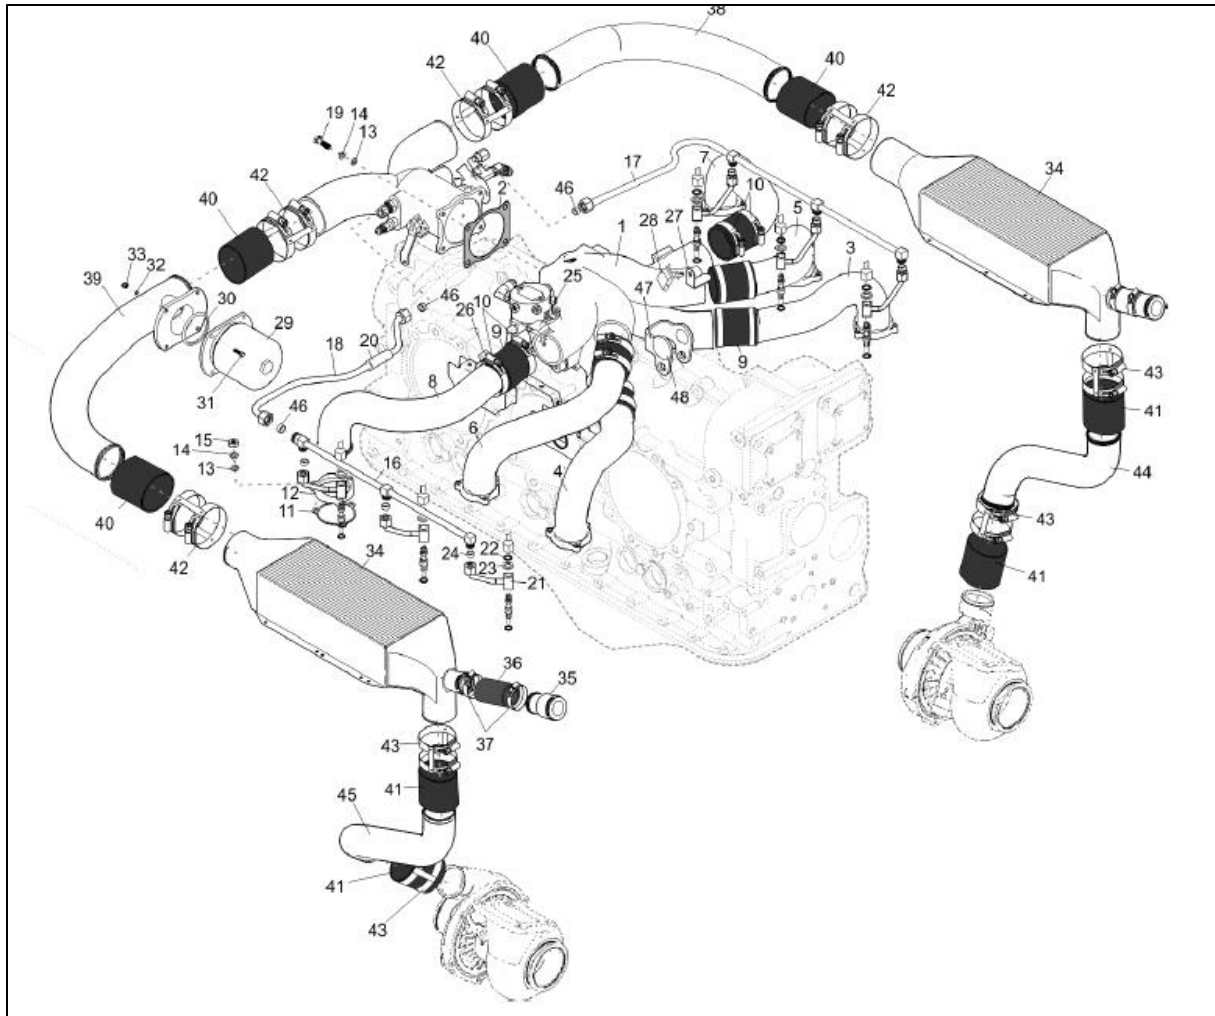
Figure 3-Continental Motors TSIO550C20B induction system parts drawing.

The left side induction tube connecting the turbocharger compressor outlet to the intercooler inlet remained attached. The two single band clamps on the turbocharger compressor outlet side did not have a stamped part number but instead showed dimensions of the clamp's limitations (1-13/16 and 2-3/4). The two clamps on the intercooler side had a part number of MS-35842-13. The tail end of the band clamps separated near the adjustment screws. See Figure 3, part 41, which shows the correct band clamp assembly (629163-7).

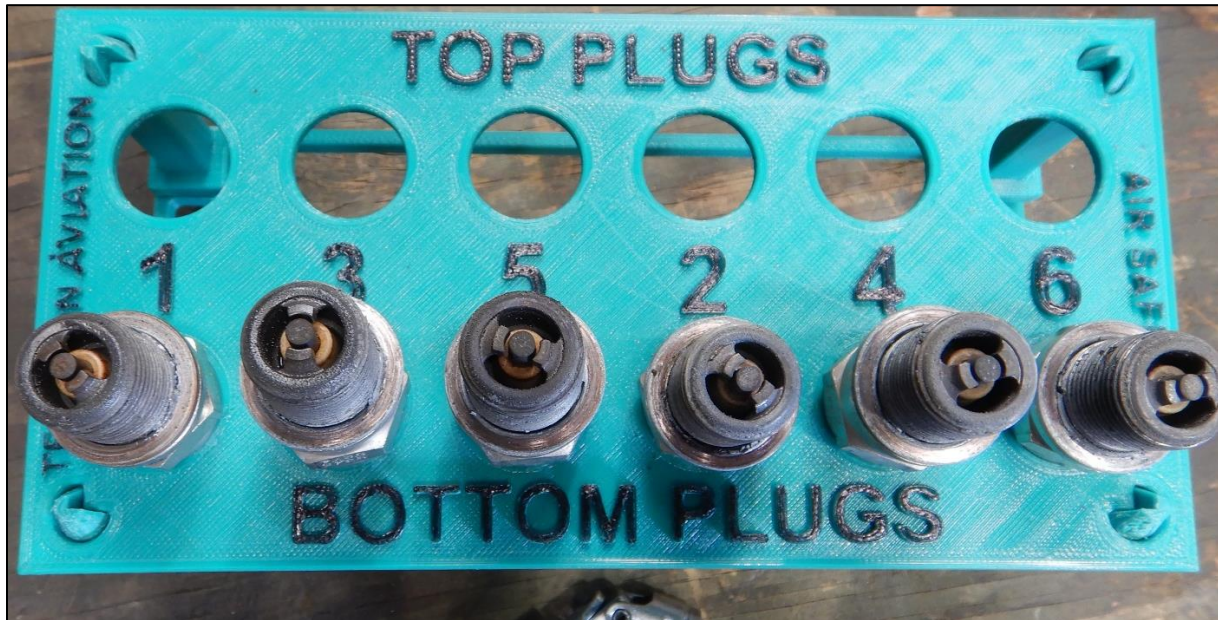
The ignition leads were removed from all sparkplugs. The lower spark plugs were removed from the cylinder and displayed in a rack. The electrodes showed no signs of wear and the electrode areas were dark in color.

Figure 4-Lower sparkplugs.

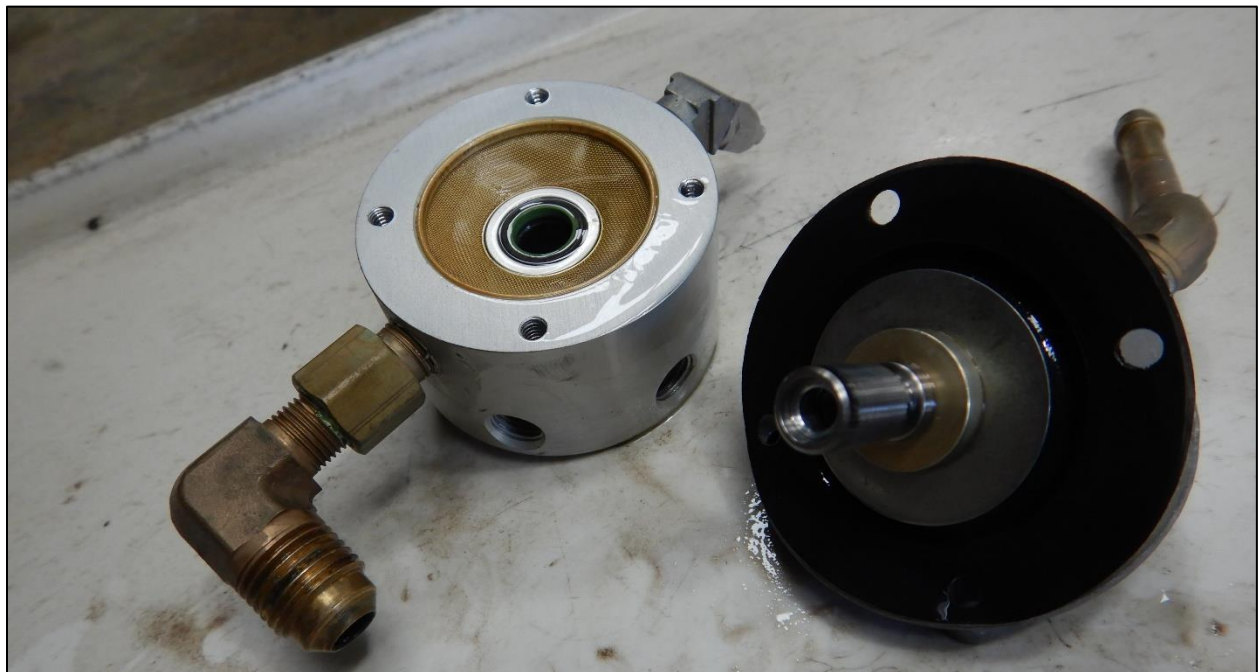
The manifold valve was removed and disassembled. The diaphragm and the internal components were undamaged. The manifold valve had fuel in the cavity and the inlet screen captured a small amount of fibrous debris.

Figure 5-Fuel manifold valve, disassembled.

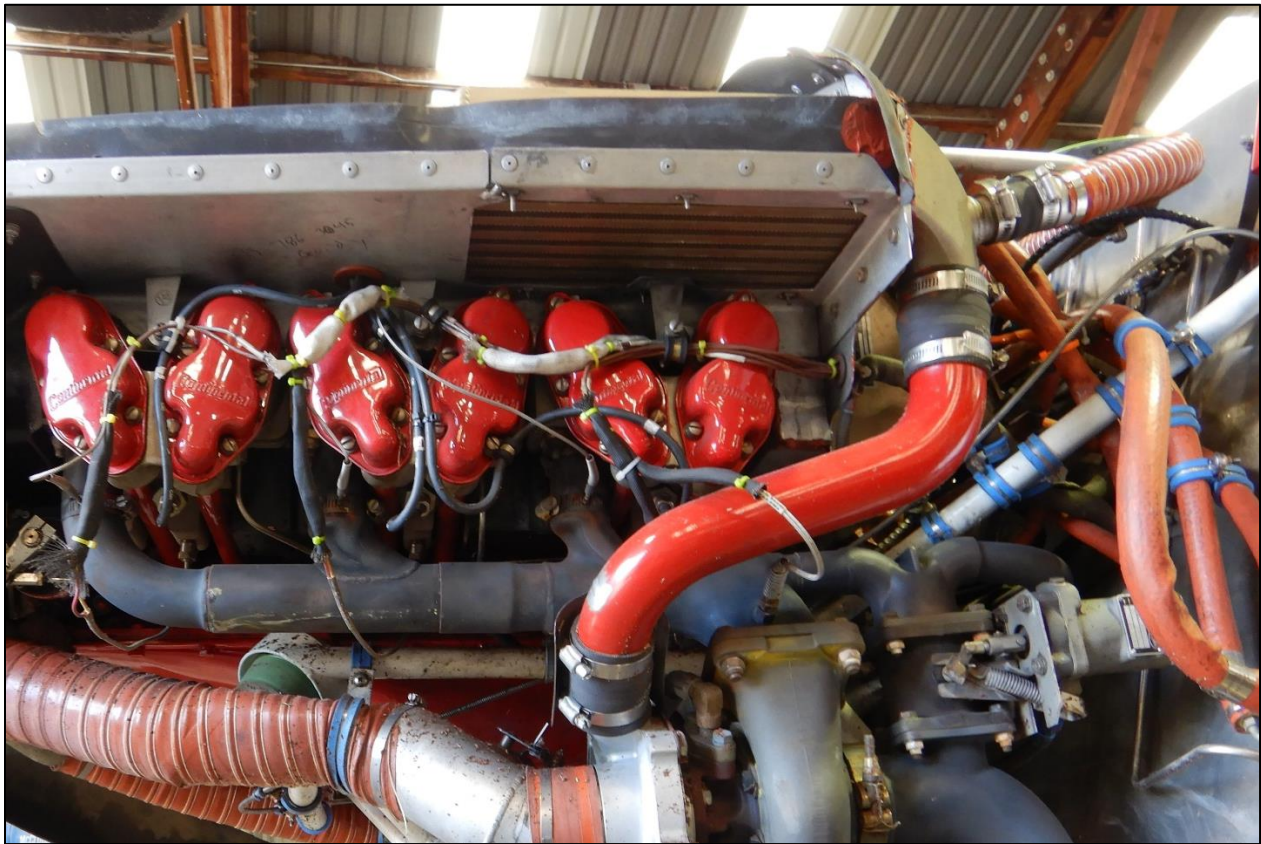
The lower cowling was installed on the airframe and the damage located on the right side of the cowling was concentrated at and below the right turbocharger location.

Figure 6-Left side view of the engine.
