# National Transportation Safety Board

WPR22LA090

## **ENGINE TEST RUN REPORT**

Location: Ravendale, California  
Date: January 28, 2022  
Time: 1425 PDT  
Airplane: Textron Aviation T240

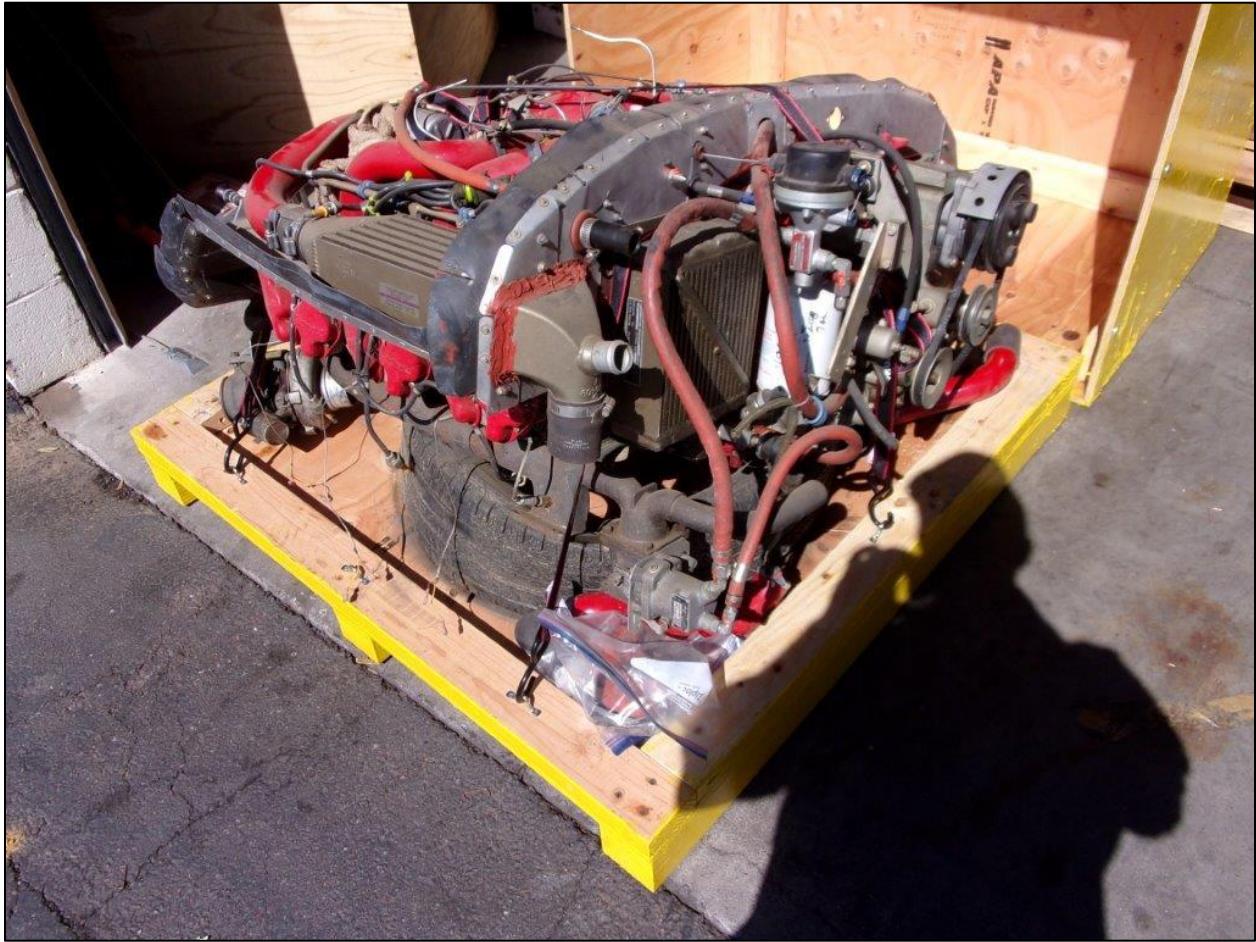
The engine was shipped to Aircraft Engine Specialists from the wreckage recovery facility in Pleasant Grove, California. The turbochargers, parts of the exhaust piping and induction tubes were removed in preparation for shipping.

**Figure 1-Engine after shipment.**

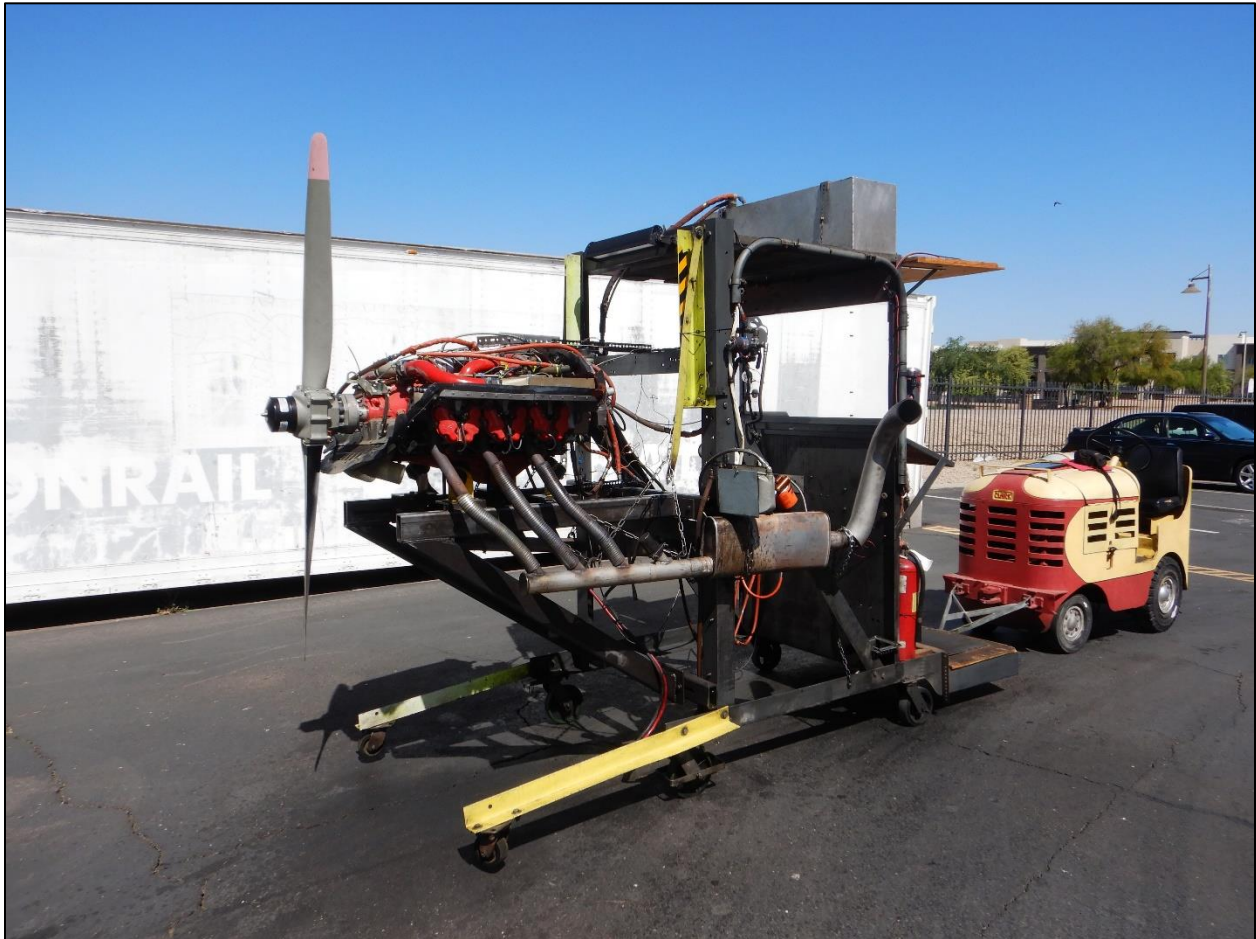
The engine was removed from the shipping container and attached to an engine mount assembly and test stand. The turbochargers, wastegate, exhaust stacks and mufflers were not installed on the engine for the test run. The oil filter was removed, and a new filter was installed. The engine was serviced with 8 quarts of oil. A two-bladed fixed-pitched test propeller was attached to the crankshaft propeller flange.

**Figure 2-Engine installed on a test stand.**

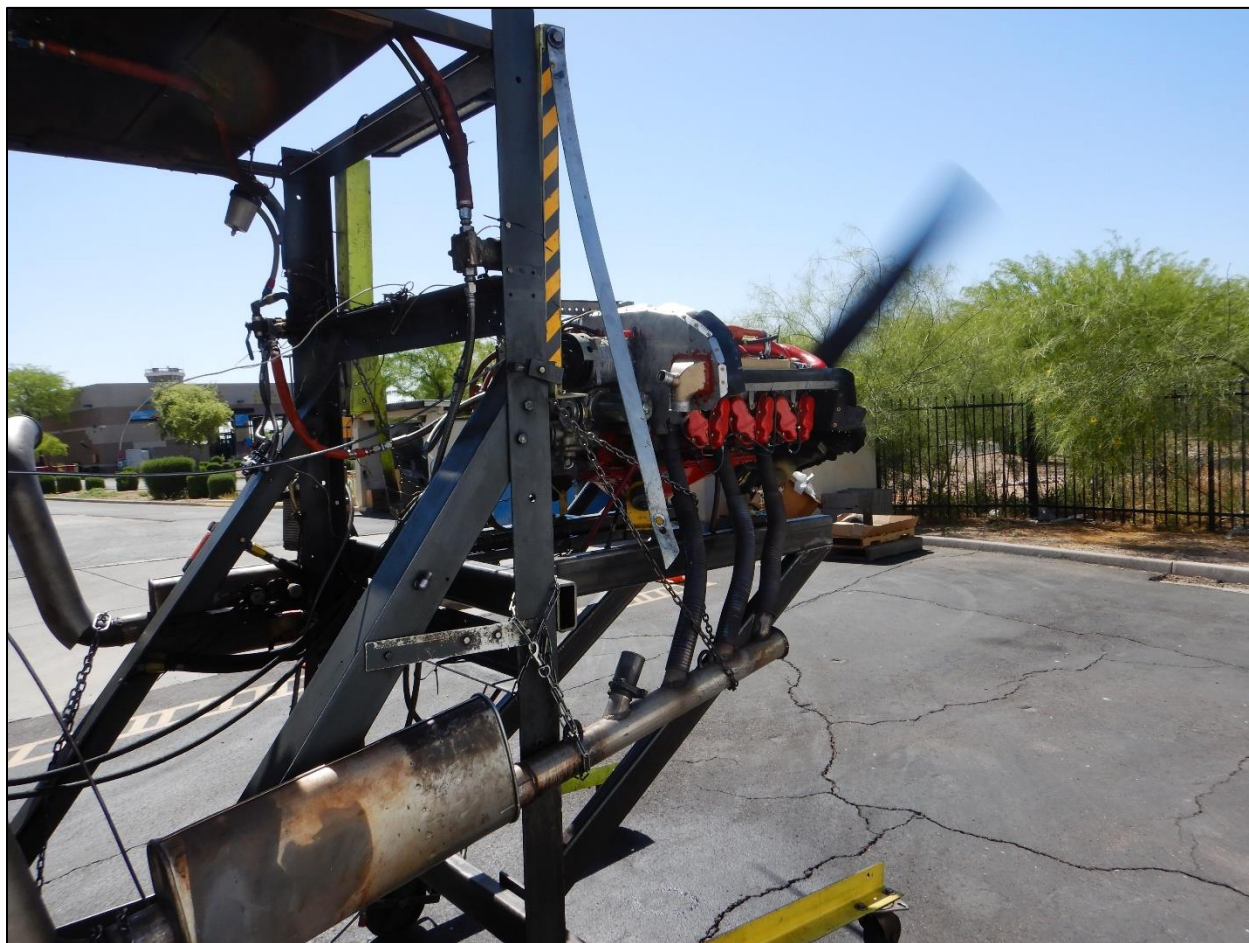
The engine started with no hesitation and continued to idle smoothly at about 1,000 rpm for about 6 minutes. During this time, oil temperature increased to a normal level. Oil pressure continued to rise to about 80 psi.

**Figure 3-Engine operating on the test stand.**

The engine throttle was advanced to about 1,400 rpm and a "magneto check" was performed. The rpm drop was about 70 rpm for each magneto. The engine throttle then was advanced to about 2,400 rpm, where the engine continued to run smoothly at this rpm for about 7 minutes. No anomalies were noted. The engine throttle was brought back to an idle rpm where the engine continued to cool down for about 2 minutes. The mixture was pulled to the "cutoff" position and the engine shutdown normally.

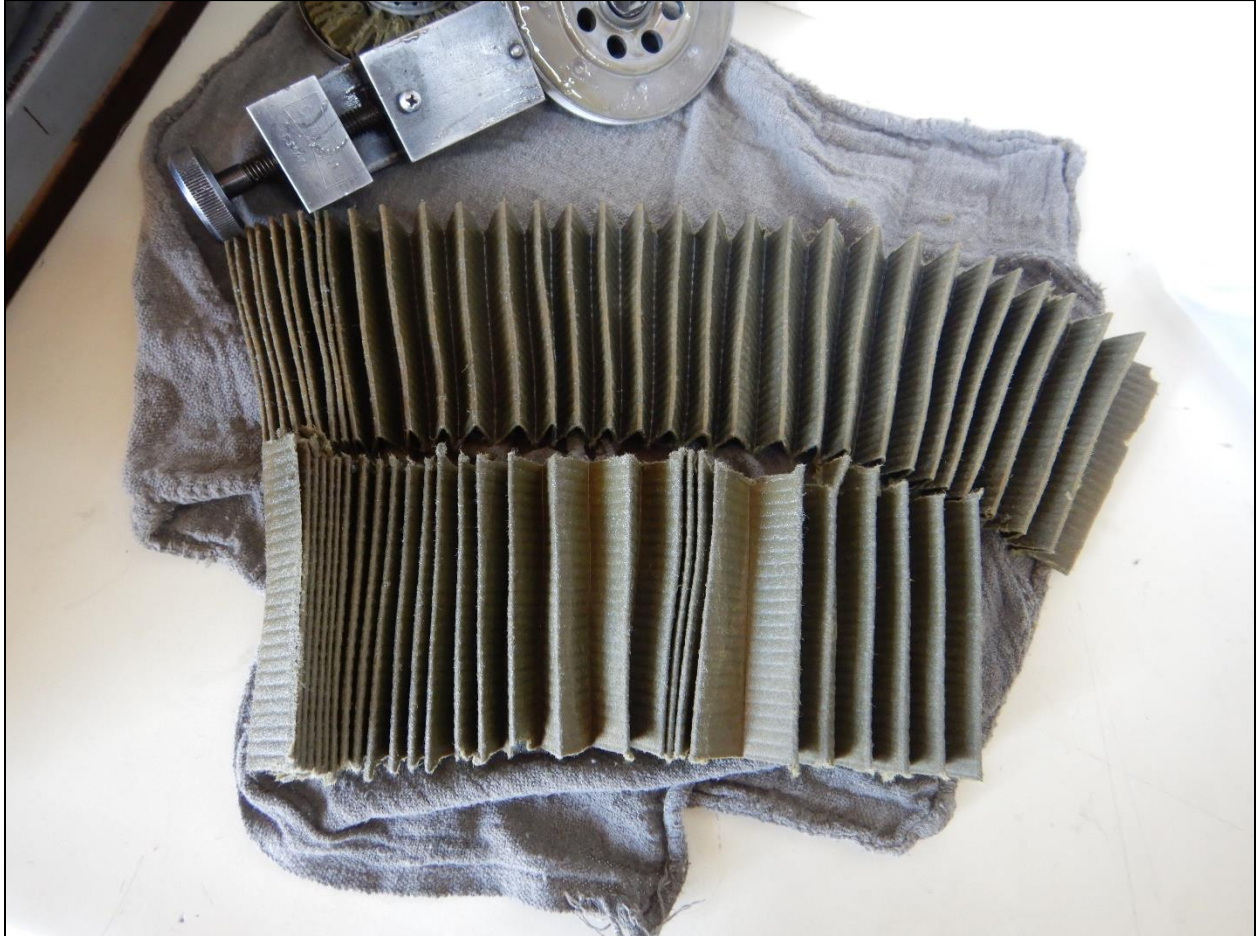
The oil filter that was removed prior to the engine test run and disassembled. The filter revealed no contamination.

**Figure 4-Disassembly of the oil filter.**
