# National Transportation Safety Board

WPR22LA093

## **MATERIALS LABORATORY**

Factual Report 23-001

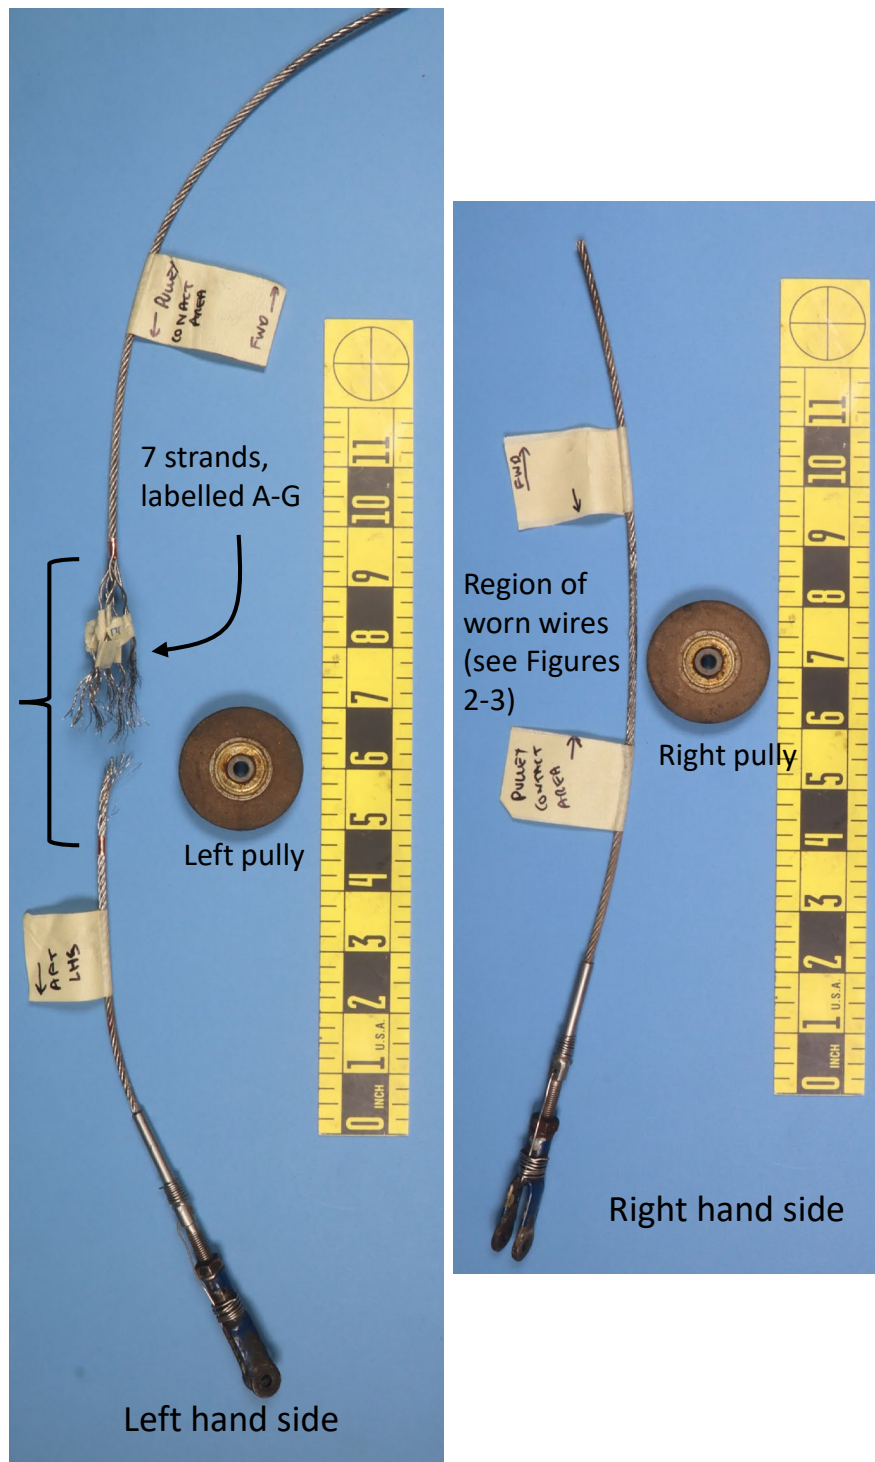
A visual inspection of right and left pulleys was performed. The grooves in the pulleys exhibited deposits and remnants of dried or degraded grease. No fresh grease was present.

**Figure 1.** Image of the submitted items. The rudder cables showed evidence of wear in the area that corresponded to their respective pulleys.

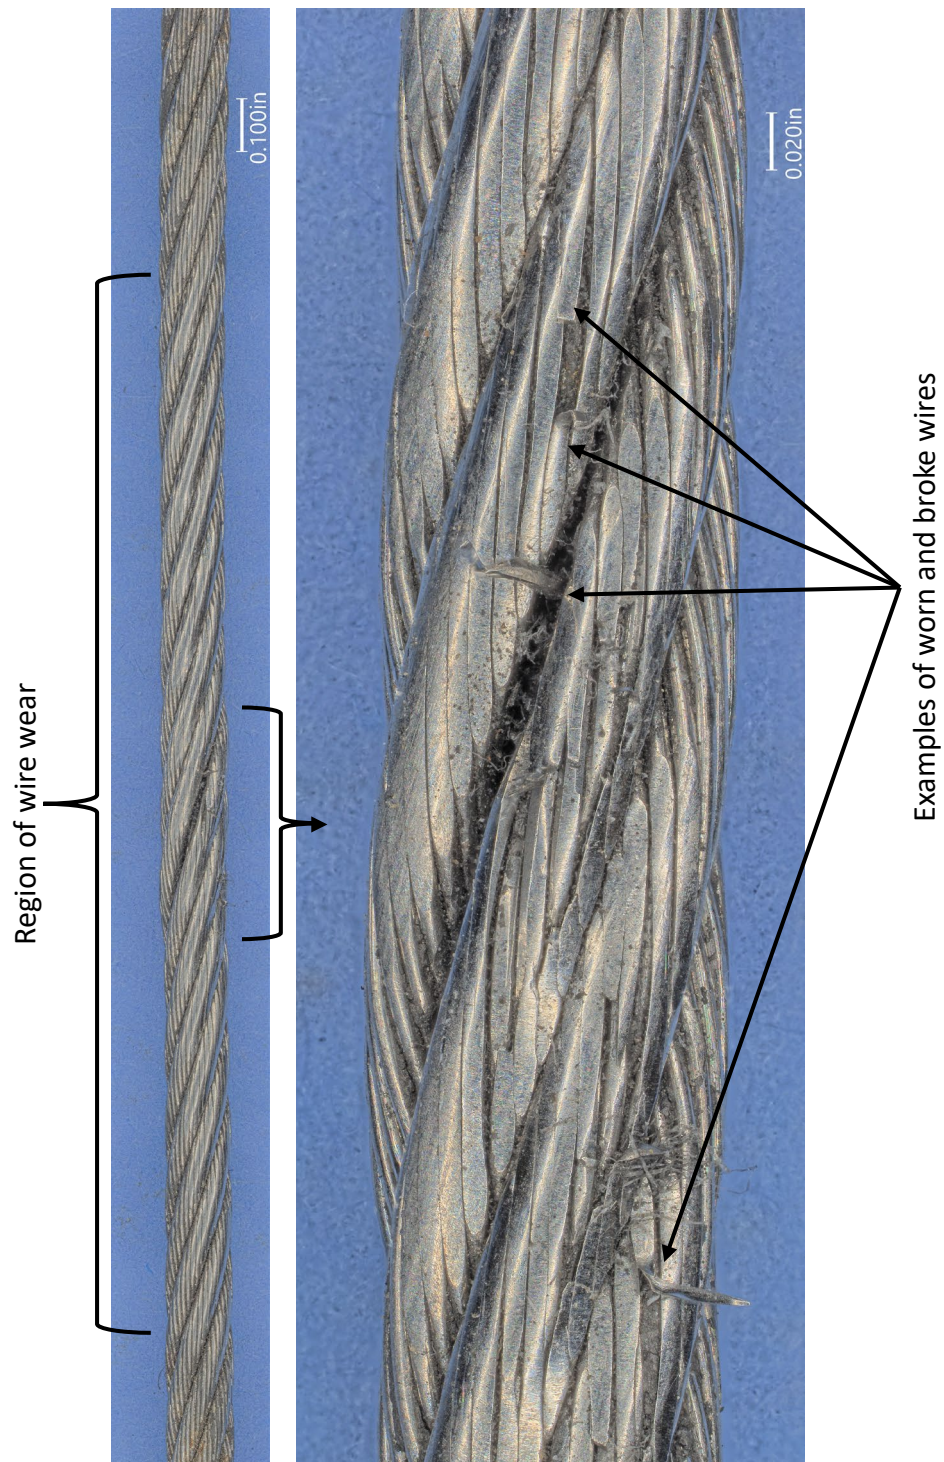
Examination of the portion of right rudder cable revealed wire wear as documented in Figure 2. Wires that had worn through were observed. The right rudder cable piece had an average diameter of 0.132 inch. In the worn region the typical diameter ranged from 0.105 inch to 0.117 inch. An Olympus Vanta X-ray fluorescence (XRF) portable alloy analyzer identified the material of the right cable as grade 304 stainless steel.

**Figure 2.** Digital microscope images of the worn area on the right rudder cable piece.

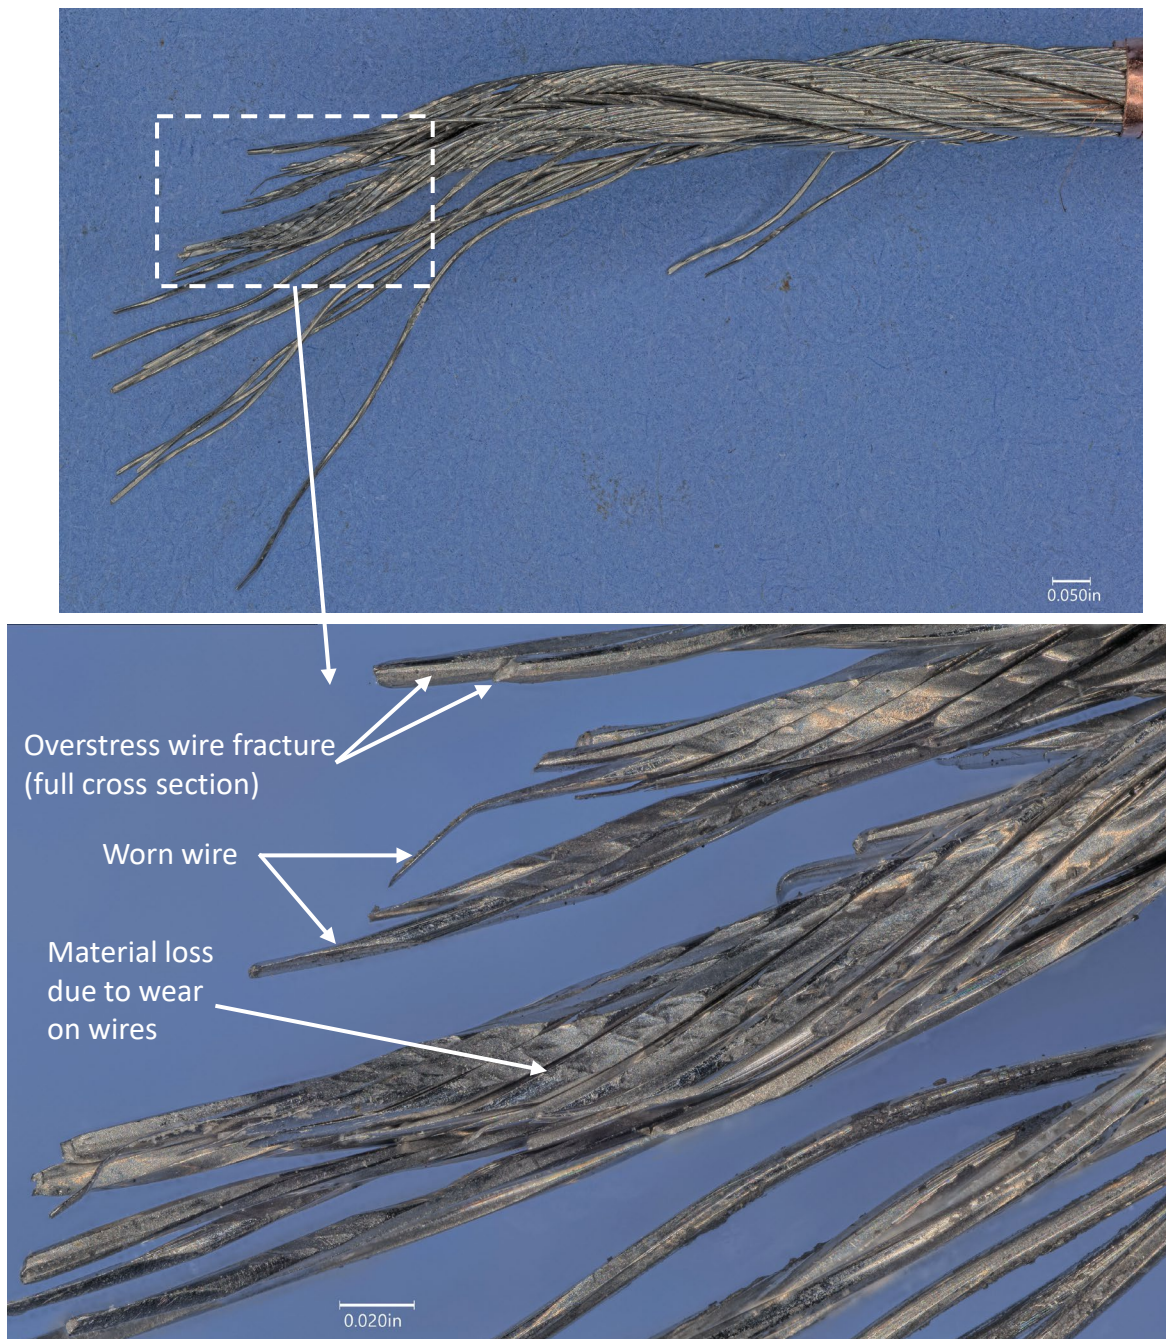
Examination of the portions of left rudder cable revealed that the cable fully fractured in a region exhibiting wear as documented in Figures 3 through 7. Figure 3 shows close images of the aft fractured piece. Wear of individual wires was observed.

**Figure 3.** Digital microscope images of the worn area on the aft pieces of left rudder cable portion.

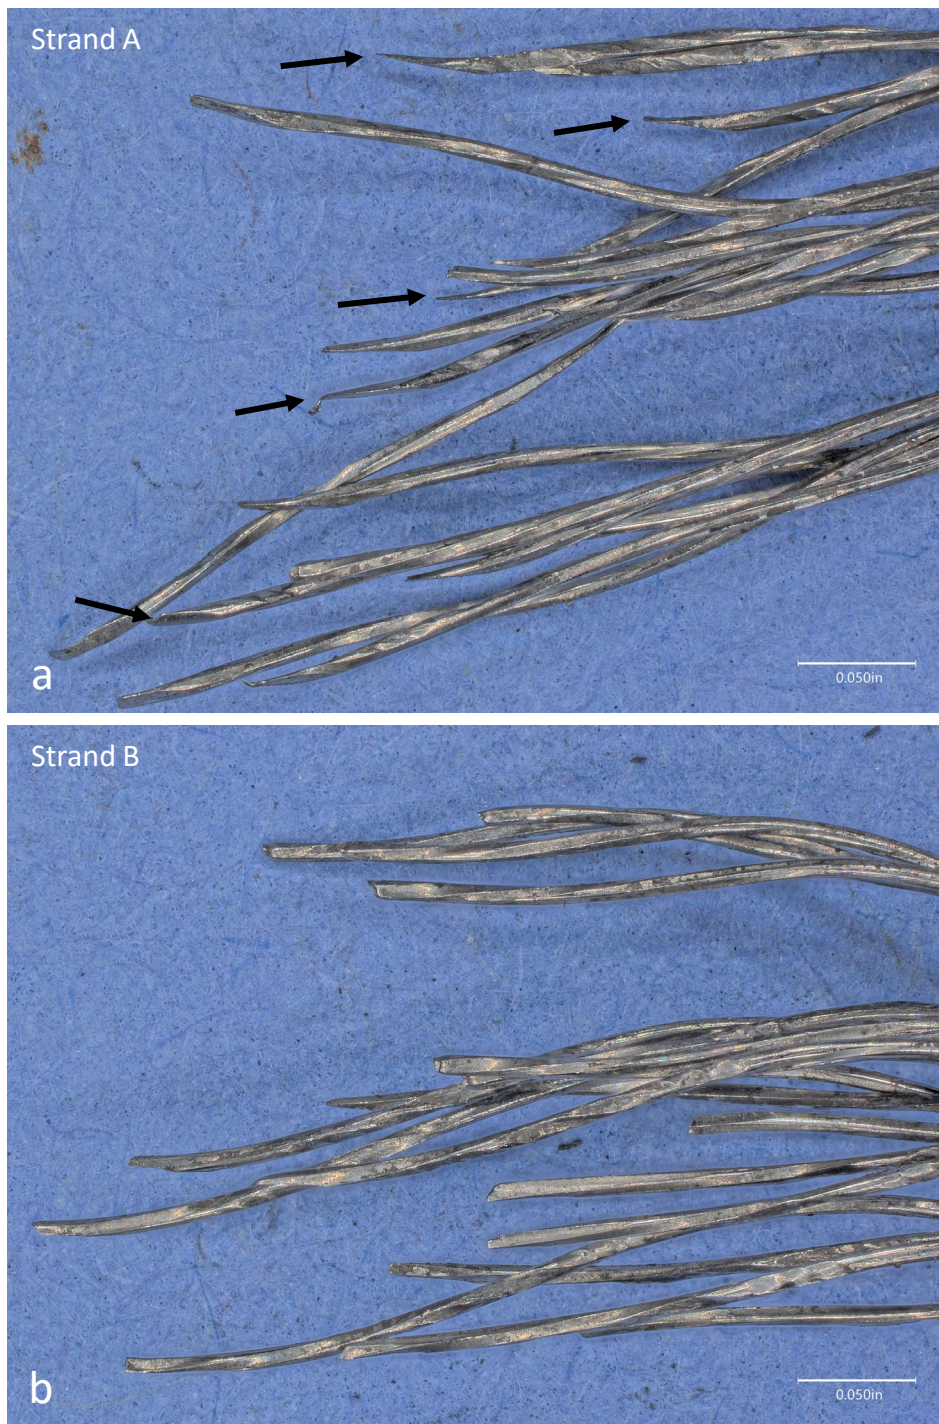
ends in each strand were imaged using a digital microscope as documented in Figures 4 through 7. Approximately 52% of the wires exhibited wear with about 43% of the wires exhibiting material loss through the full diameter of the wire due to wear. The balance of the wires fractured in overstress across the full wire diameter.

**Figure 4.** Digital microscope images of the left side forward rudder cable piece (see Figure 1). View a shows the fractured wire ends in strand A. Wear reduced the ends of the wire to a knife edge, indicated by arrows. View b shows the fractured wire ends in strand B.

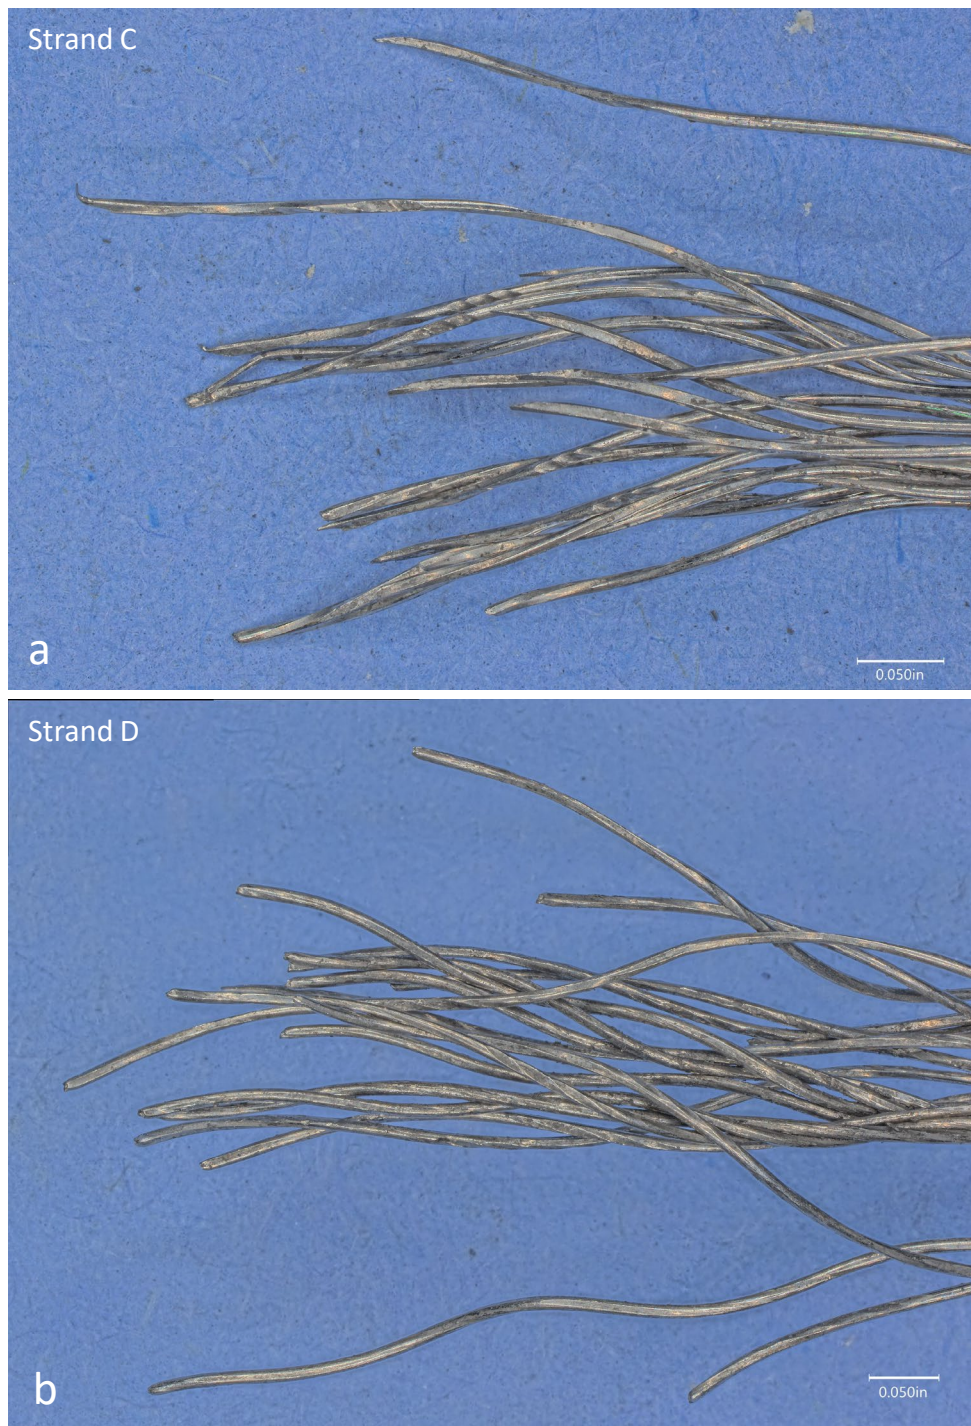
**Figure 5.** Digital microscope images of the left side forward rudder cable piece (see Figure 1). View a shows the fractured wire ends in strand C. View b shows the fractured wire ends in strand D.

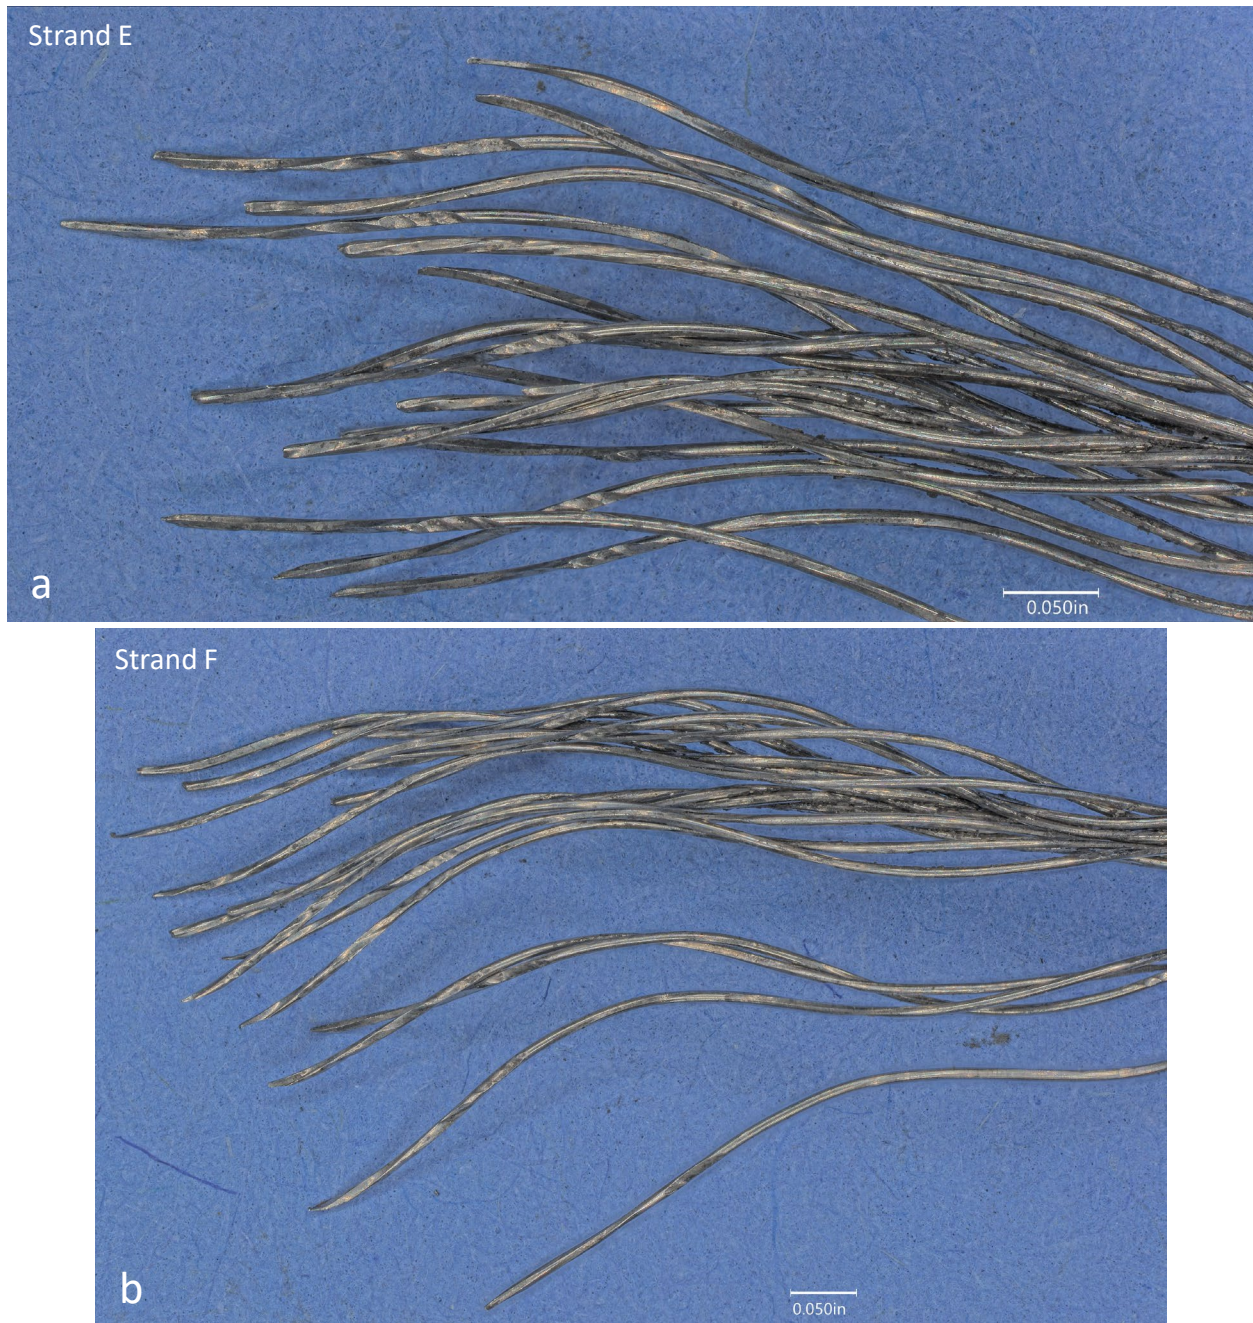
**Figure 6.** Digital microscope images of the left side forward rudder cable piece (see Figure 1). View a shows the fractured wire ends in strand E. View b shows the fractured wire ends in strand F.

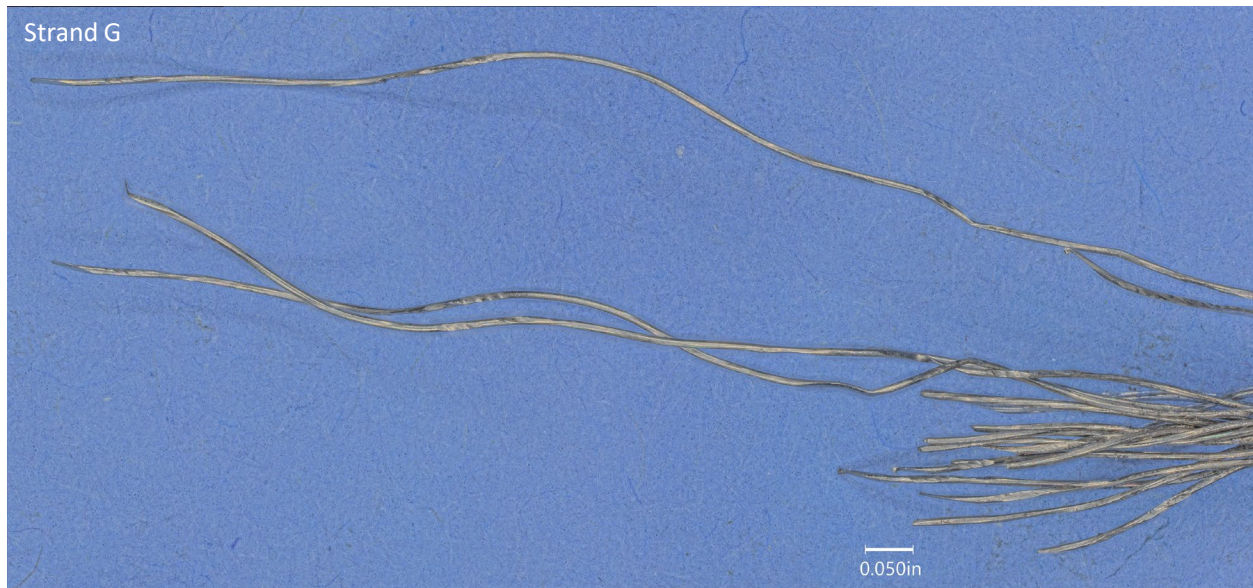
**Figure 7.** Digital microscope image of the left side forward rudder cable piece (see Figure 1) showing the fractured wire ends in strand G.
